Inspection Photos  
Location Name: Southern Ute #16  
API: 05-067-07613

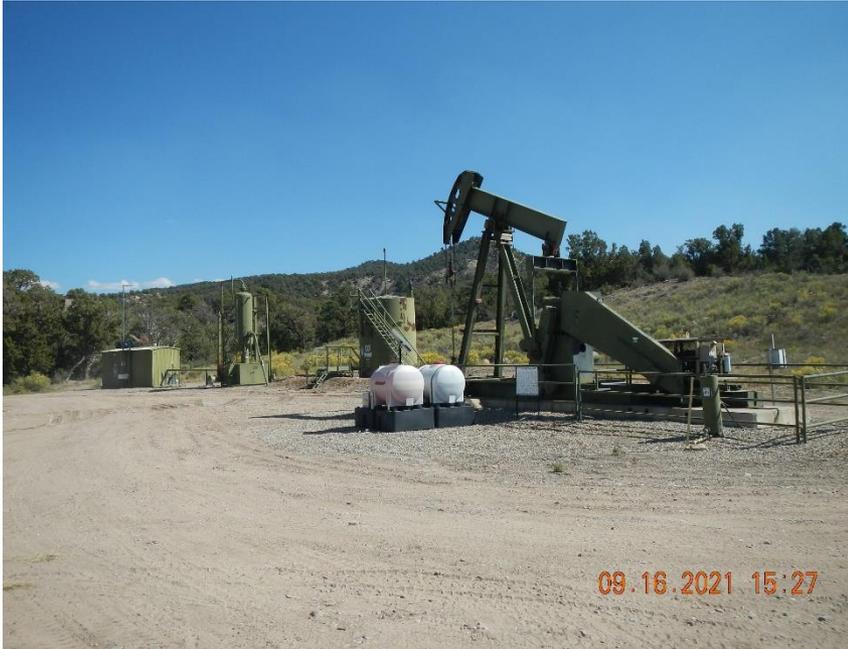
Southern Ute #16 location photo.

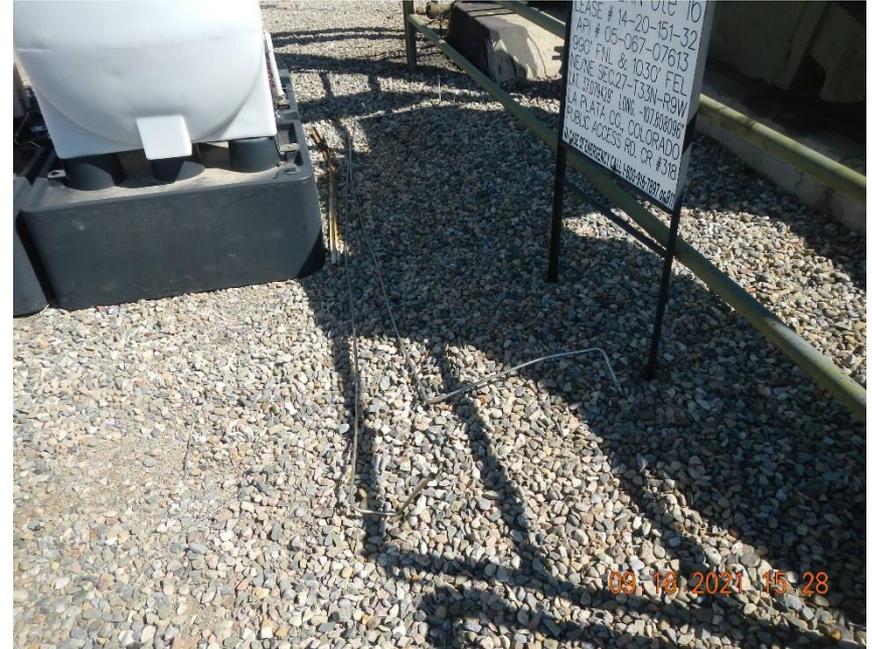
Chemical injection systems are not in use.

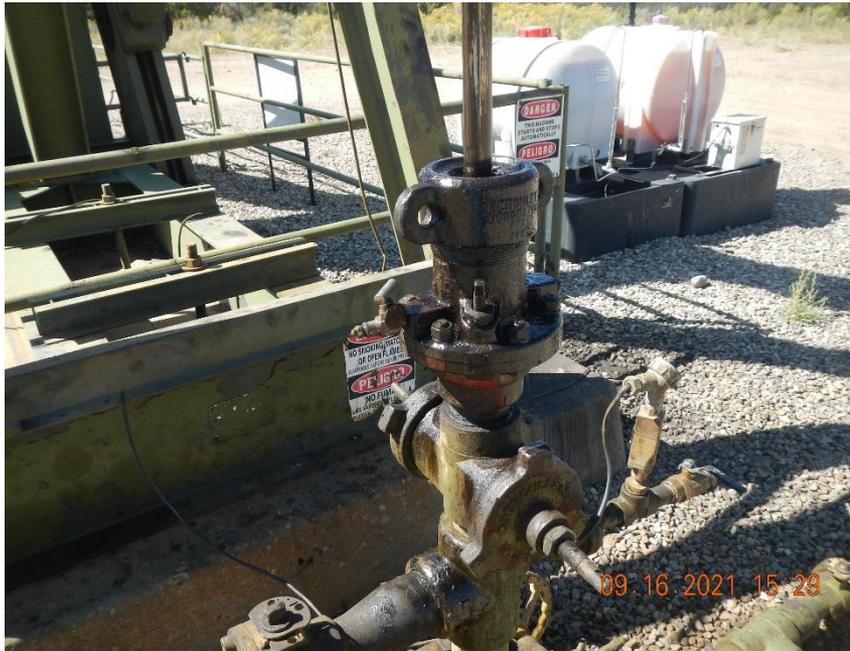
Well head is stained and wet.

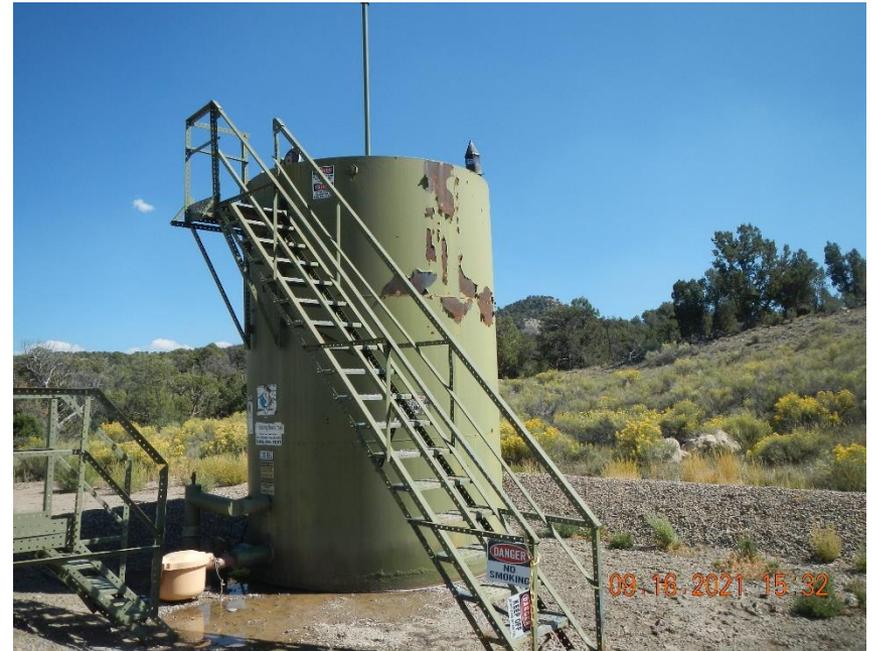
Paint is peeling off of AST. Hole in AST is the point source for Spill/Release Point ID #480754.

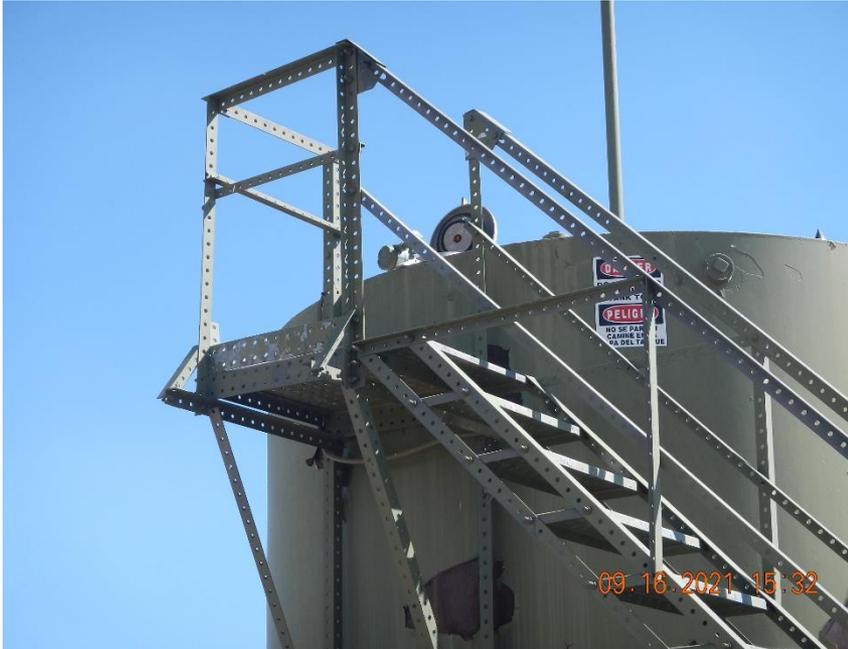
**Gauge hatch was open that the time of this inspection.**

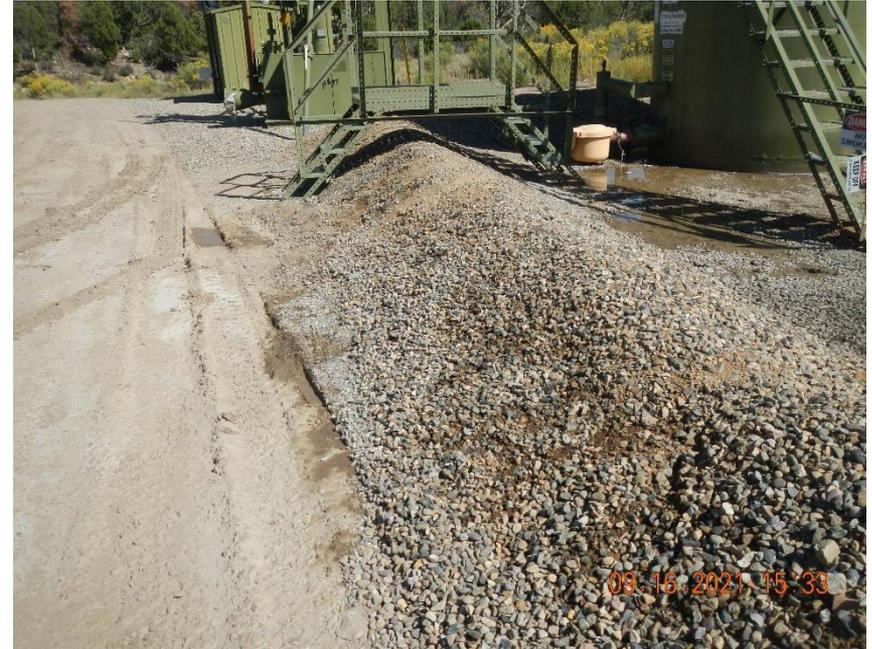
**Secondary containment berm is wet and stained.**

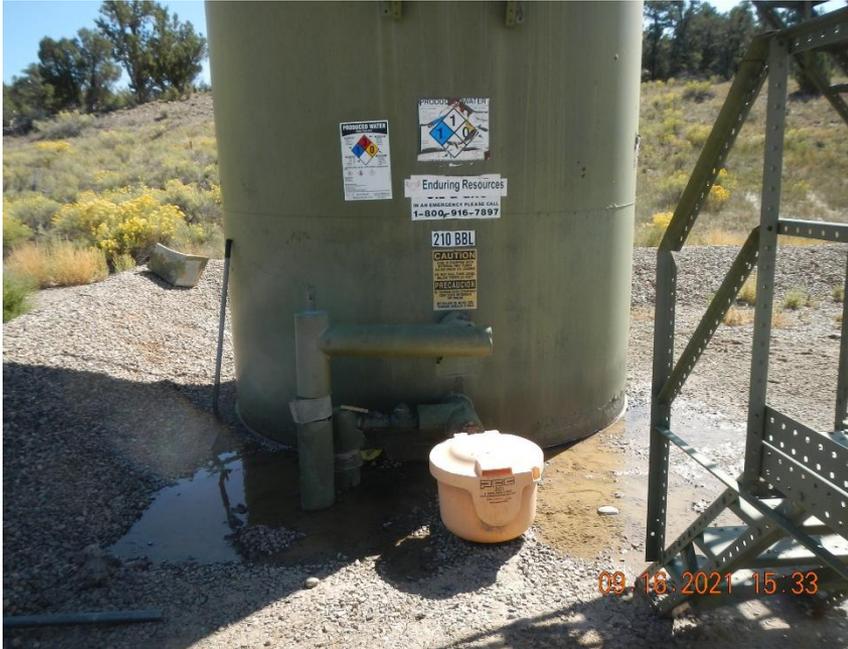
**Standing water near base of AST.**

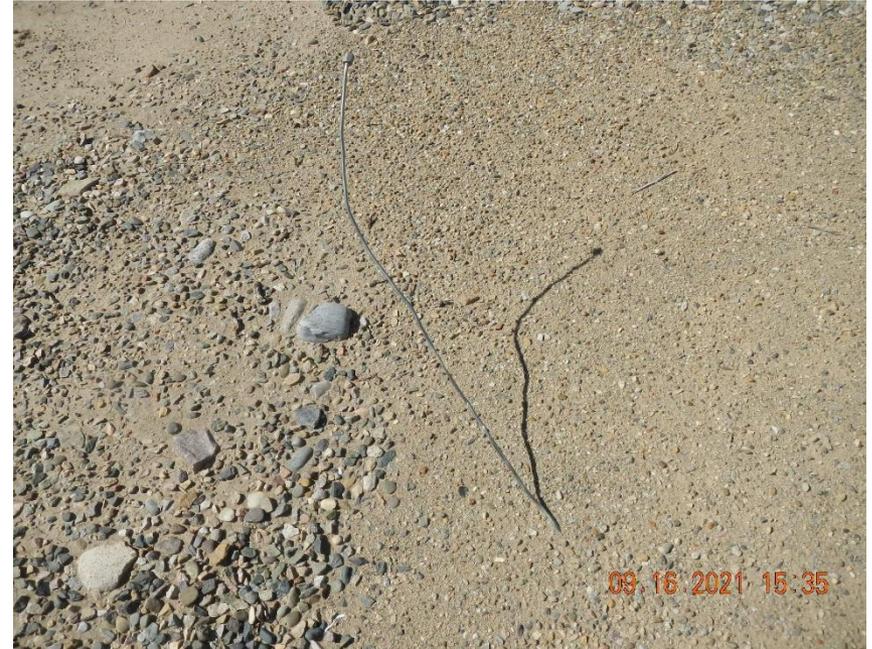
**Stainless steel tubing protruding from ground.**

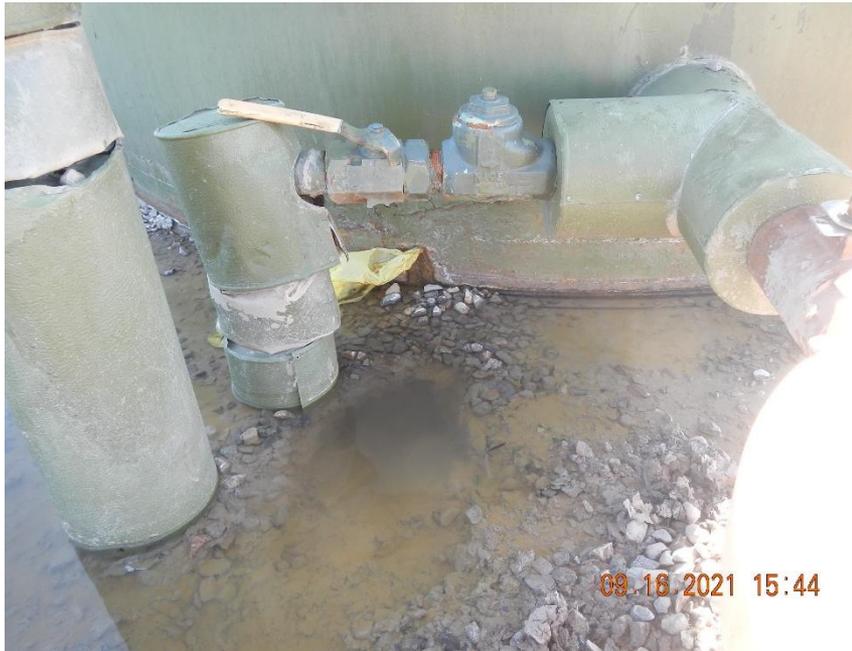
**Hole in AST near load out valve. Yellow plastic bag stuck in hole.**

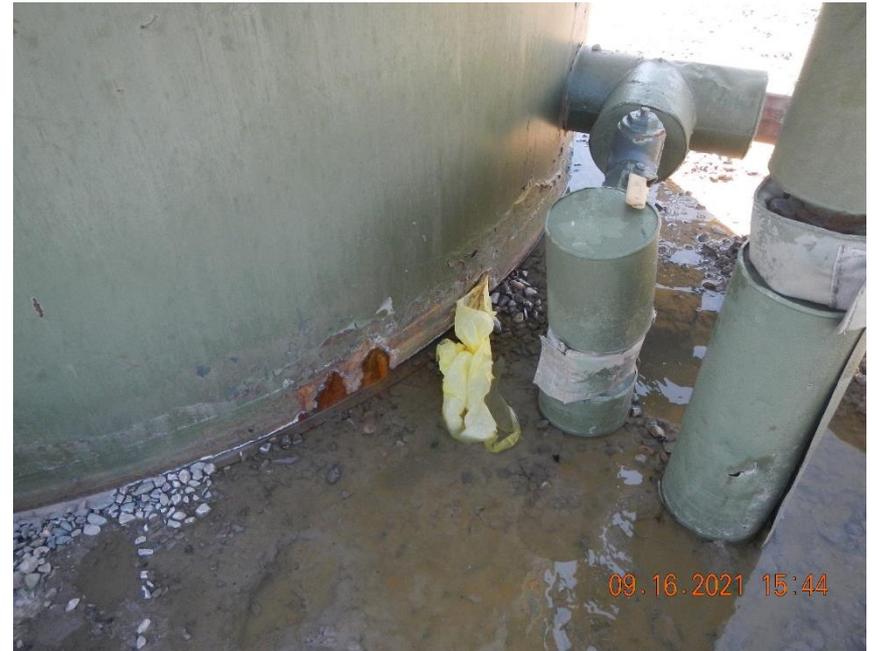
**Point source of Spill/Release Point ID #480754 with yellow plastic bag protruding from hole in AST.**

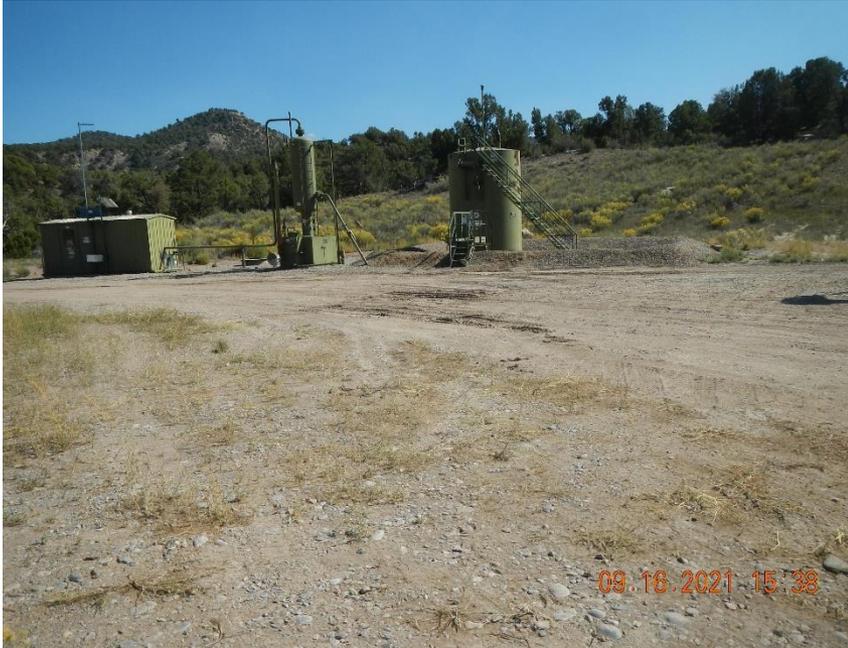
**Evidence of flow from Spill/Release Point ID #480754 from AST towards the northern edge of location.**

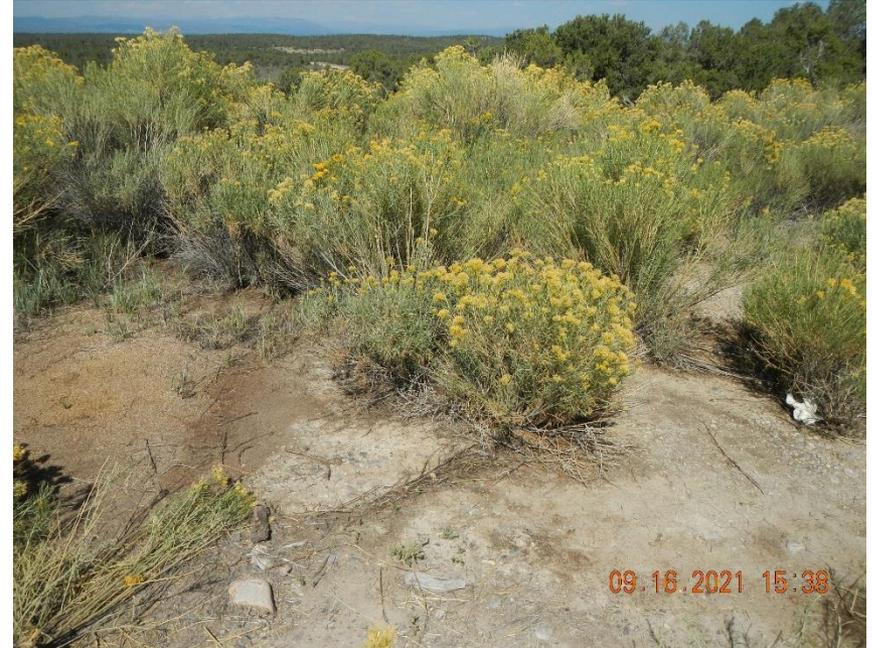
**Northern edge of Southern Ute #16 location with wet and stained soil present.**

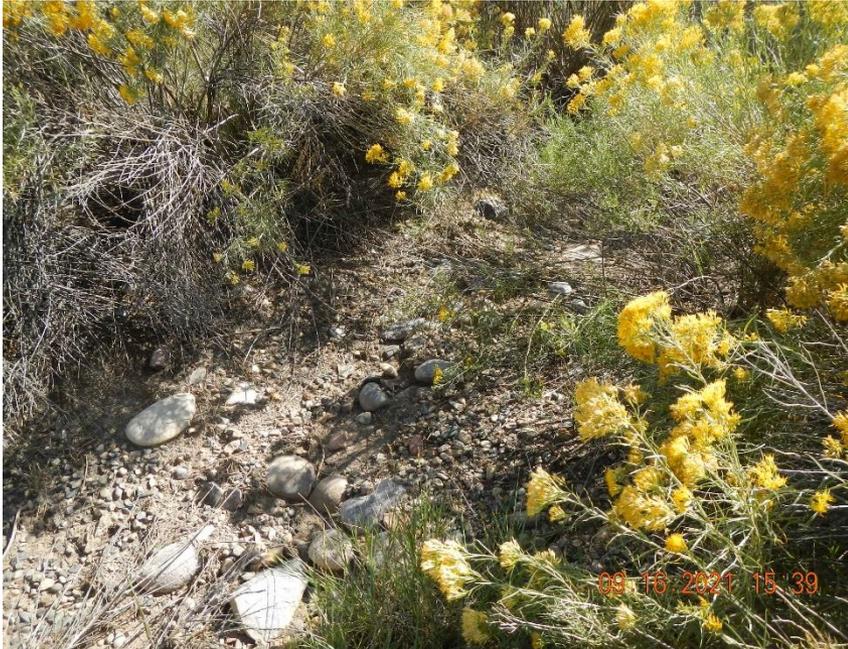
**Erosional channel on fill slope along northern edge of location.**

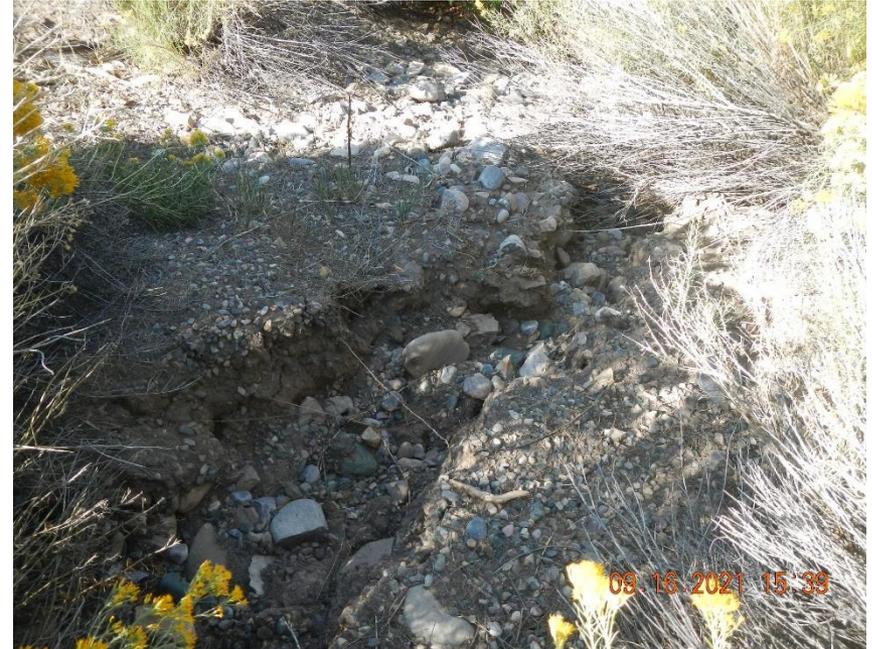
**Incised erosional channel on fill slope along northern edge of location.**
