Inspection Photos
Operator: Simcoe
Facility: 067-06640
Date: 9/16/2021

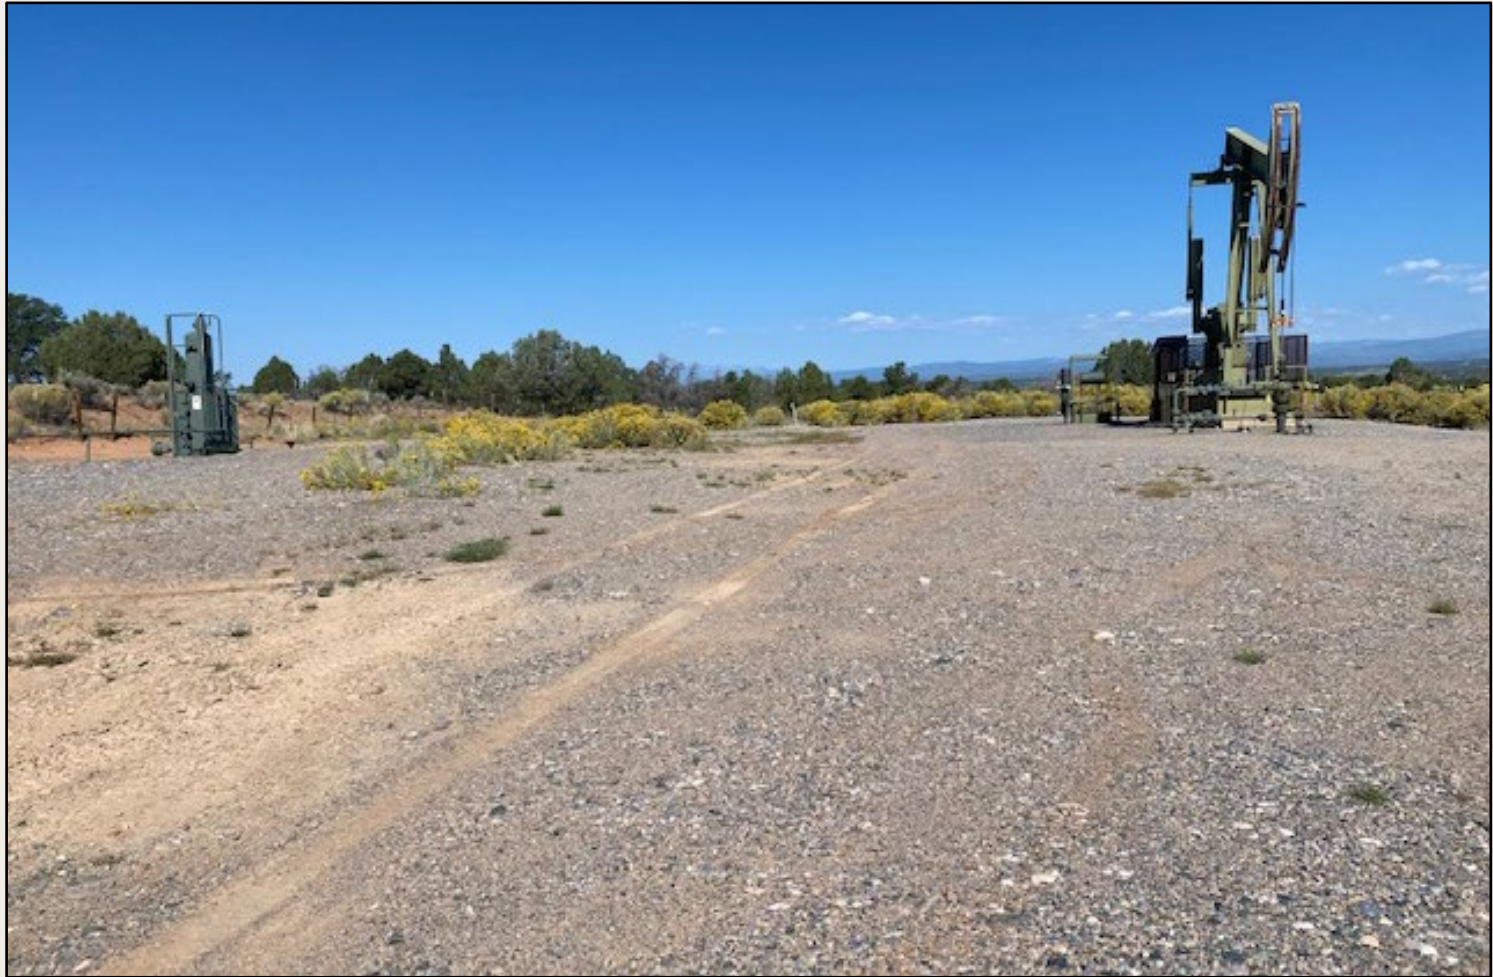
Photo 1. View of the project area from the well pad entrance facing center.

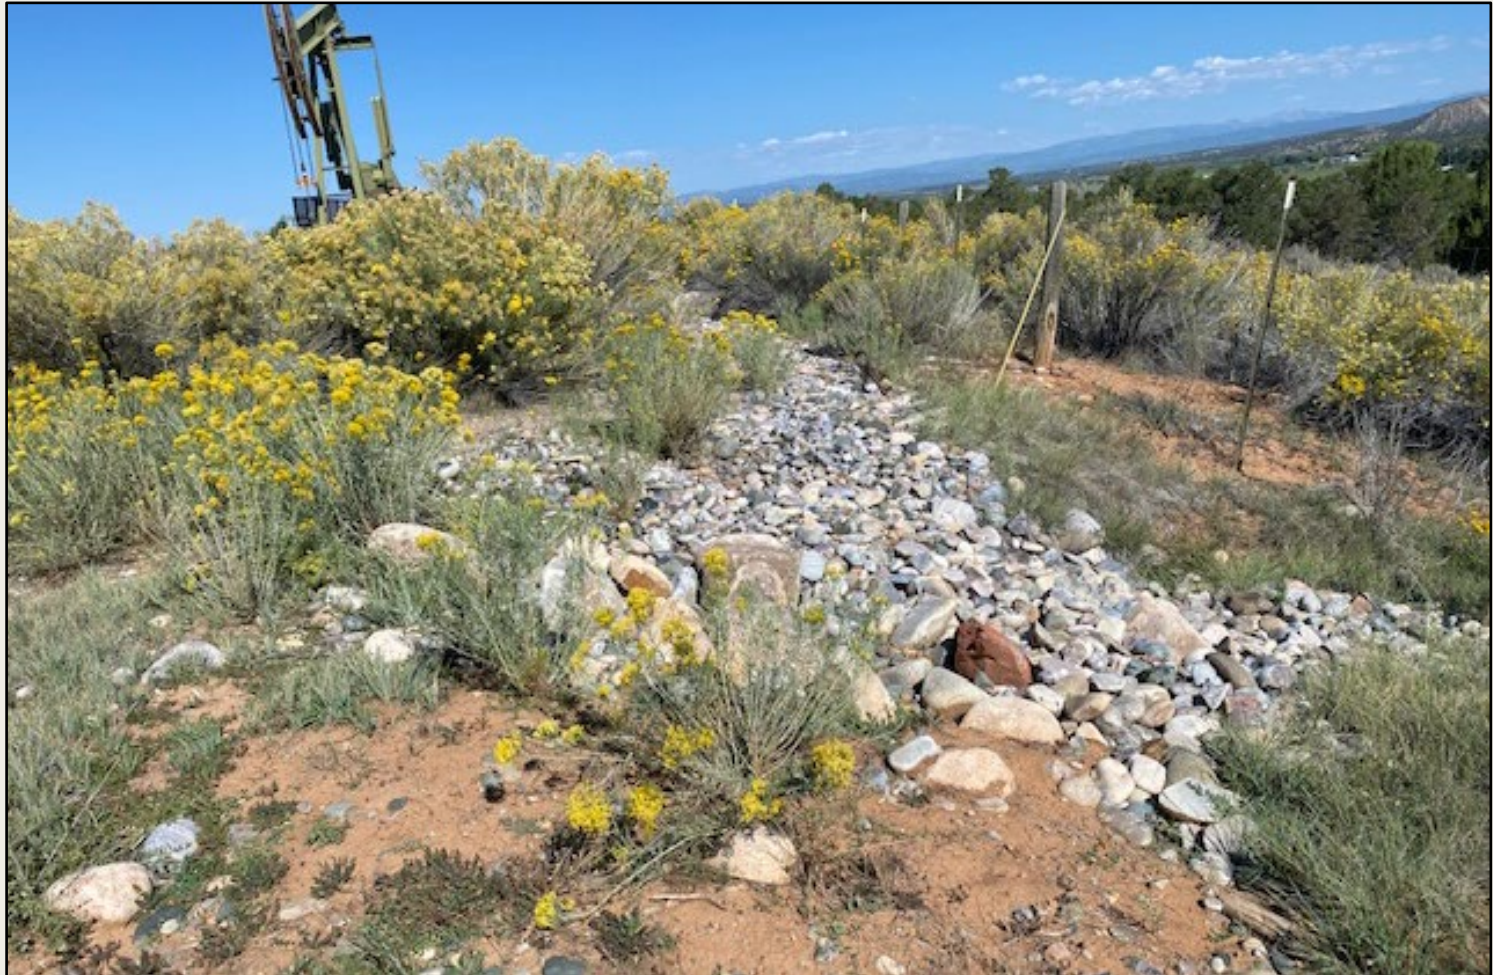
Photo 2. View of the eastern project area from the southeastern corner facing northward. Revegetation is progressing with western wheatgrass and rubber rabbitbrush.

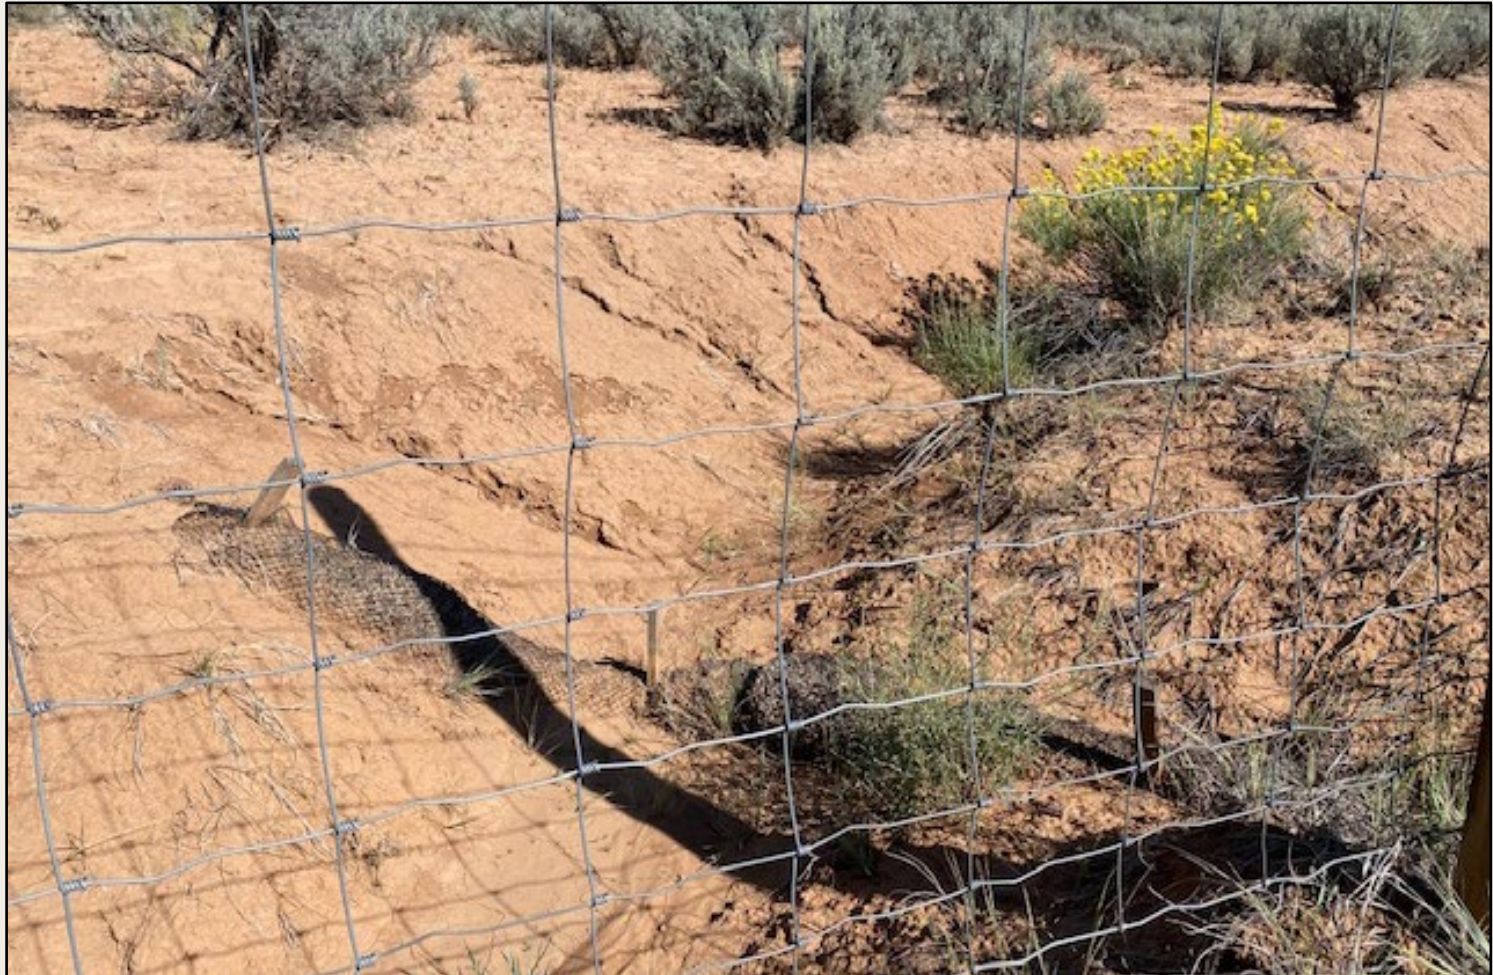
Photo 3. View of erosional channel leading out of the northern edge of the project area, where wattles are inundated, and banks are eroding and lack stabilization. Wattles are not adequate BMPs here.

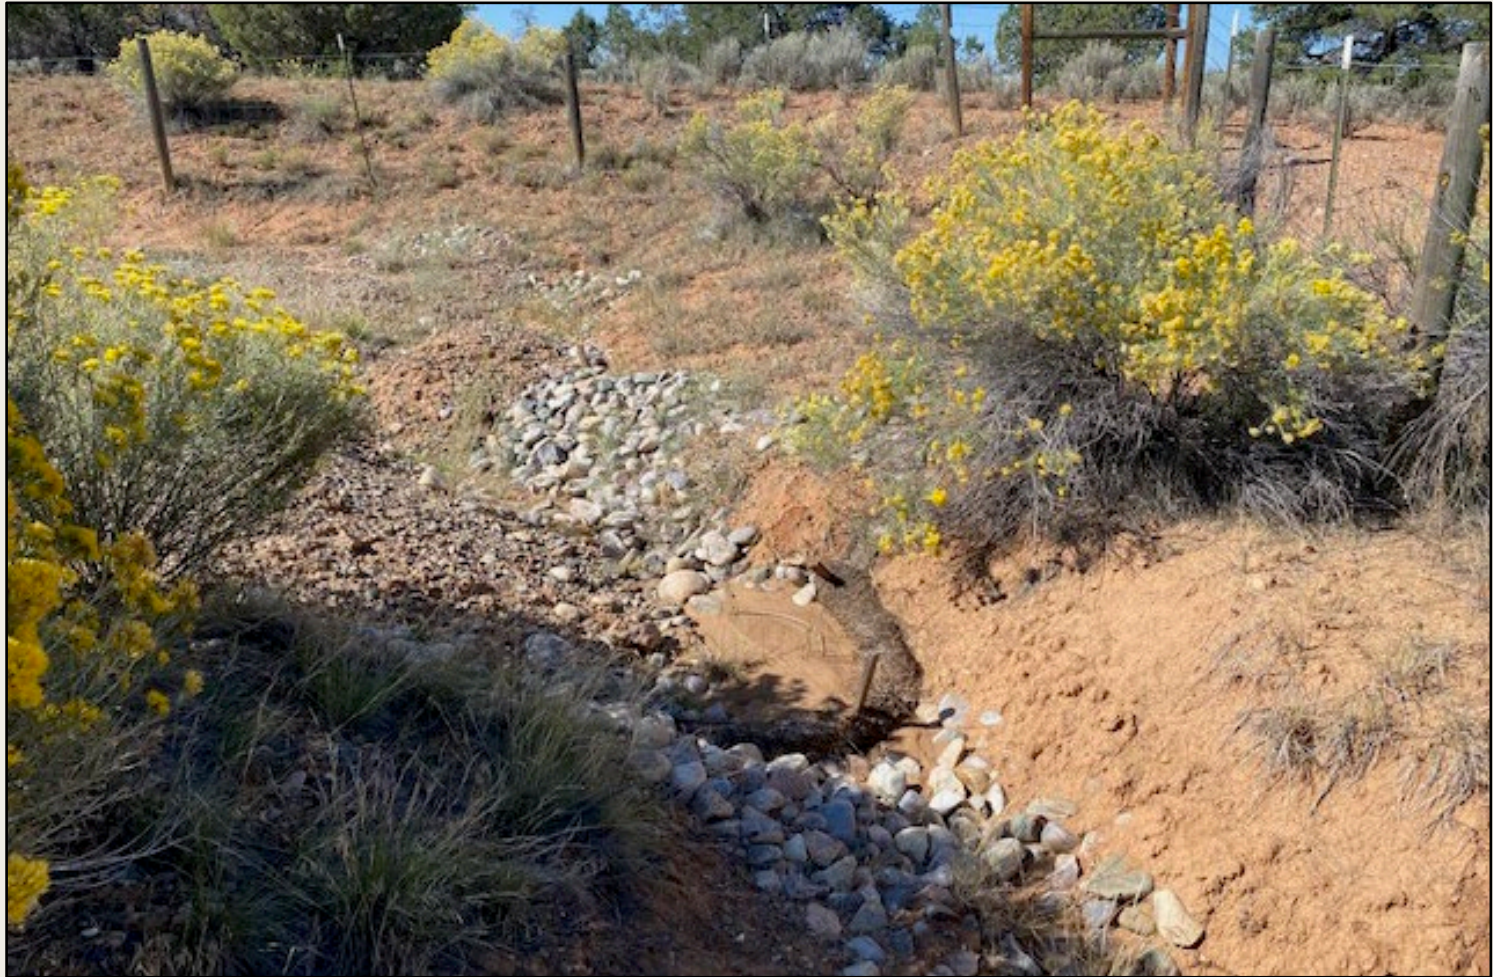
Photo 4. View of area in the northwestern corner of the project area where stormwater flows off of the project area, conveying significant sediment loads and inundating BMPs.

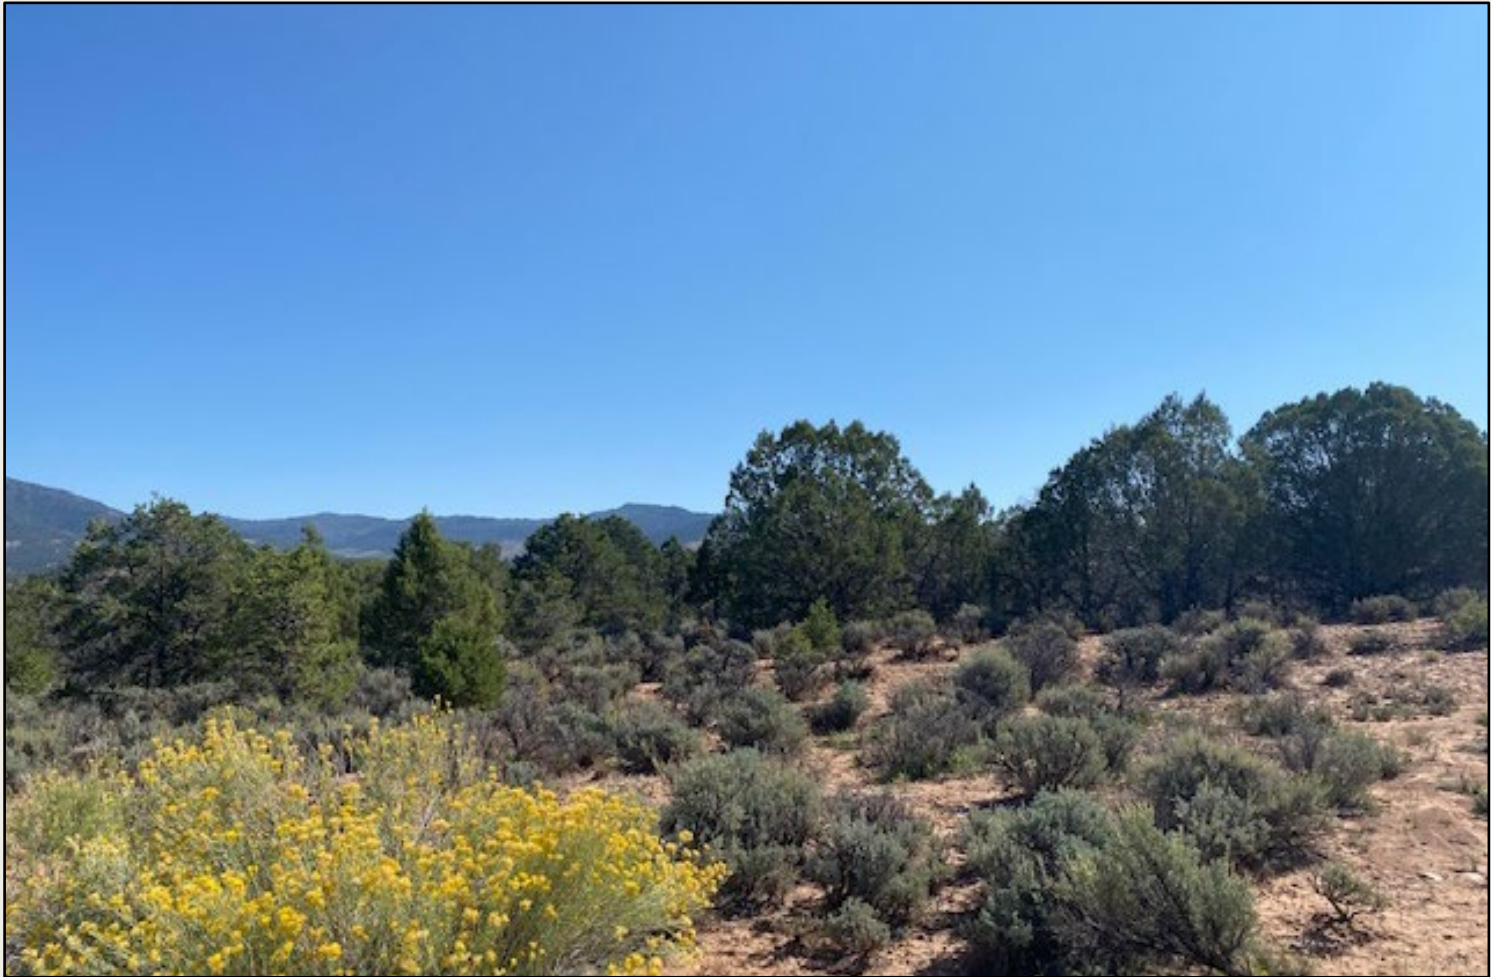
Photo 5. View of the reference area, comprised of sagebrush shrubland with open pinyon and juniper woodland and blue grama, squirreltail, four o'clock, and goldenaster in the understory.
