Inspection Photos

API: 055-06219

Operator: PETROGLYPH OPERATING CO

Inspection Date: 9/17/2021

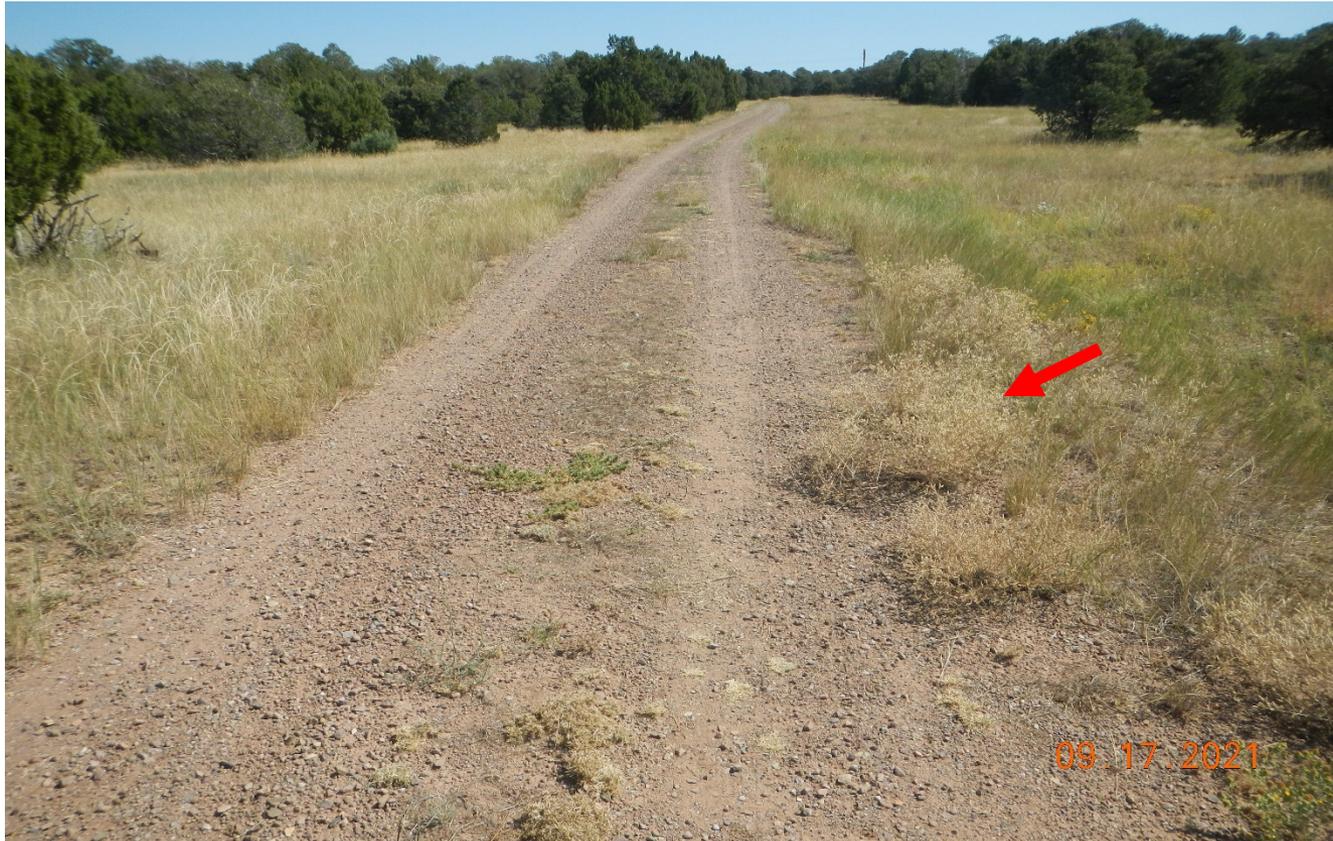
Photo 1. Facing southeast along the access road. There are noxious weeds along the road (Diffuse knapweed).

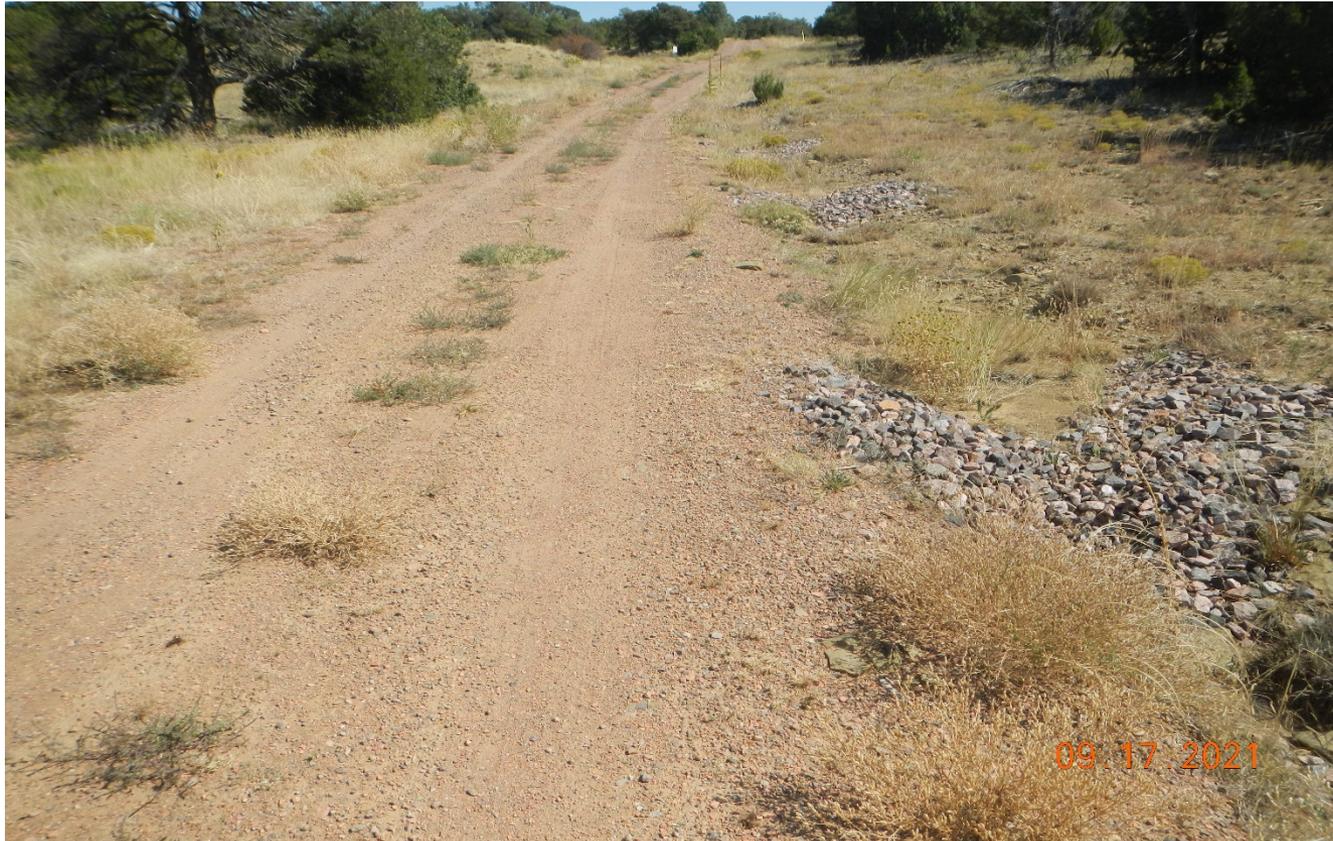
Photo 2. Facing southeast further along the access road. The rock check dams along the road side appear to be controlling erosion.

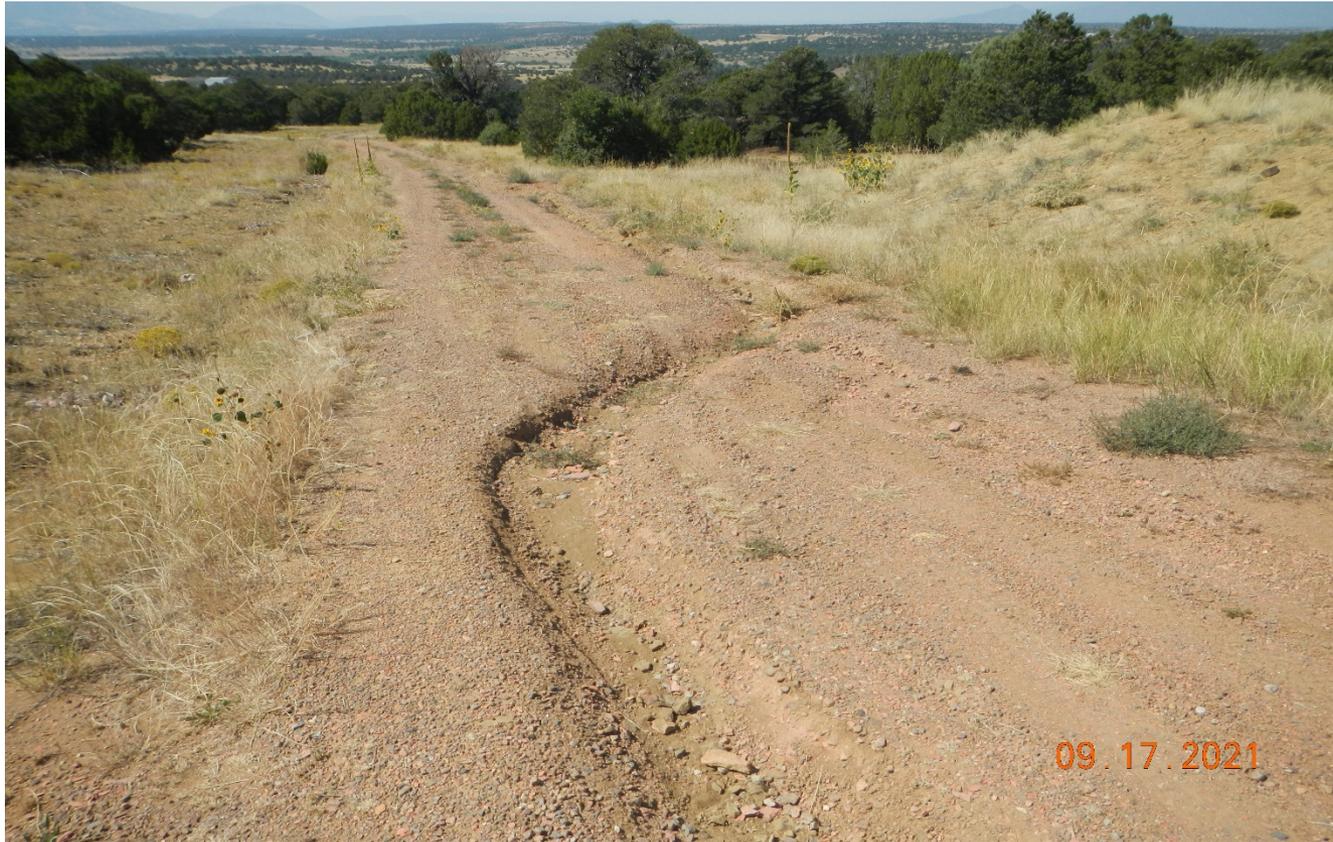
Photo 3. Facing back northwest on the road adjacent to the location. This erosion channel previously observed was never repaired.

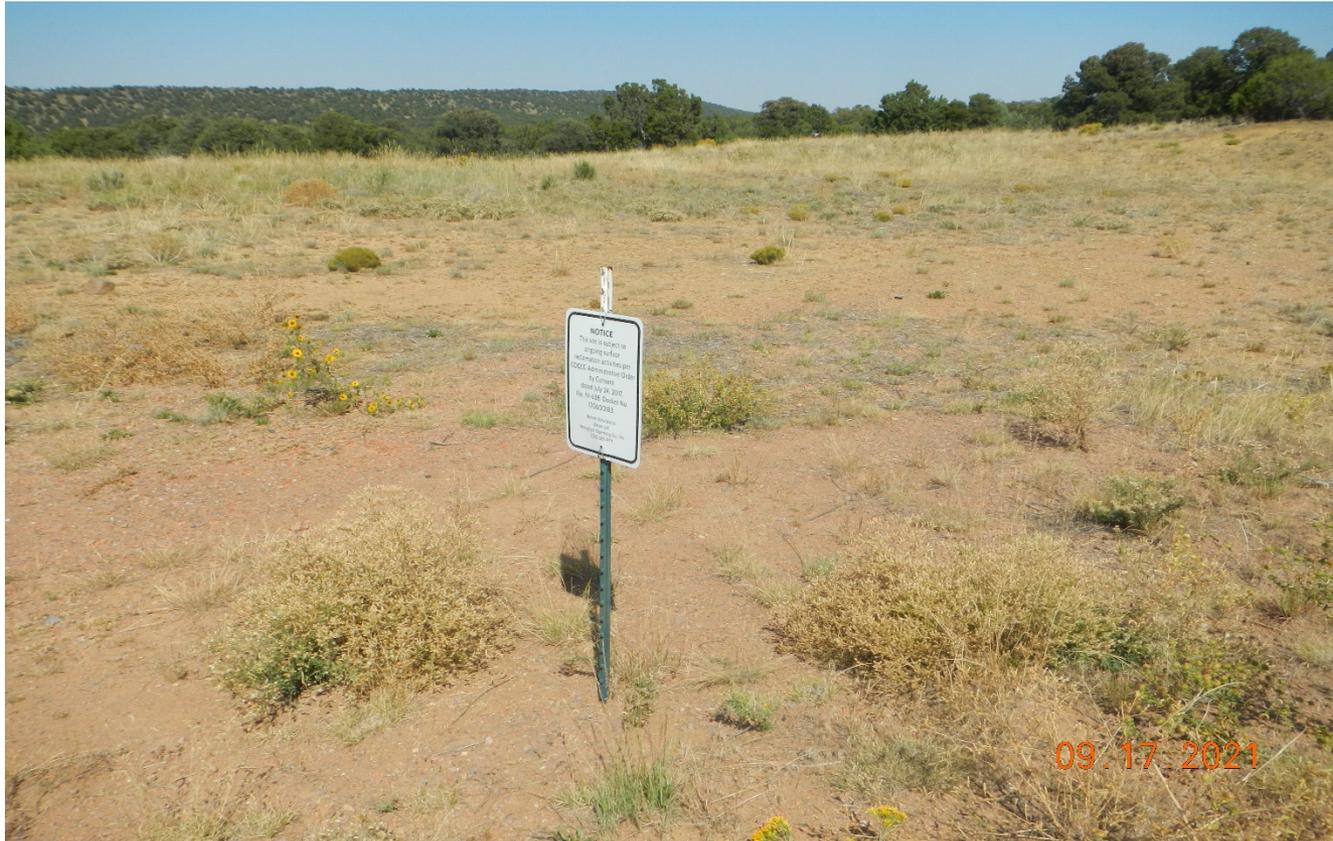
Photo 4. Facing east toward the location.

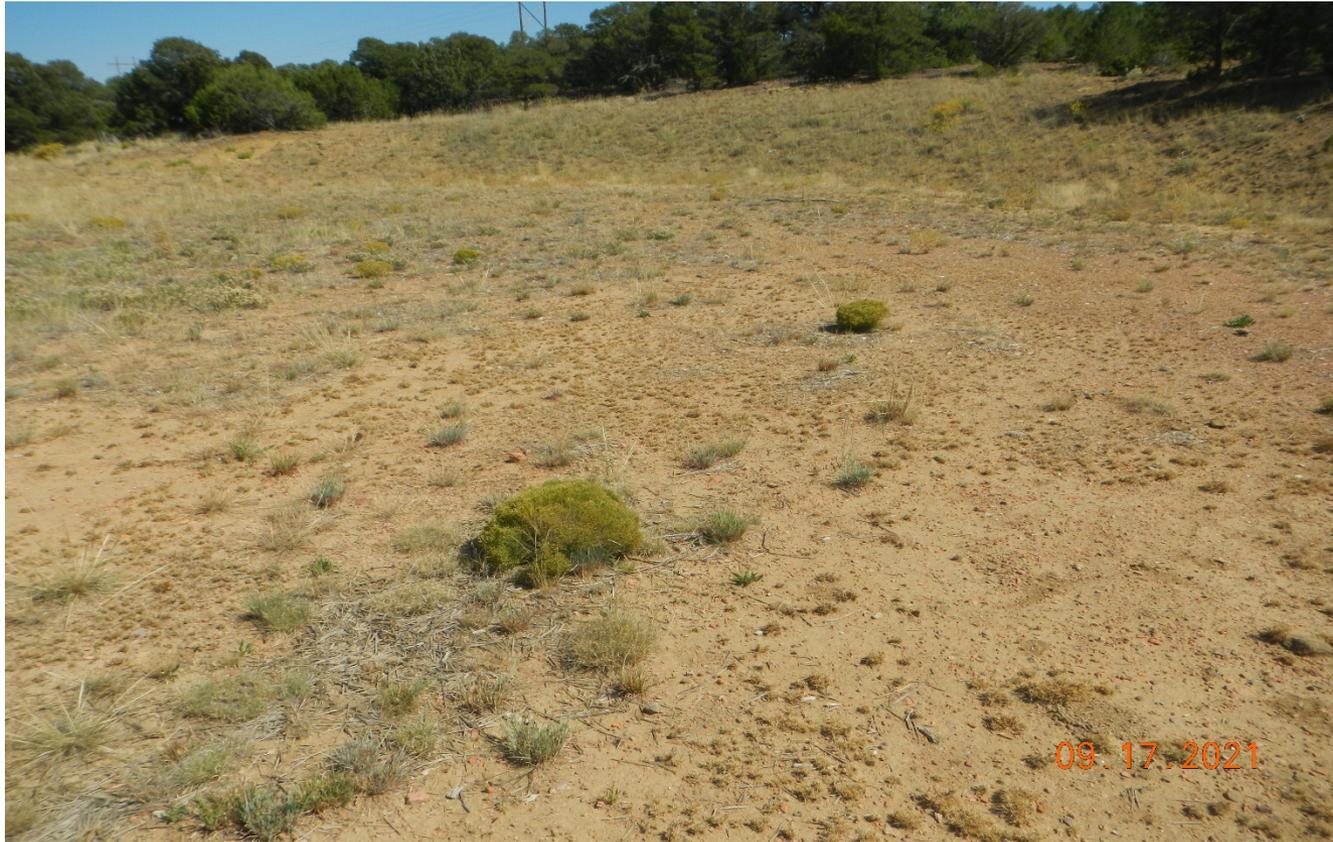
Photo 5. Facing southeast toward the location.

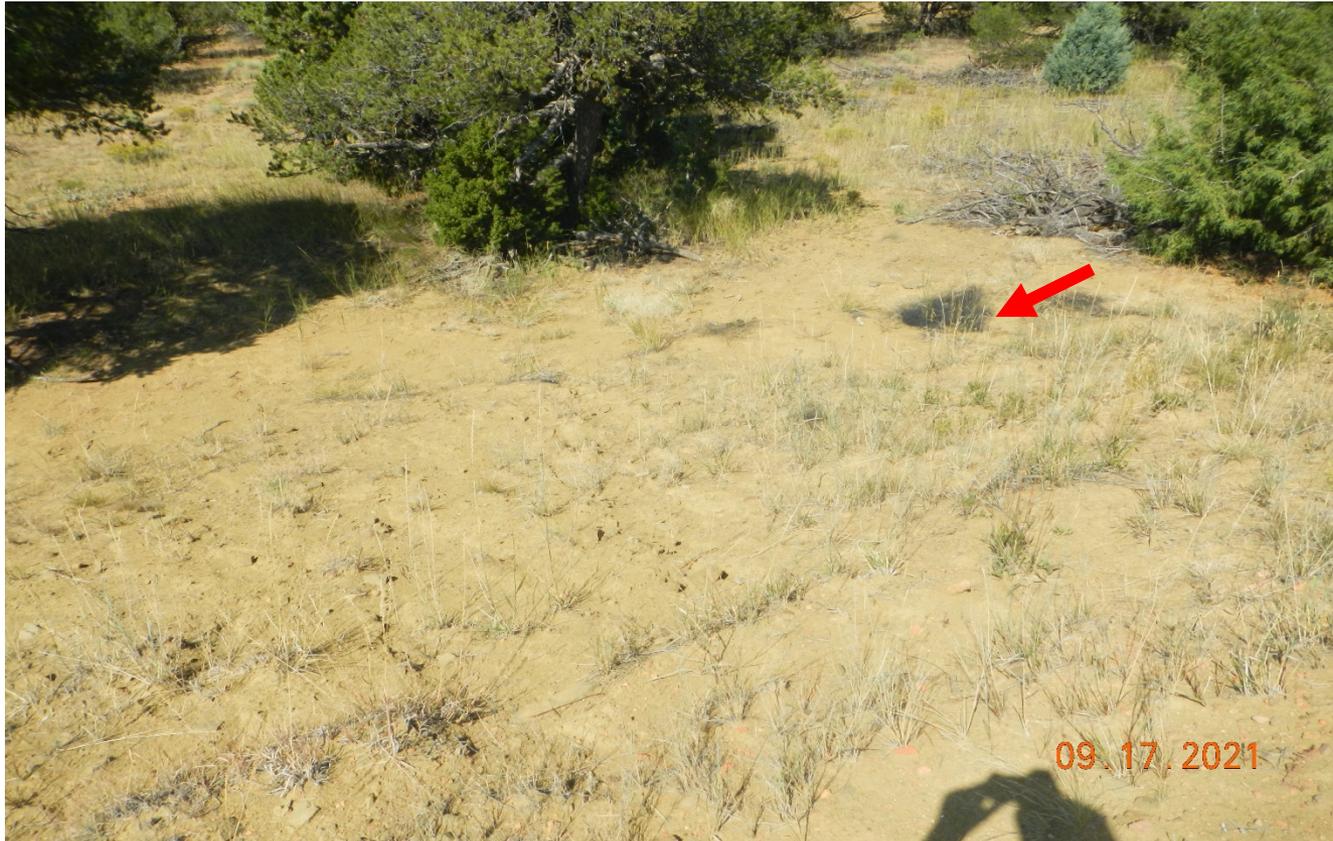
Photo 6. Facing toward the fill slope. There is sparse vegetation along the fill slope and the plastic netting still remains shown at red arrow.

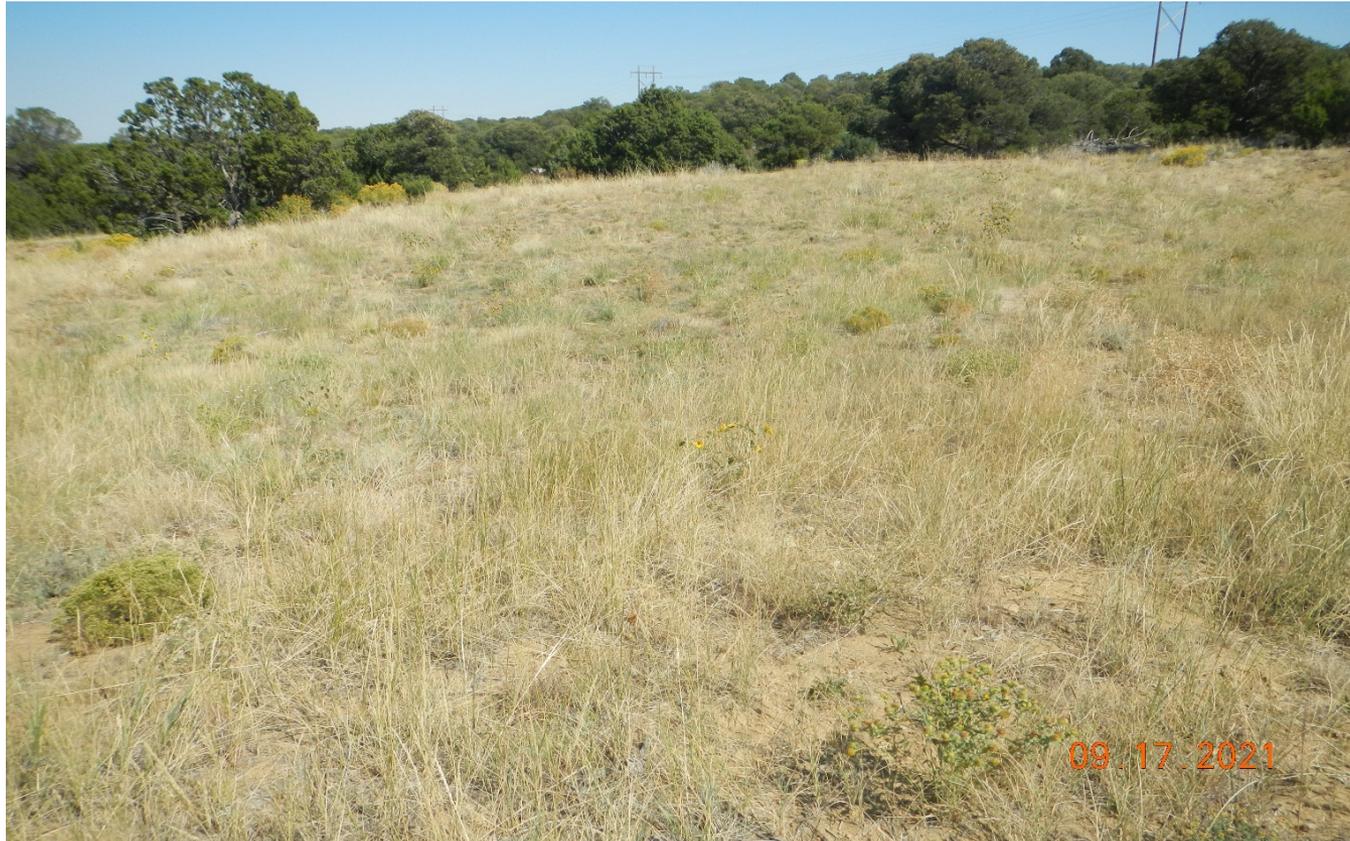
Photo 7. Facing toward the east side of the location. The vegetation is well established at the eastern portion of the location.
