# Inspection Photos

API: 055-06221

Operator: PETROGLYPH OPERATING CO

Inspection Date: 9/17/2021

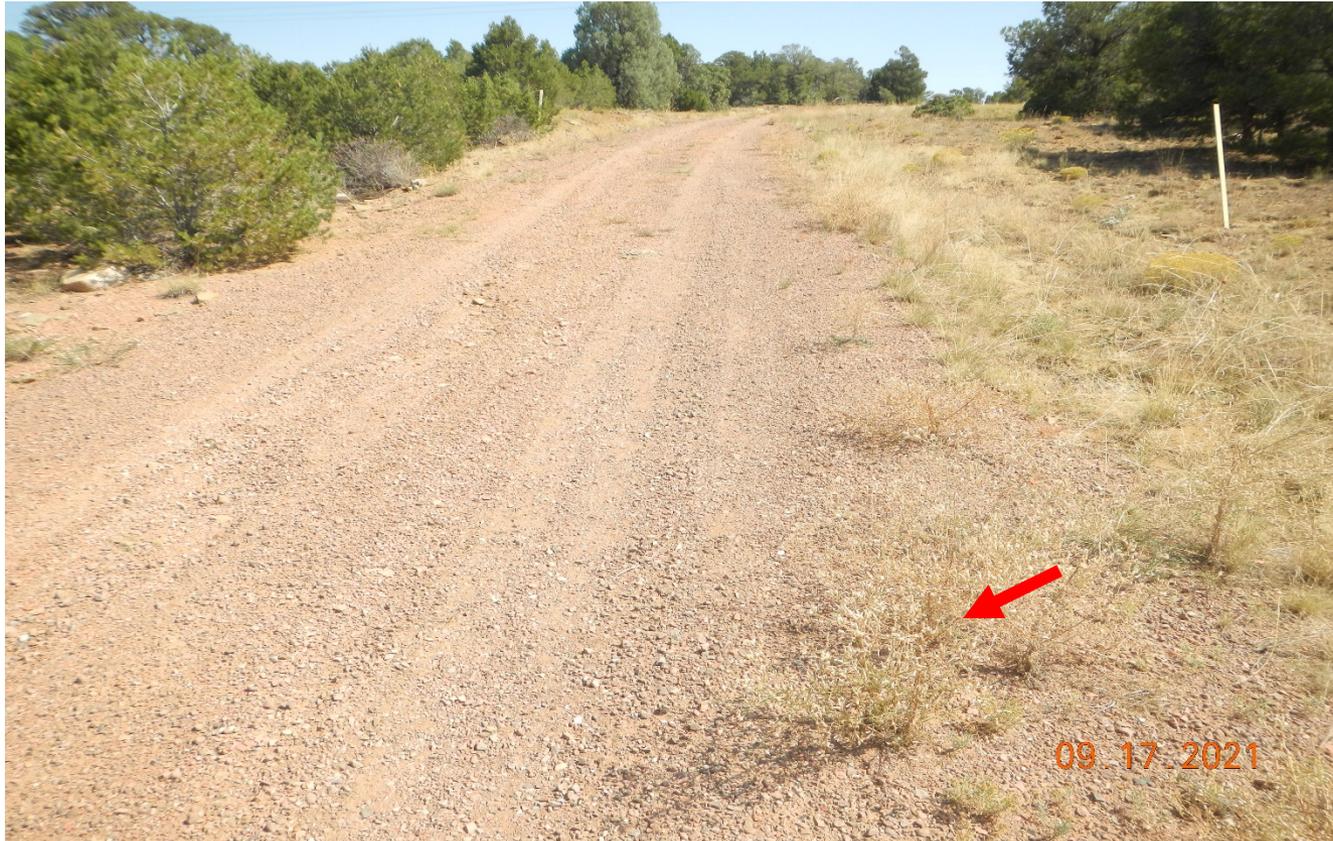
**Photo 1.** Facing southeast along the access road. There are noxious weeds along the road (Diffuse knapweed).

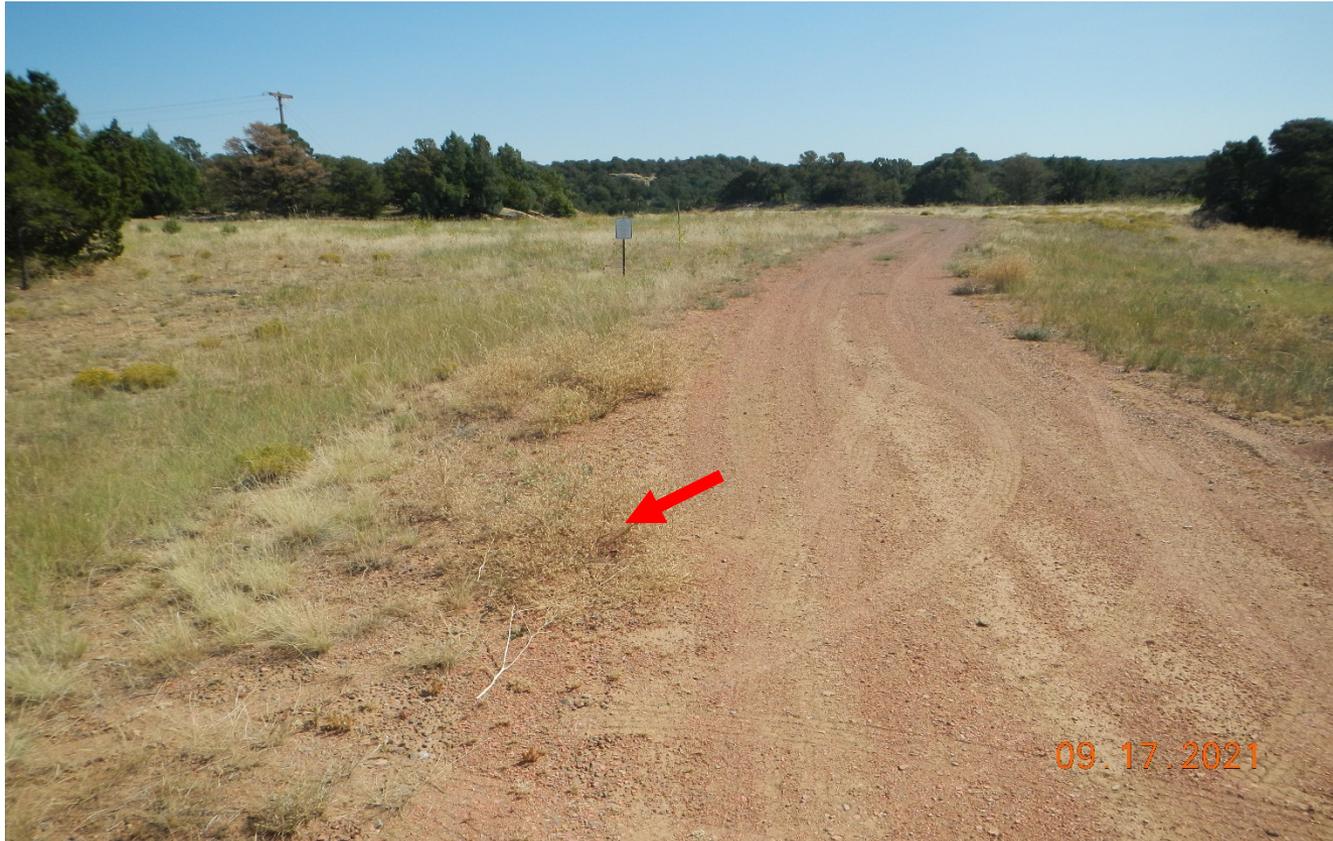
**Photo 2.** Facing southeast along the access road toward the location. There are noxious weeds along the road (Diffuse knapweed).

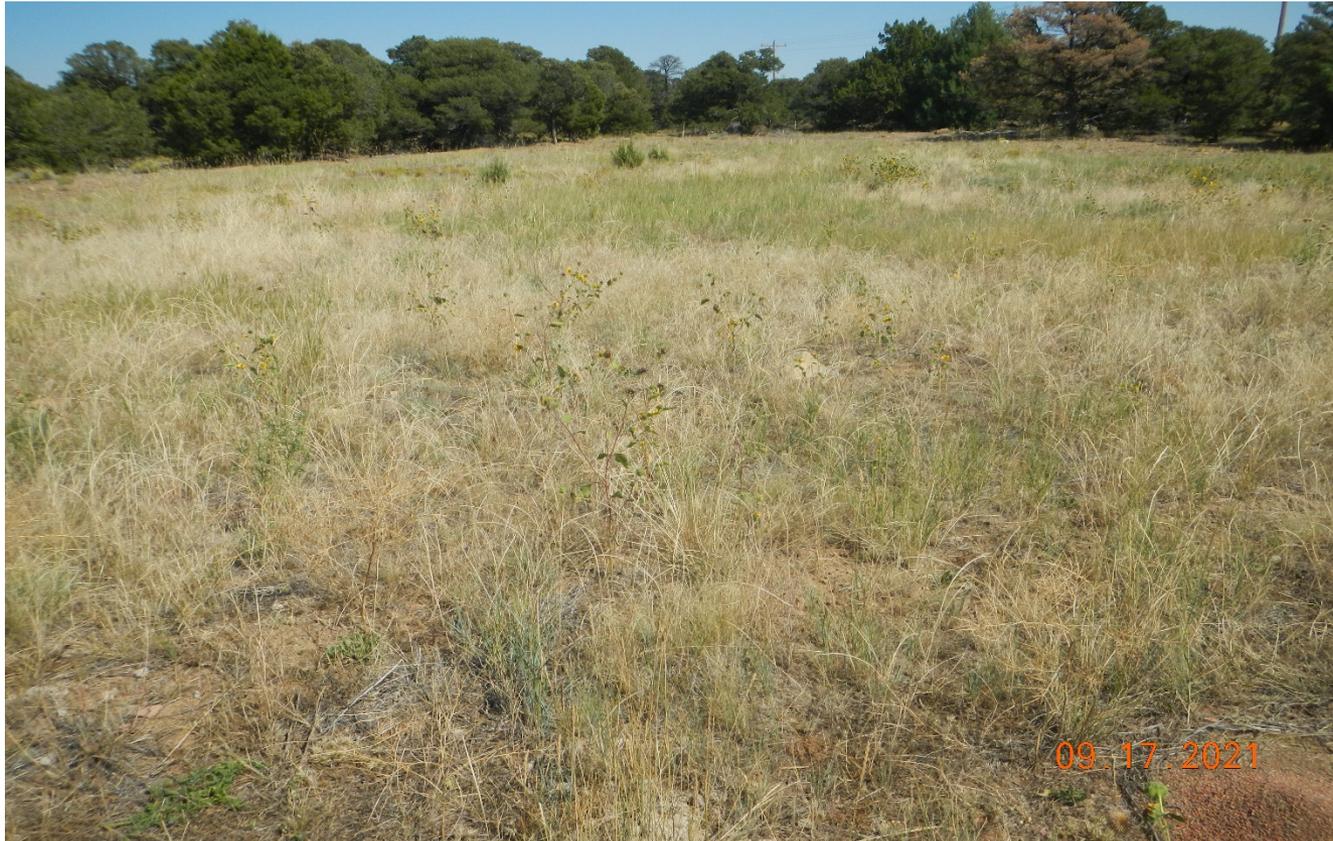
**Photo 3.** Facing east toward the location. Perennial vegetation is established throughout the location.

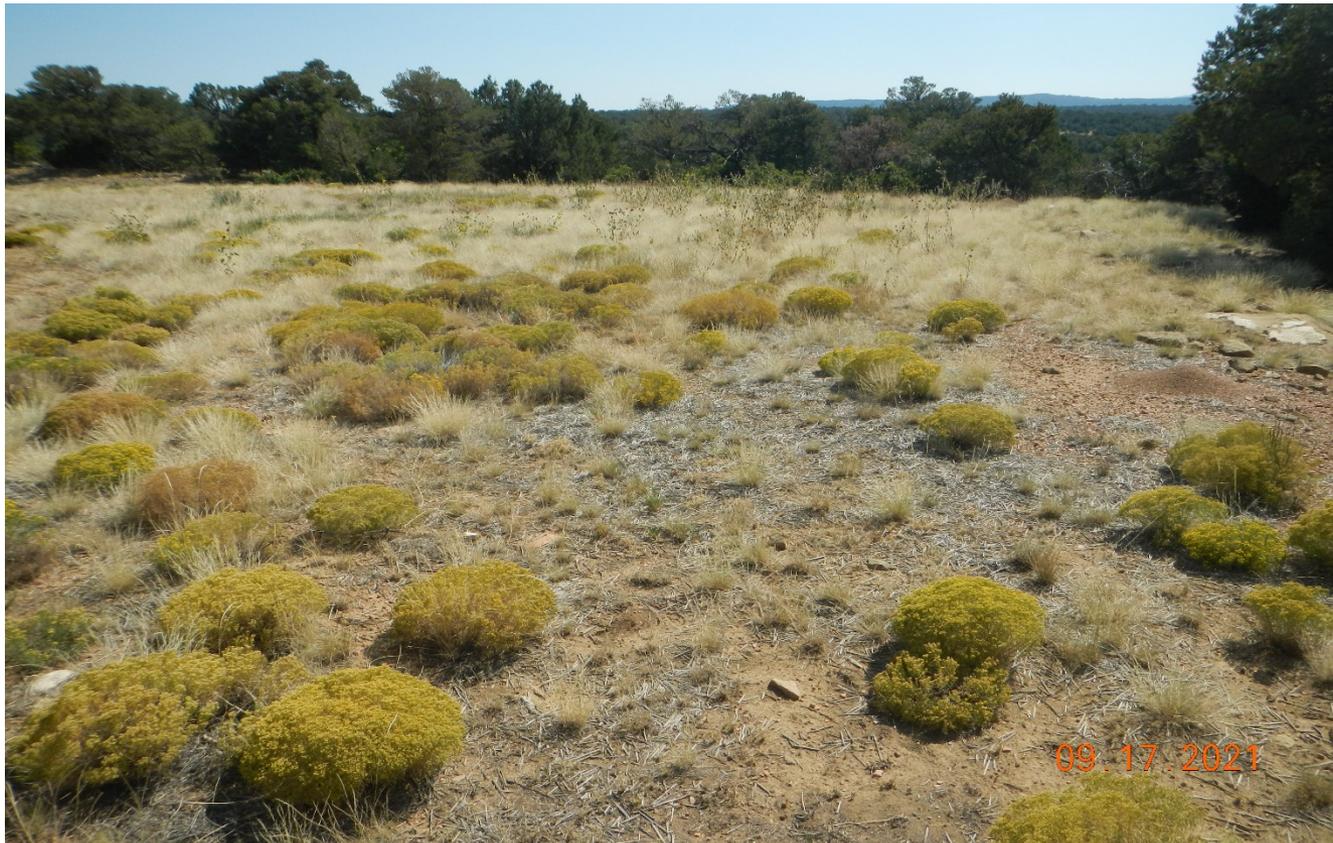
**Photo 4.** Facing south toward the location. Perennial vegetation is established throughout the location.

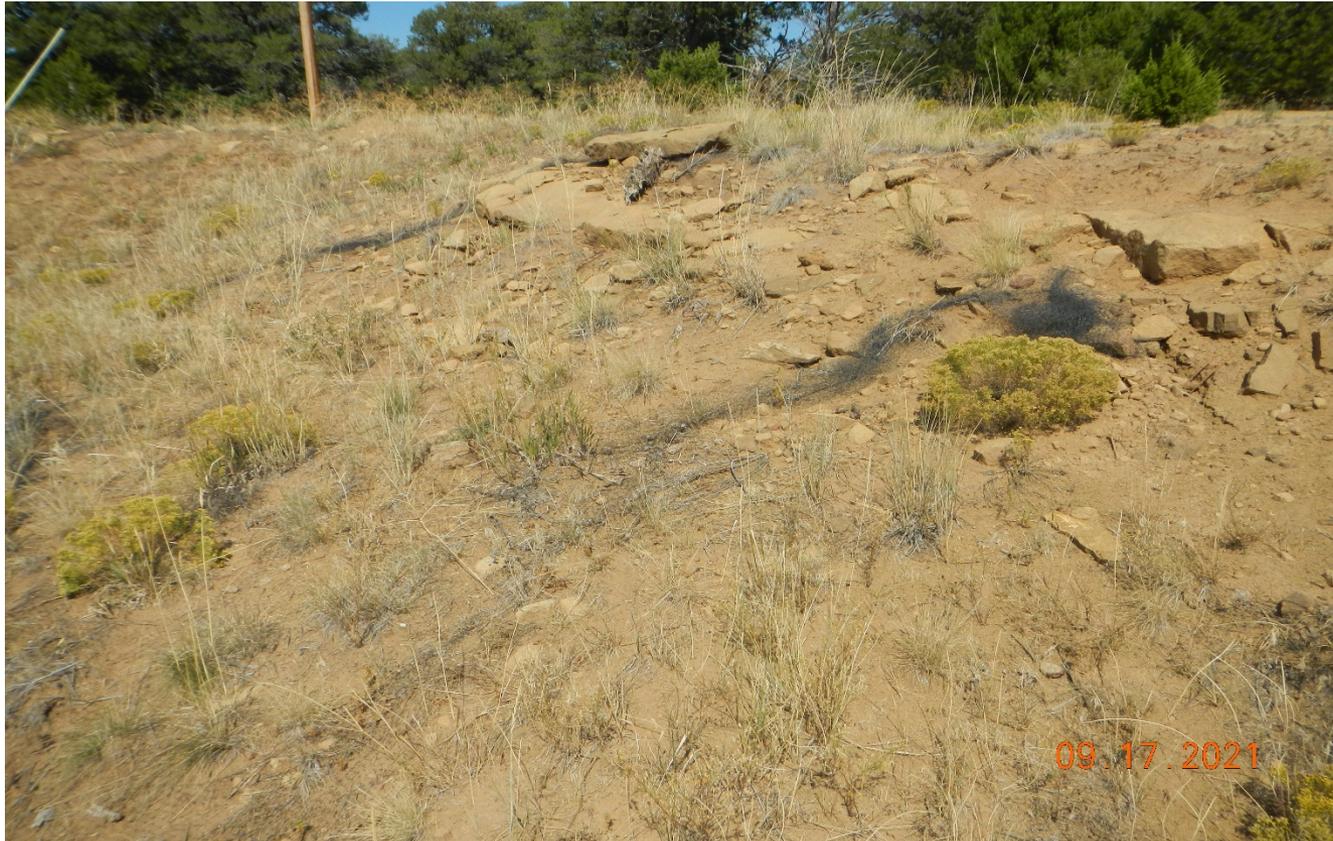
**Photo 5.** There is plastic netting debris along the southeast cut slope that still remains.

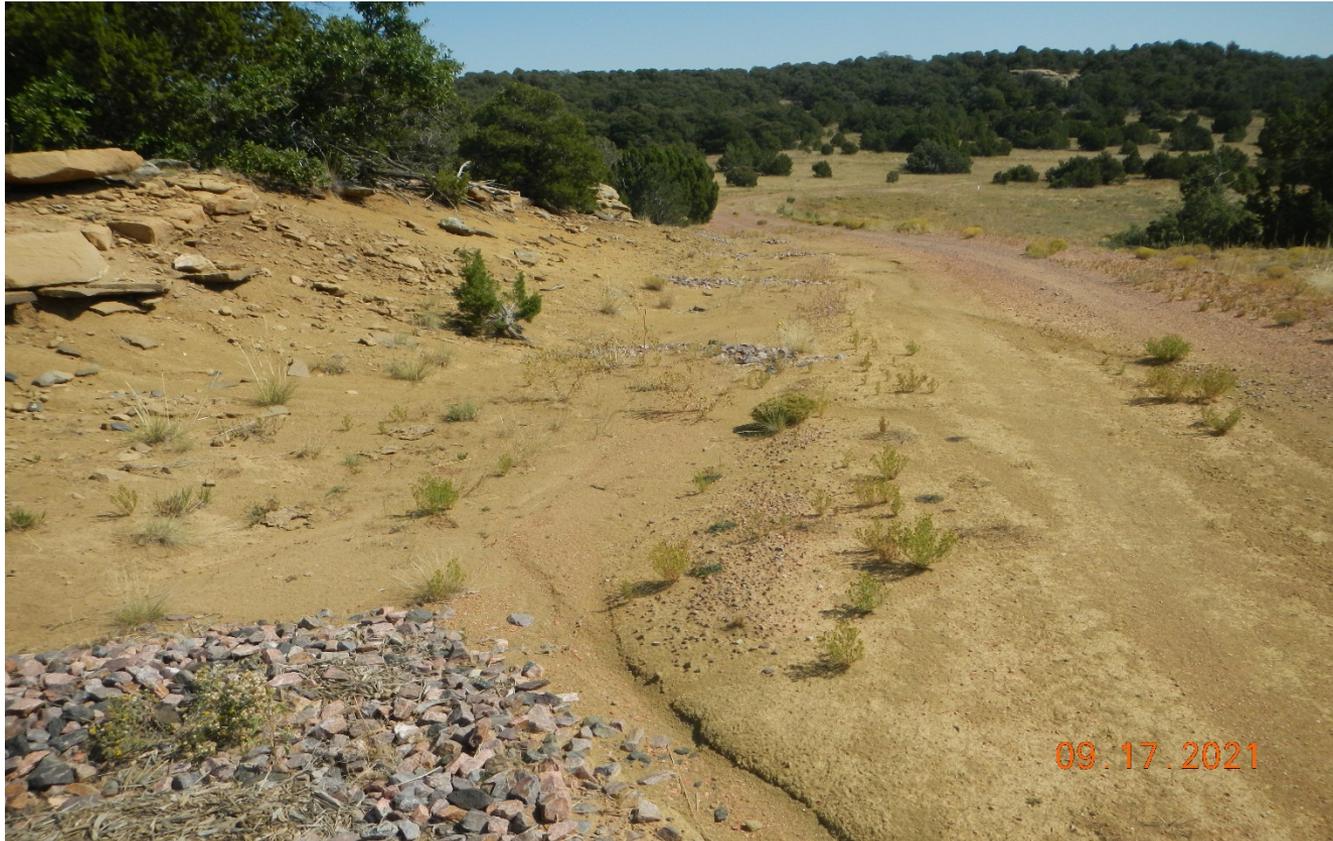
**Photo 6.** Facing southeast at the south side of the location. The access road continues past the location. This area along the roadside is not stabilized.
