Inspection Photos

API: 055-06155

Operator: PETROGLYPH OPERATING CO

Inspection Date: 9/17/2021

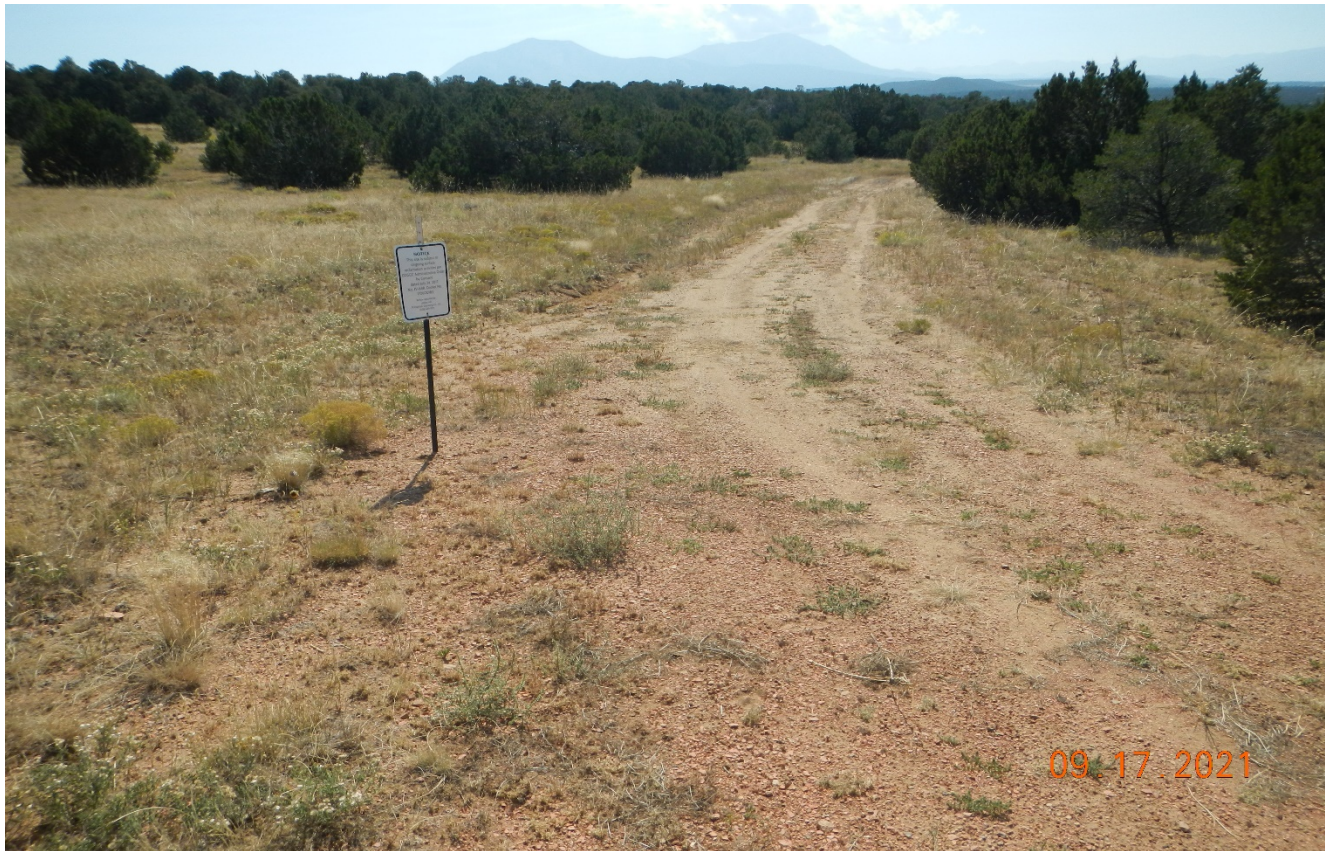
Photo 1. Facing south along the access road.

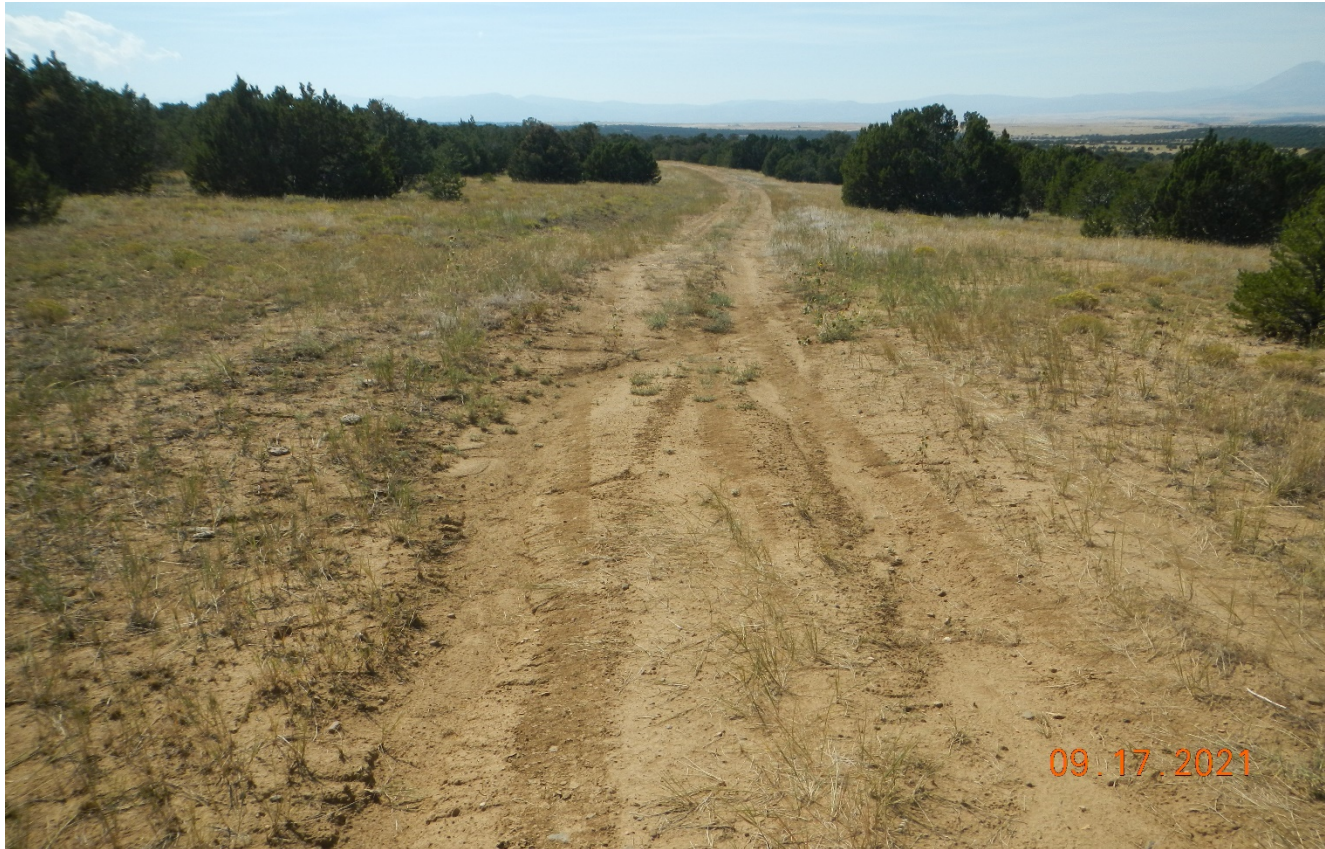
Photo 2. Facing west further along the access road.

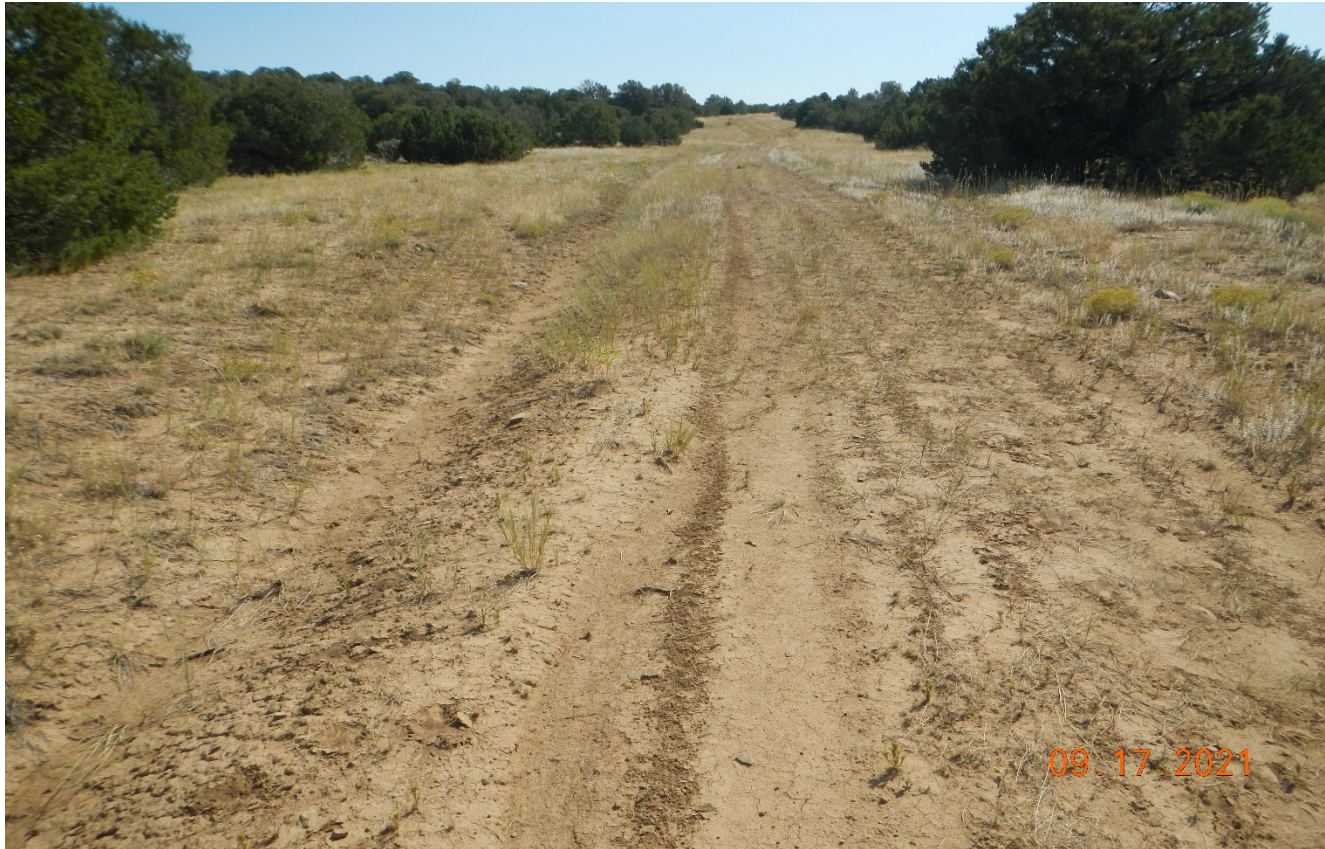
Photo 3. The road then turns back to the southeast. Areas of the road are stabilized with vegetation.

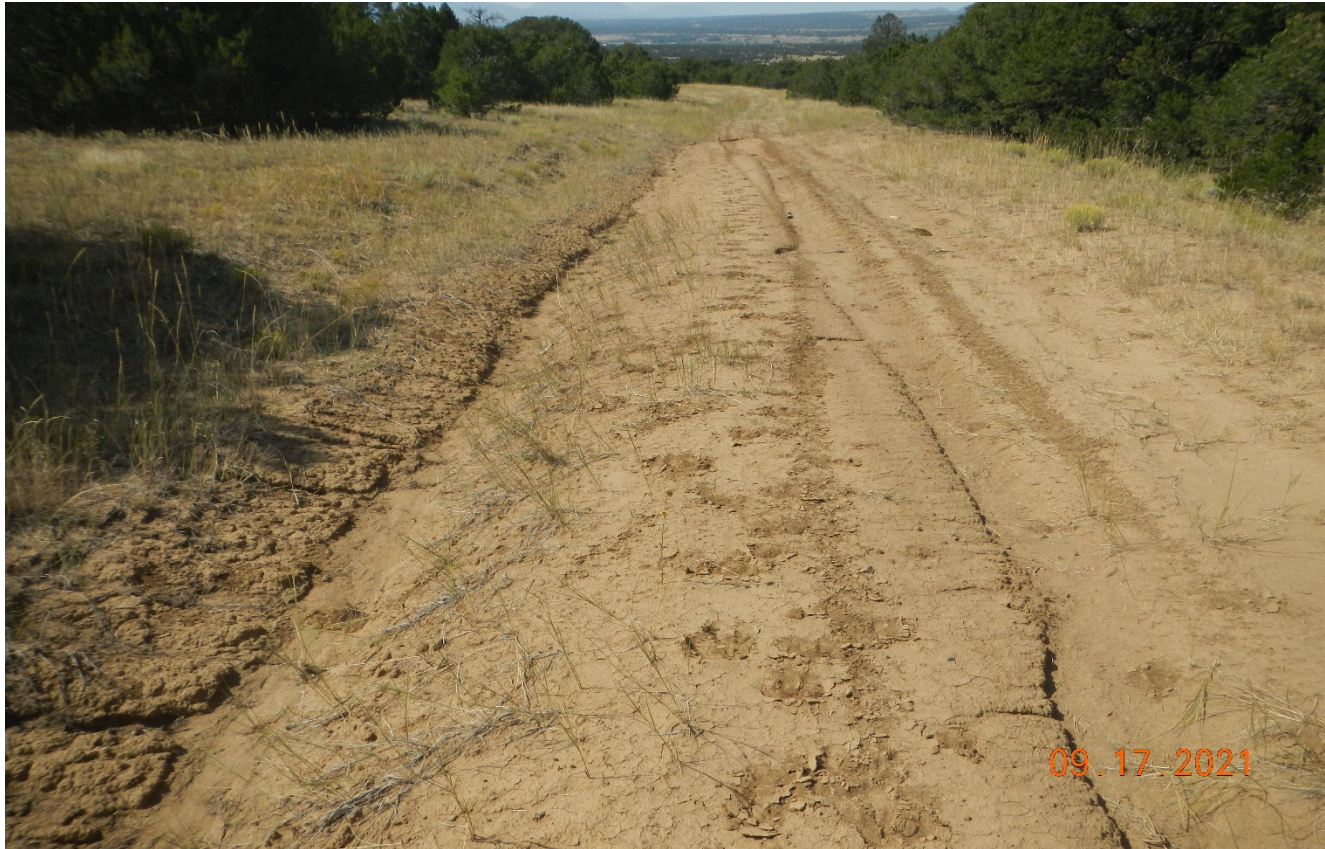
Photo 4. Facing west along the road. There are some signs of erosion. There are water bars installed along the road to help divert stormwater.

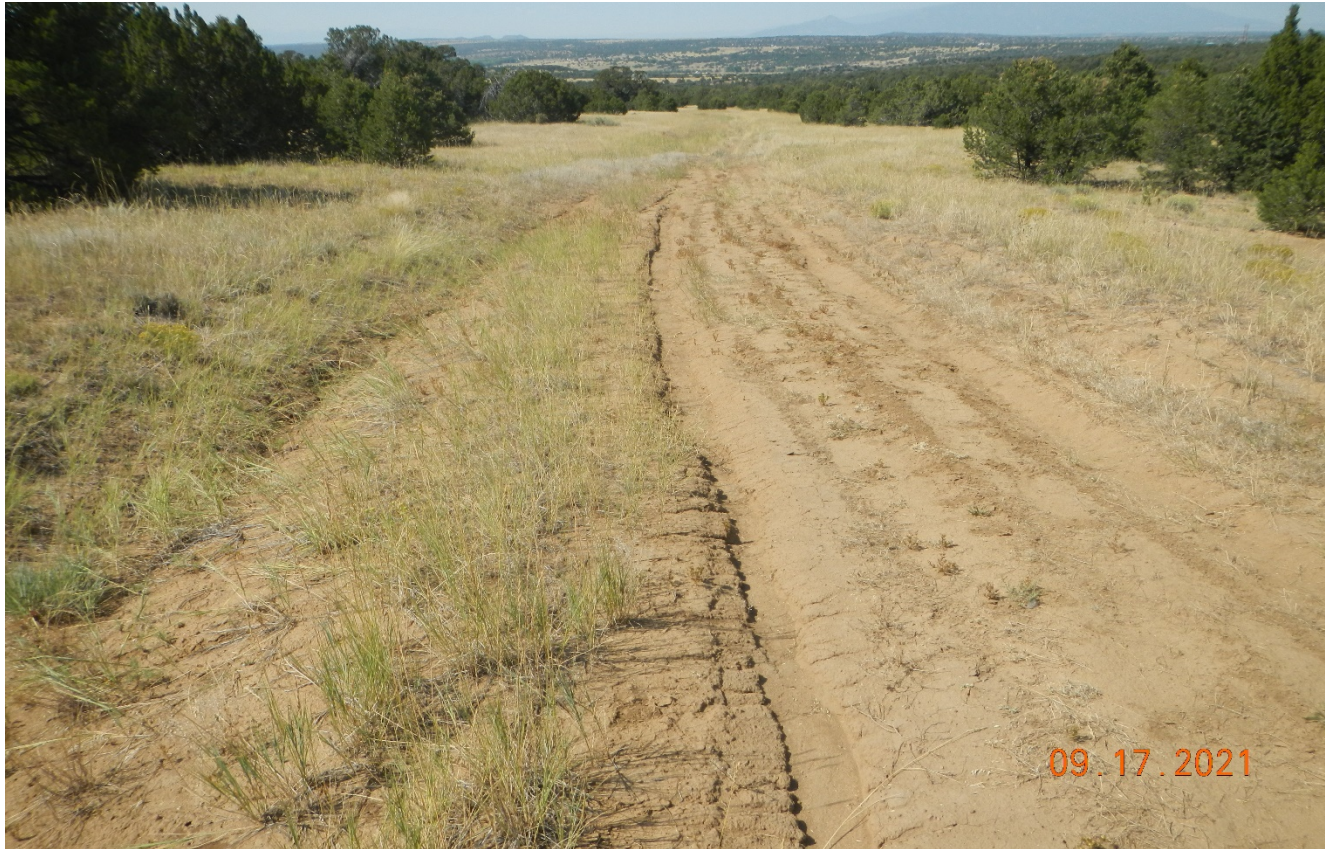
Photo 5. Facing northwest further along the access road.

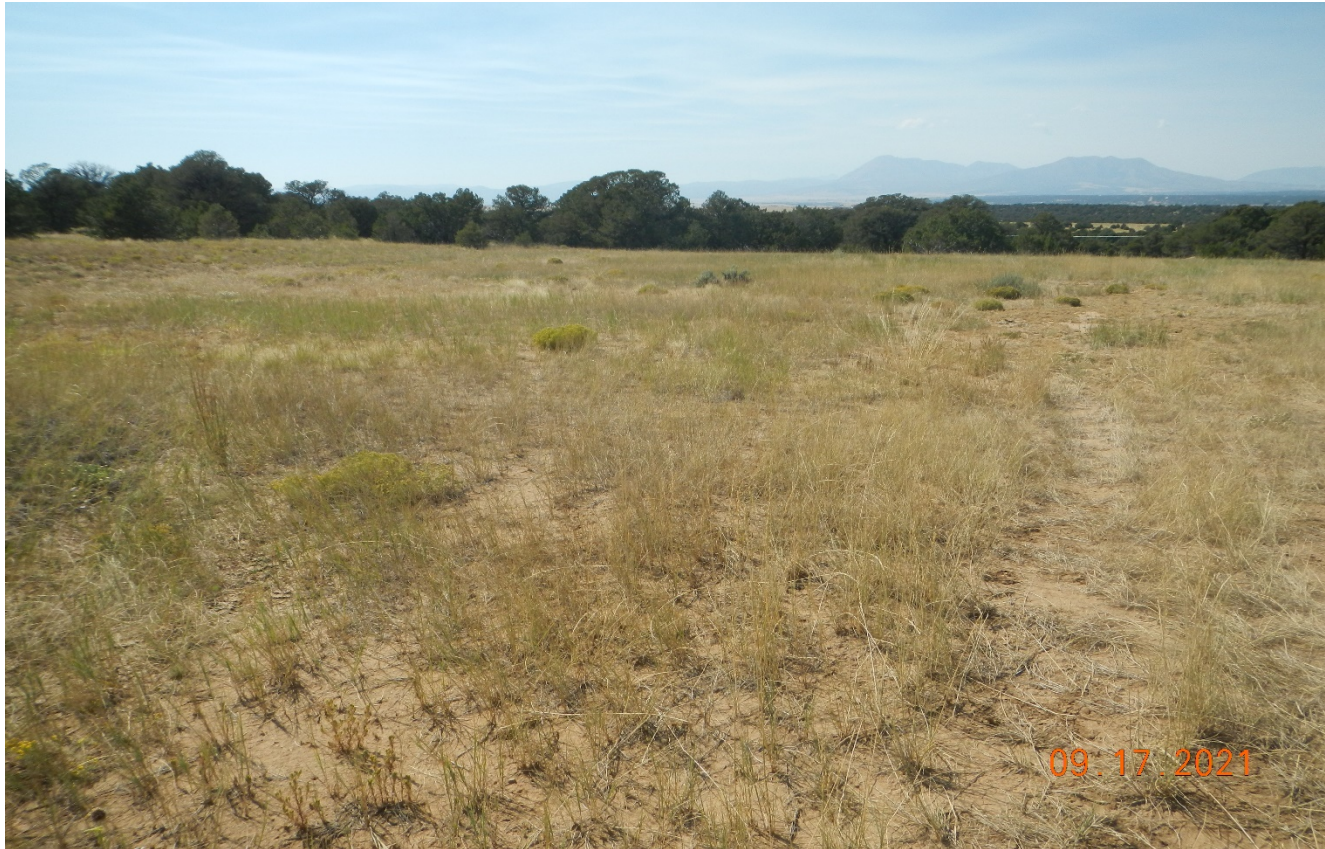
Photo 6. Facing west toward the location. The perennial vegetation has uniformly reestablished at the location.

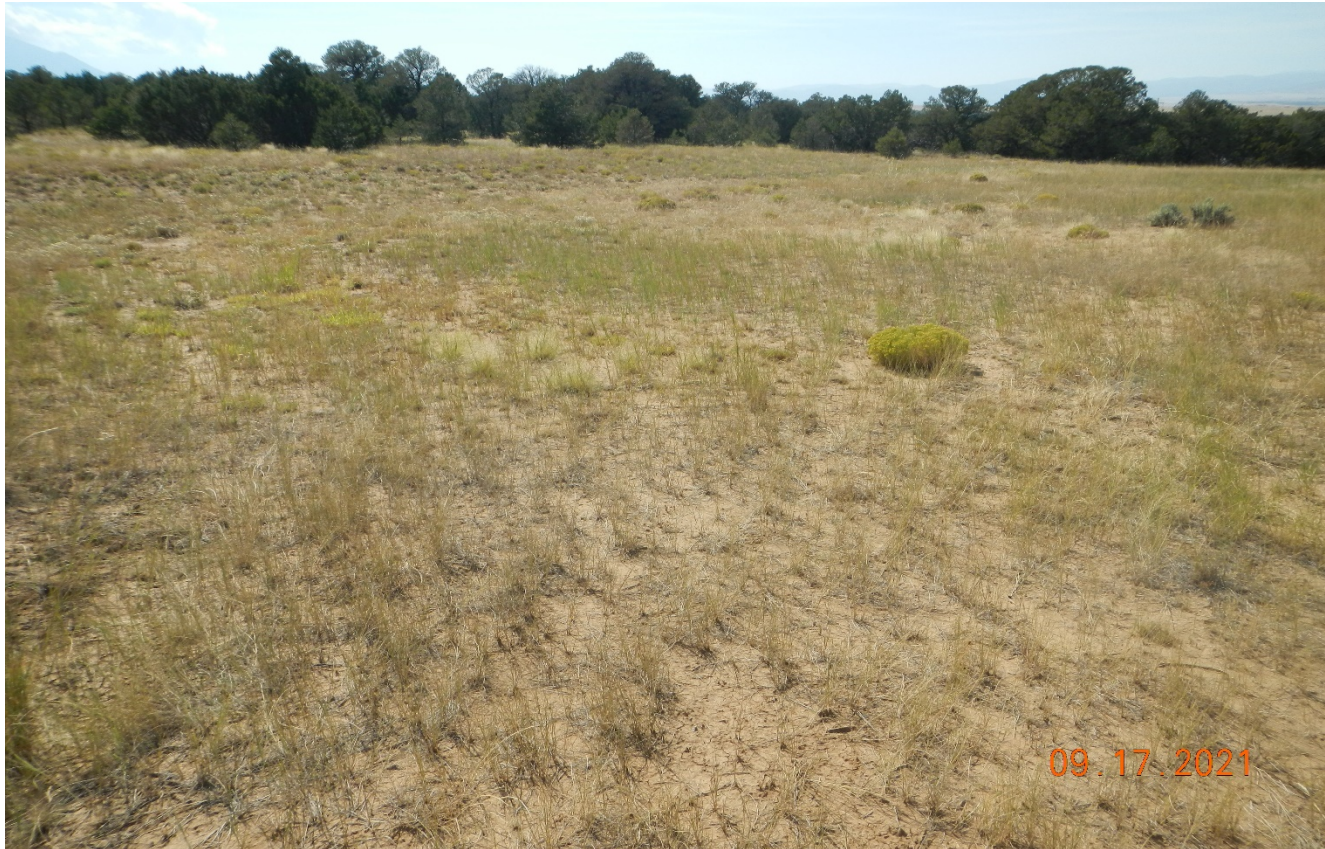
Photo 7. Facing southwest toward the location. The perennial vegetation has uniformly reestablished at the location.
