TEP
RWF 14-29
Location # 429828

COLORADO
Oil & Gas Conservation
Commission
Department of Natural Resources

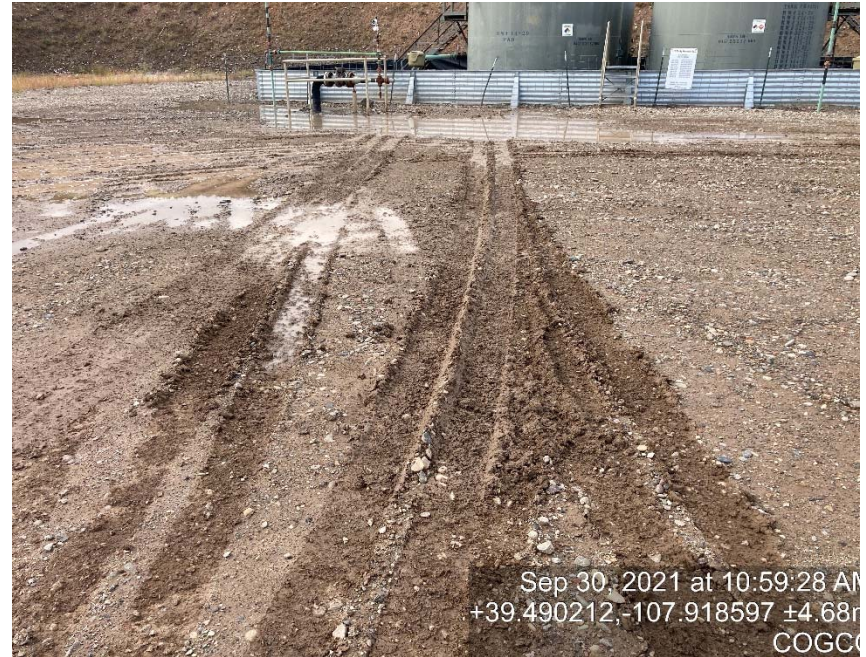
Lack of stabilization/compaction

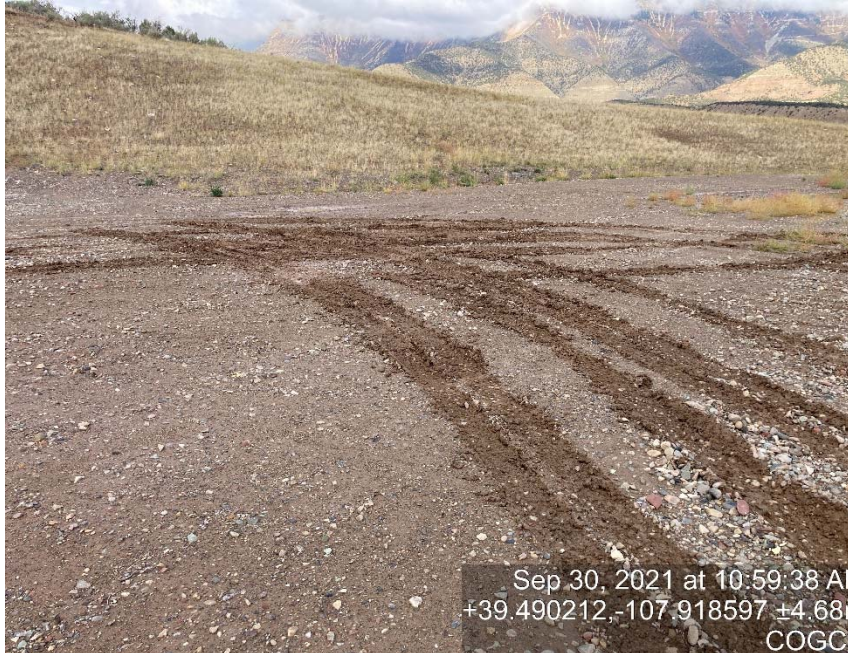
Lack of stabilization/compaction

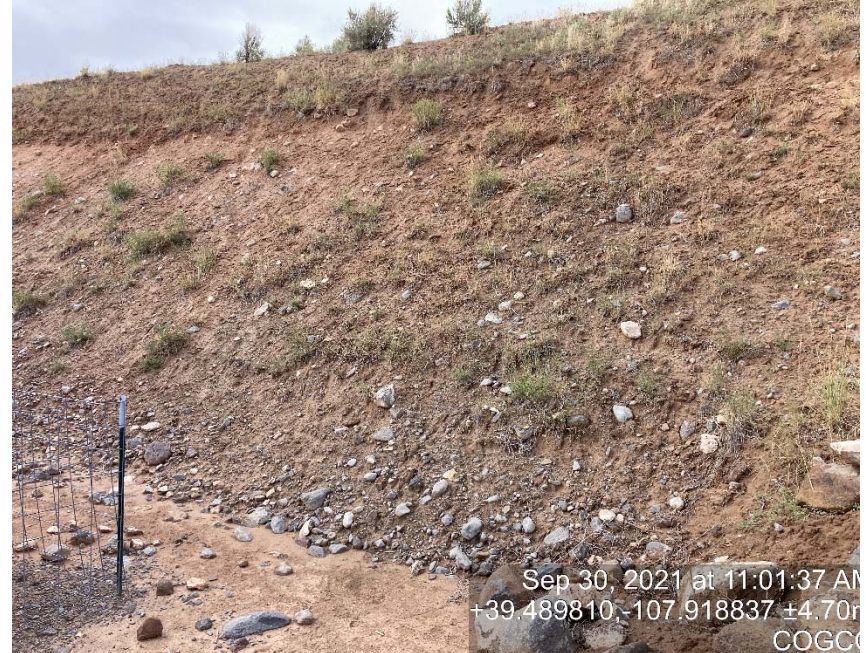
Lack of stabilization/erosion

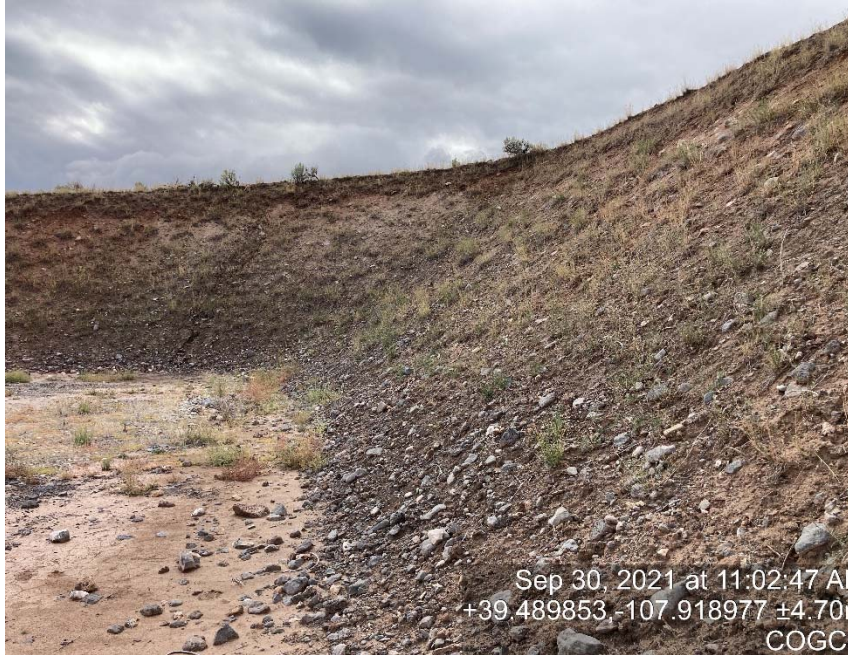
Lack of stabilization/erosion

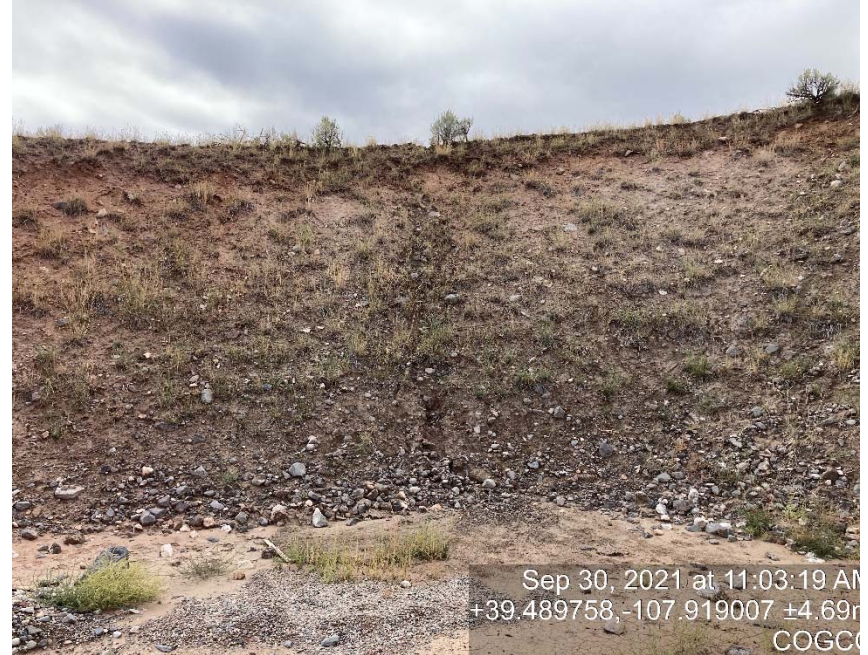
Lack of stabilization/erosion

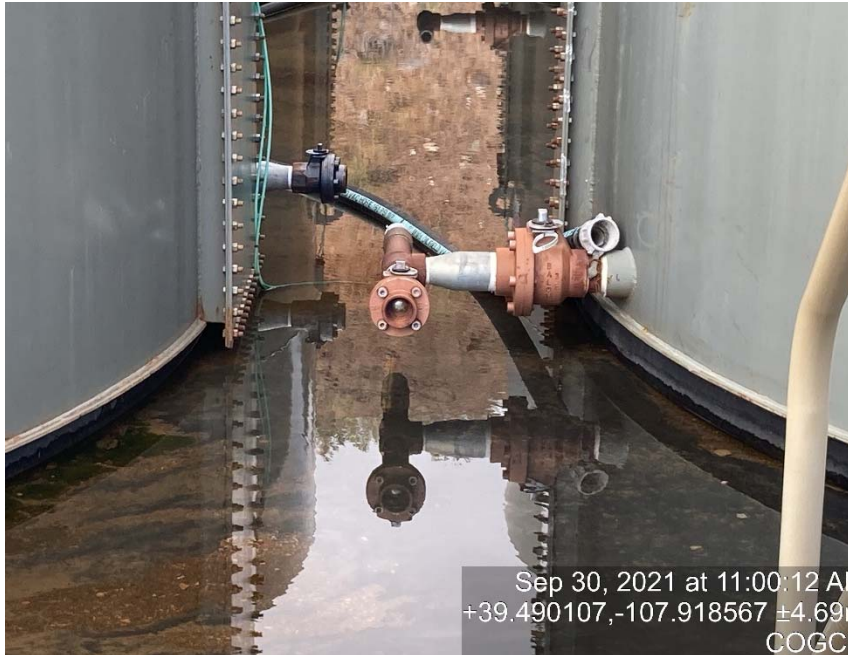
Missing bull plugs/caps on load out lines

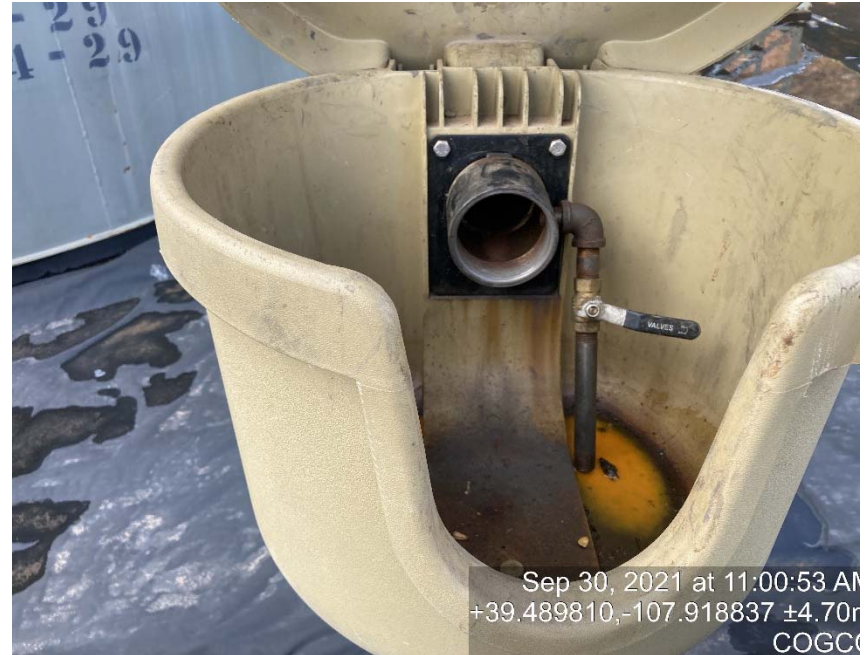
Missing bull plugs/caps on load out lines

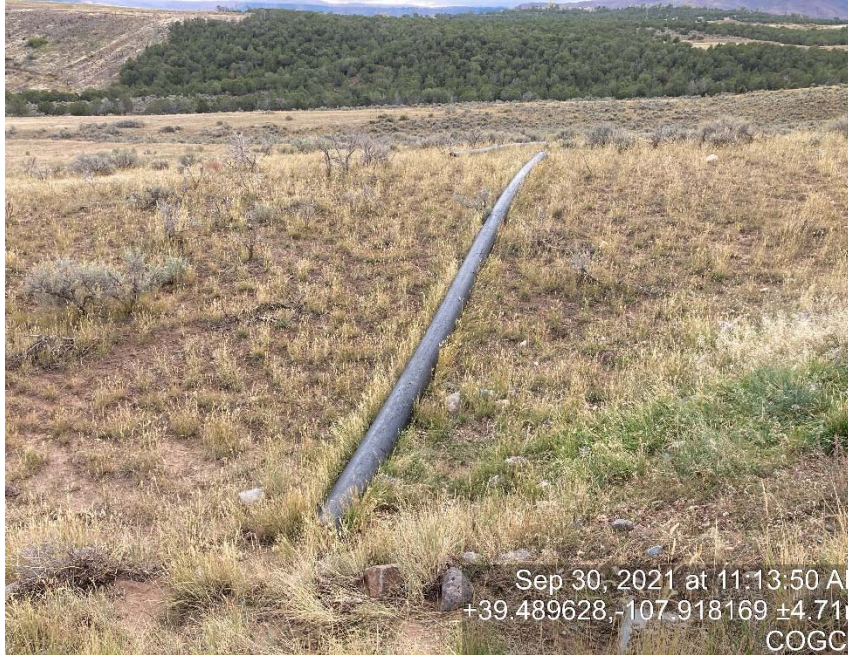
**Unused /stored steel and poly pipe near access road
and at right of way**

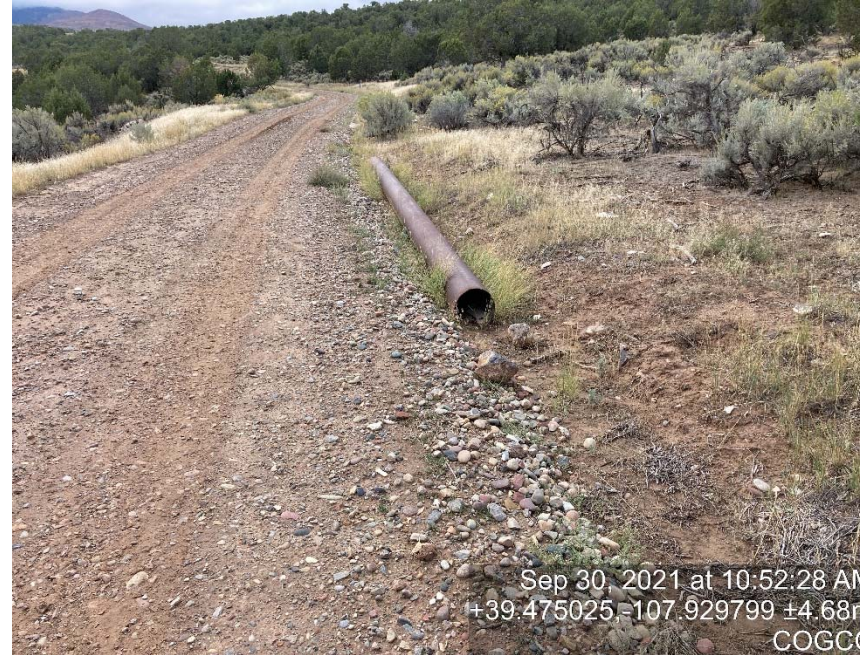
**Unused /stored steel and poly pipe near access road
and at right of way**

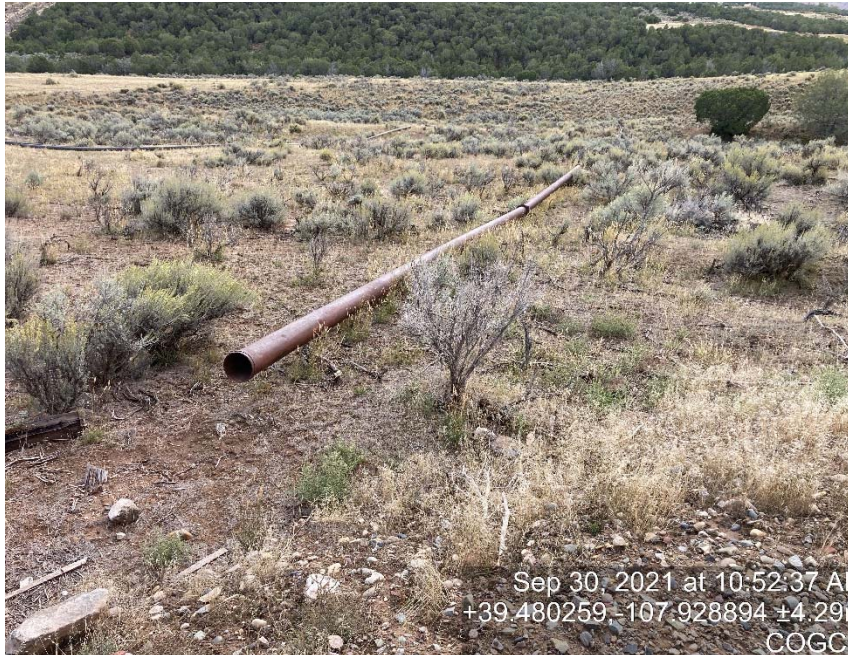
**Unused /stored steel and poly pipe near access road
and at right of way**

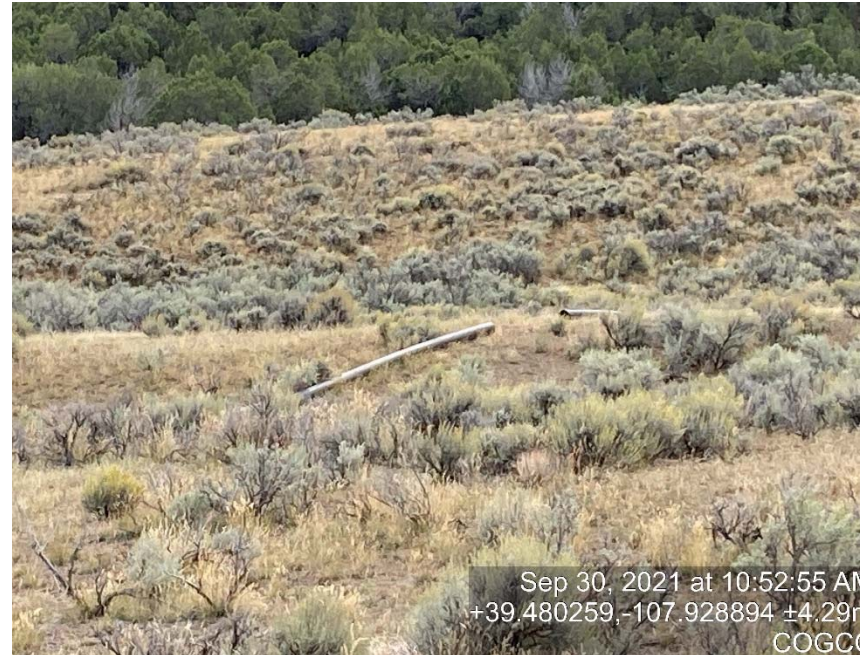
**Unused /stored steel and poly pipe near access road
and at right of way**

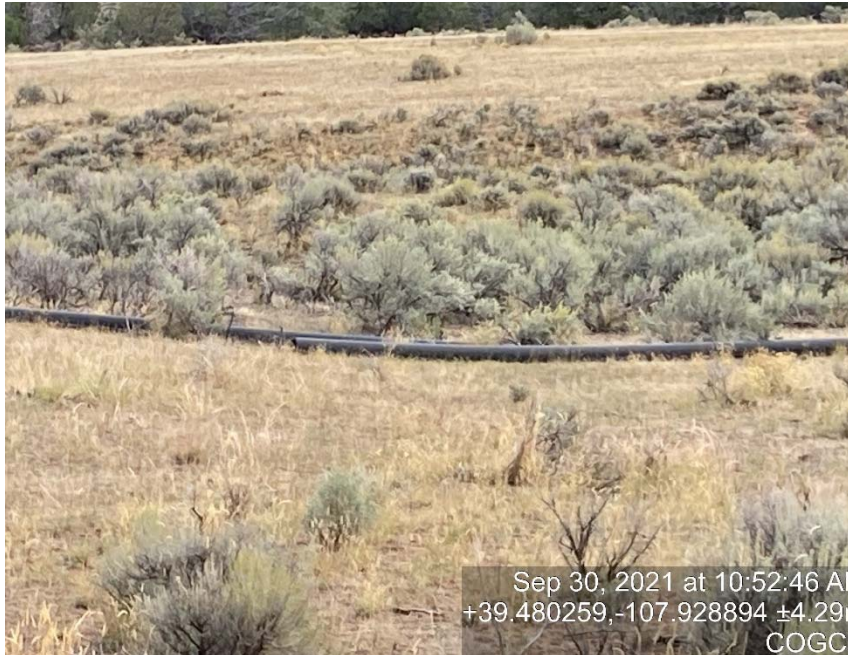
**Unused /stored steel and poly pipe near access road
and at right of way**

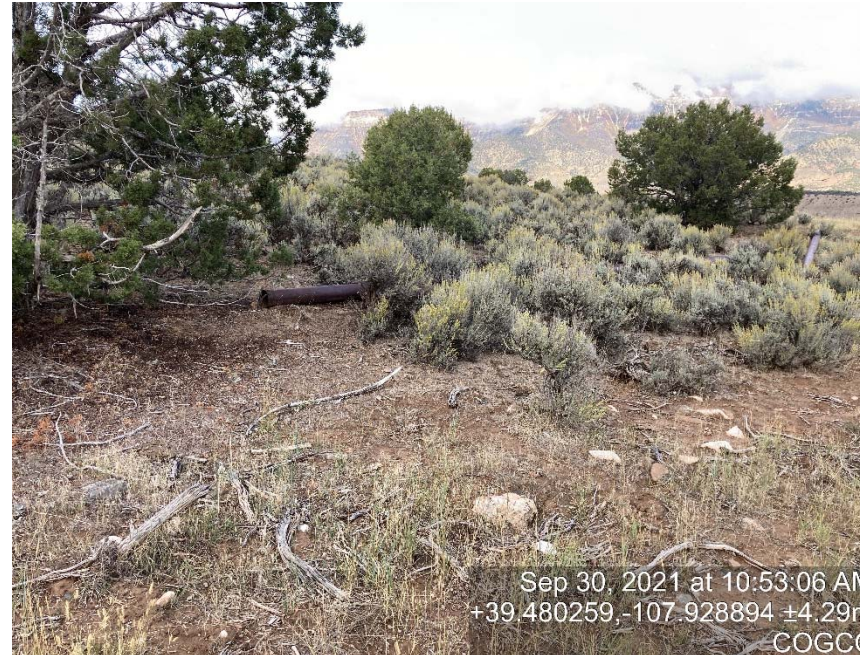
**Unused /stored steel and poly pipe near access road
and at right of way**

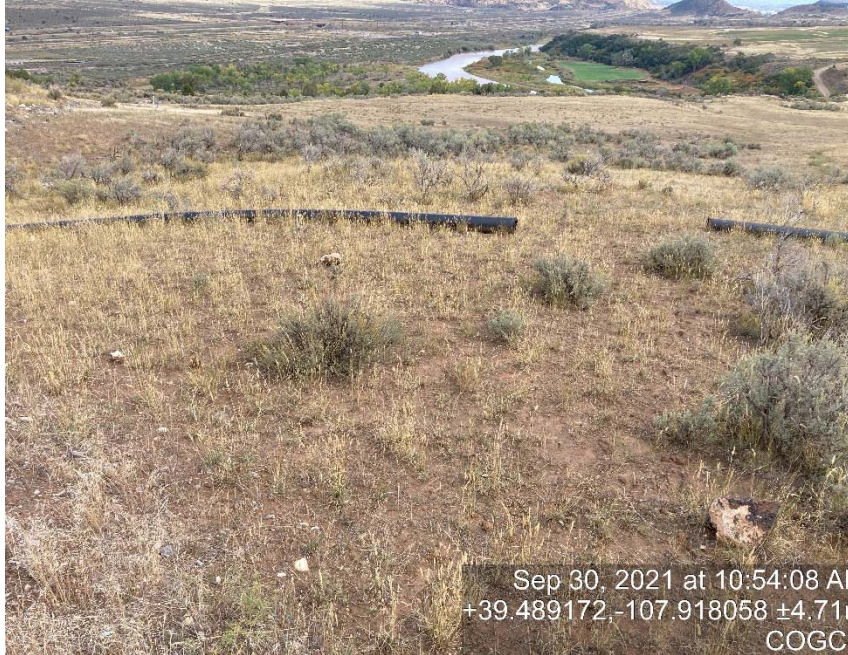
**Unused /stored steel and poly pipe near access road
and at right of way**

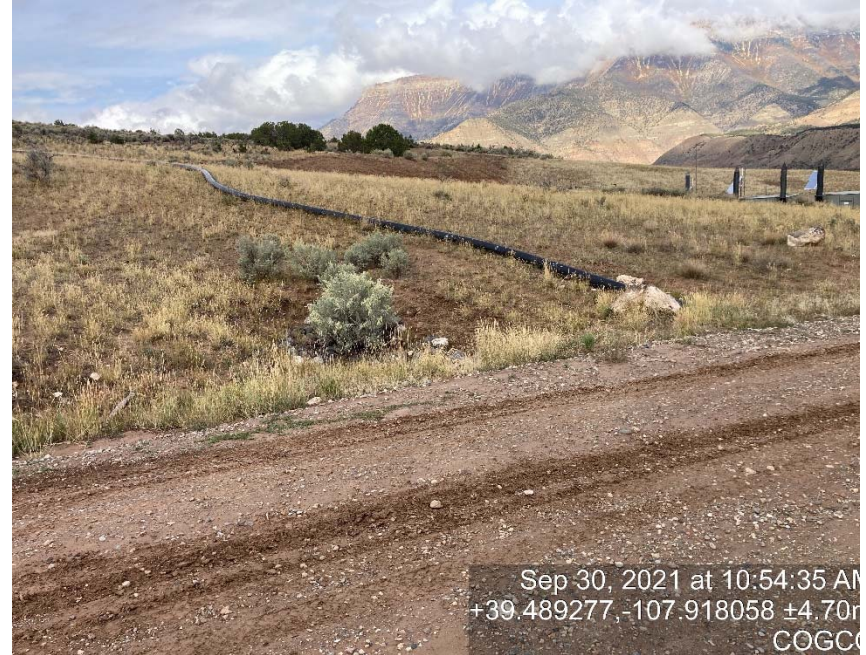
**Unused /stored steel and poly pipe near access road
and at right of way**

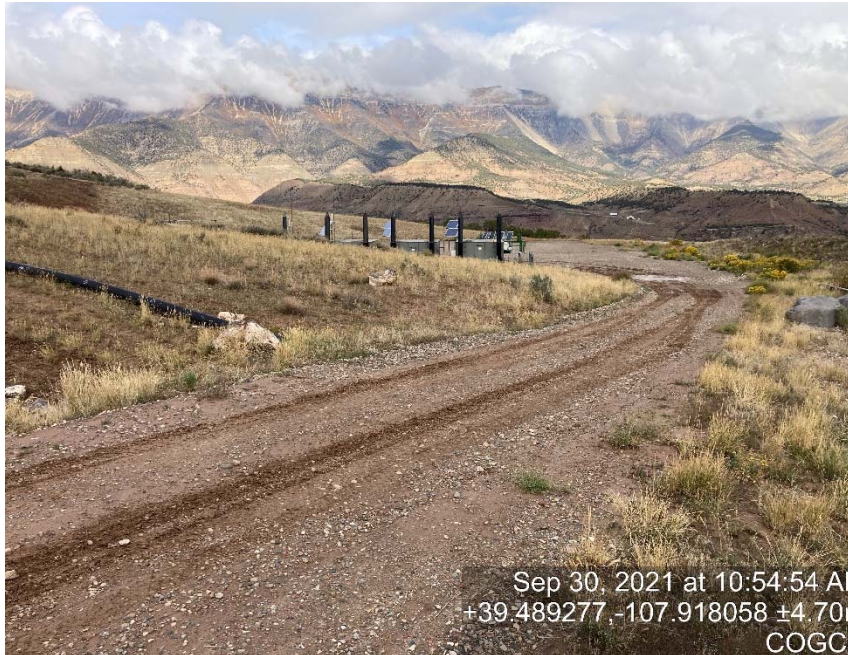
Location where unused poly and steel piping run under road

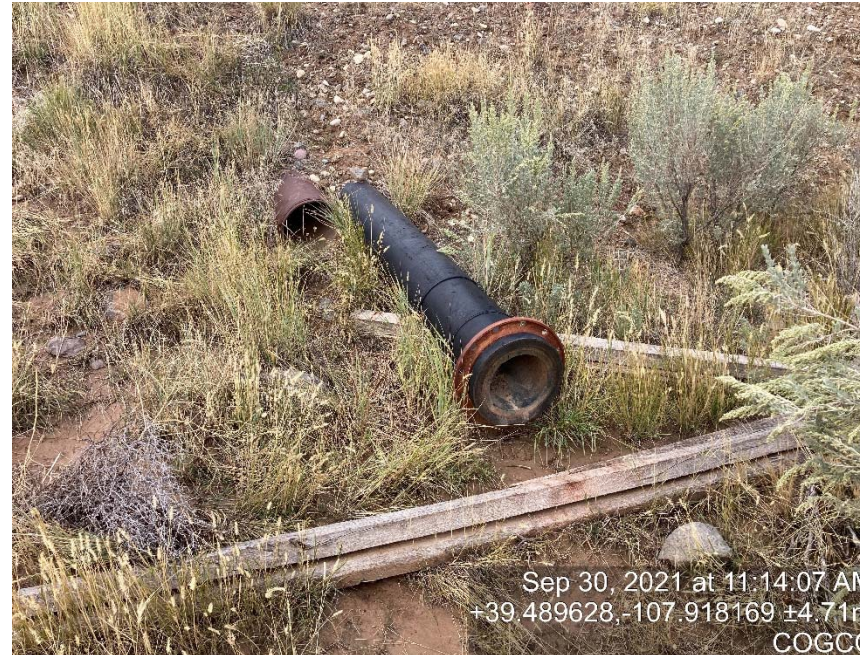
Open ended poly that runs up the hill on right of way

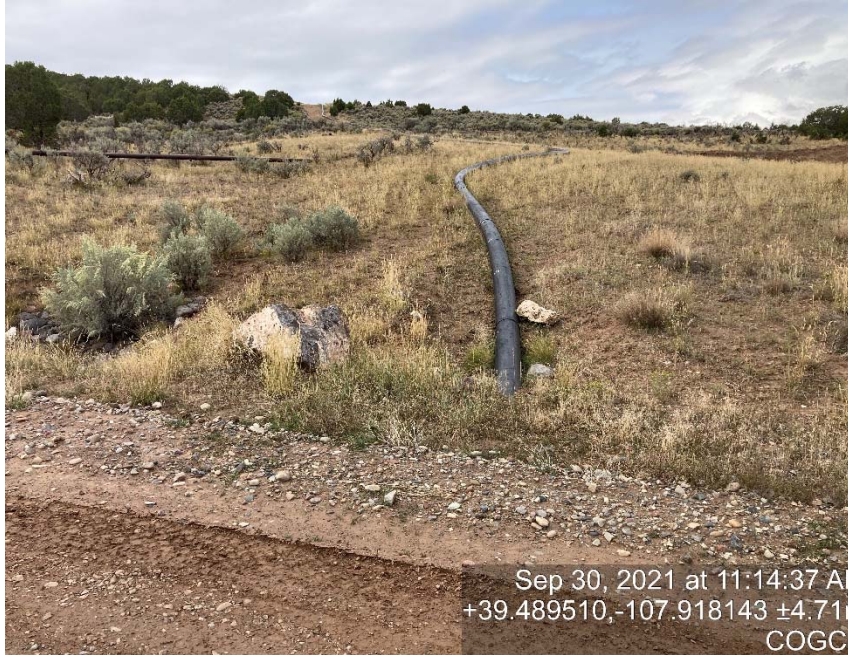
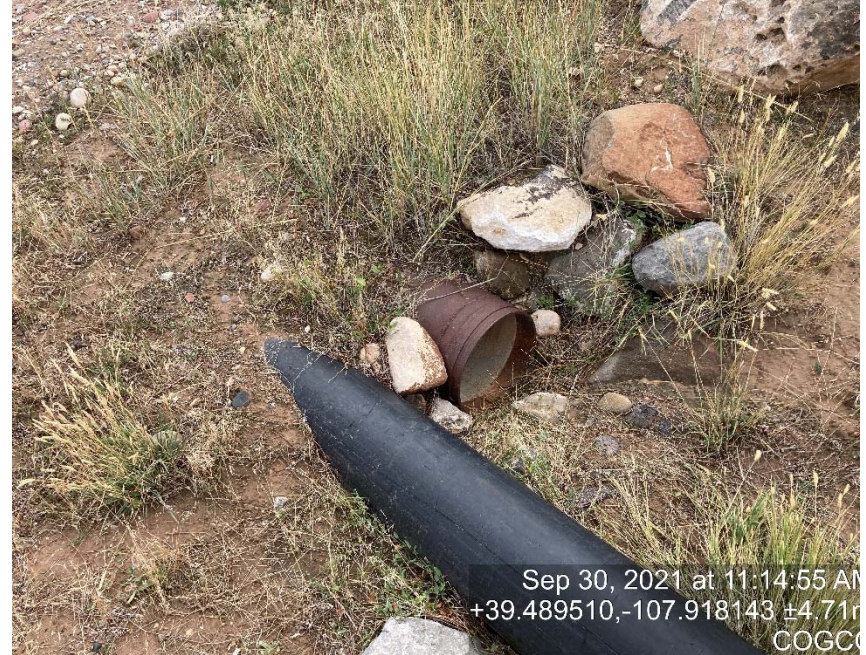
**Unused /stored steel and poly pipe near access road
and at right of way**
