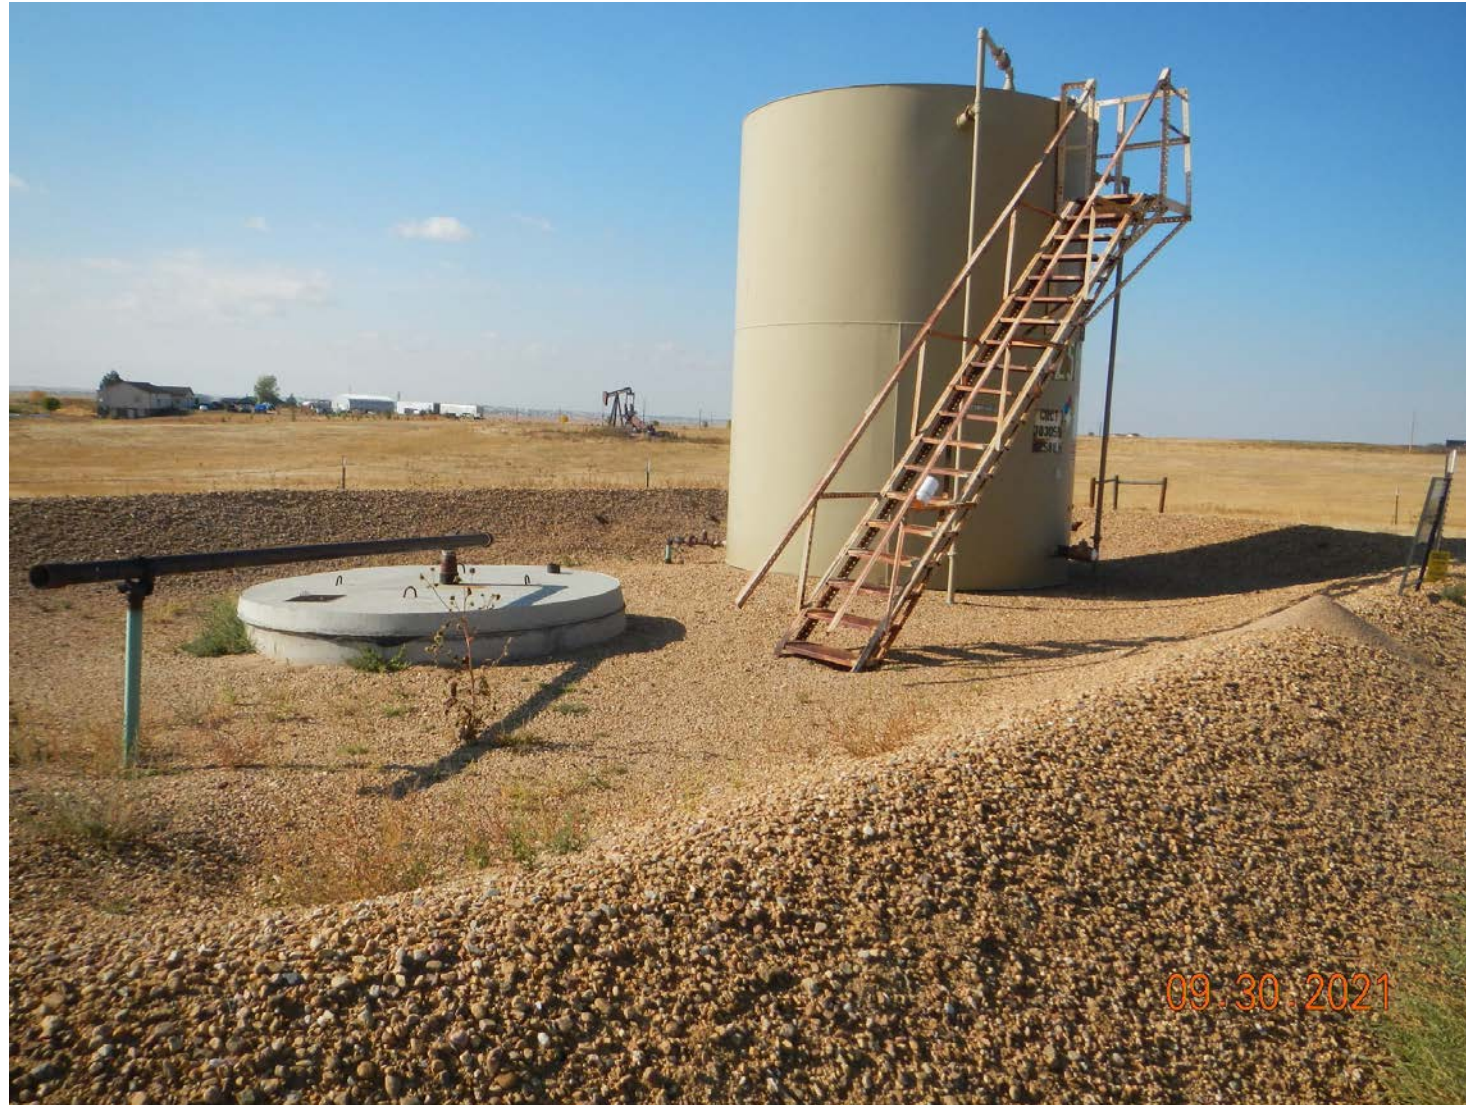
- Photo 2 – Tank battery, view northeast, wellhead in the background

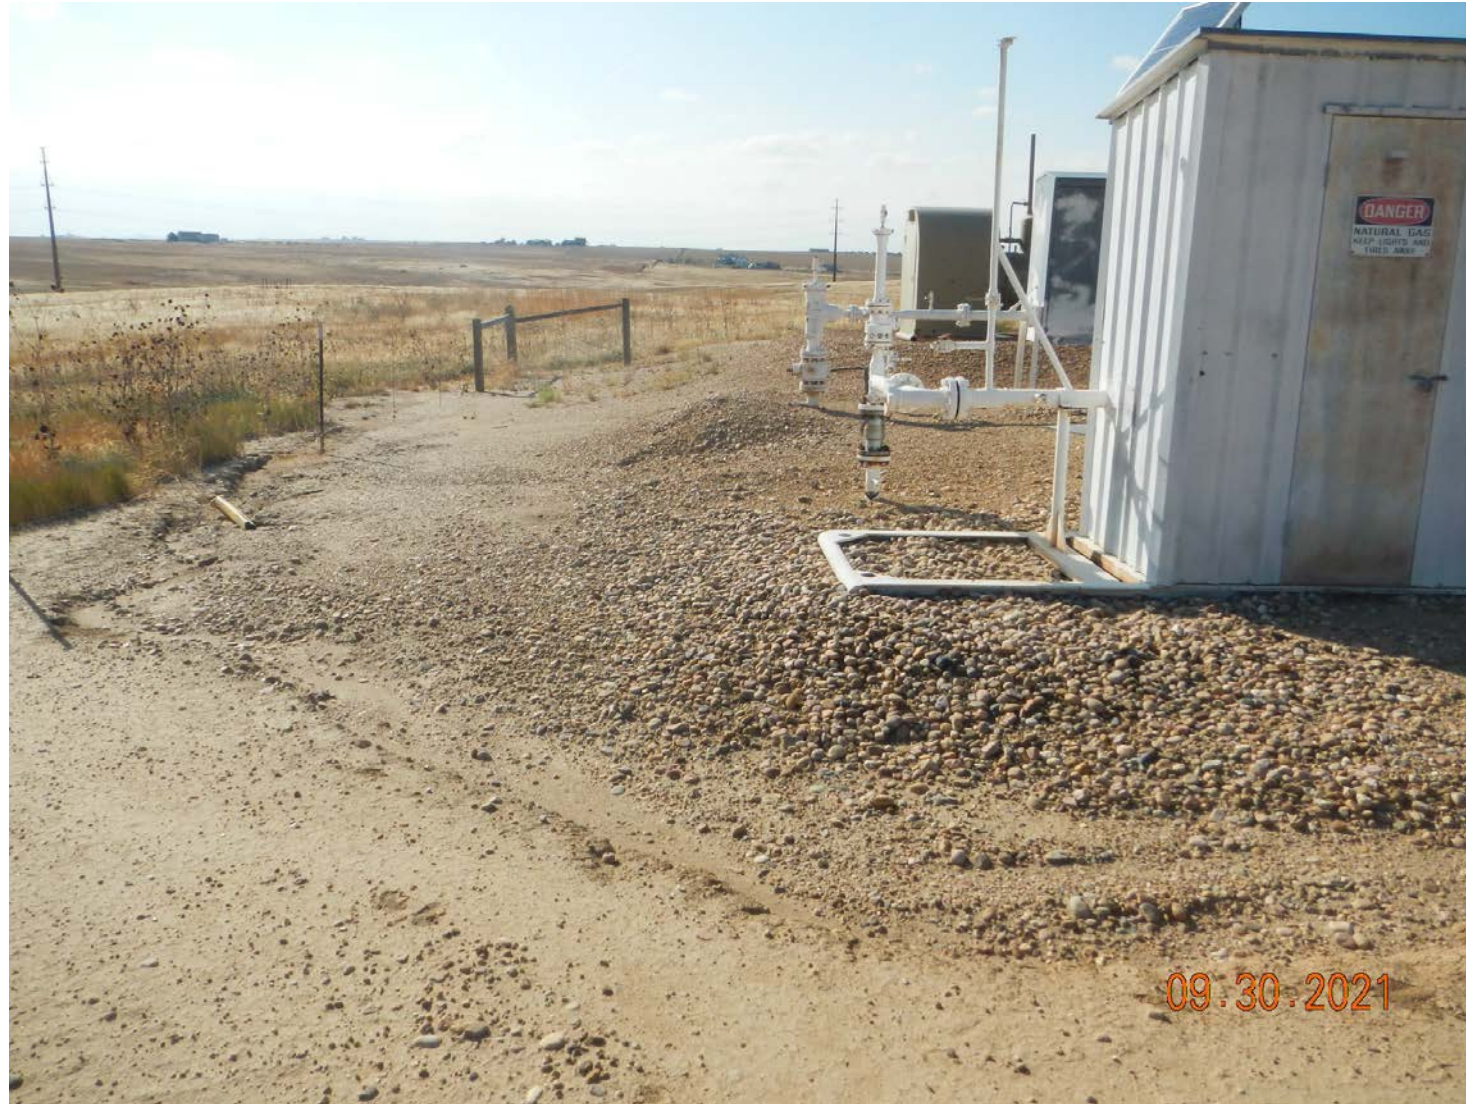
- Photo 3 – South end of tank battery, view west, erosion control needed

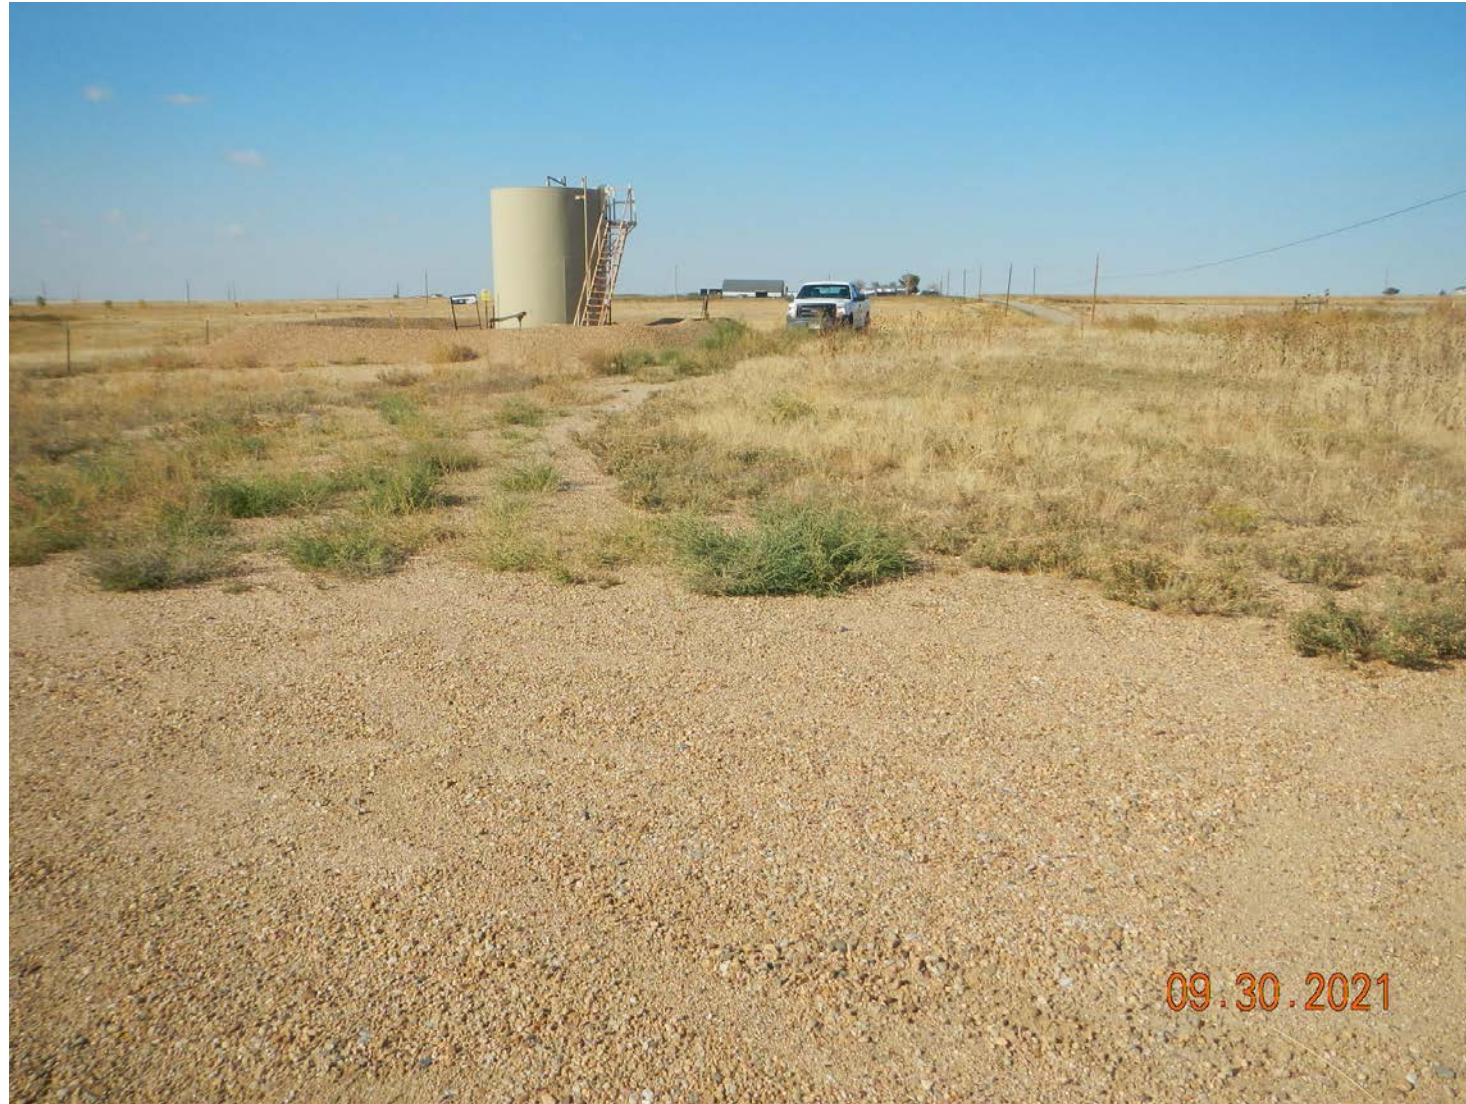
- Photo 5 – View north, weeds on access road need mowing or other control

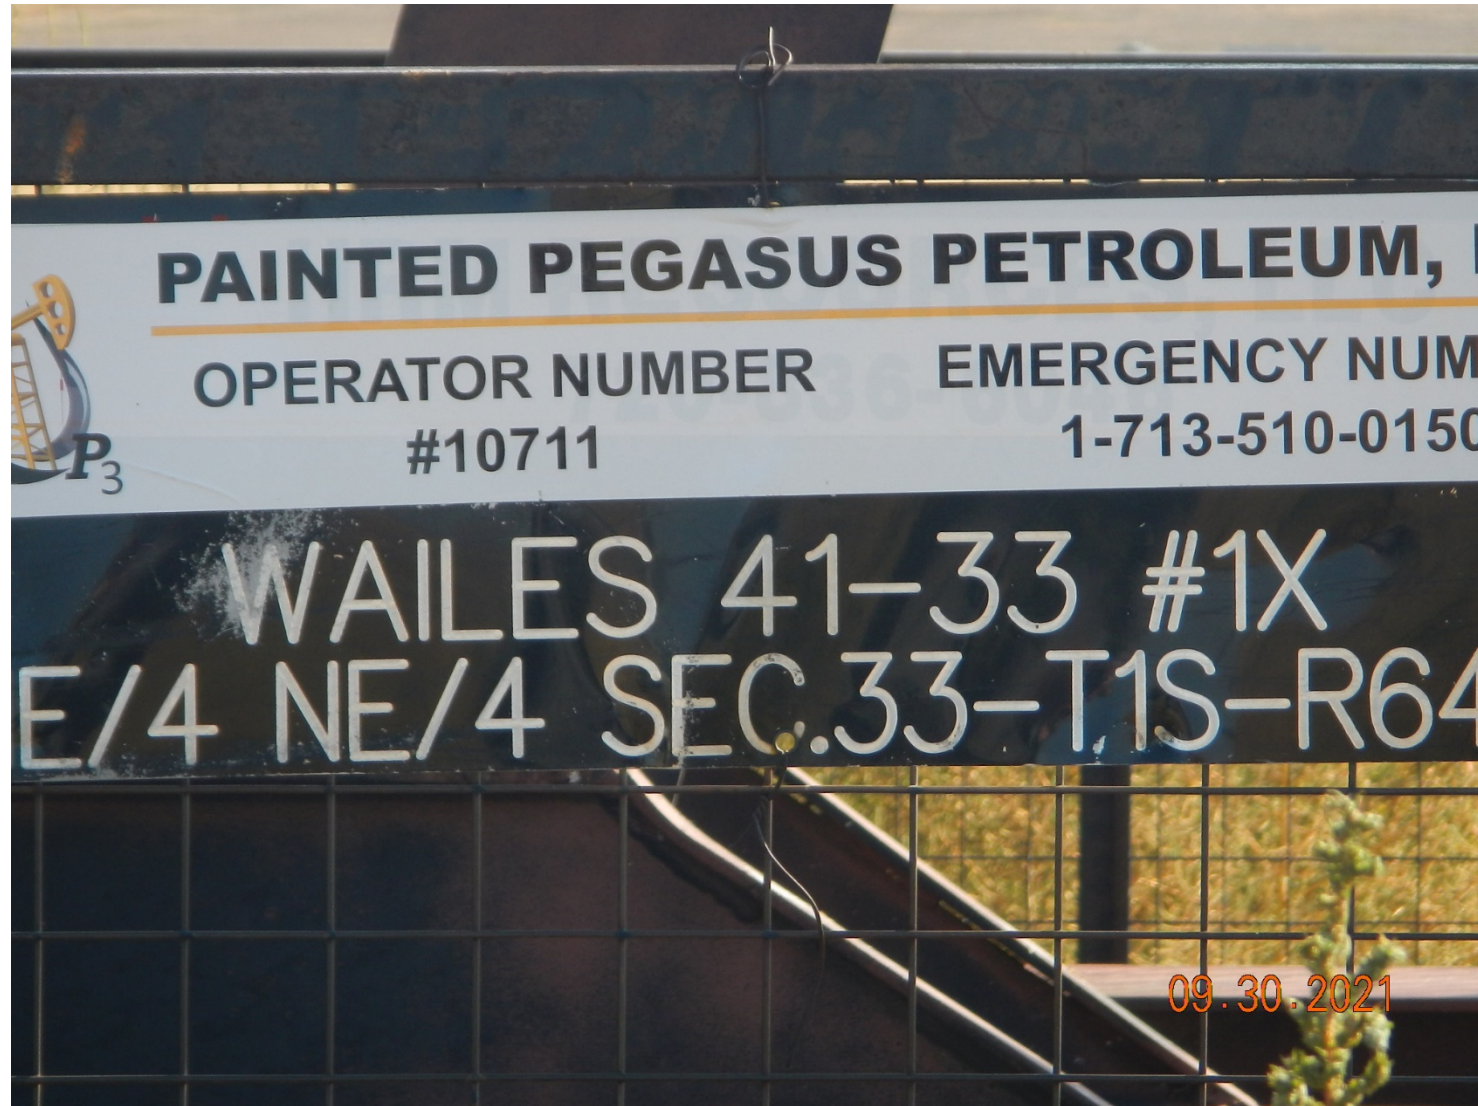
- Photo 6 – Well sign

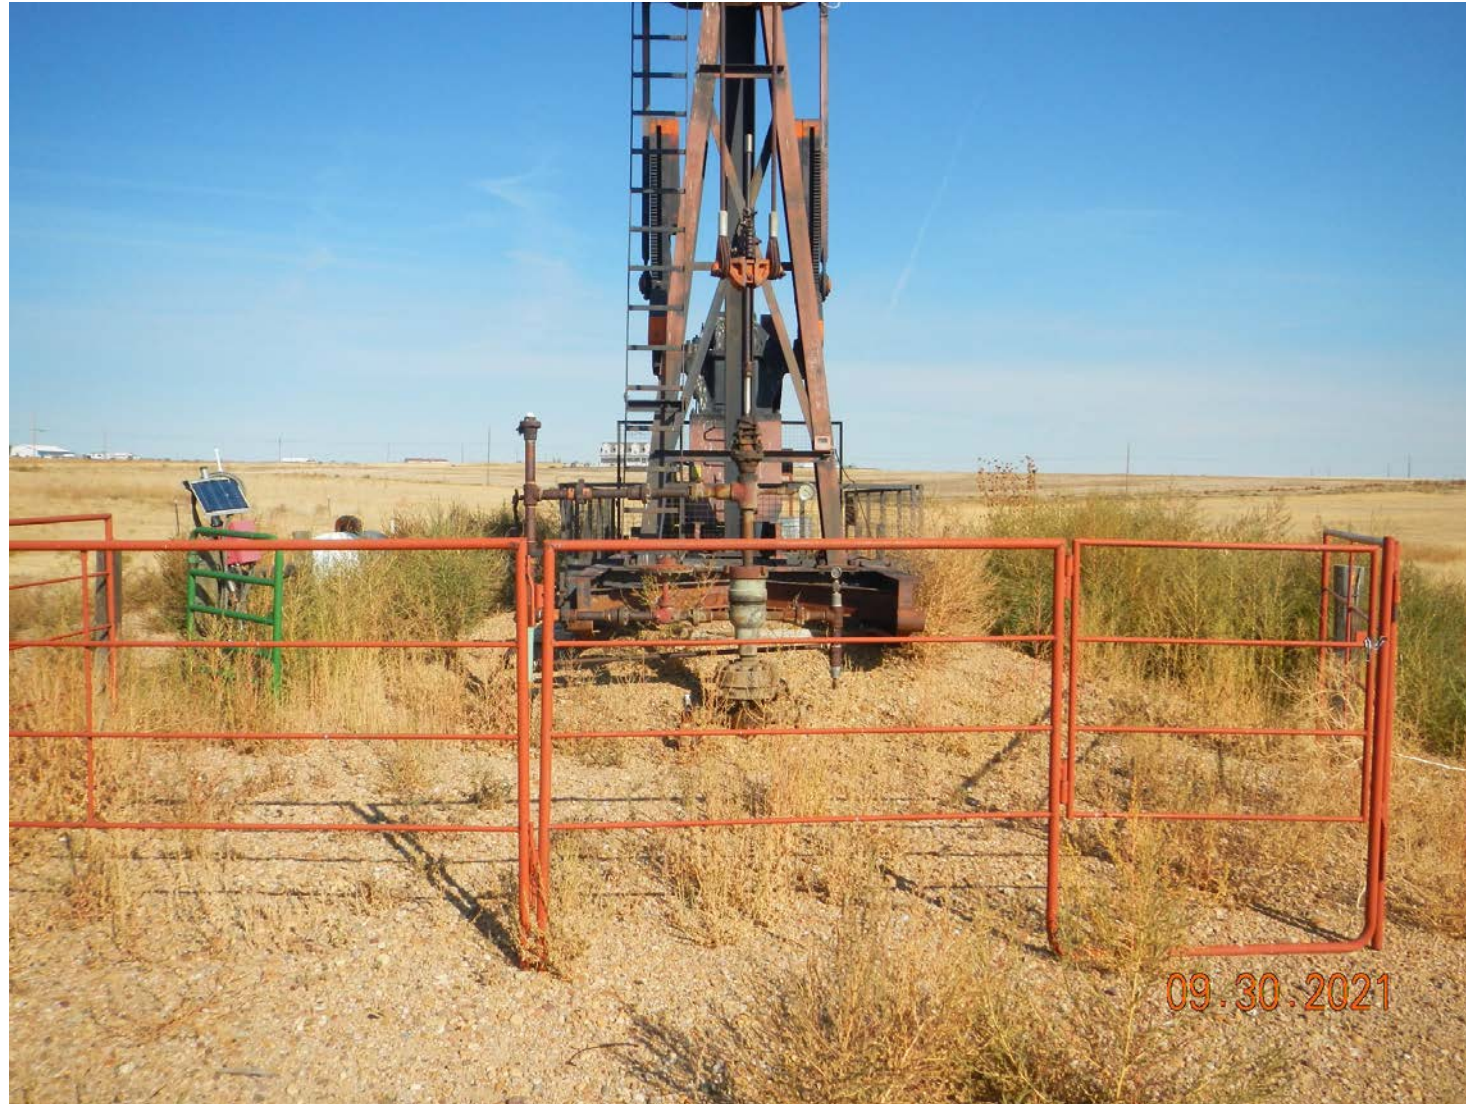
- Photo 7 – Wellhead, view east

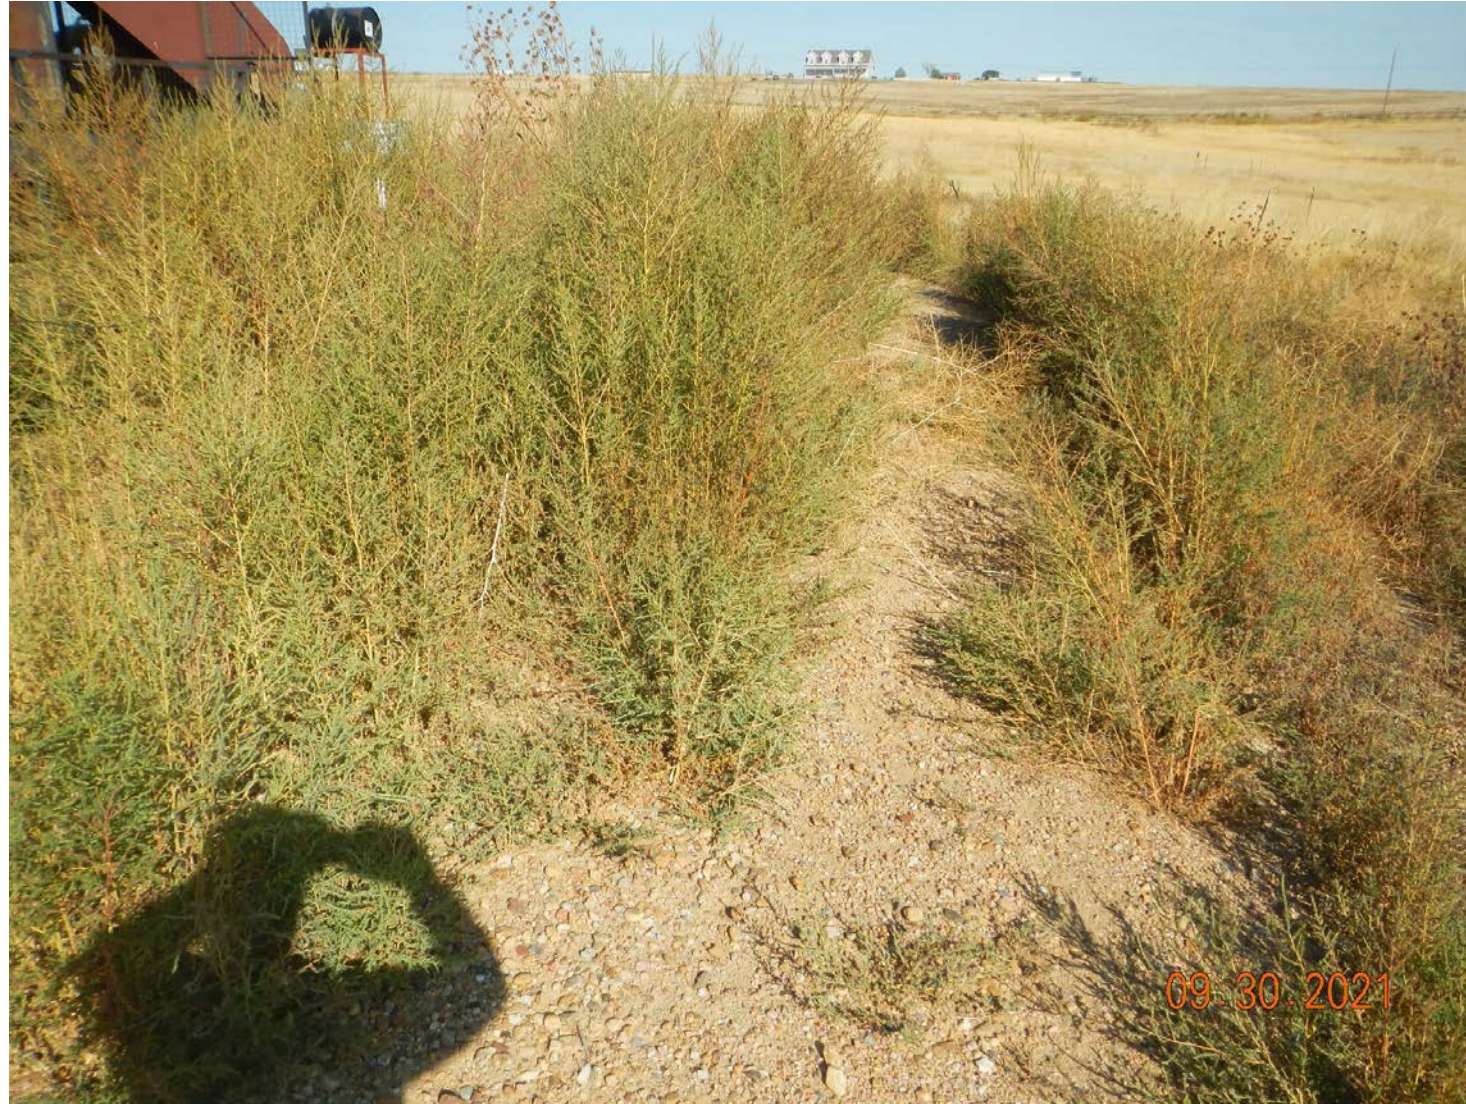
- Photo 7 – South side of wellhead, weeds, view east

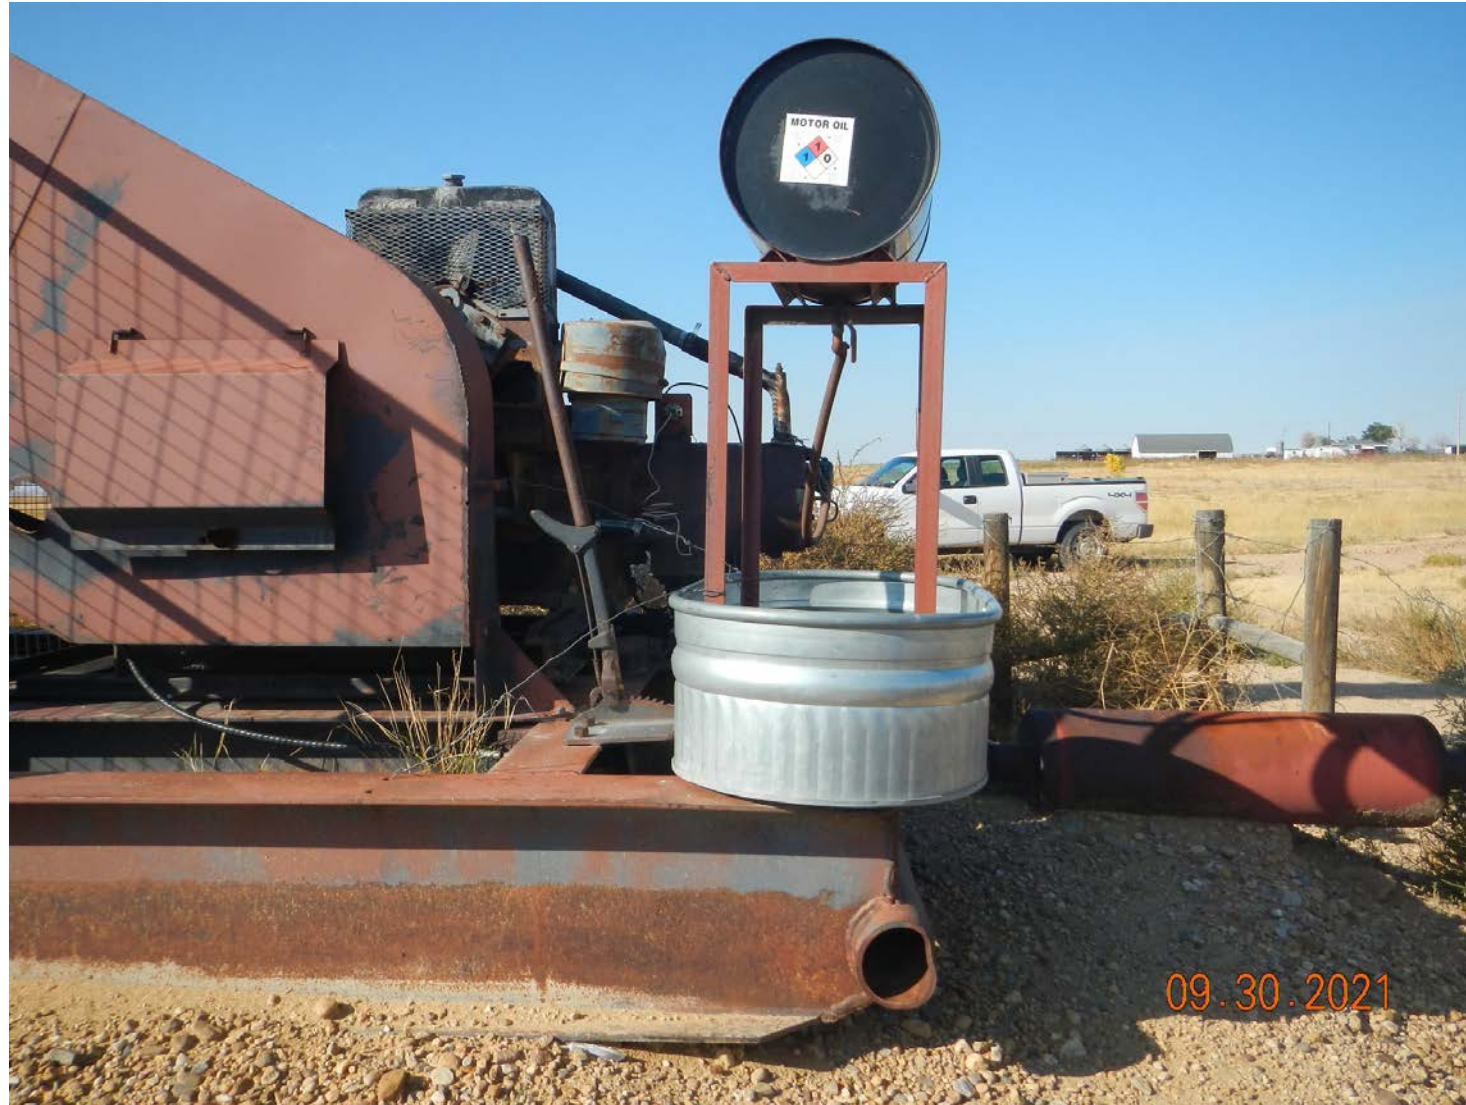
- Photo 9 – East side of well area, weeds in the background, view north

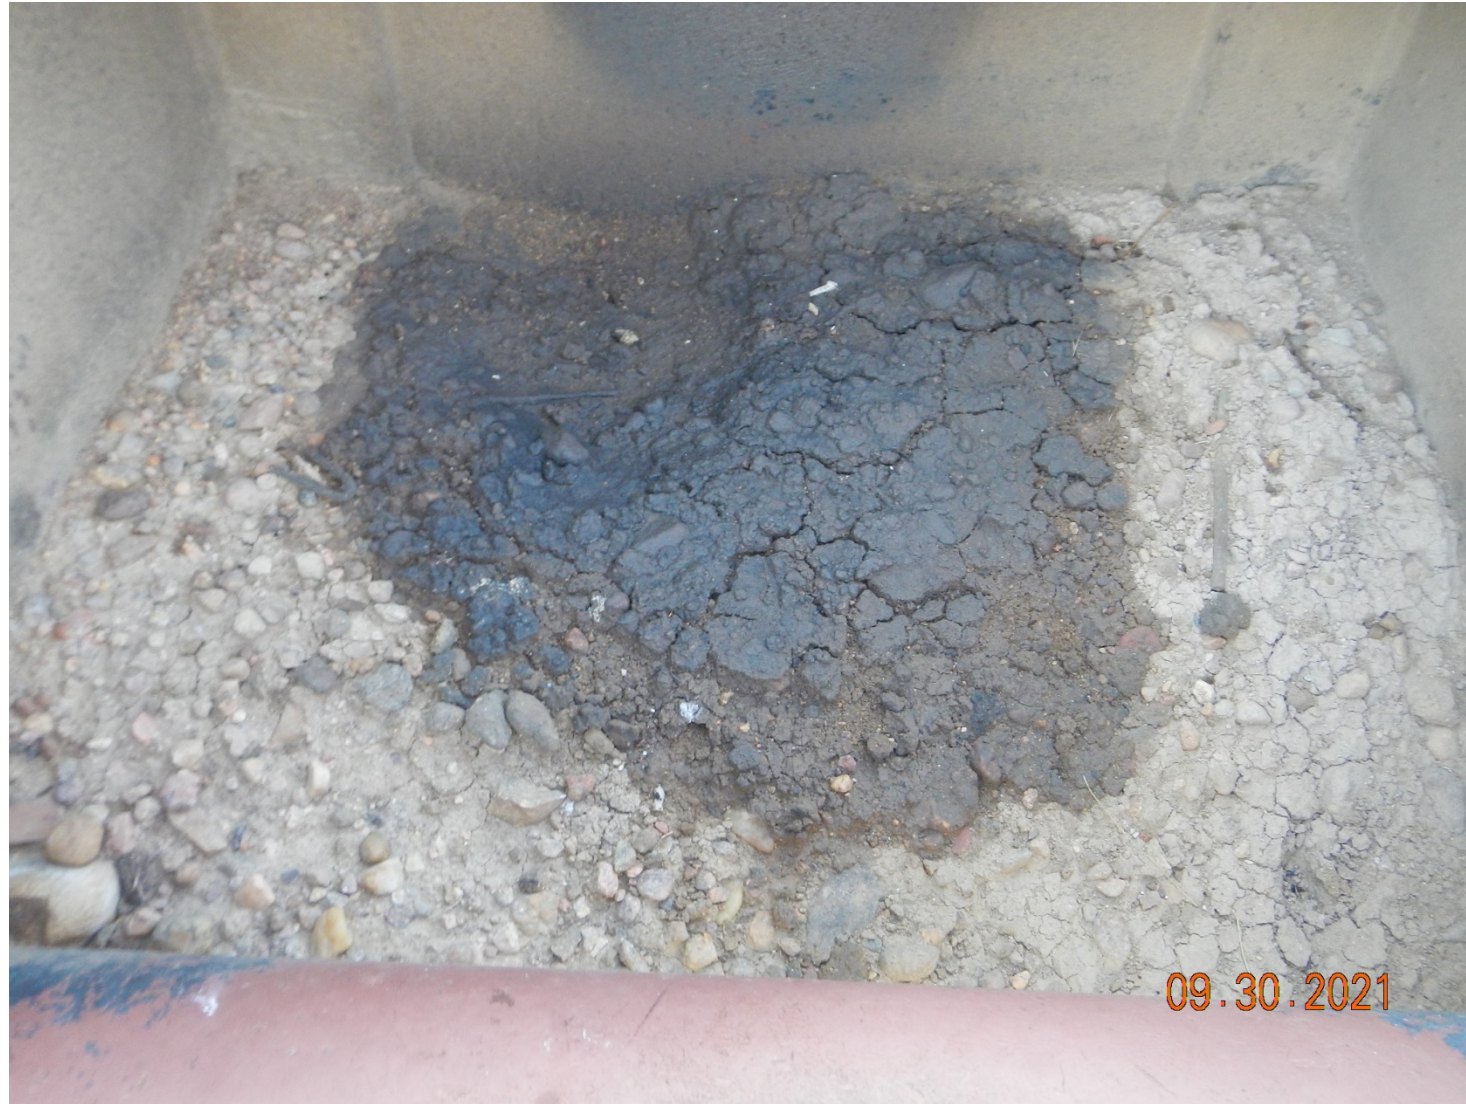
- Photo 10 – oily soil under motor

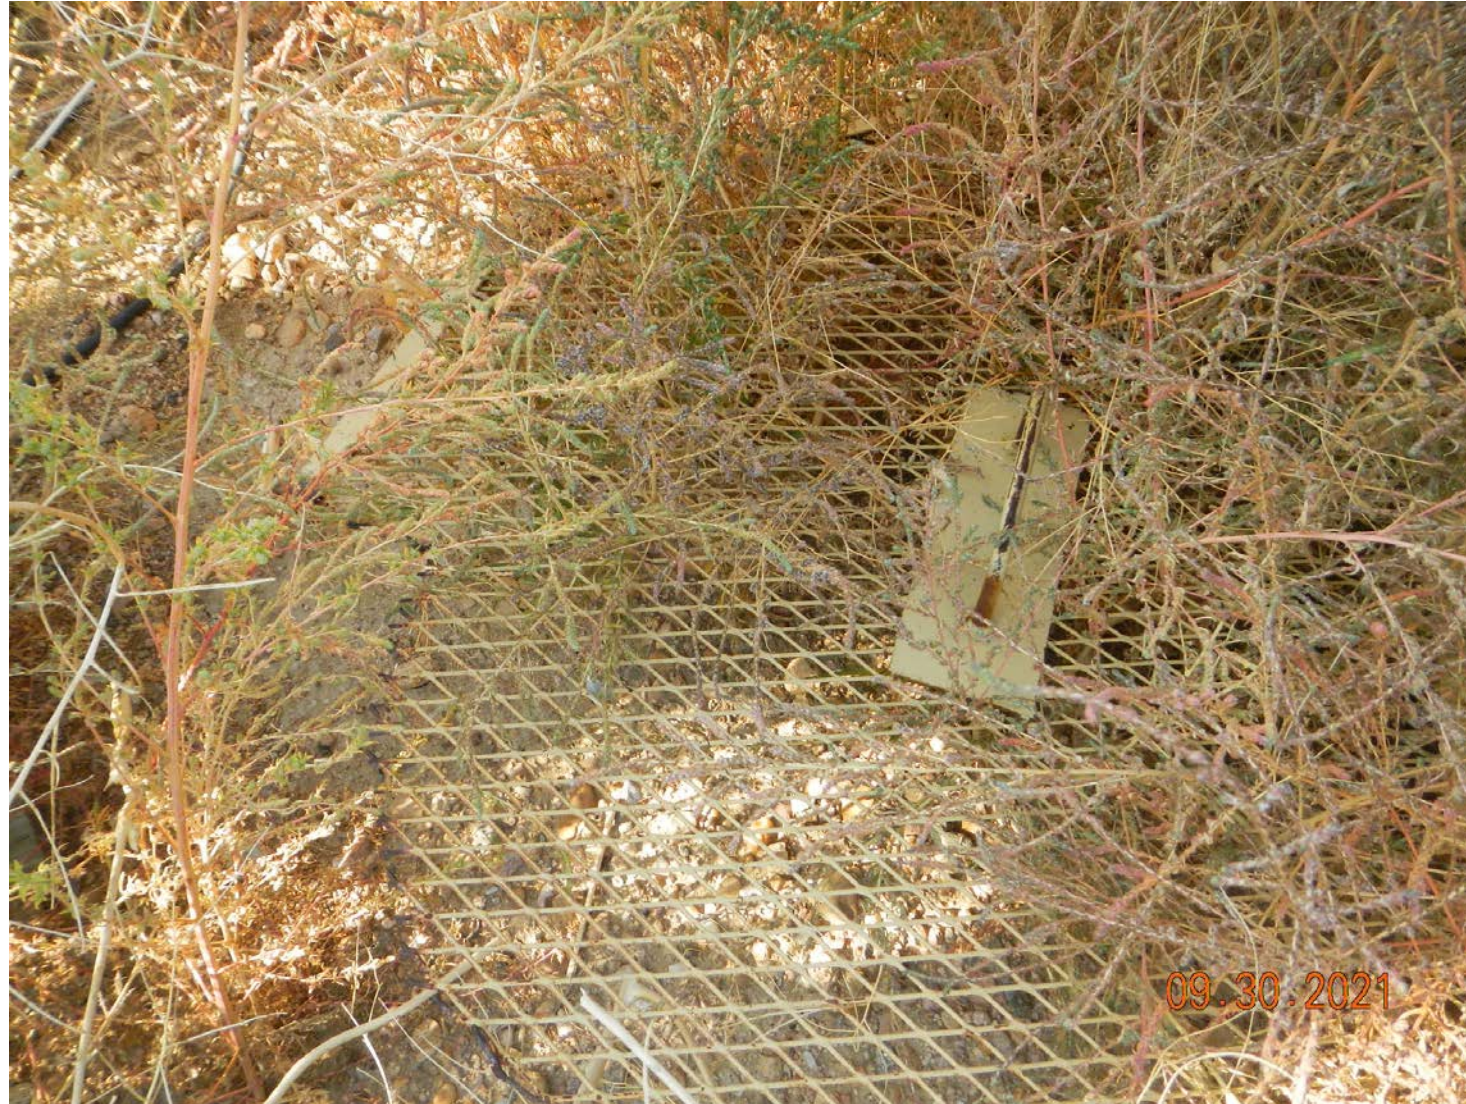
- Photo 11 – Flywheel guard off, weeds on north side of pumpjack
