Inspection Photos
Operator: Simcoe
Facility: 067-08812
Date: 9/20/2021

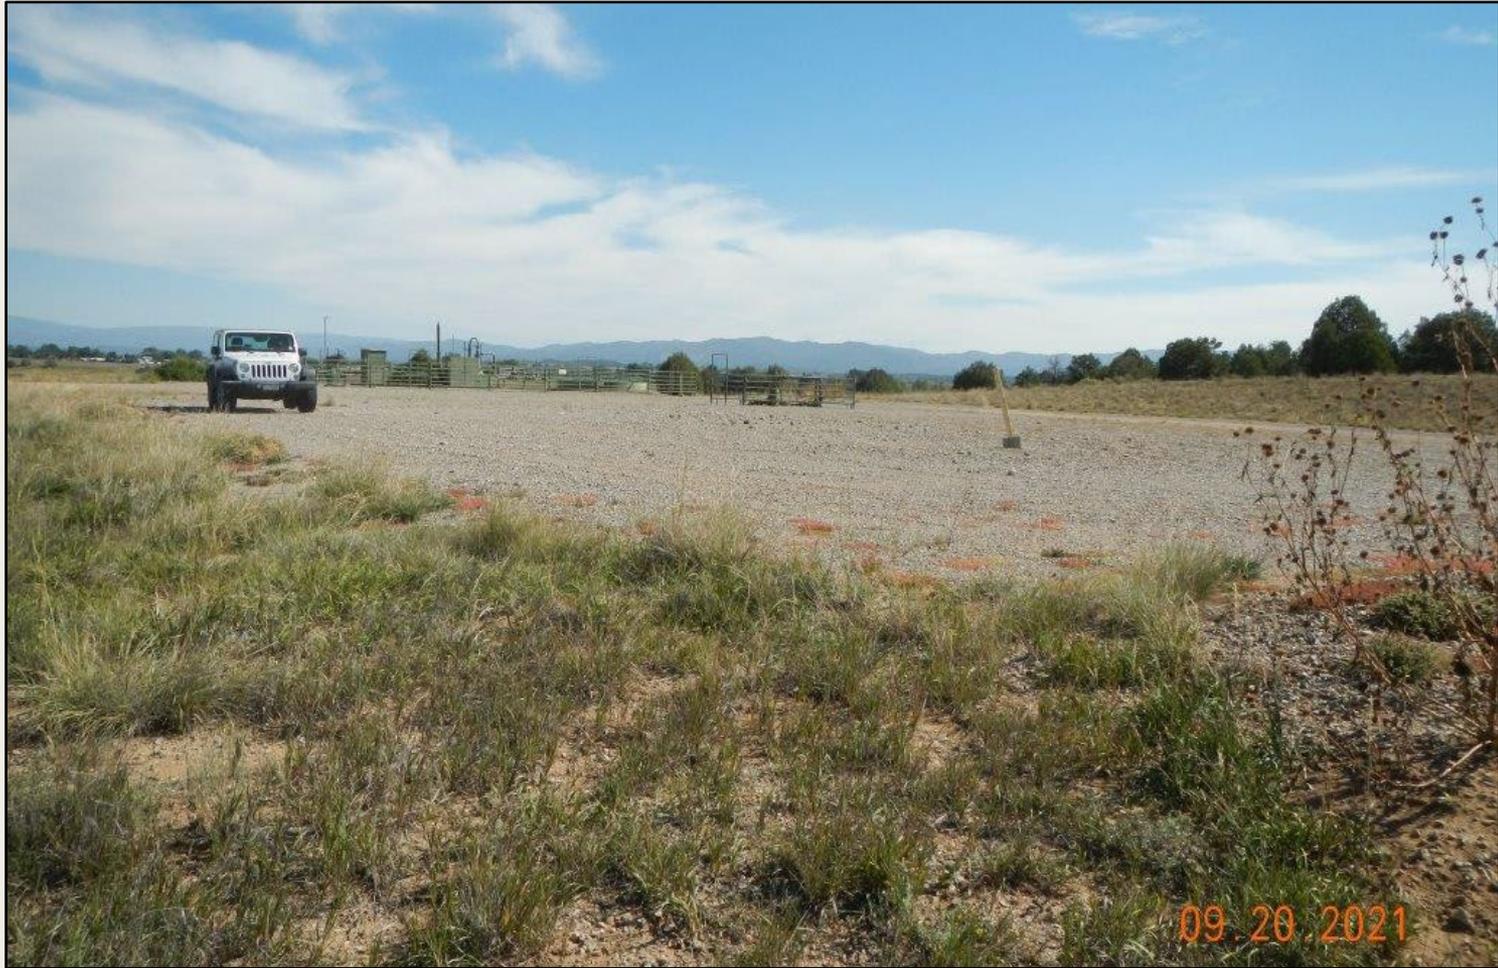
Photo 1. View of project area from the southwestern corner facing center.

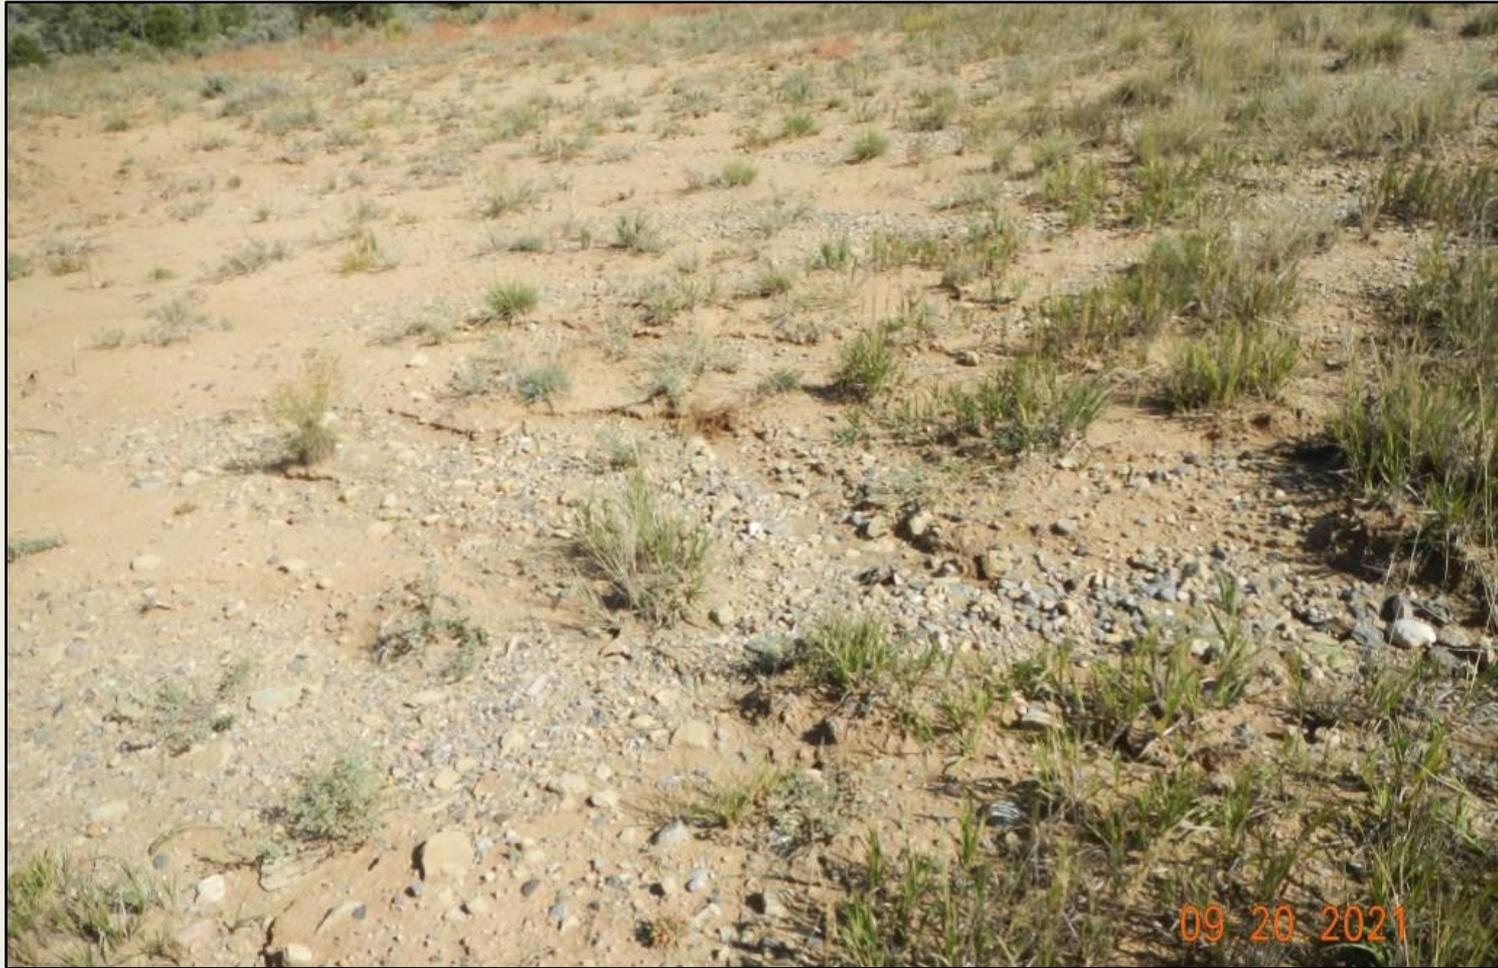
Photo 2. View of western fill slope. Revegetation is progressing with western wheatgrass, smooth brome, and crested wheatgrass. Erosion is occurring along the edges of the seeded area, at the toe of the slope.

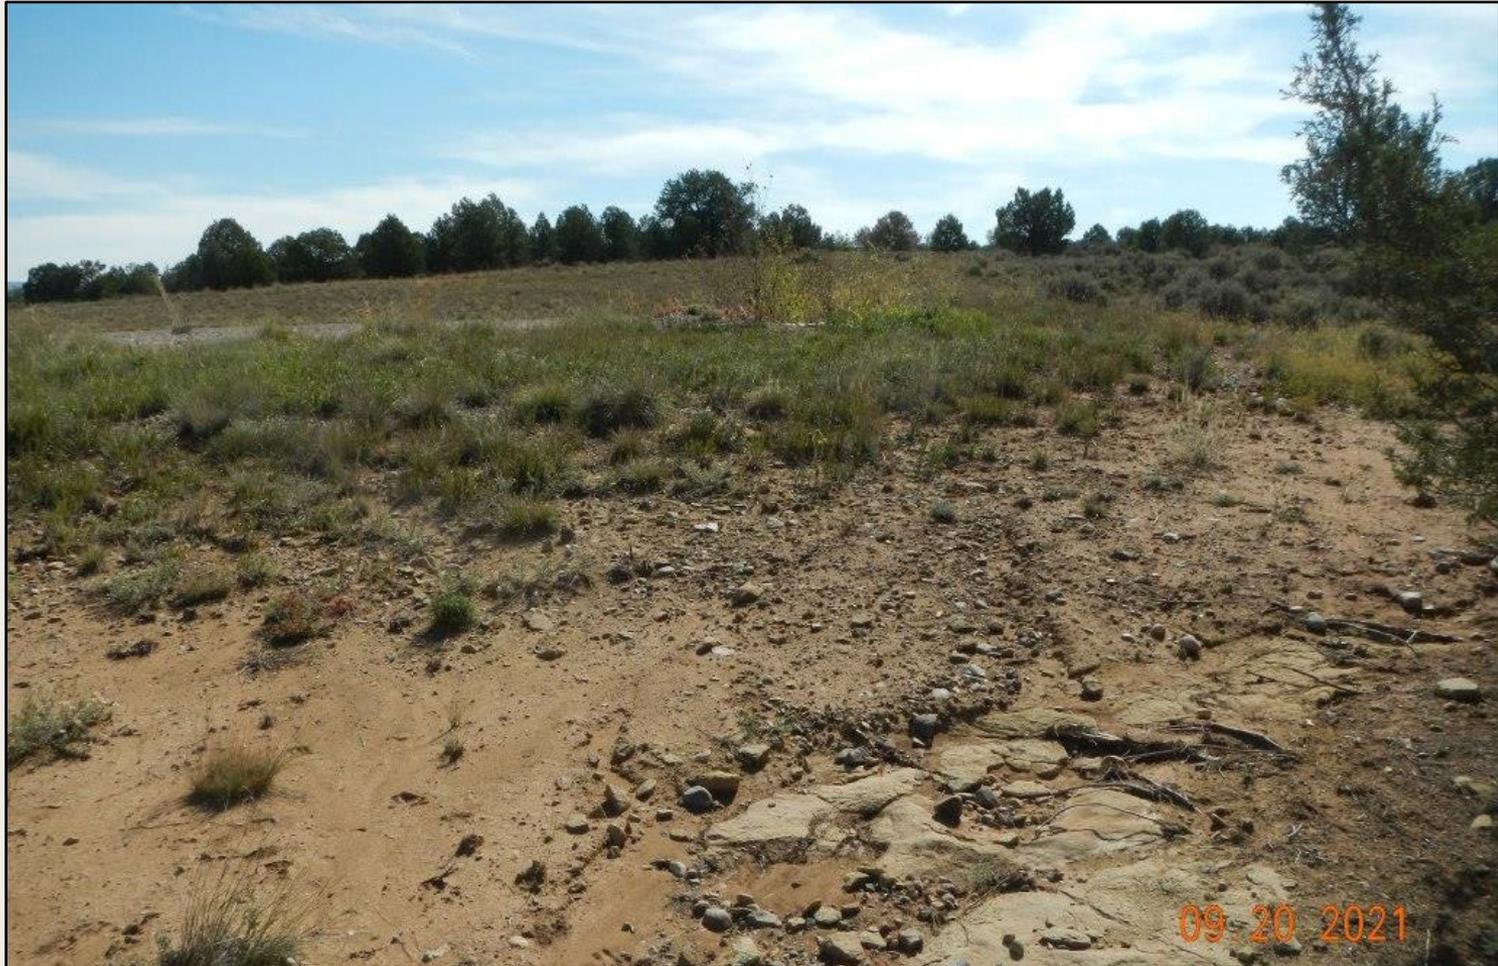
Photo 3. Another view of erosion occurring along the edge of the western project area. Diverted stormwater flows are scouring soils and vegetation in the southwestern corner.

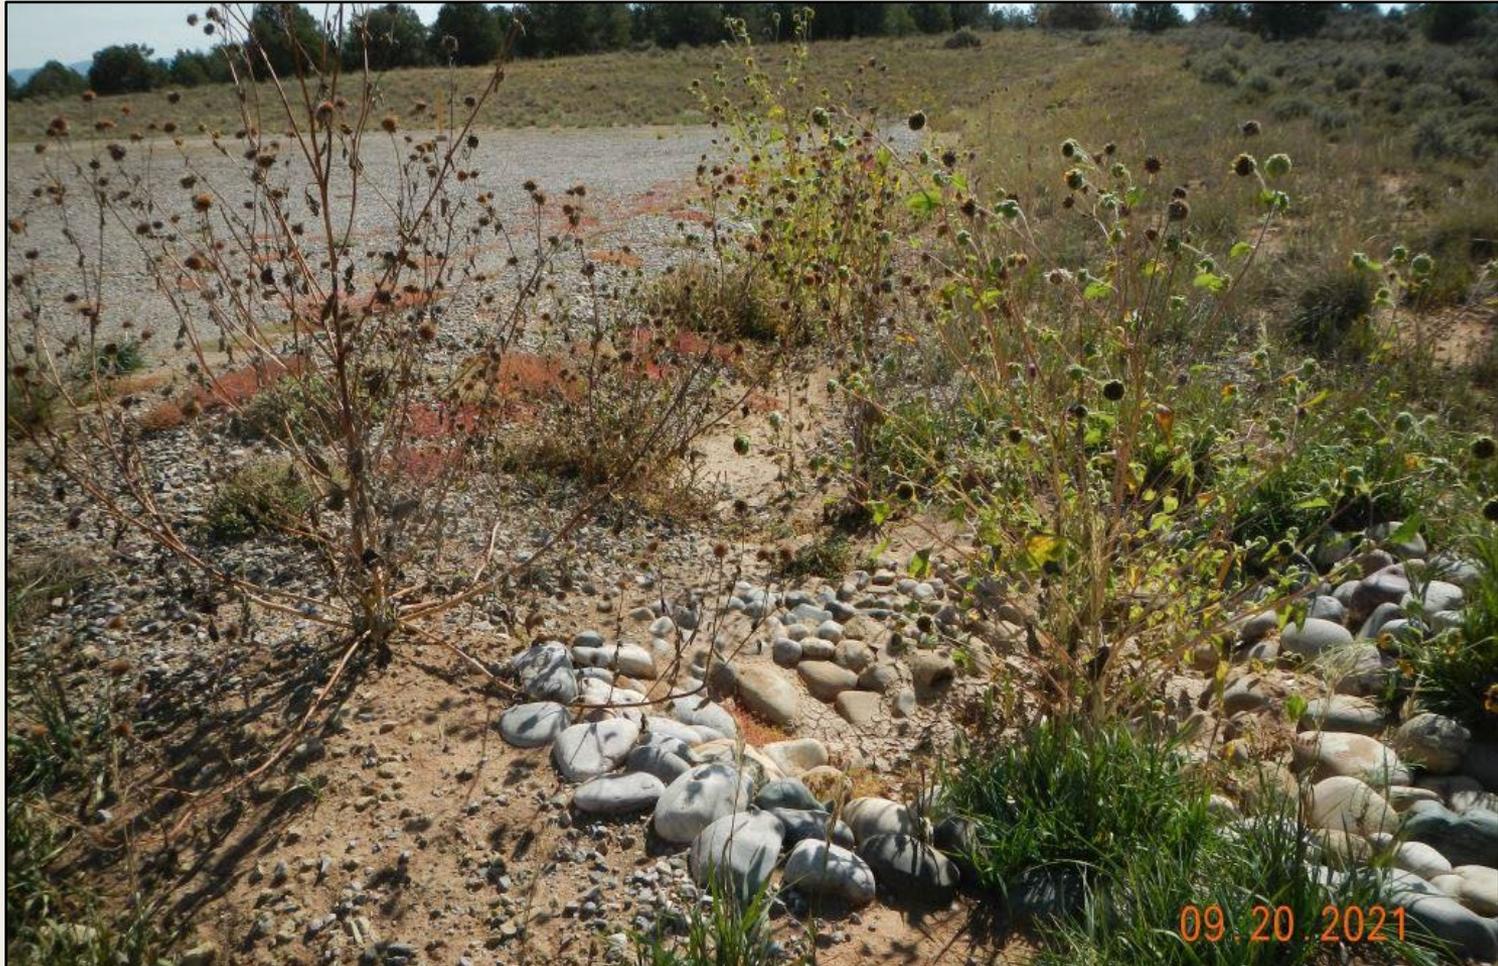
Photo 4. View of silt trap in the southwestern corner of the project area. This BMP is not adequate to contain diverted stormwater flows from the well pad, as evidenced by active down-slope erosion (Photo 3).

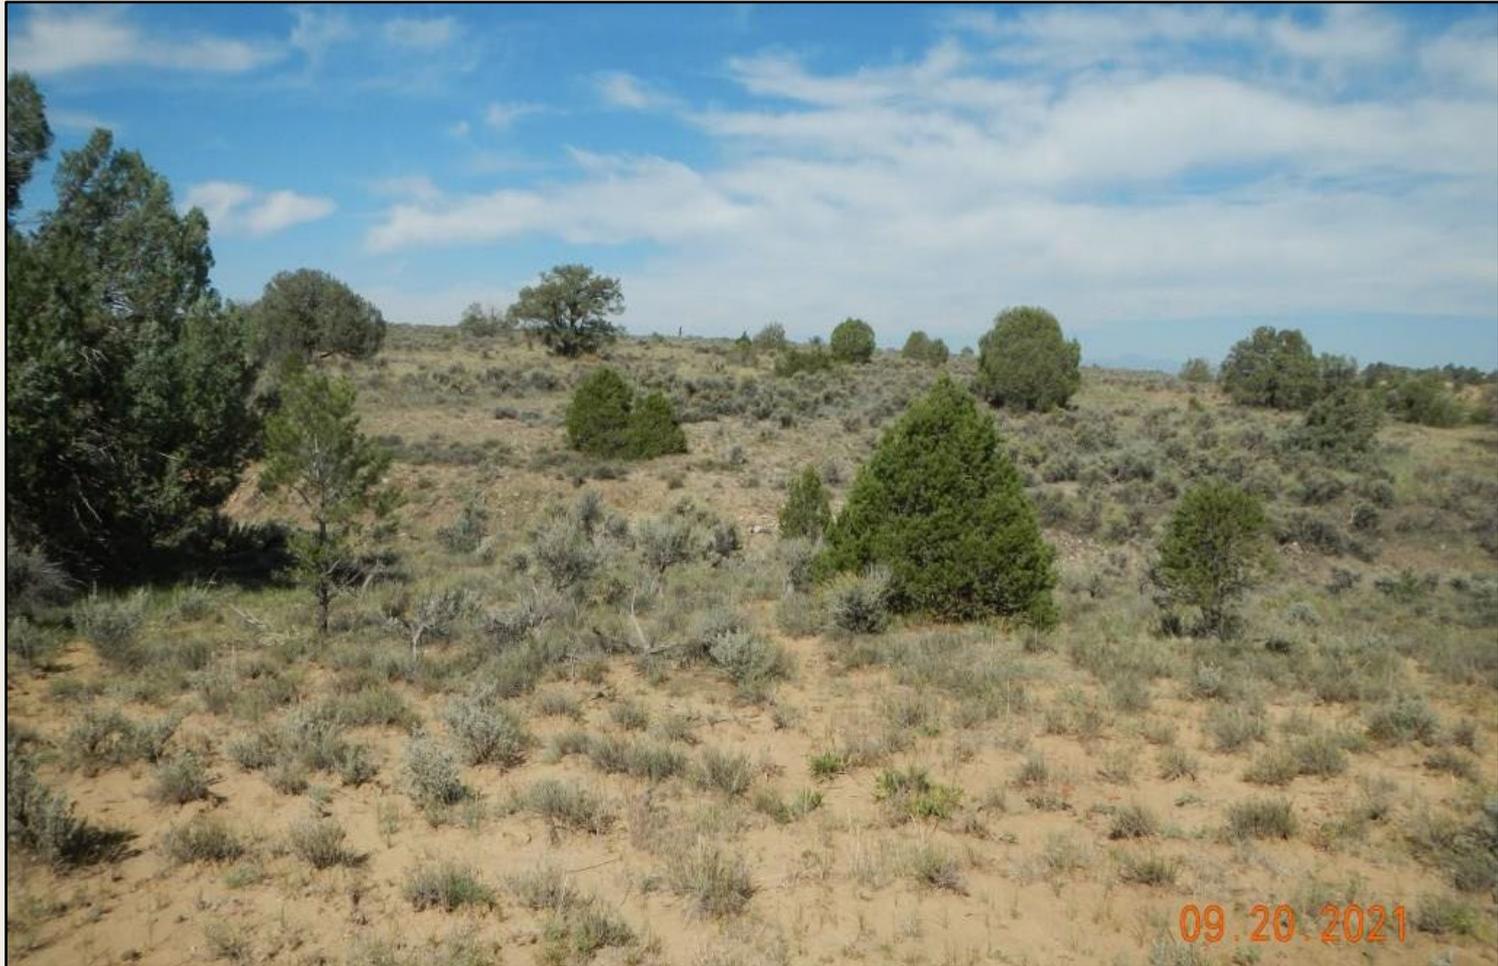
Photo 5. View of reference area comprised of sagebrush shrubland with snakeweed, James galleta, buckwheat, and penstemons in the understory.
