Inspection Photos
Operator: Simcoe
Facility: 067-06983
Date: 9/20/2021

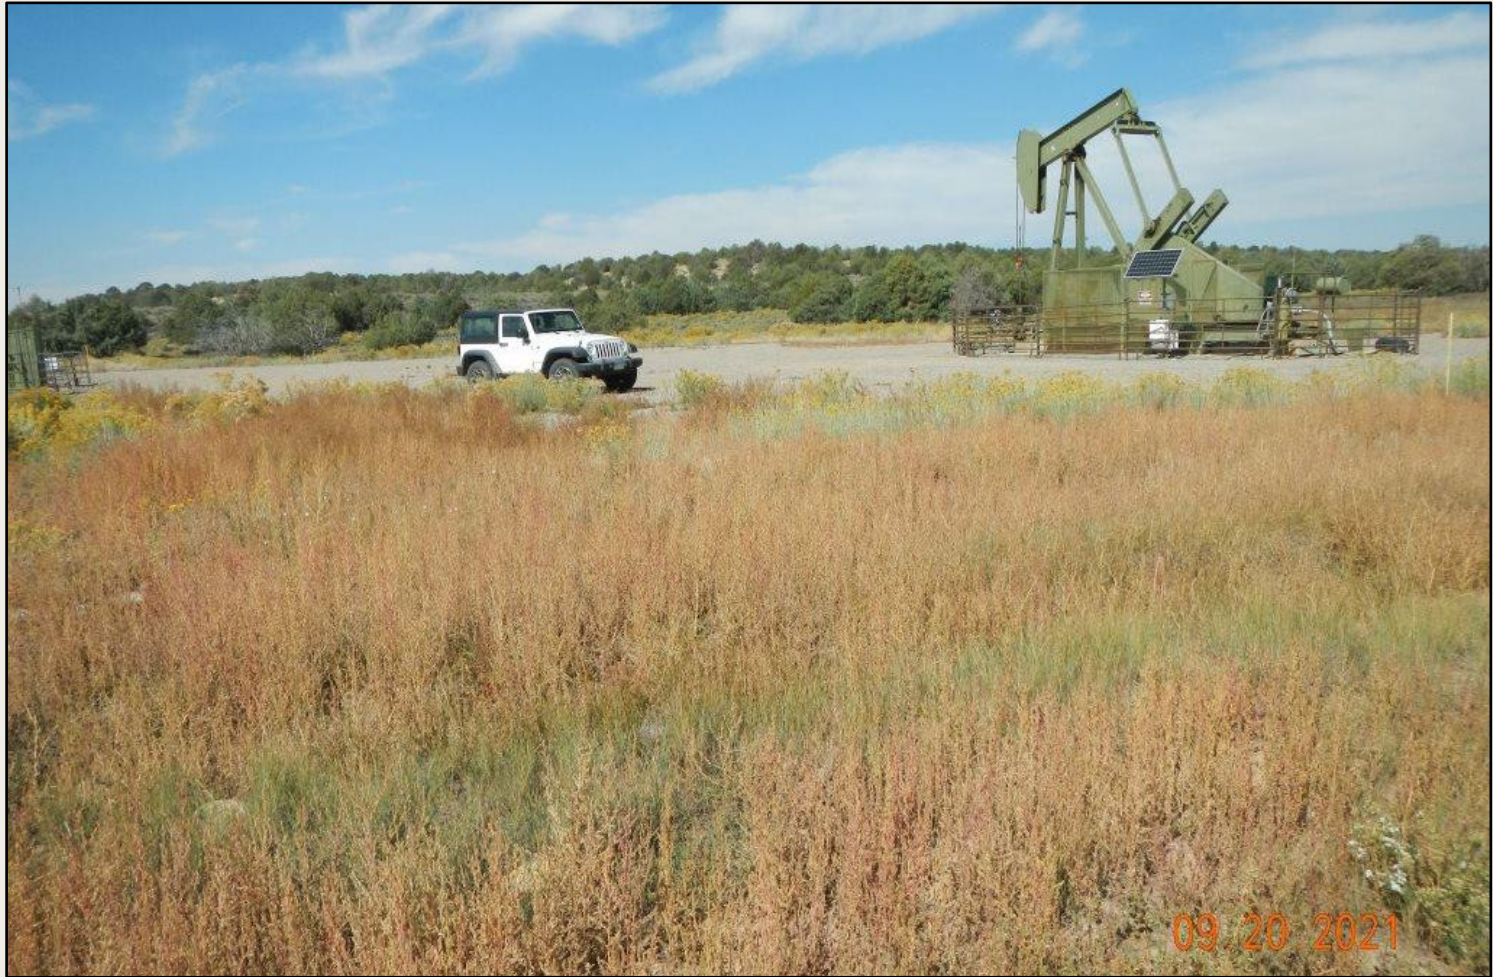
Photo 1. View of project area from the southeastern corner facing center.

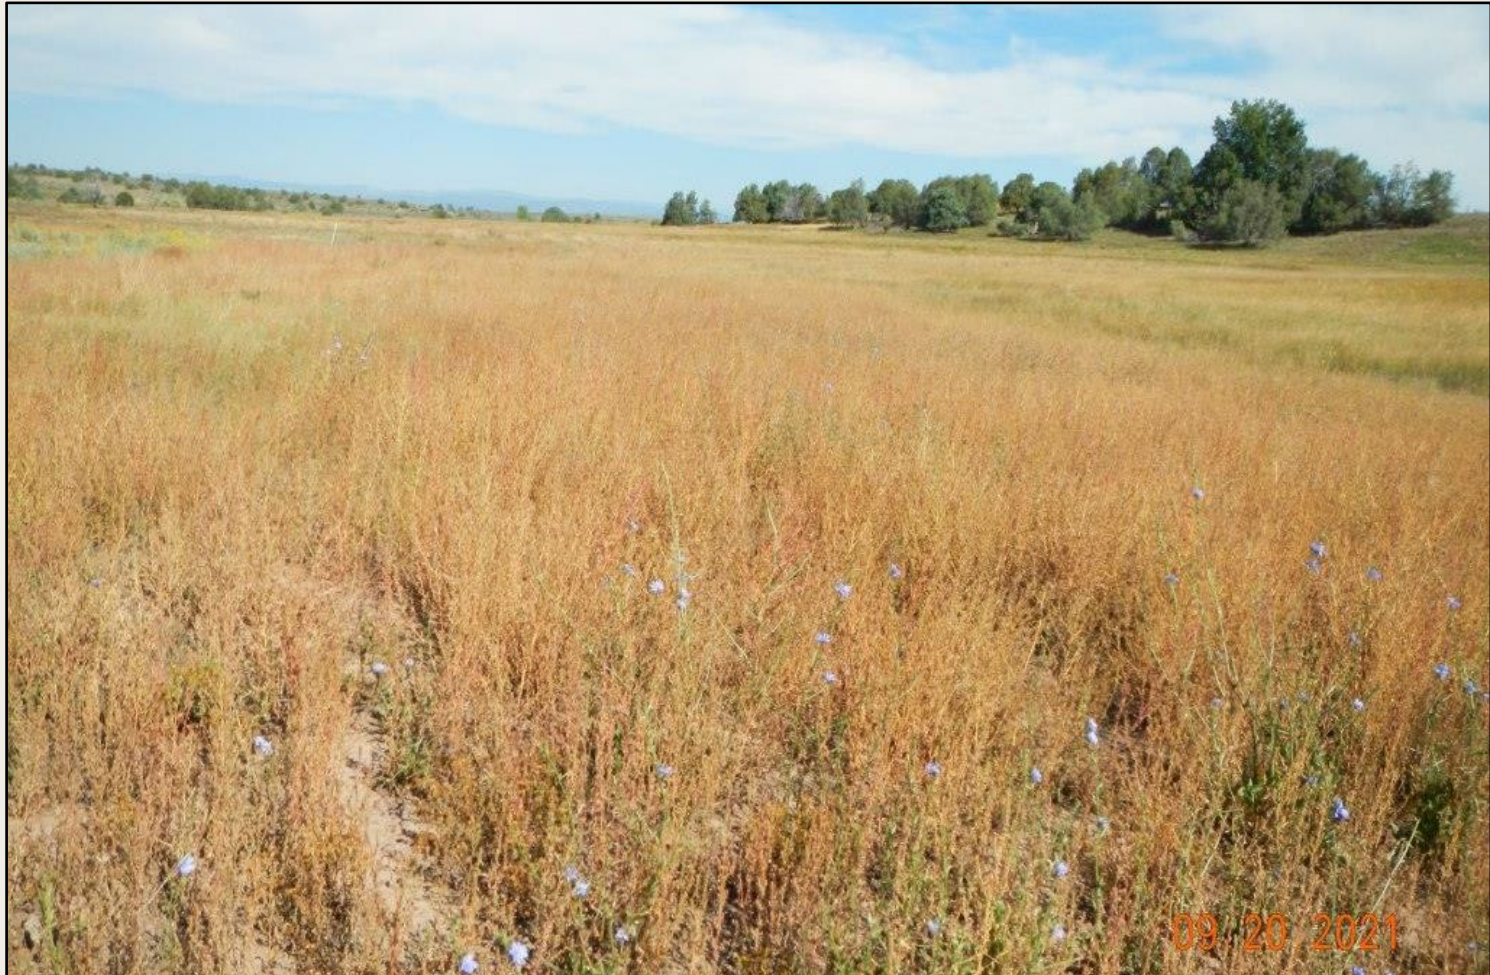
Photo 2. View of eastern project area from the southeastern corner facing northward. Dense kochia present needs management (ie: mowing) to encourage desirable vegetation. Revegetation is progressing with western wheatgrass, smooth brome, and crested wheatgrass.

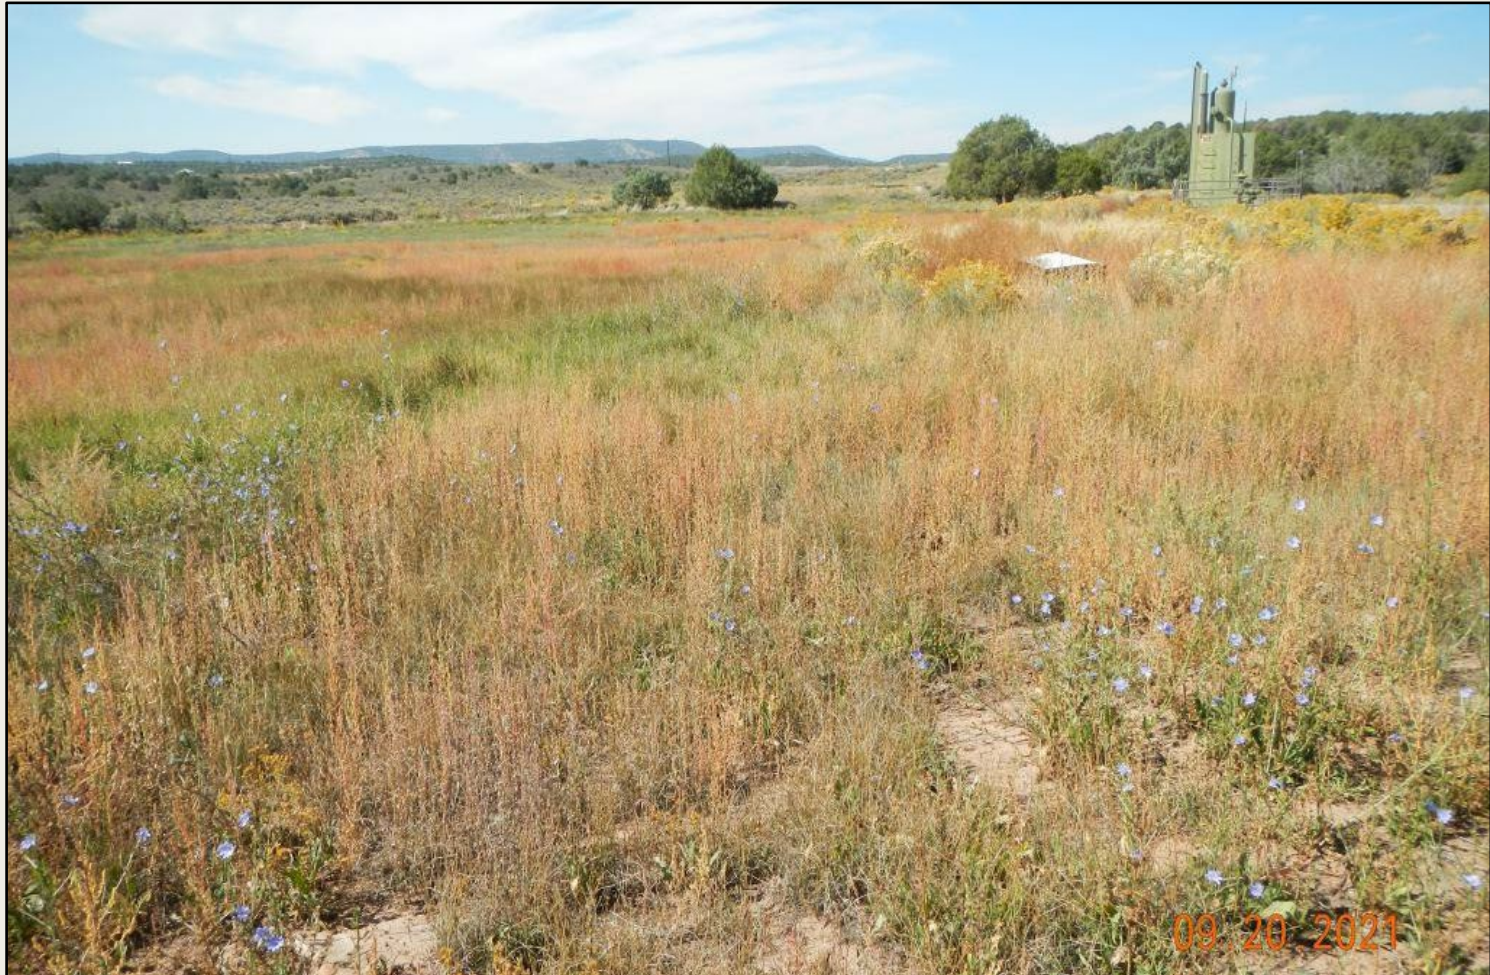
Photo 3. View of the southern project area from the southeastern corner facing westward.

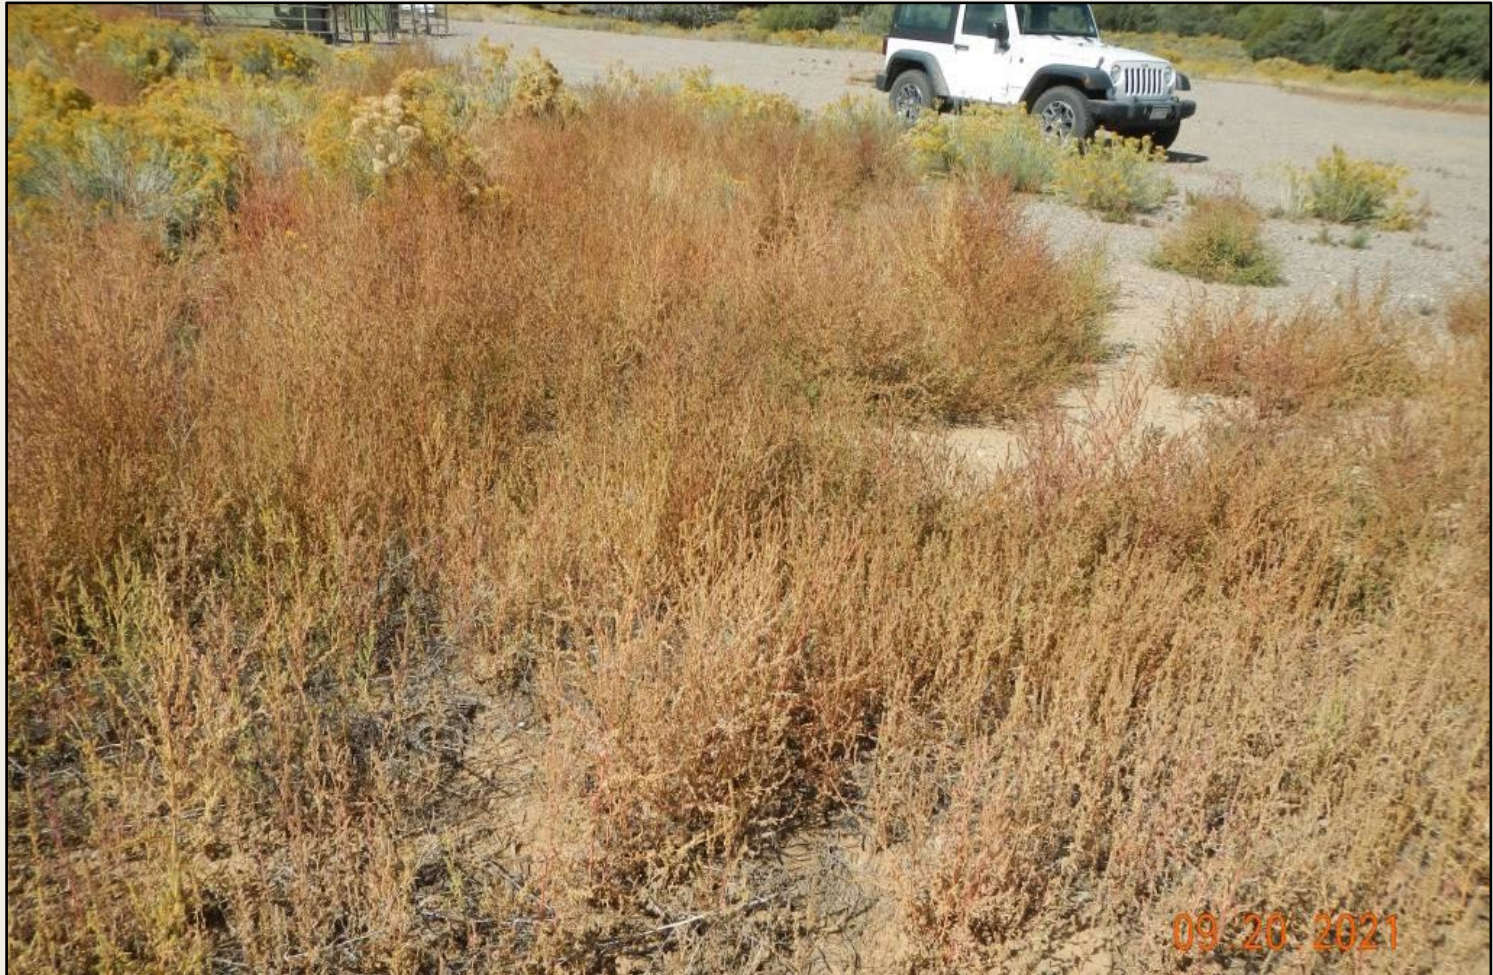
Photo 4. View of dense kochia growing on the well pad.

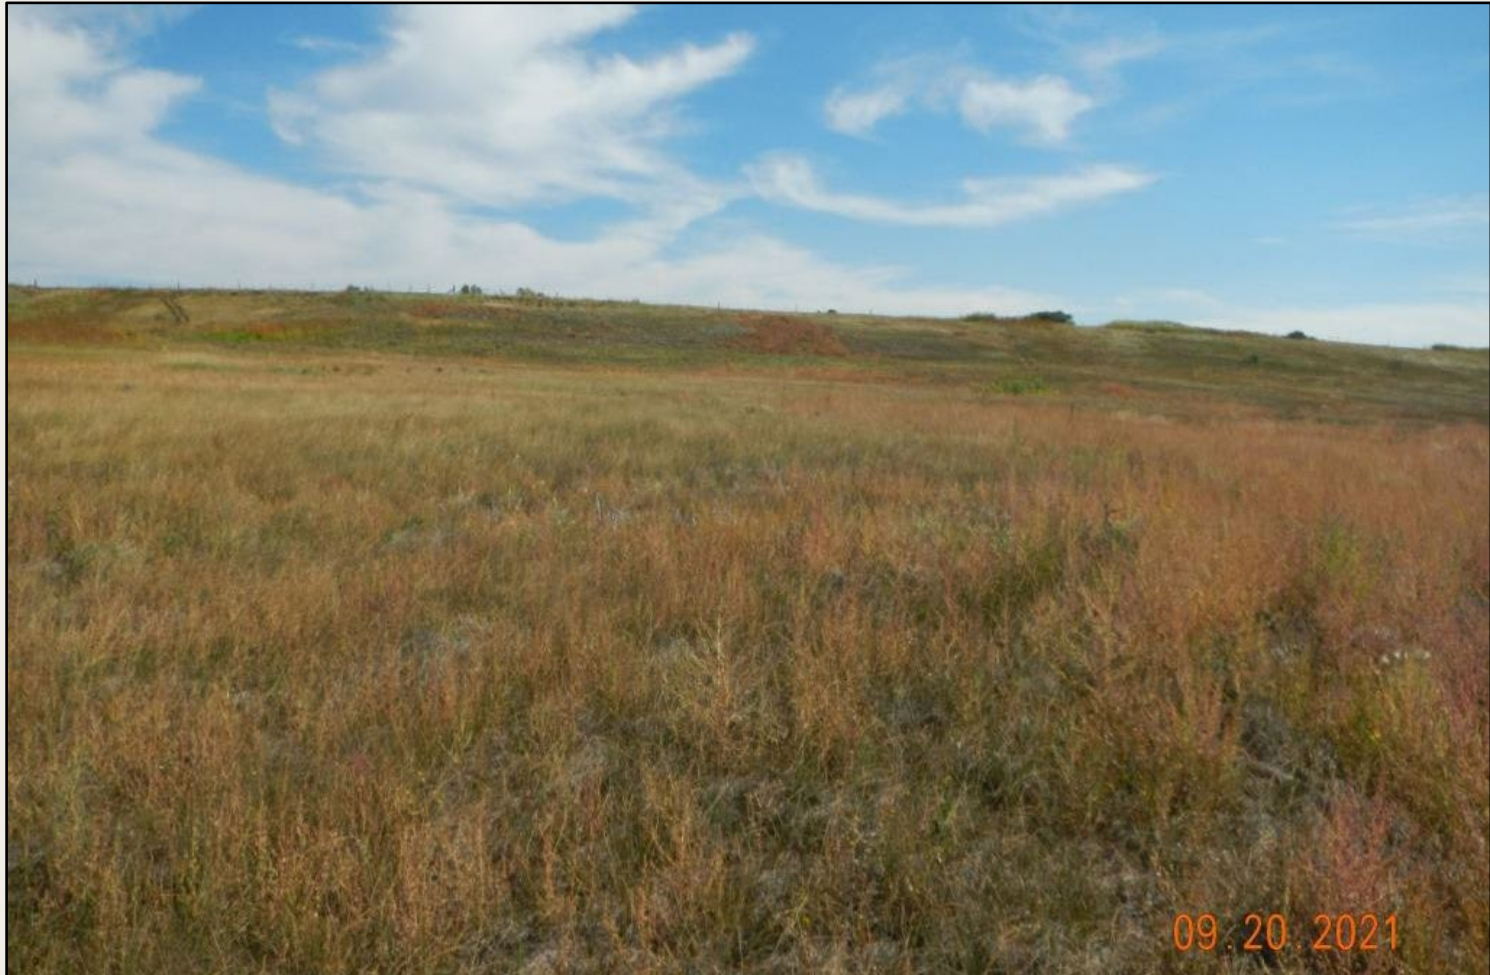
Photo 5. View of reference area (in background) comprised of irrigated grass field with western wheatgrass and mixed pasture grasses.
