## Inspection Photos

Location Name: CAERUS PICEANCE LLC FEDERAL-67S95W /30SESW

Location ID: 334060

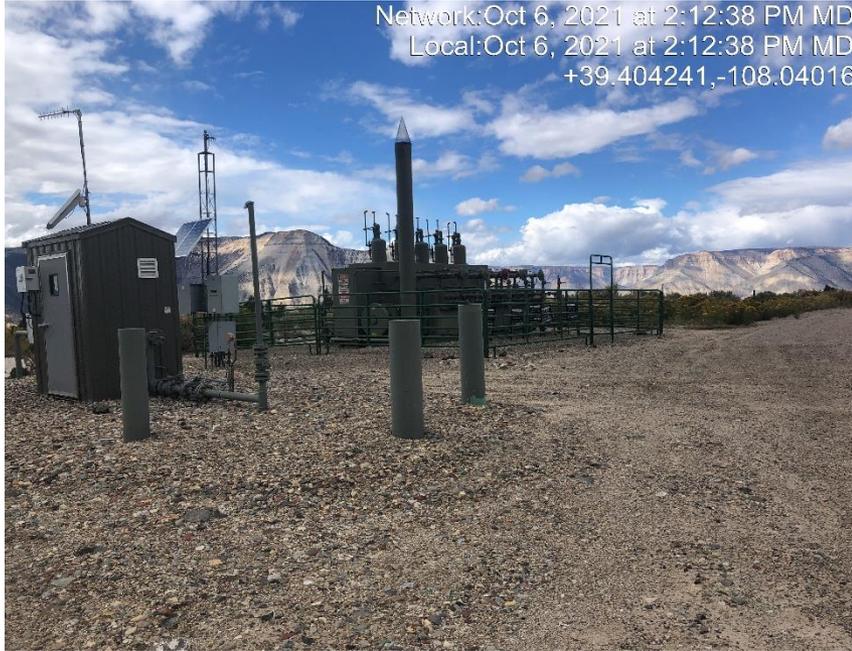
Photo #5027 from entrance to location.

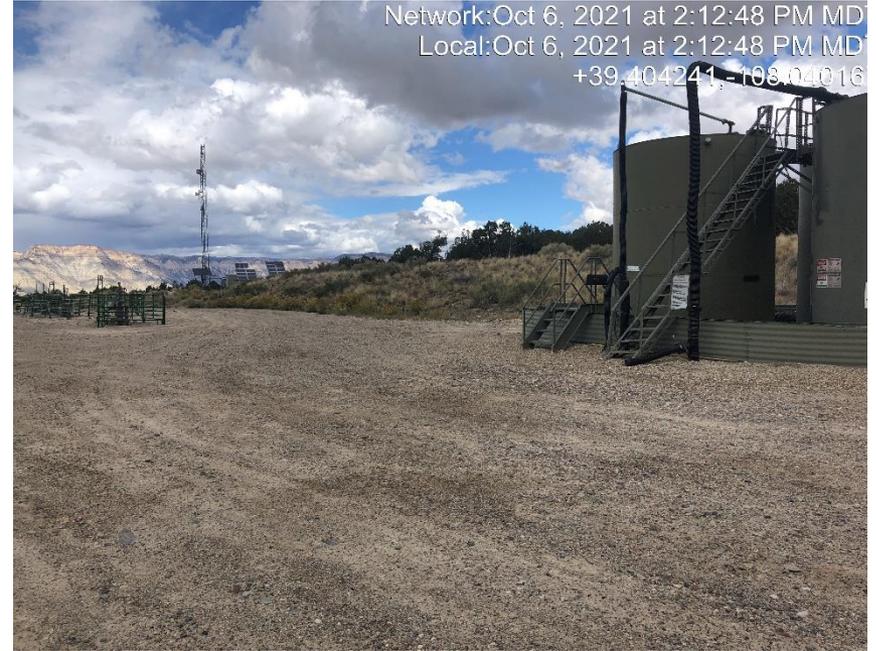
Photo #5028 from entrance to location.

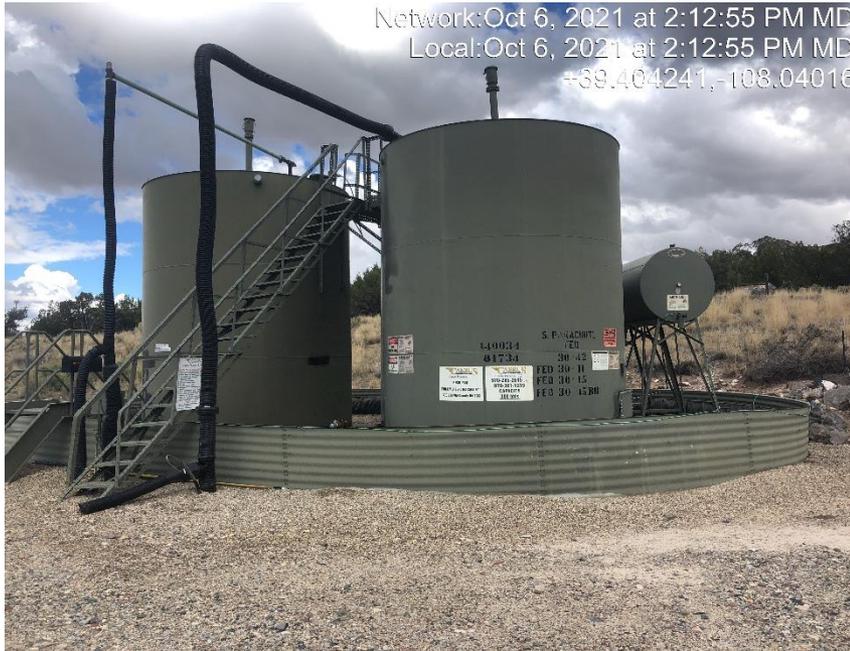
Photo #5029 No battery sign located at the tank battery.

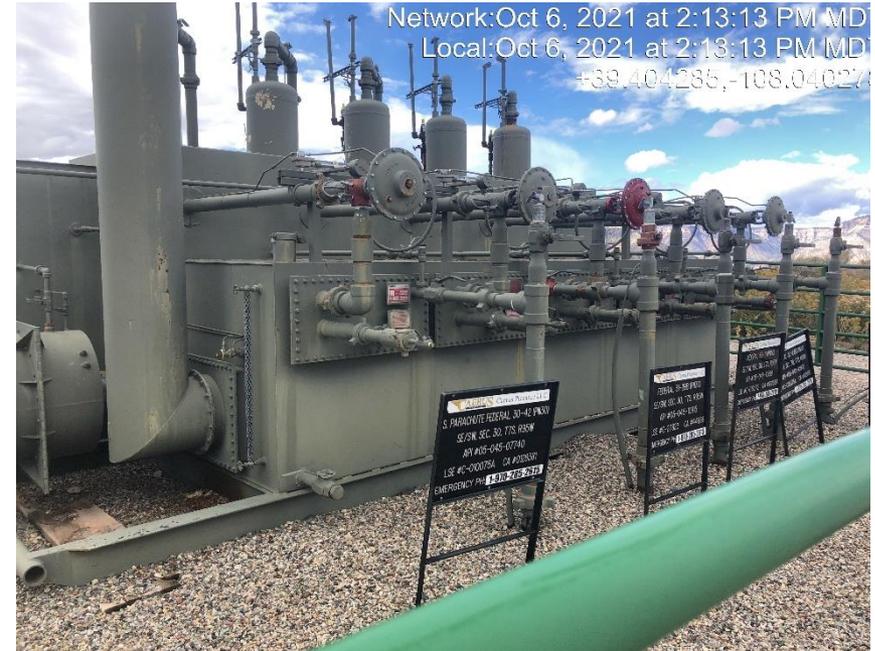
Photo #5030 Glycol storage tank missing required information.

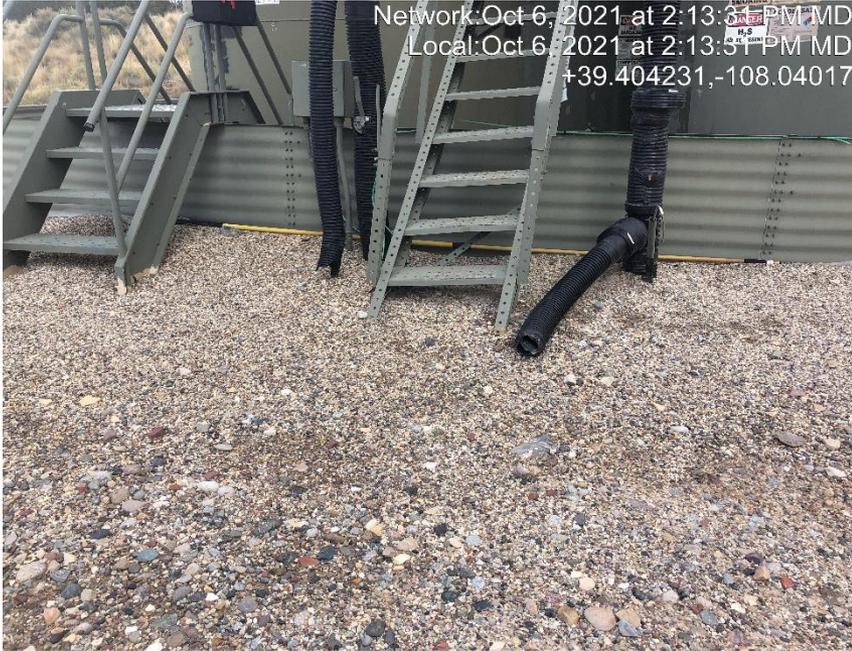
**Photo #5031 Flowline heating insulation open ended and not capped.**
