Inspection Photos

API: 071-07604

Operator: EVERGREEN NATURAL RESOURCES

Inspection Date: 10/12/2021

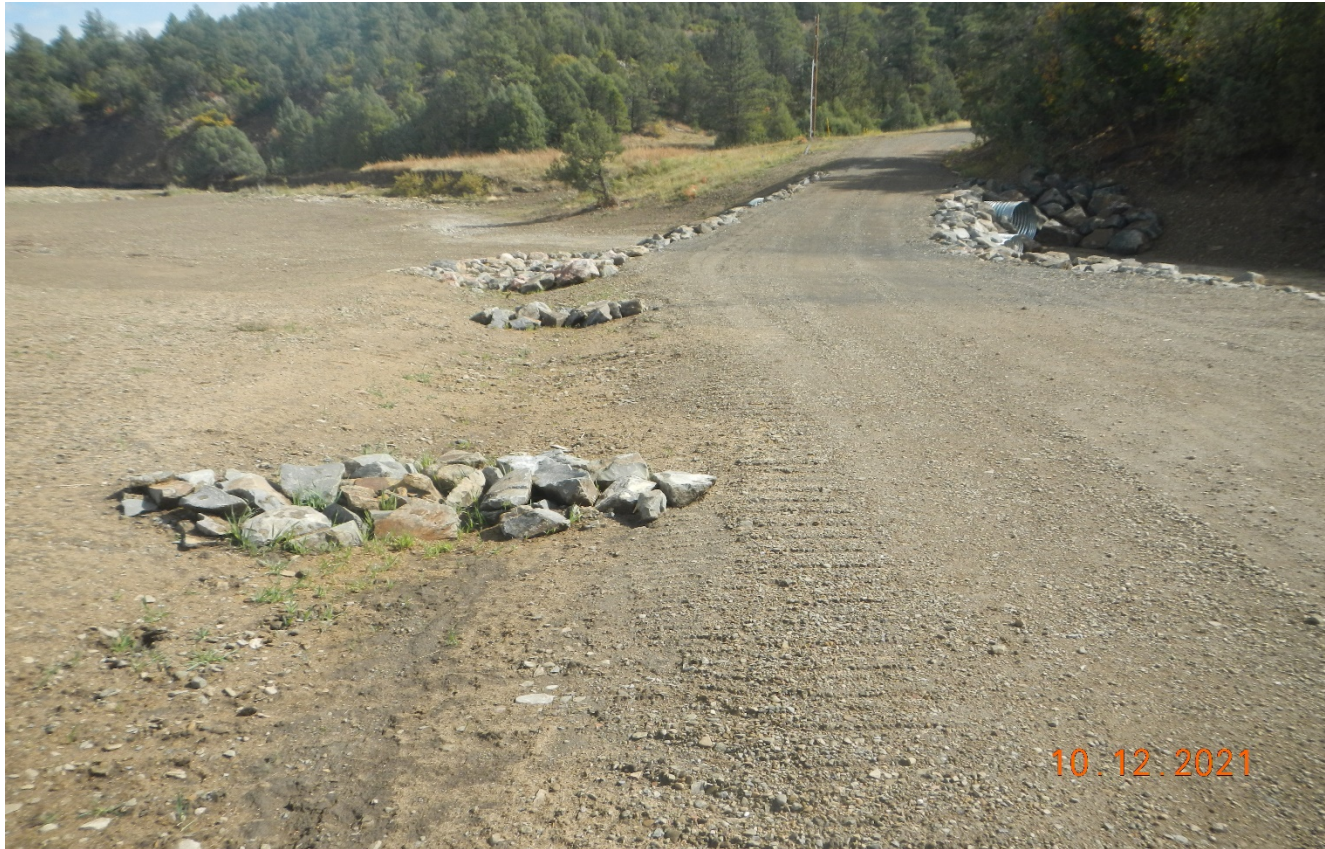
Photo 1. Facing east toward the access road stream crossing.

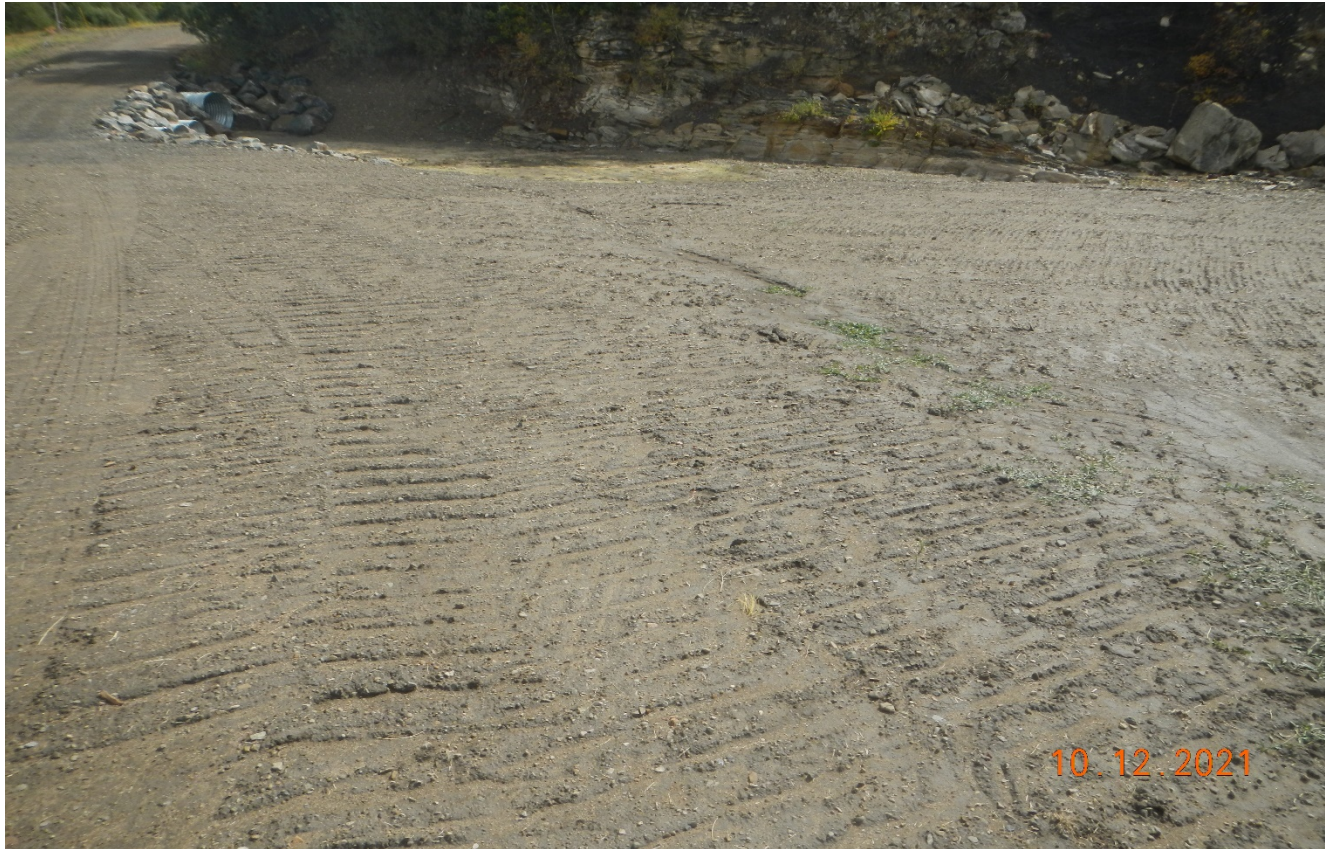
Photo 2. Facing toward the disturbance area along the road side. All disturbed areas along the road side need to be seeded and stabilized.

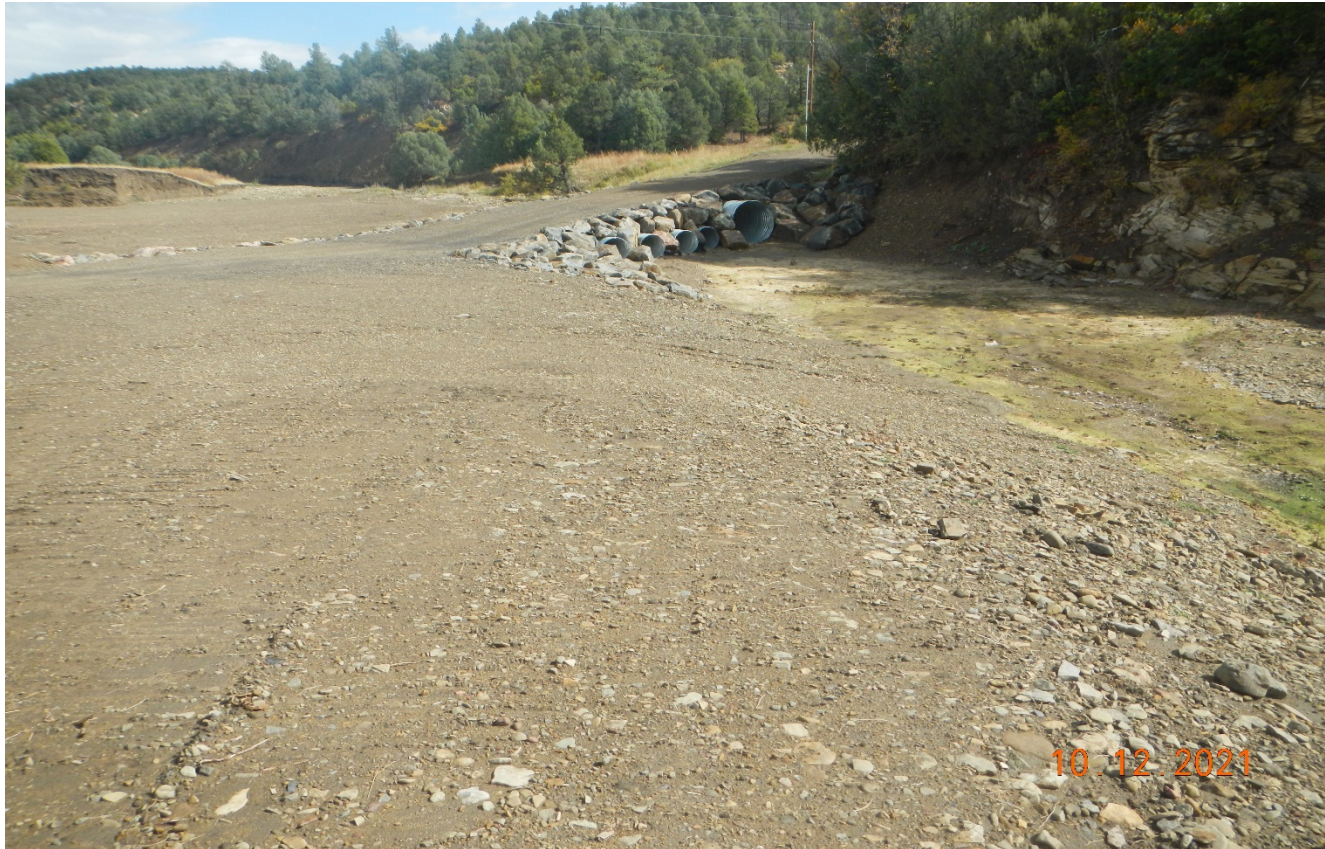
Photo 3. There are multiple culverts installed and rock rip/rap was installed for bank stabilization.

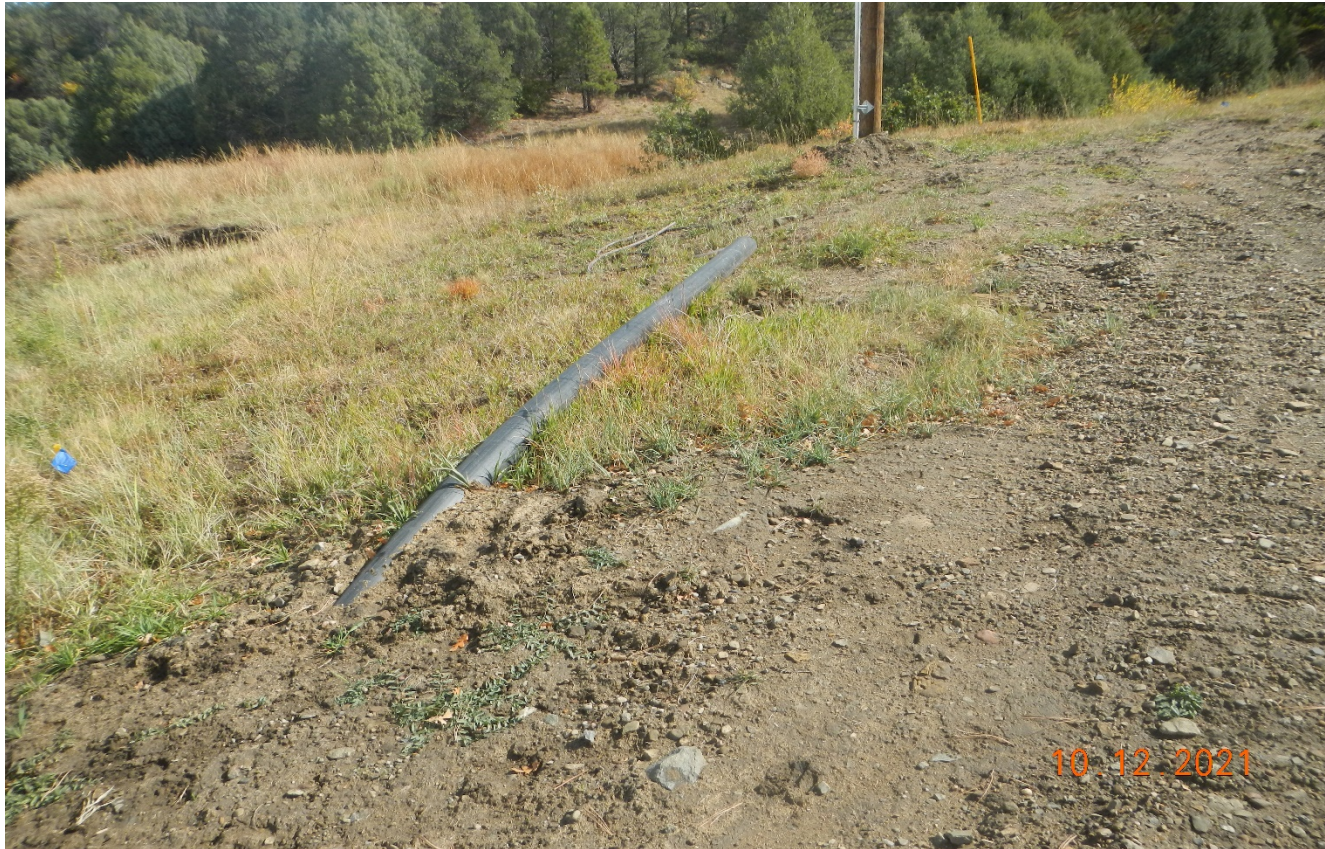
Photo 4. There is a black plastic pipe extending out of the ground on the east side of stream crossing. This needs to be removed or repaired.

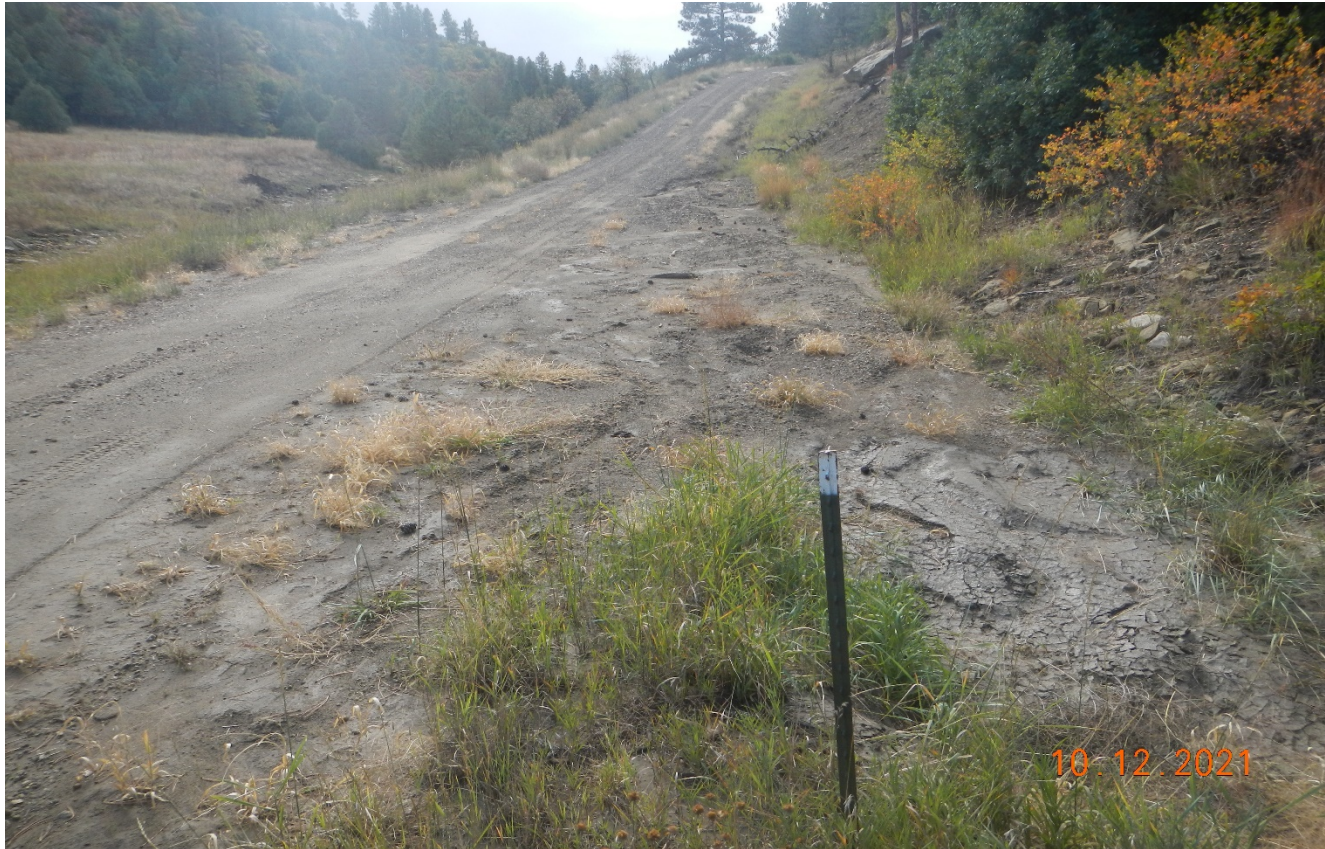
Photo 5. Facing southeast along the access road. The culverts along the access road are filled in with sediment.

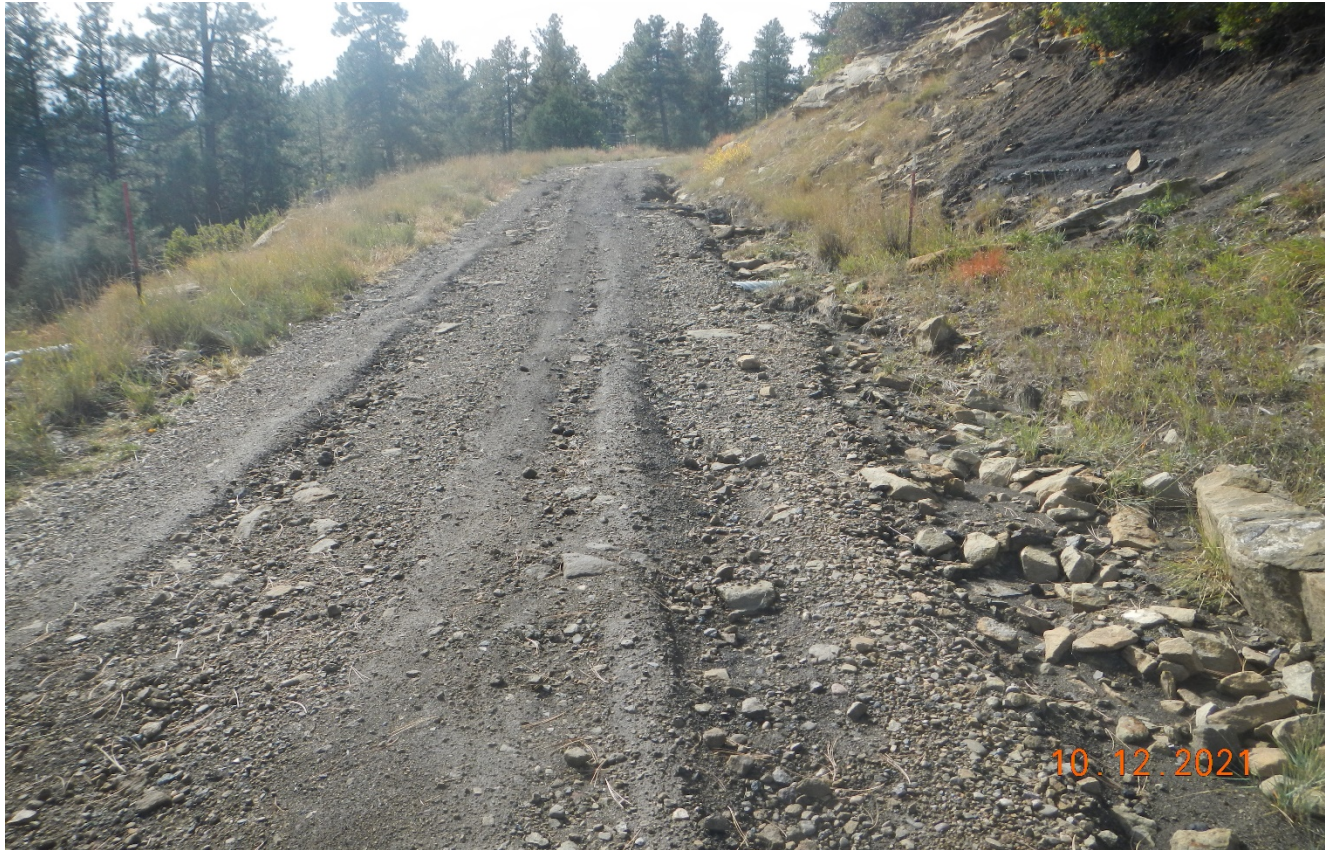
Photo 6. The culverts along the access road are filled in with sediment causing stormwater erosion down the road.

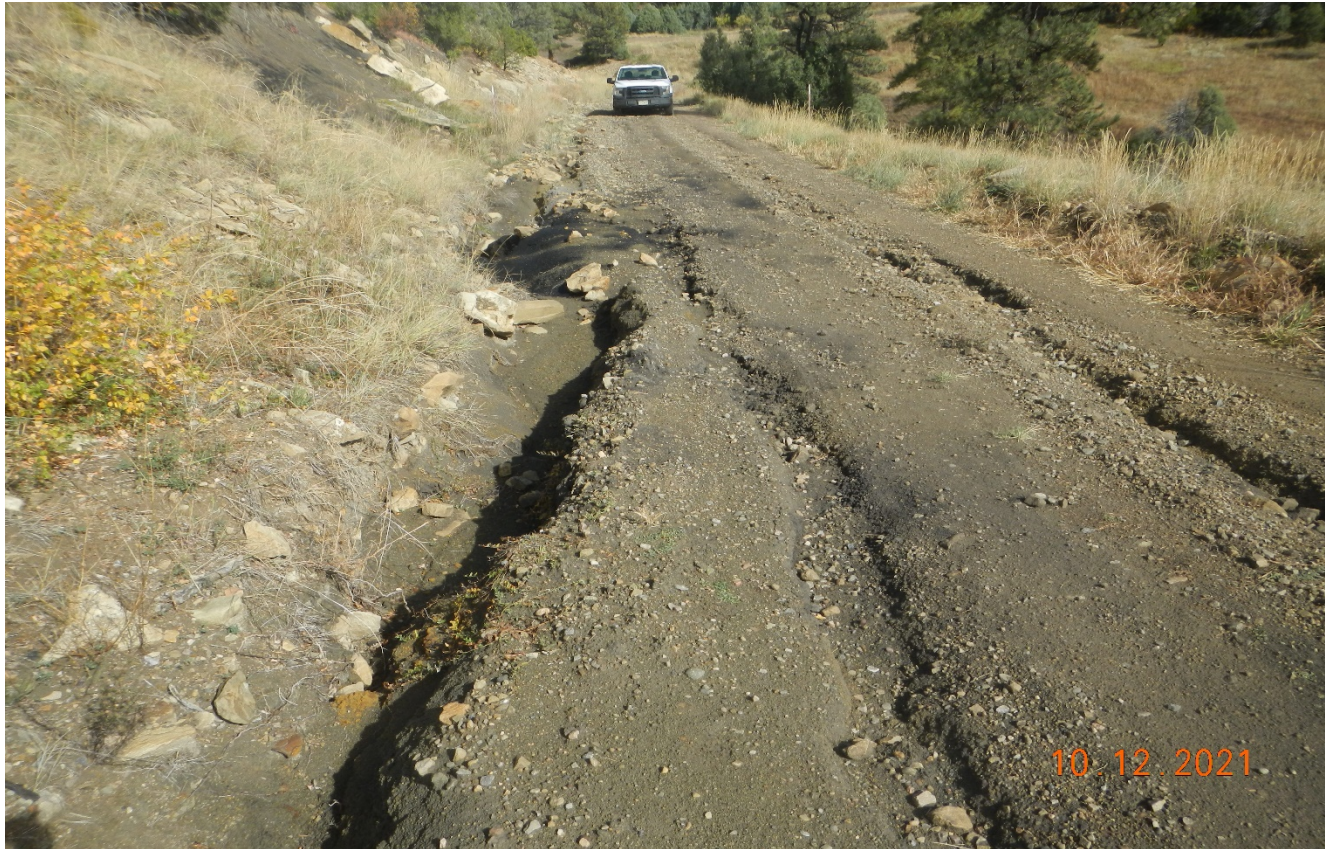
Photo 7. Facing back down the road. There is erosion along the road side and stormwater is bypassing culverts which will cause further erosion. BMP's need to be repaired.

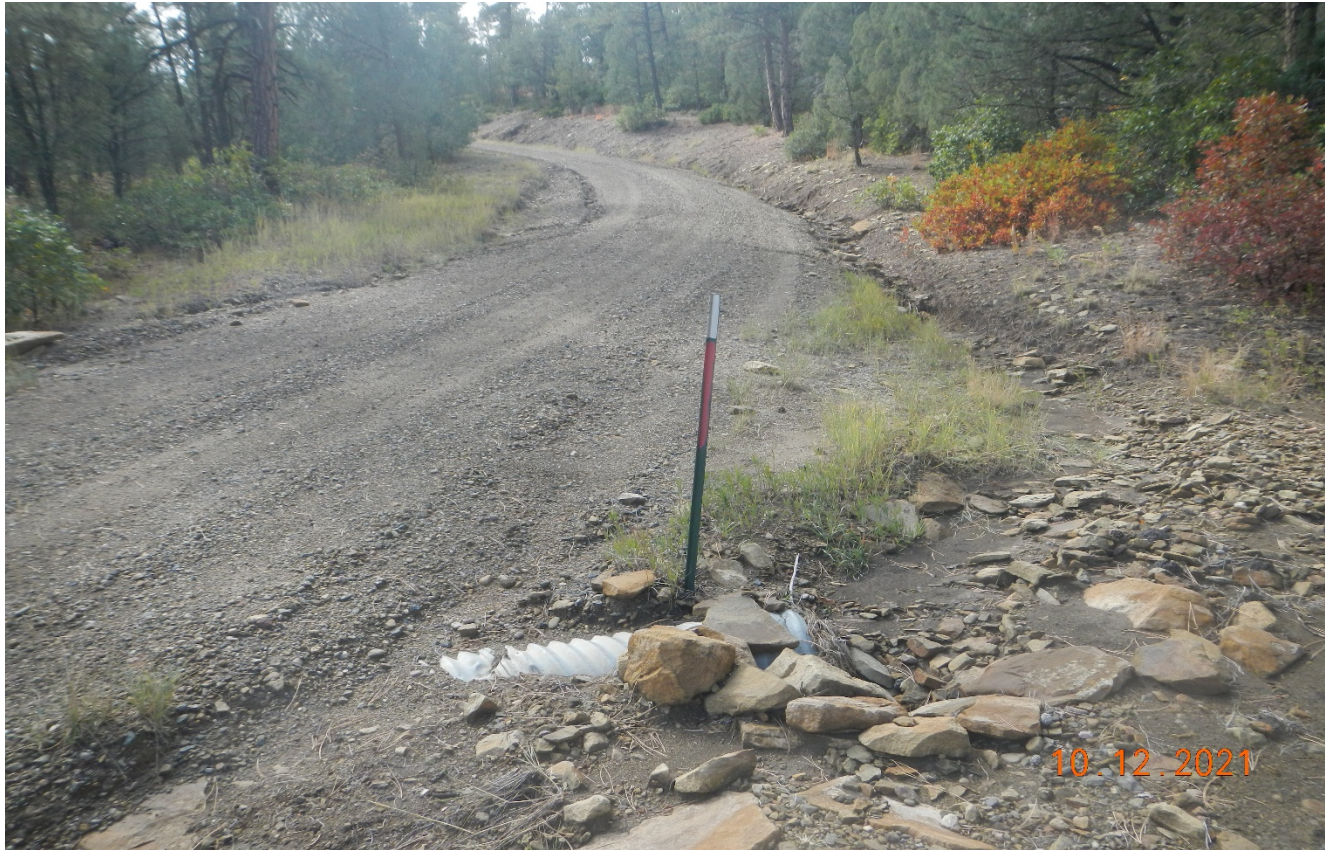
Photo 8. Another culvert further along the road is filled in with sediment.

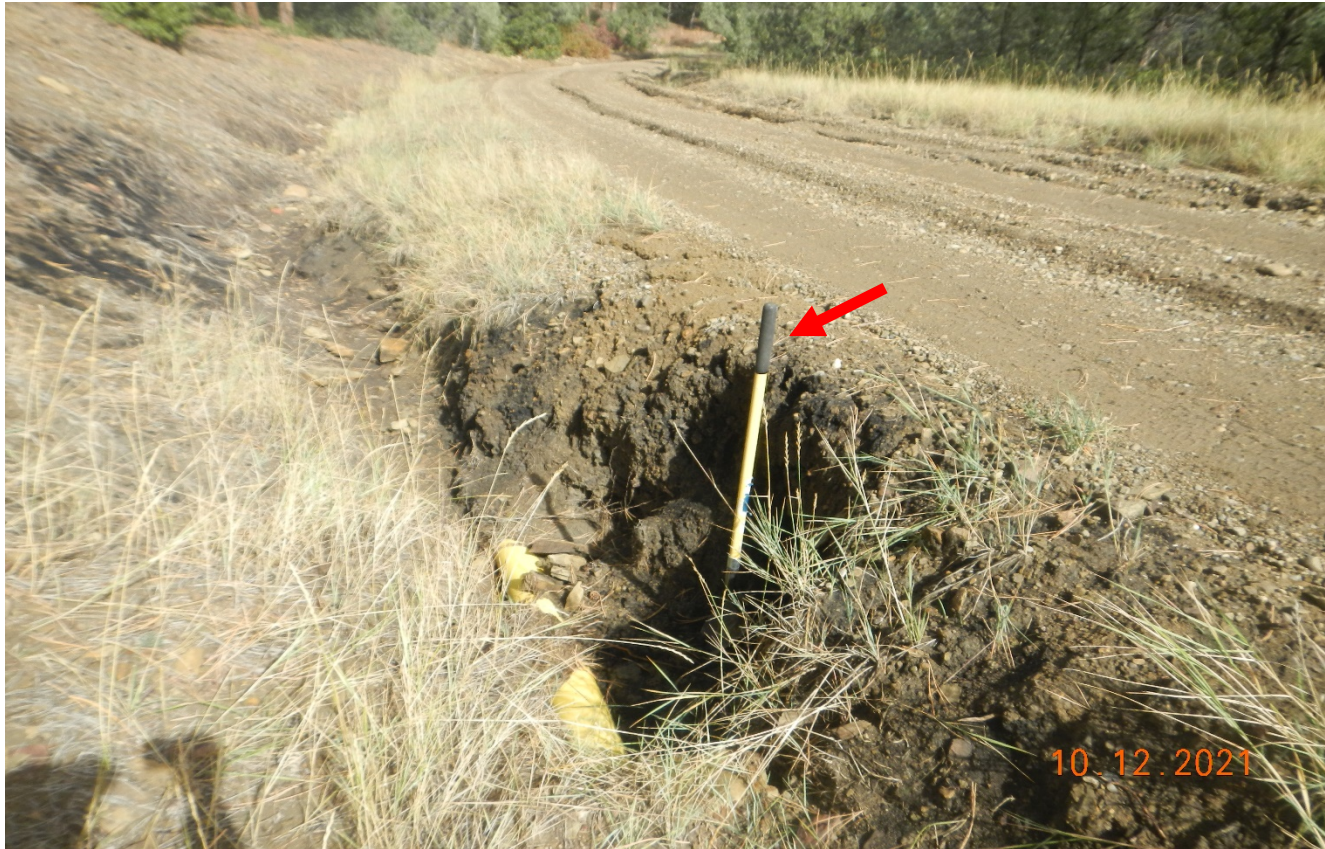
Photo 9. Erosion along the roadside has exposed a pipeline. Arrow points to 4.5 ft. shovel.

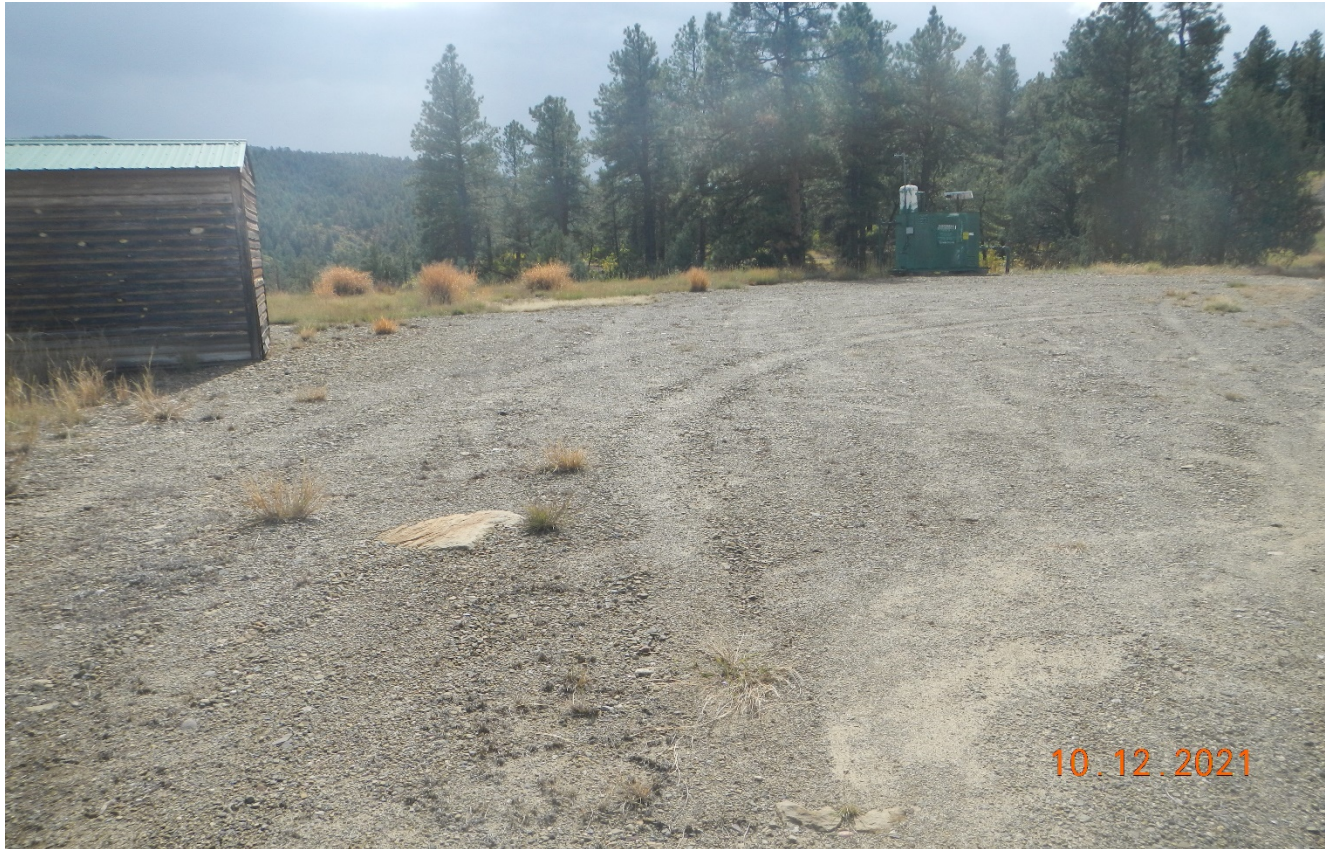
Photo 10. Facing southeast toward the well site.
