Inspection Photos

API: 071-08082

Operator: EVERGREEN NATURAL RESOURCES

Inspection Date: 10/12/2021

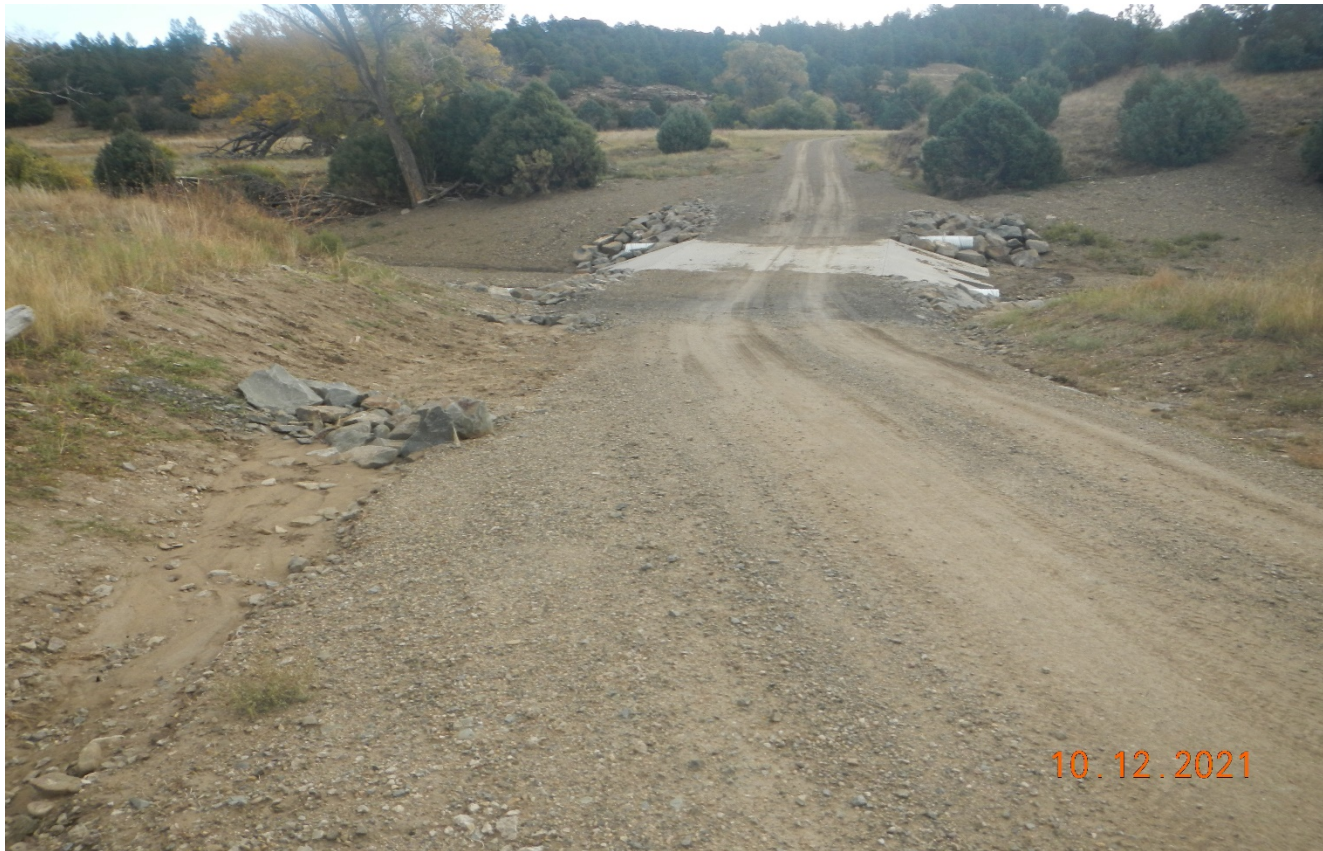
Photo 1. Facing east toward the access road stream crossing. The road side area was repaired and rock check dams were installed.

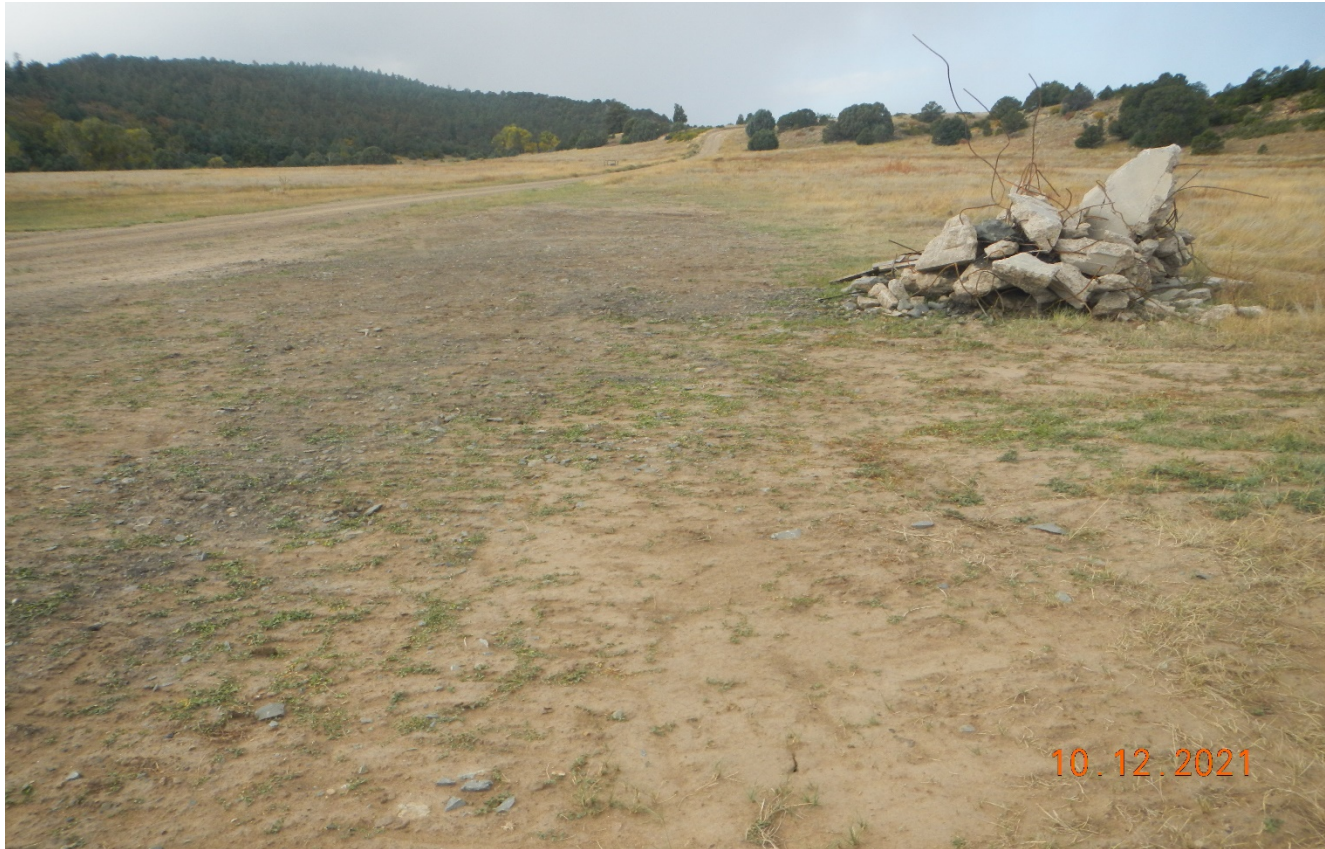
Photo 2. Facing back southwest. There is a pile of cement debris that needs to be removed. This area of disturbance needs to be reclaimed.

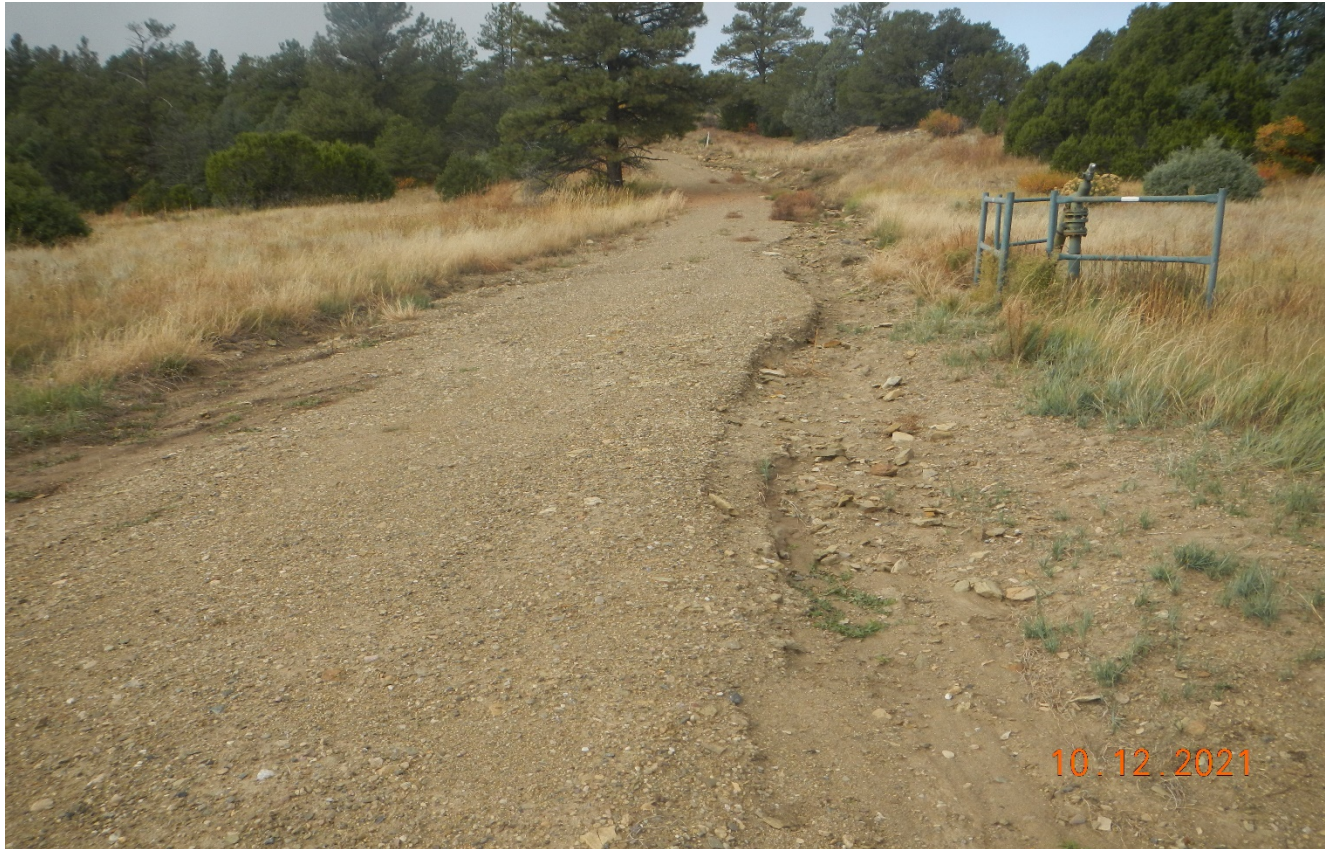
Photo 3. Facing southwest toward the access road. This area of erosion has not been repaired and stabilized. Previous corrective action was not completed.

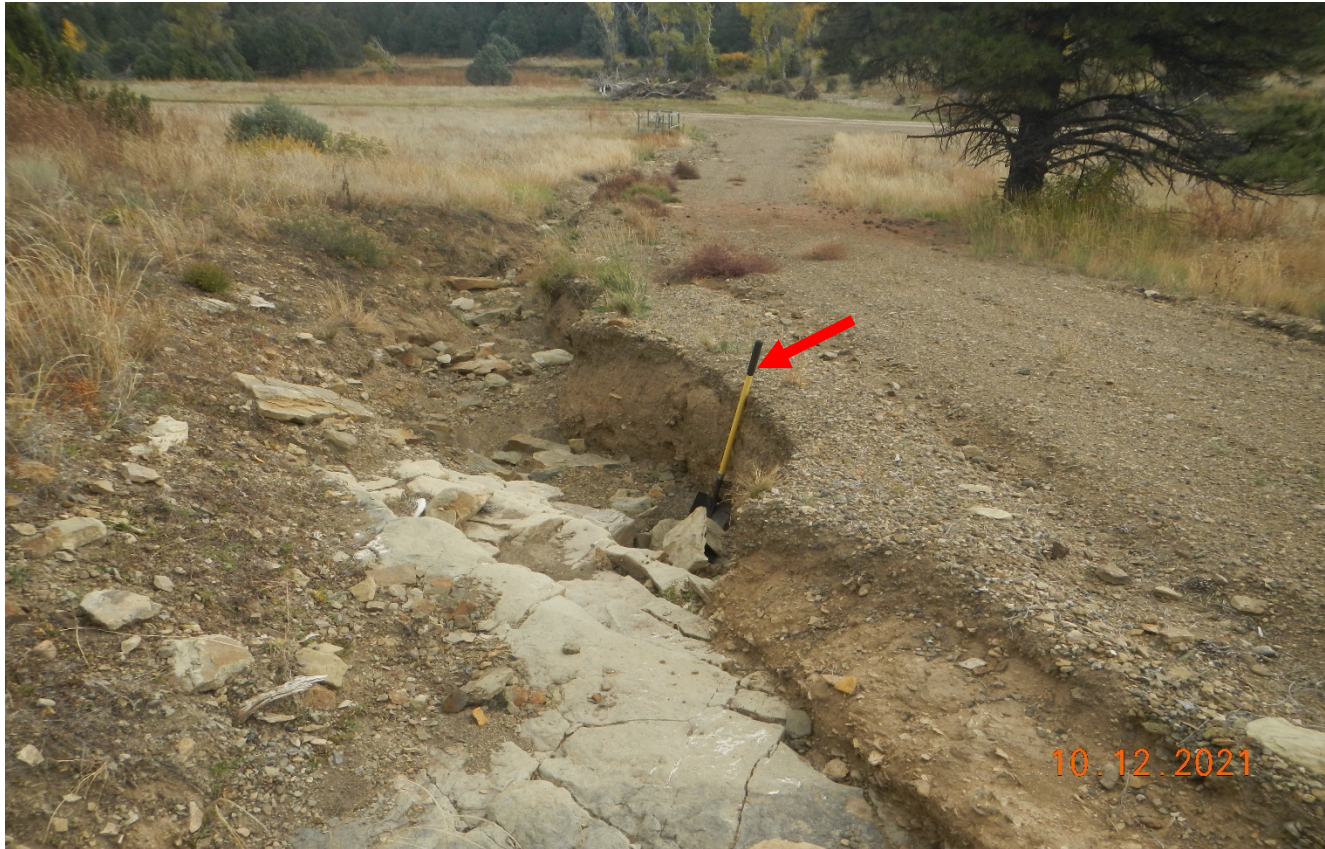
Photo 4. Facing back down the road. The erosion along the road side has not been repaired and stabilized. Arrow points to 4.5 ft. shovel.

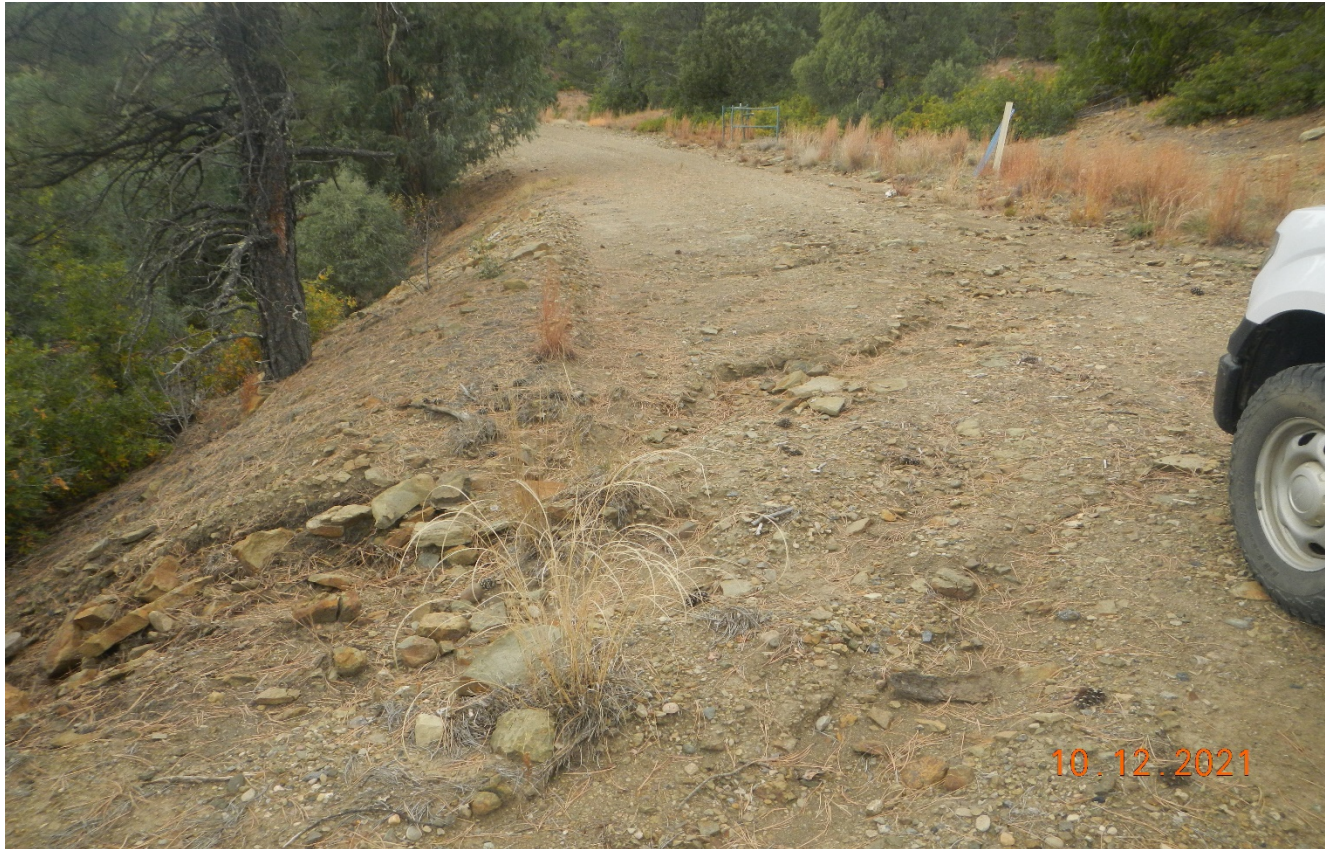
Photo 5. Further up the access road. There is stormwater erosion across the road. This area may need a culvert.

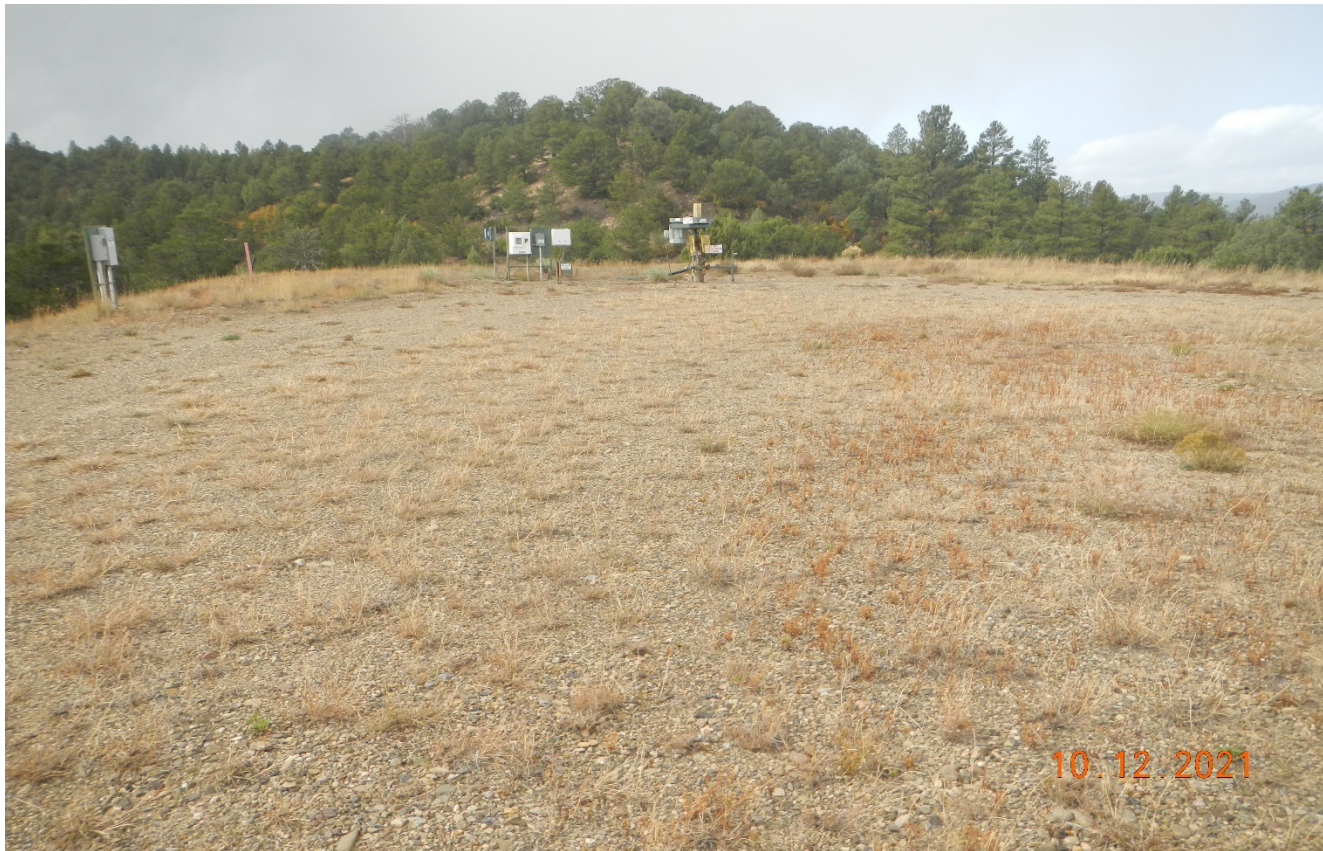
Photo 6. Facing toward the well site.
