Inspection Photos

API: 071-07085

Operator: EVERGREEN NATURAL RESOURCES

Inspection Date: 10/12/2021

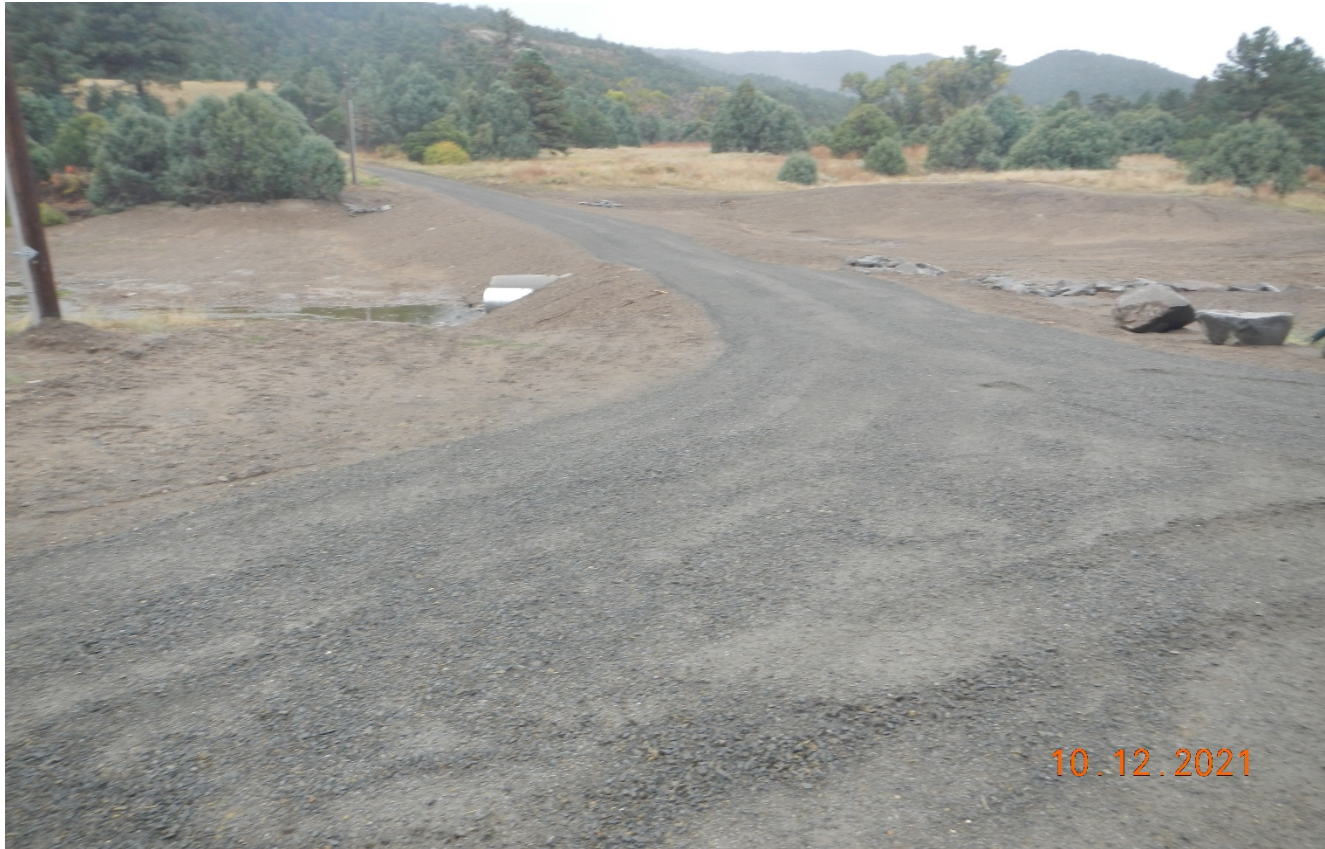
Photo 1. Facing south toward the access road stream crossing.

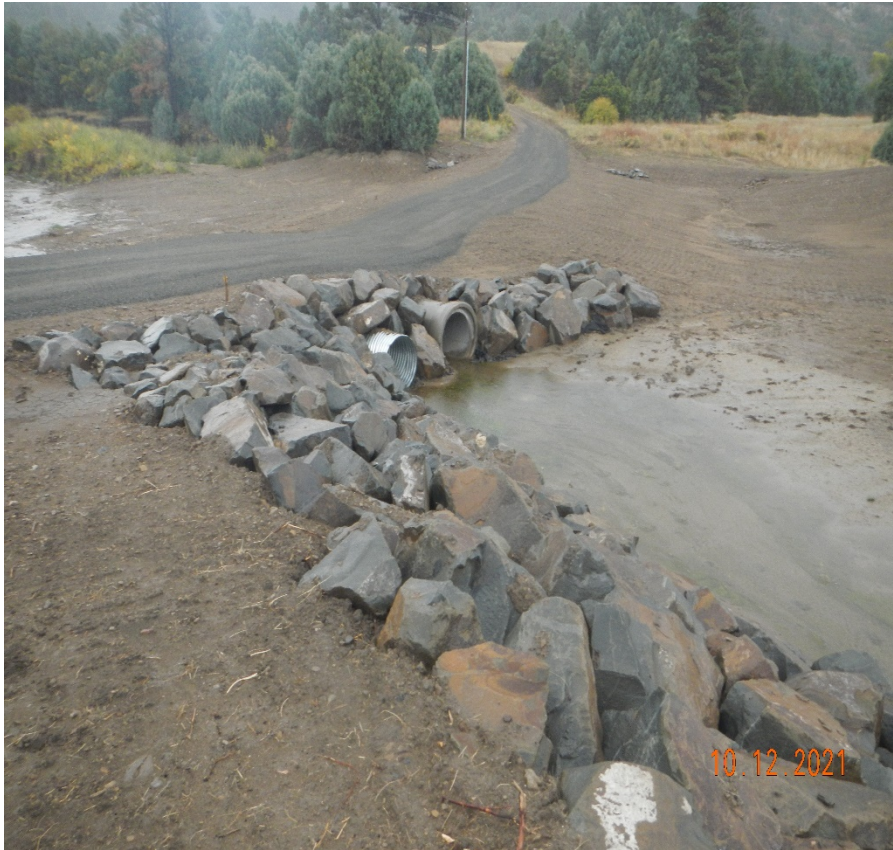
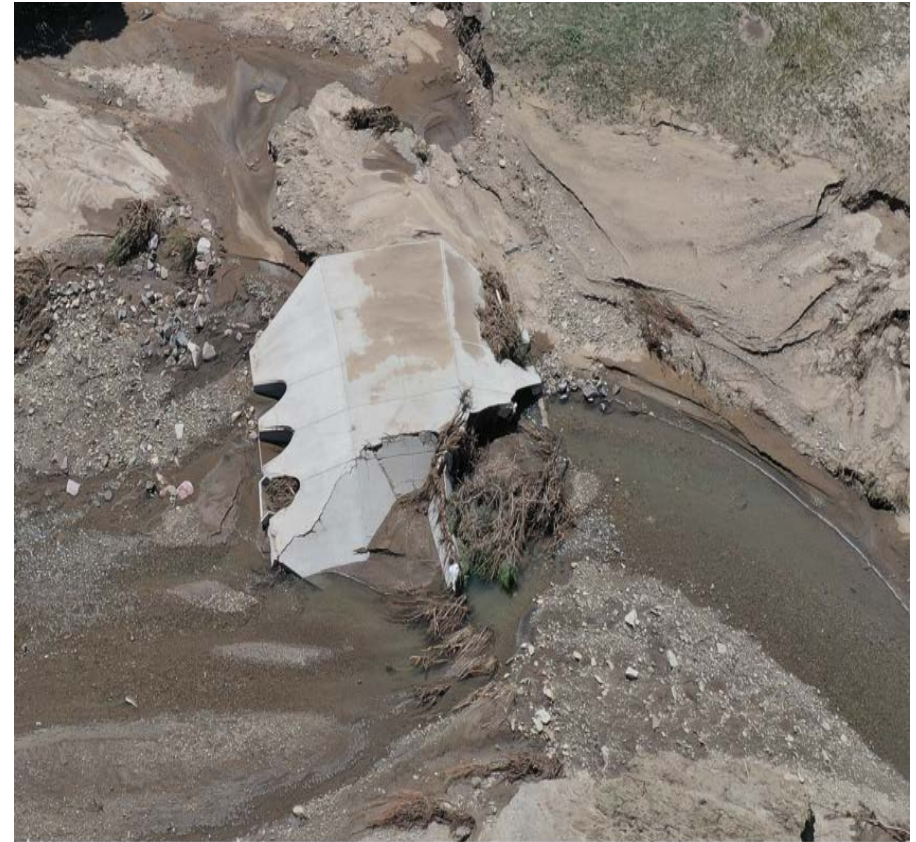
Photo 2. There are two culverts installed at the stream crossing. This appears to be inadequate as the prior cement culvert shown in the photo on the right had 3 large culverts.

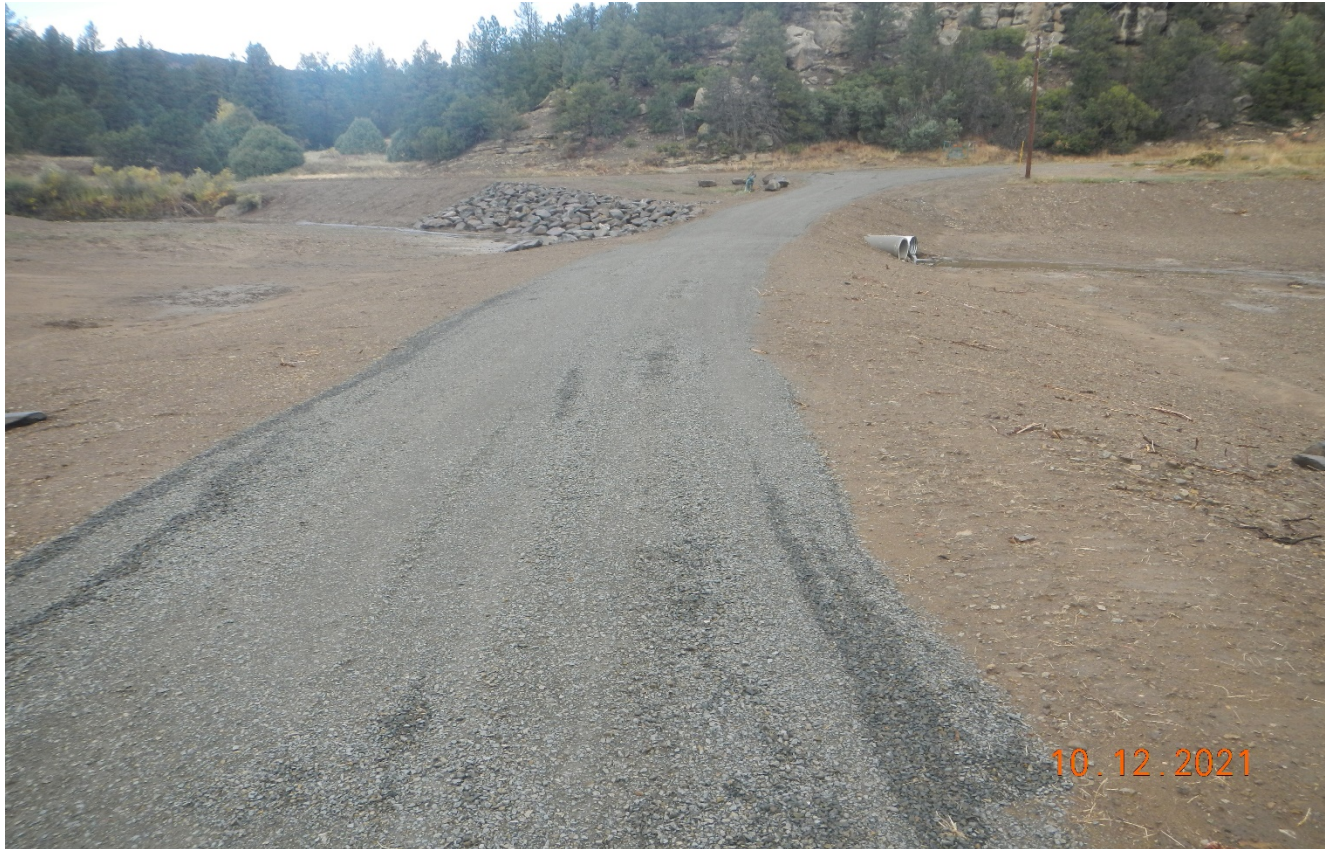
Photo 3. Facing northwest at the stream crossing. There is no bank stabilization at the outlet side.

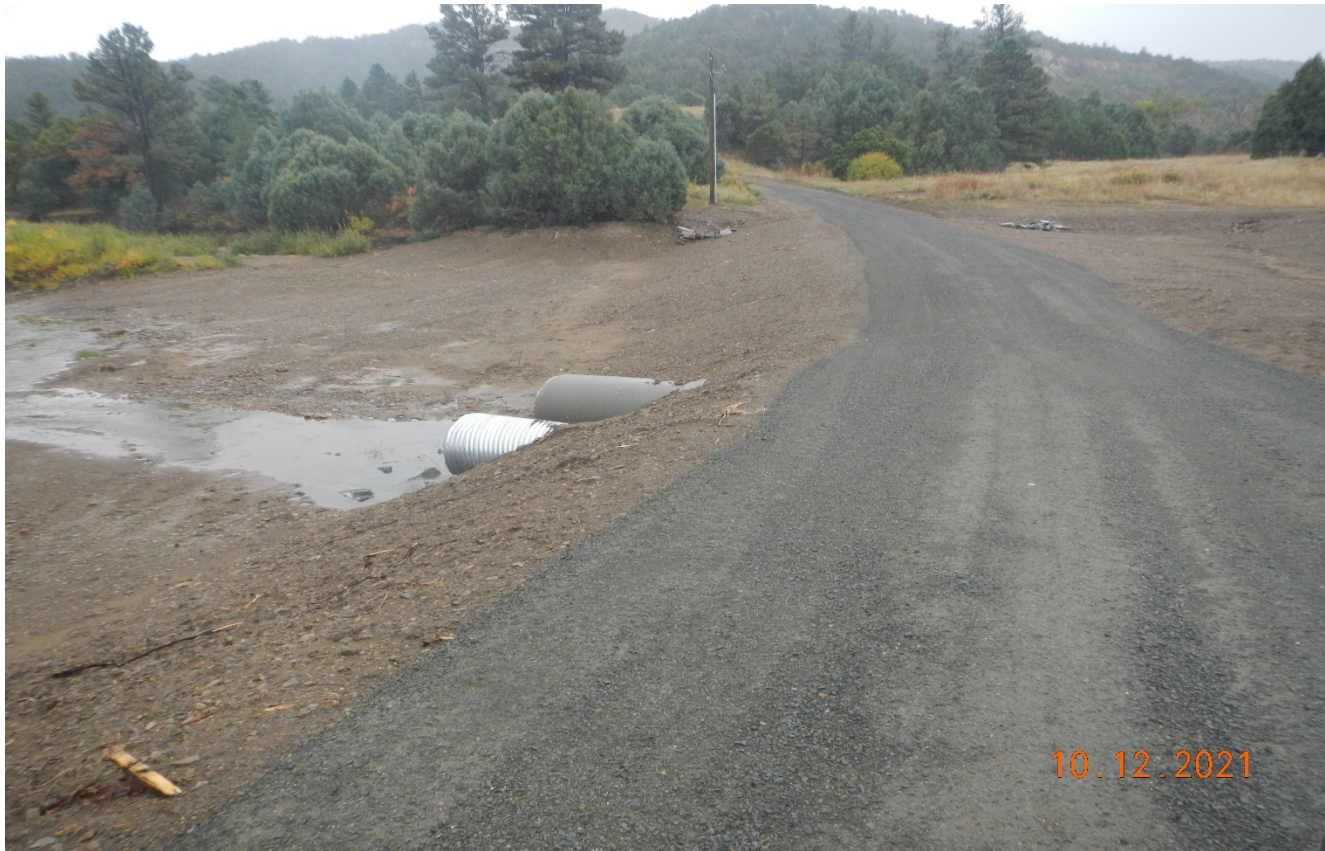
Photo 4. Facing south along the access road. All disturbed areas along the road side need to be seeded and stabilized.

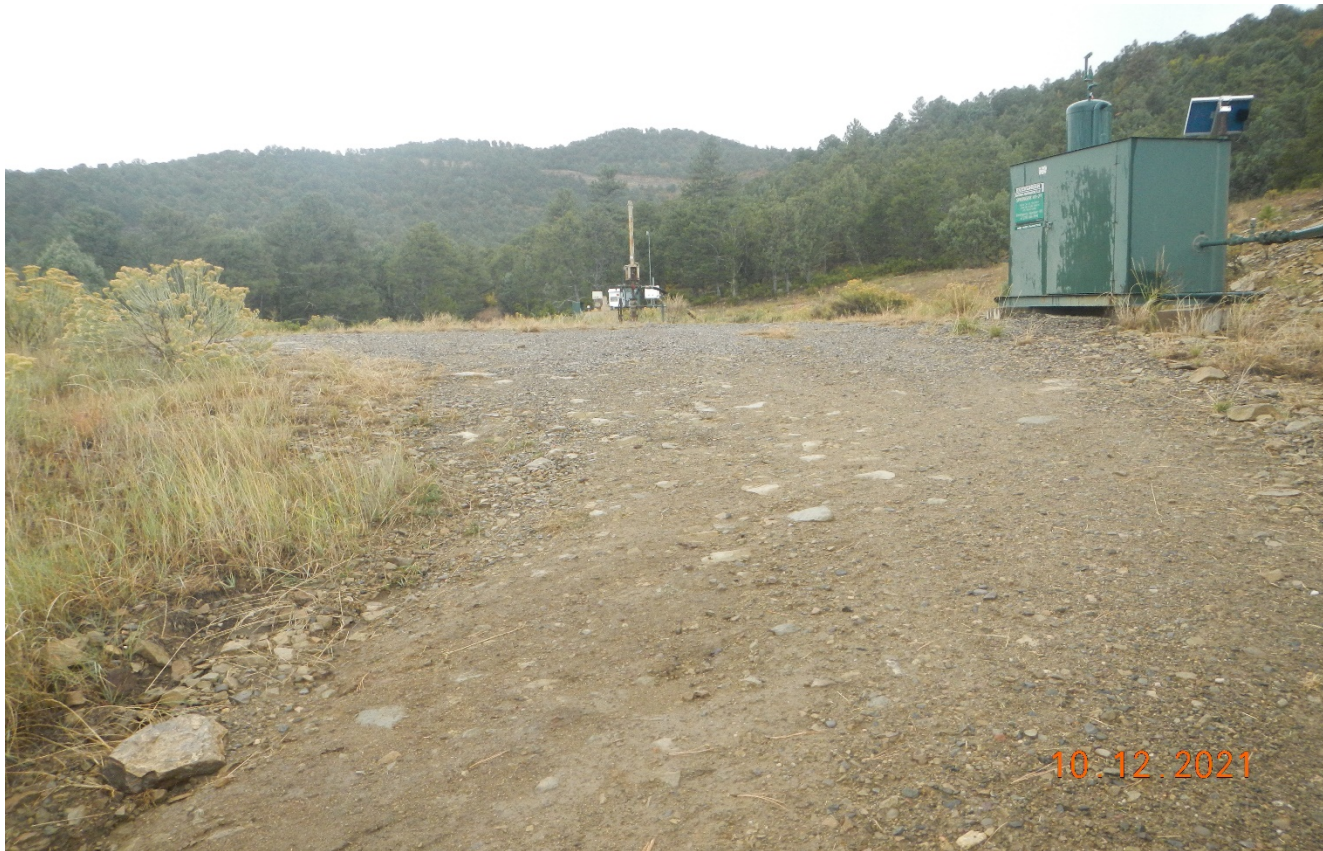
Photo 5. Facing southeast toward the well site.
