Inspection Photos

Operator: Kinder Morgan
API: 033-06133
Date: 10/11/2021

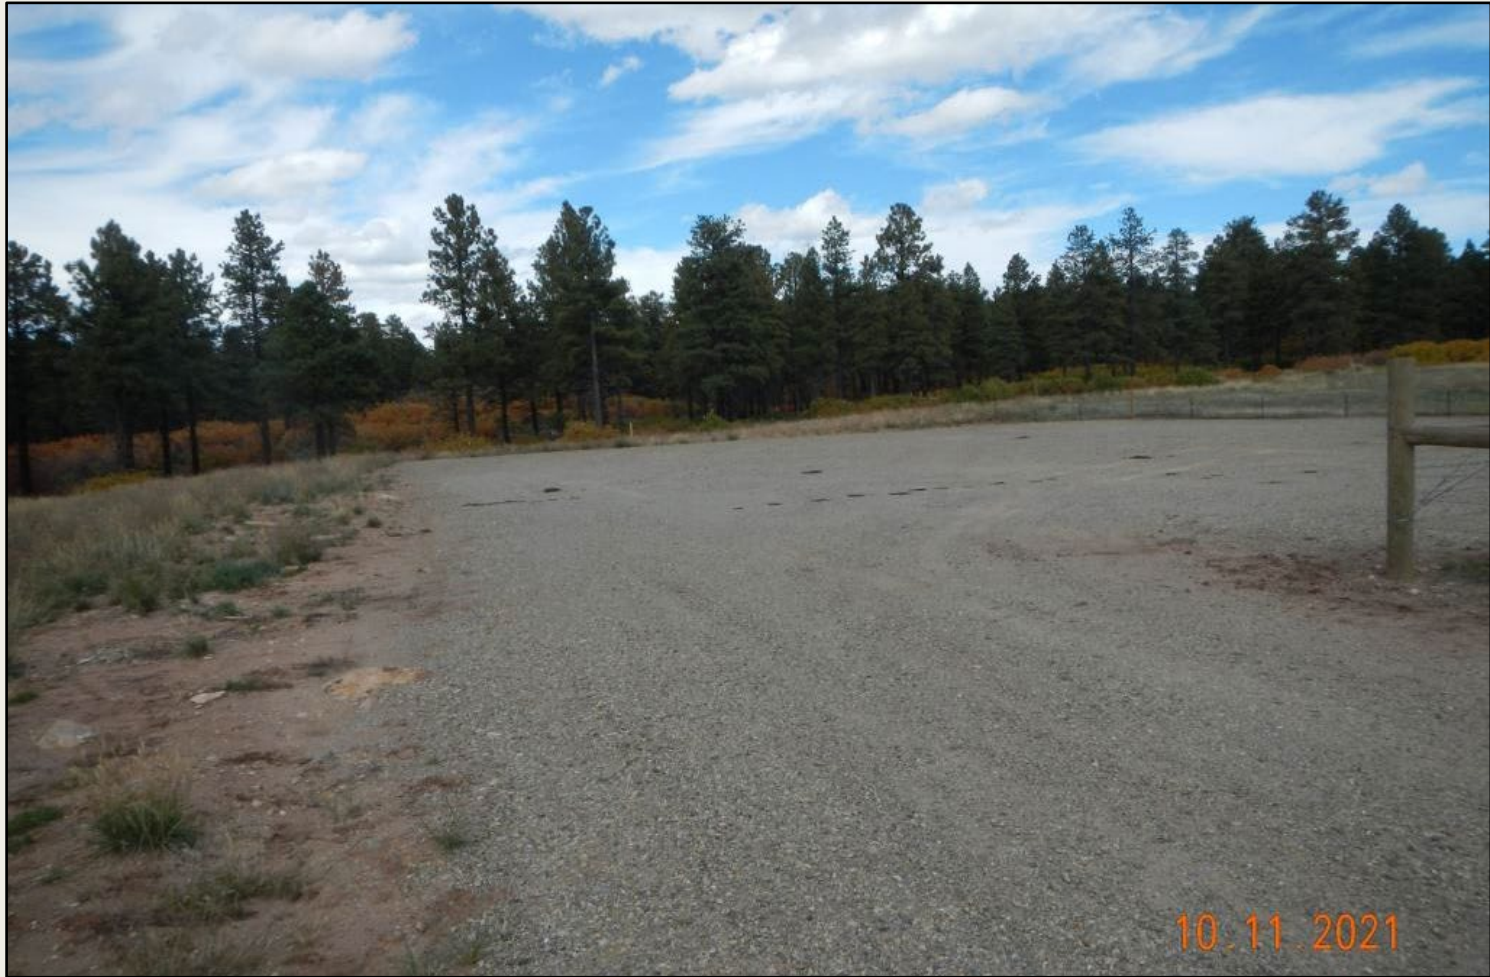
Photo 1. View of project area from the well pad entrance facing center. Well pad is not reclaimed.

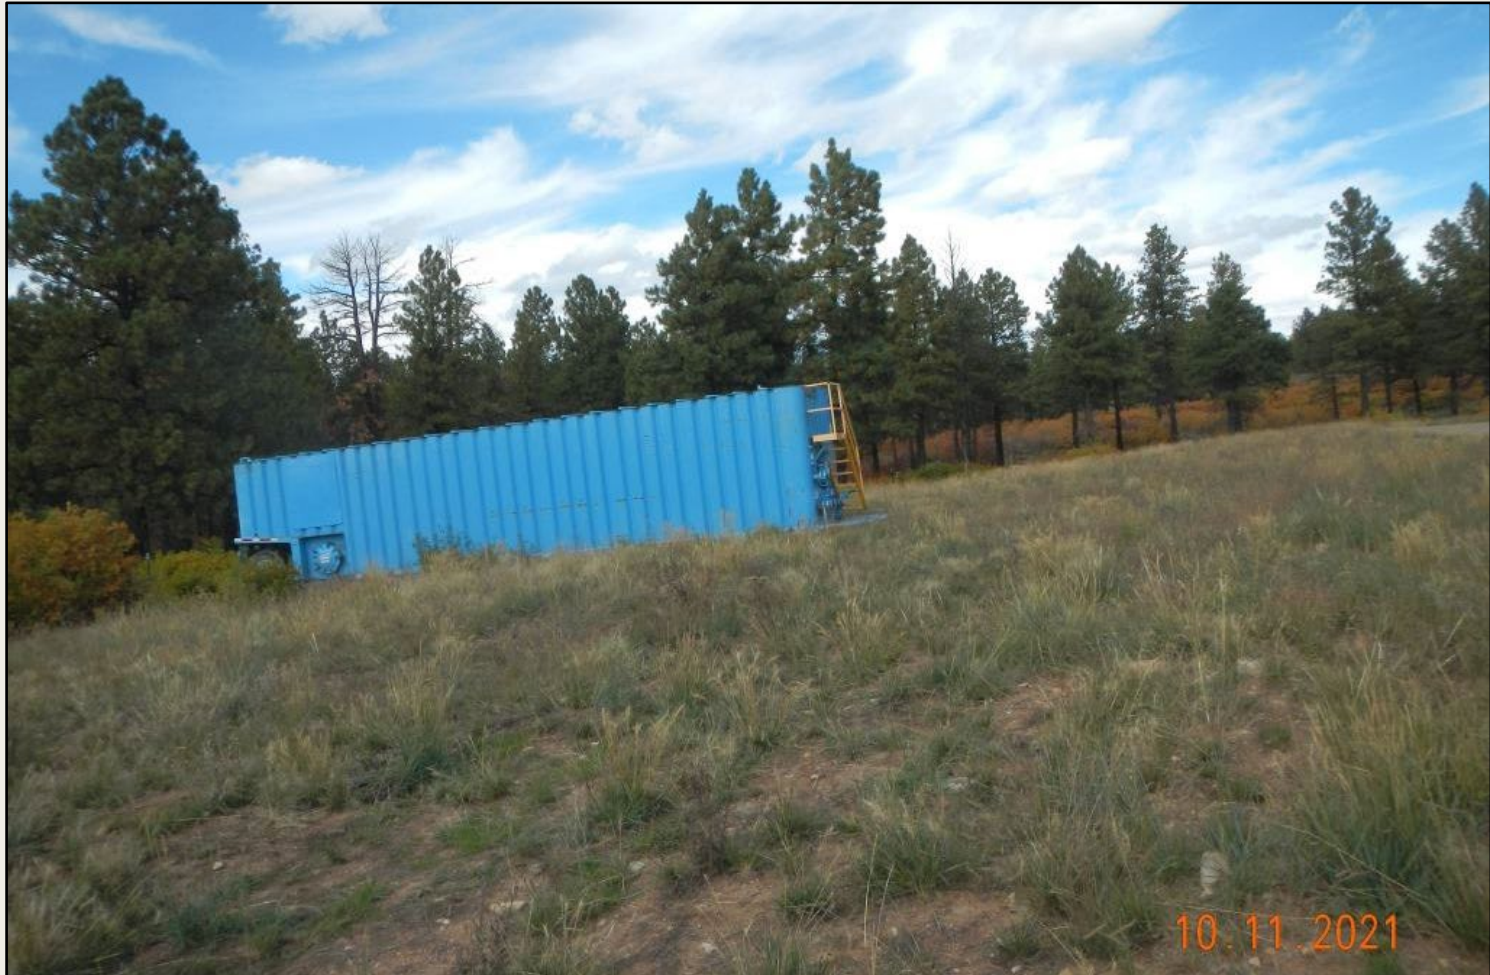
Photo 2. View of the western project area from the southwestern corner facing northward. Per communication with operator, frac tank placed on vegetation area to provide water to livestock by leasee. Frac tank is choking vegetation in the interim reclamation area.

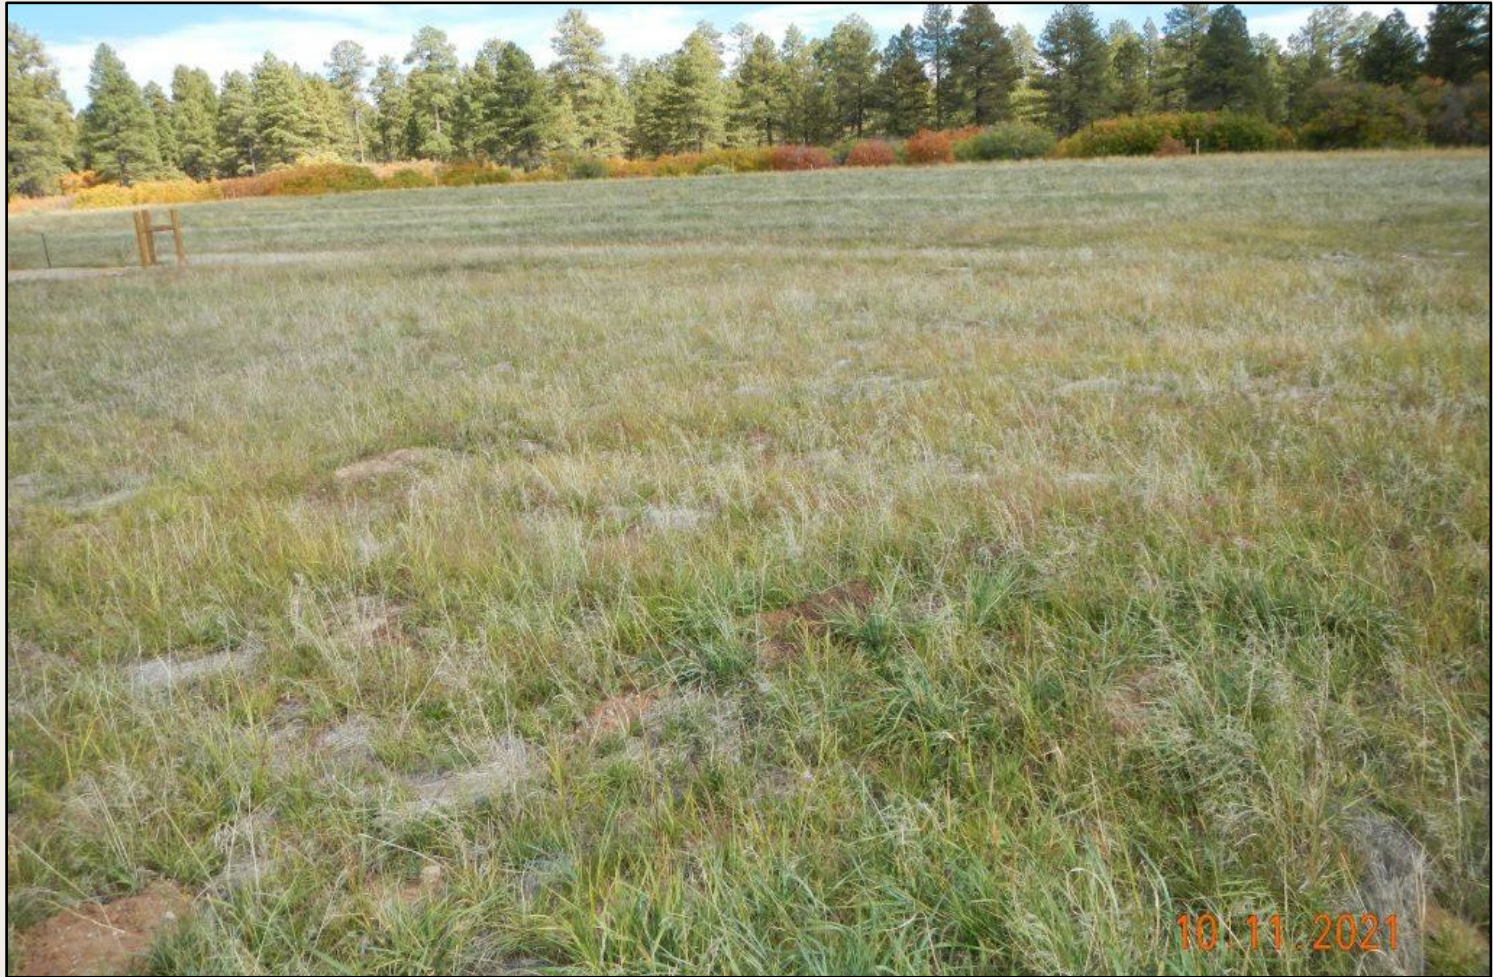
Photo 3. View of the southern project area from the southwestern corner facing eastward. Revegetation is progressing with blue grama, western wheatgrass, and squirreltail.

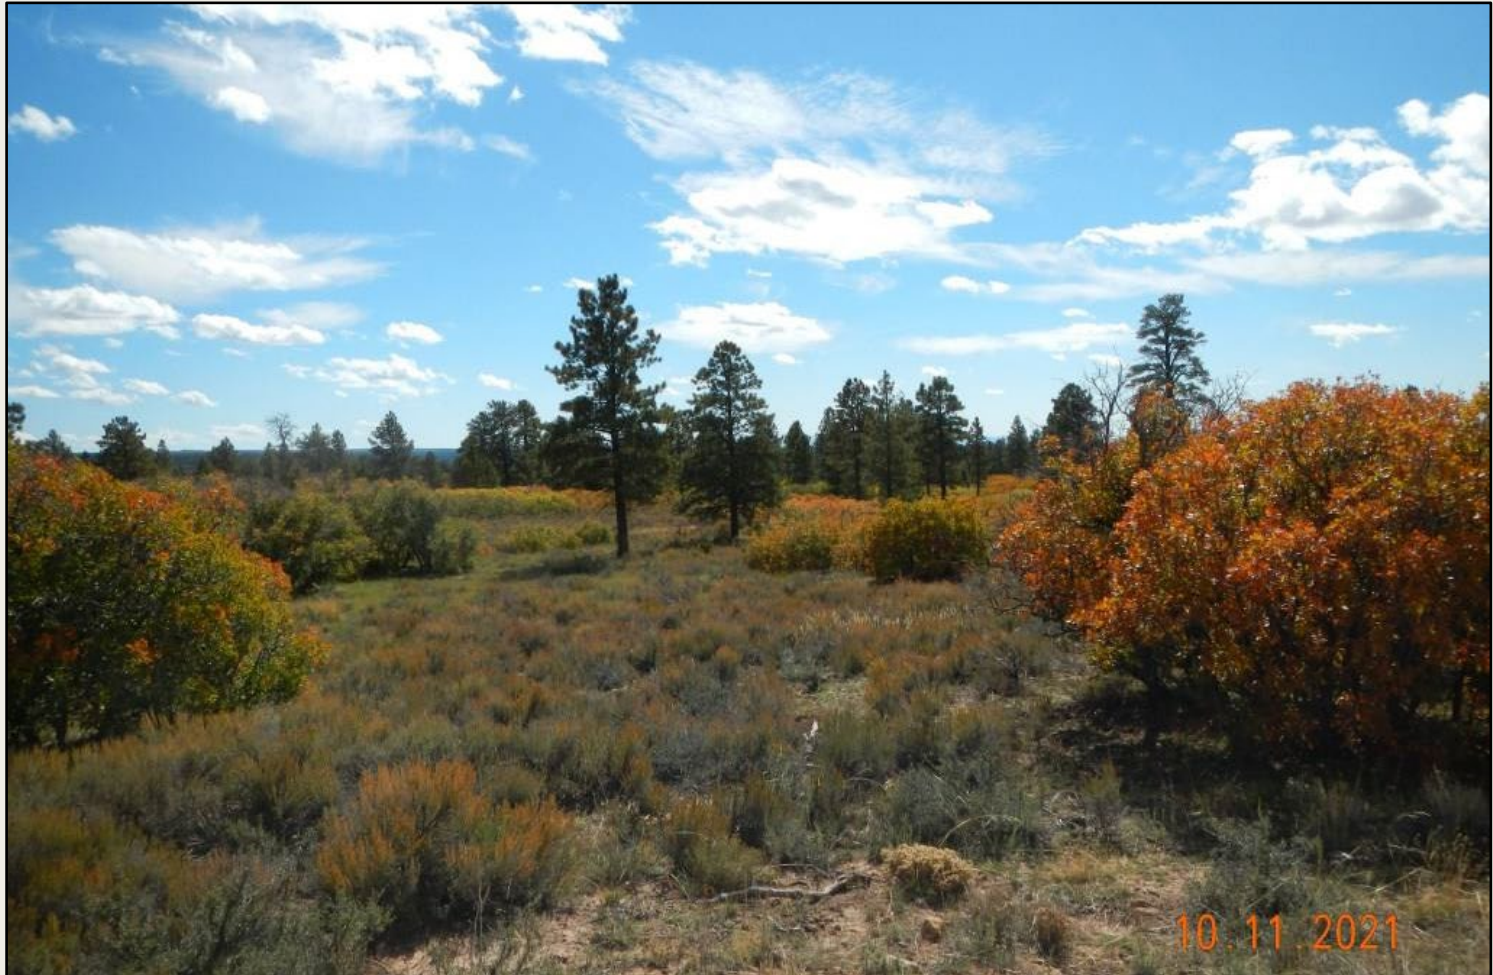
Photo 4. View of reference area comprised of Ponderosa pine woodland with serviceberry and gambel oak shrubland, and an understory of black sage, western wheatgrass, and James galleta.
