## Inspection Photos

Location Name: UPRR 60 PAN AM D 4

Location ID: 320069

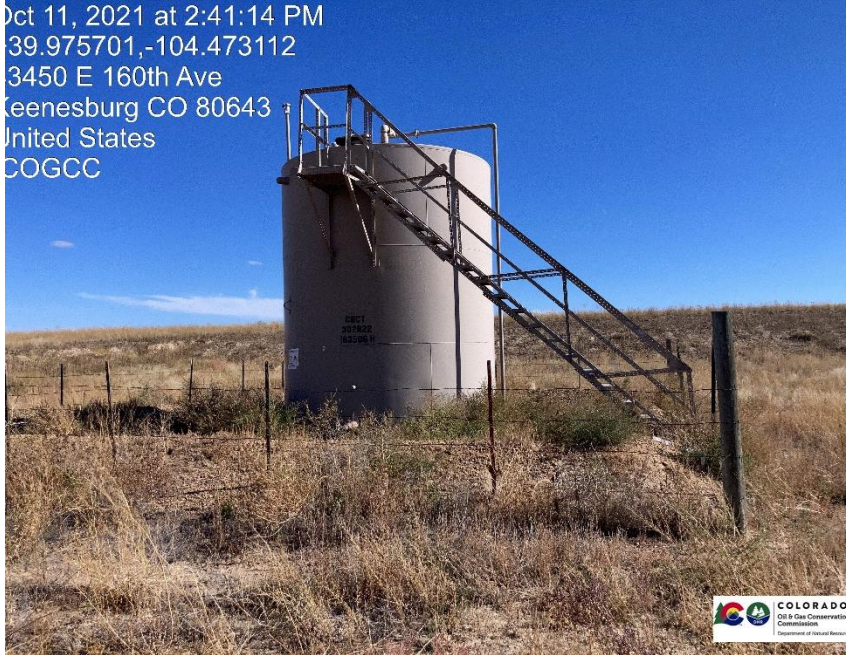
**Pic 1 tank, weeds unmanaged, sign needs to be fixed.**

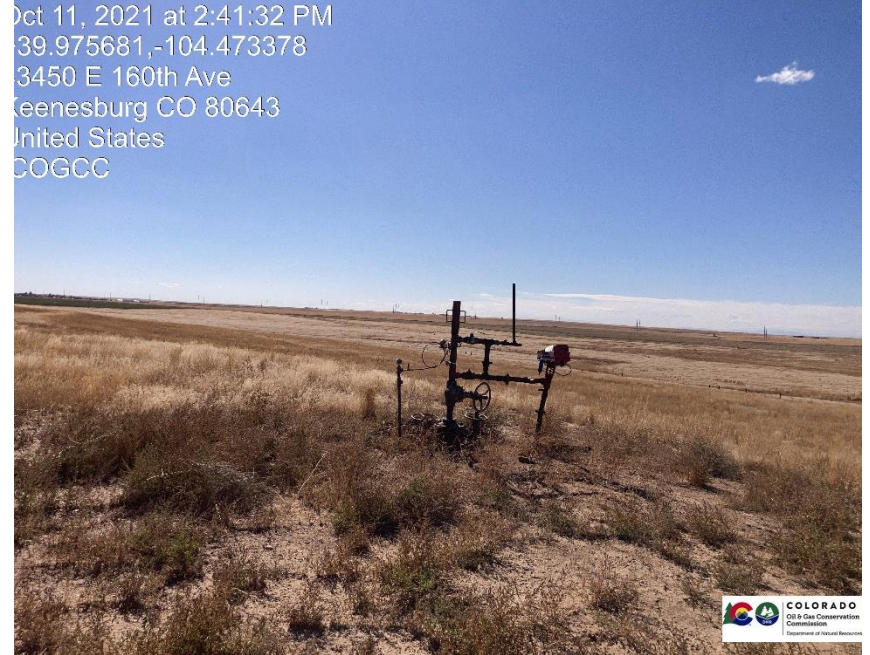
**Pic 2 wellhead, sign needs to be re-attached to wellhead**

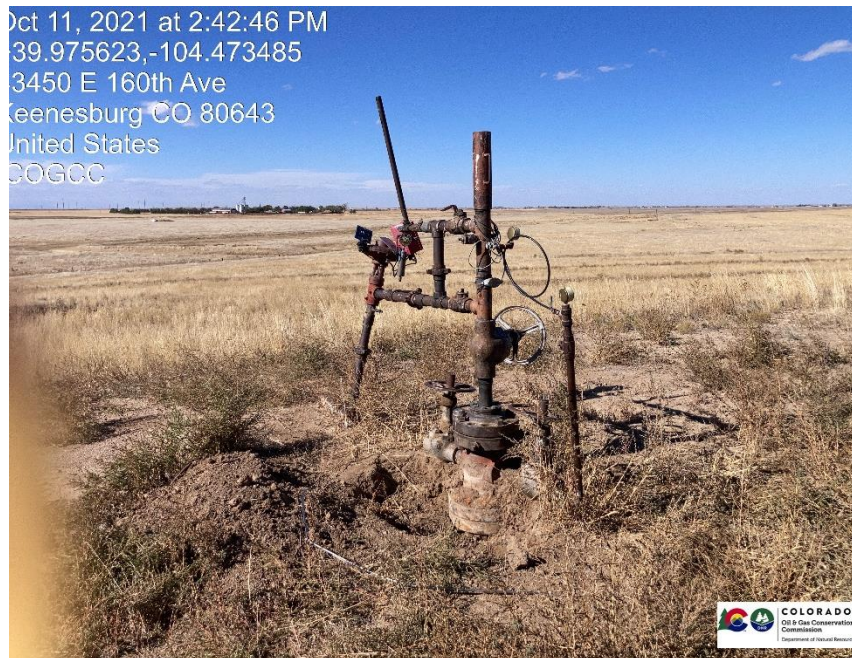
**Pic 3 wellhead, bradenhead is not plumbed to surface**

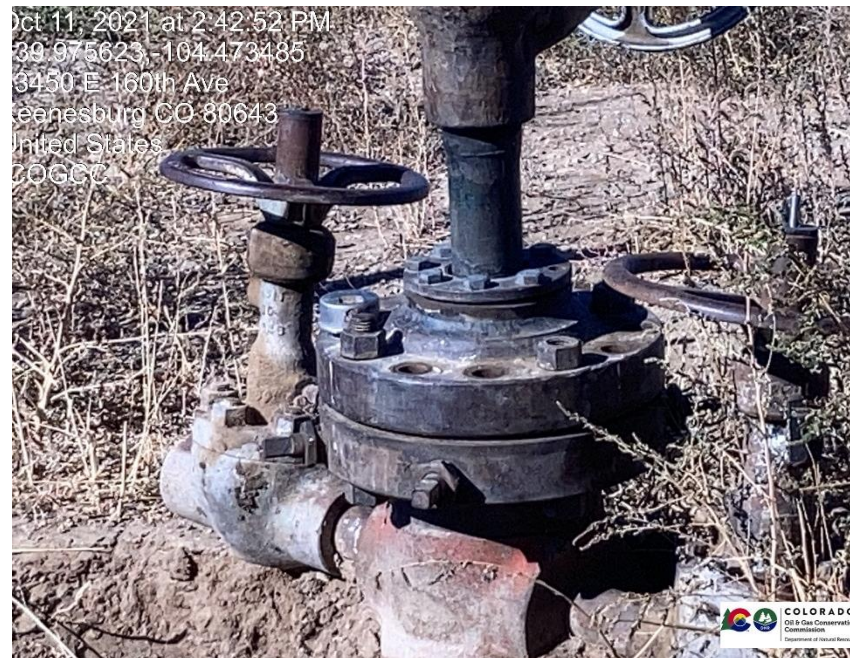
**Pic 4 wellhead only has 4 bolts securing flange from wellhead to Christmas tree. Mechanical issue.**

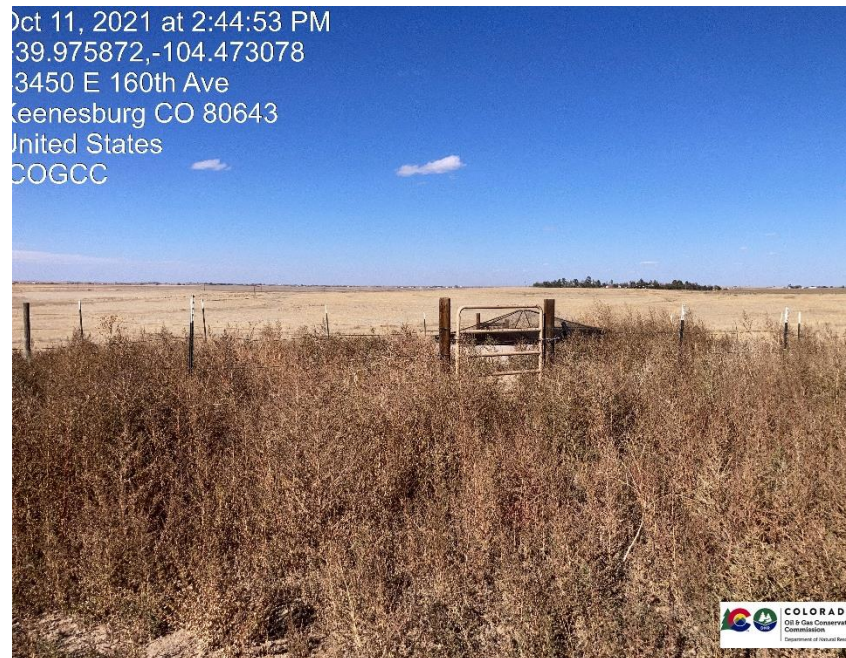
**Pic 6 Open top tank, unable to visually inspect netting due to weed growth**
