Inspection Photos
Location Name: Jacobucci #4
Location ID: 318728

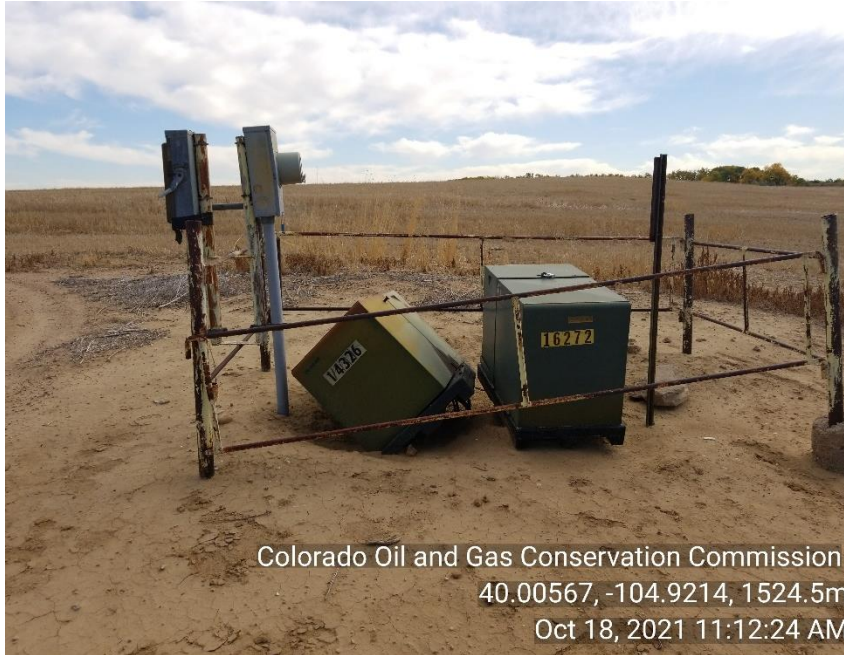
Photo 3 Mechanical issue electric panel sinking and wires showing

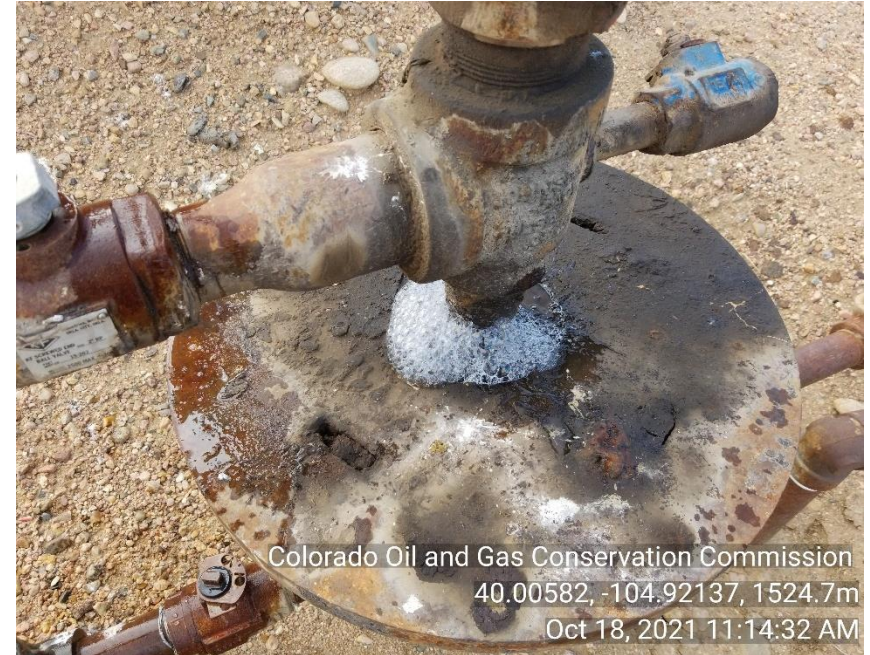
Photo 4 Mechanical issue well head leaking.
