Inspection Photos
Location Name: UPRR 43 pan AM I#25
Location ID:318383

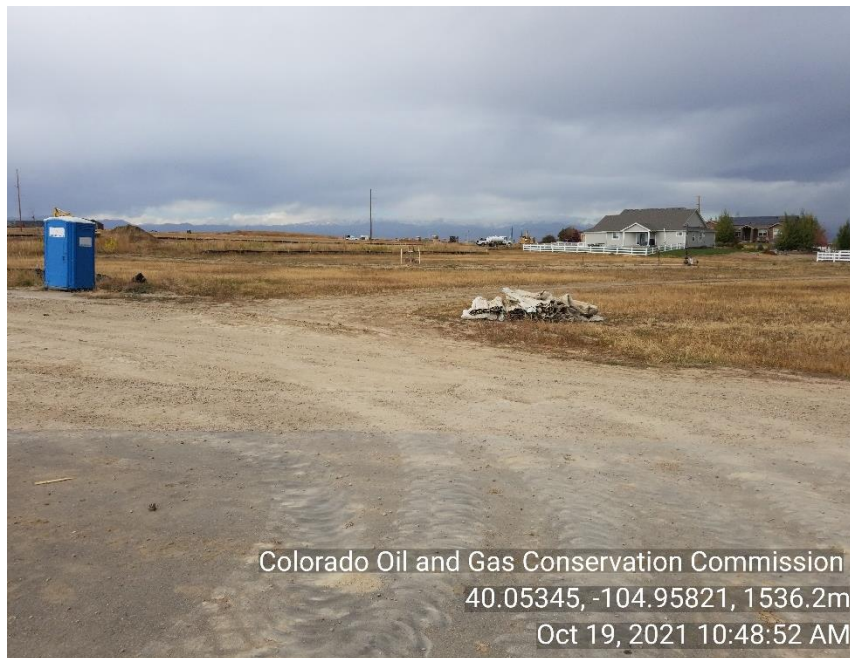
Photo 1 not tracking pad onto asphalt.

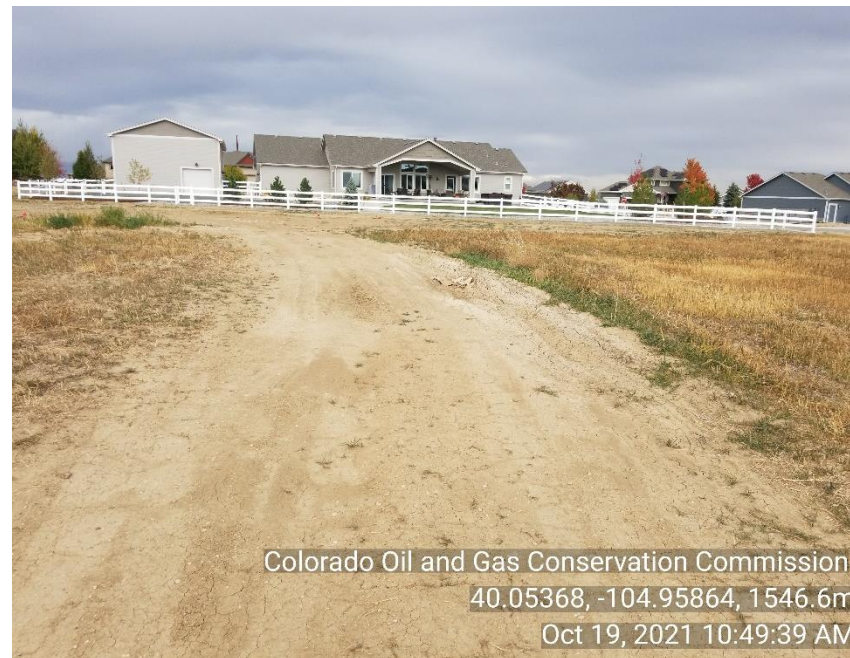
Photo 2 access road has deep ruts no BMP's in place or maintenance performed.

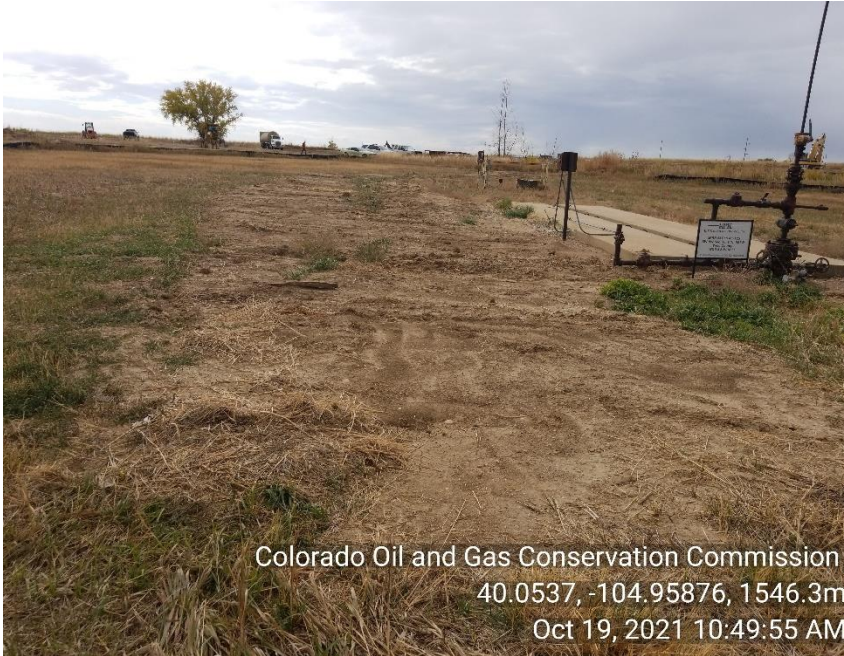
Photo 3 No BMP's in place along backfilled ditch. Area is not seeded or graded.

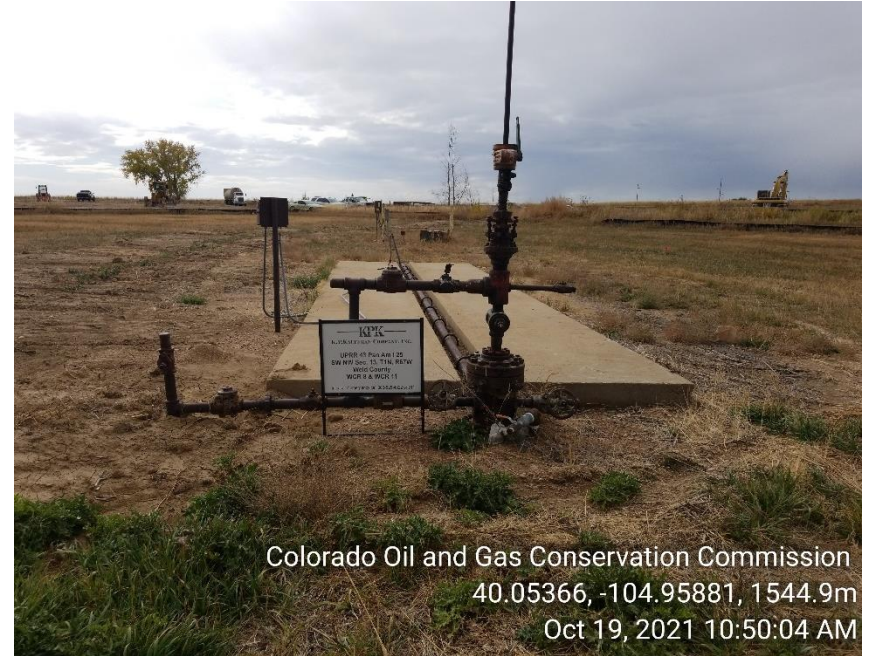
Photo 4 Unused equipment: Electric panel. Cement base

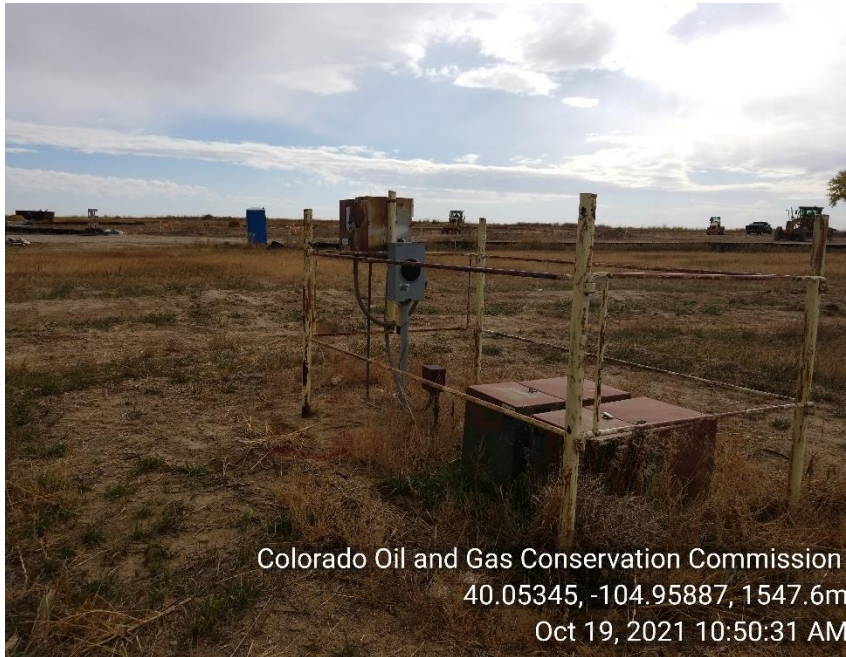
Photo 5 Unused equipment: Electric panel meter has been pulled.

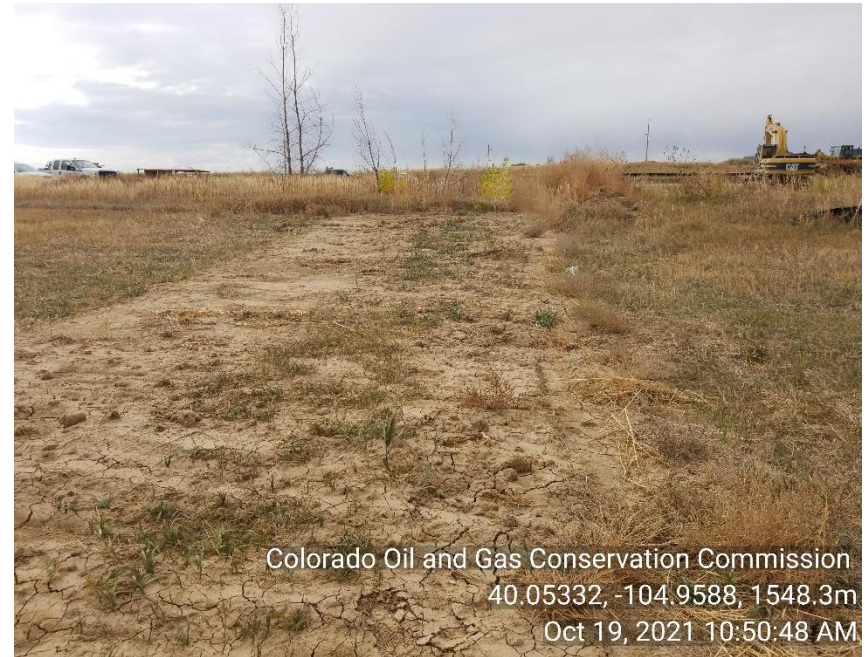
Photo 6 No BMP's in place on backfilled ditch.

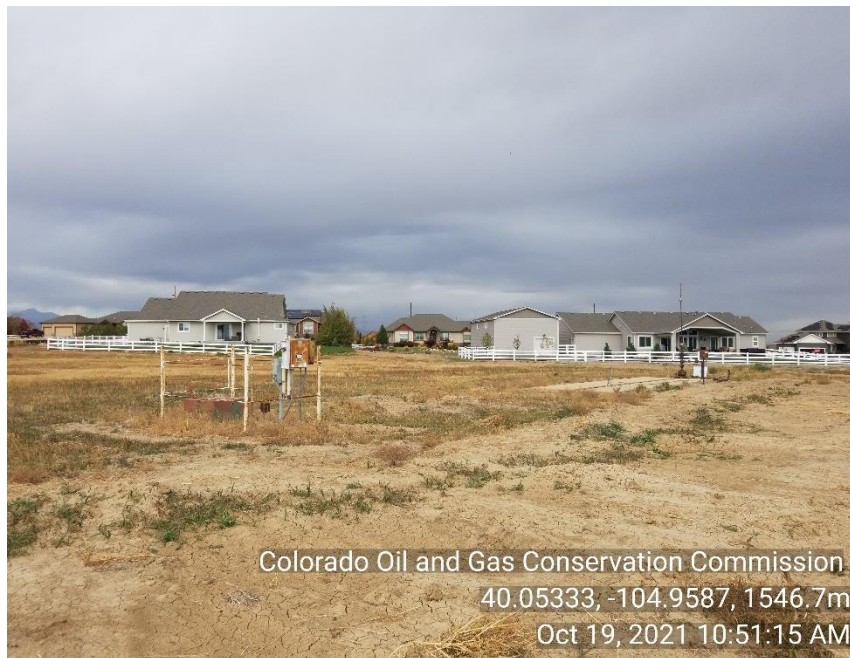
Photo 7 Well is with in 100 feet of homes.

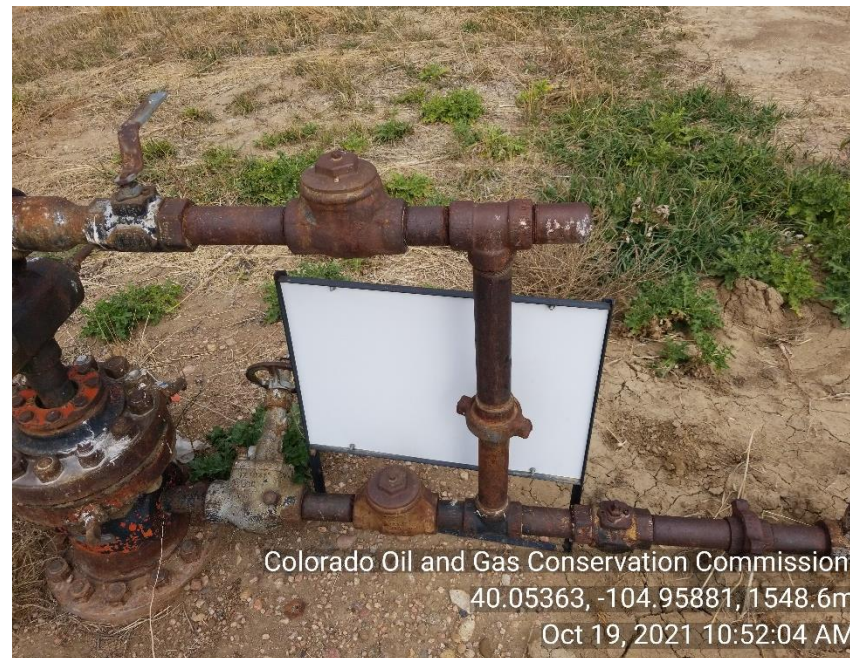
Photo 8 Well head flow line valves is the closed position.
