Inspection Photos

API: 071-06094

Operator: AMOCO PRODUCTION COMPANY

Inspection Date: 10/19/2021

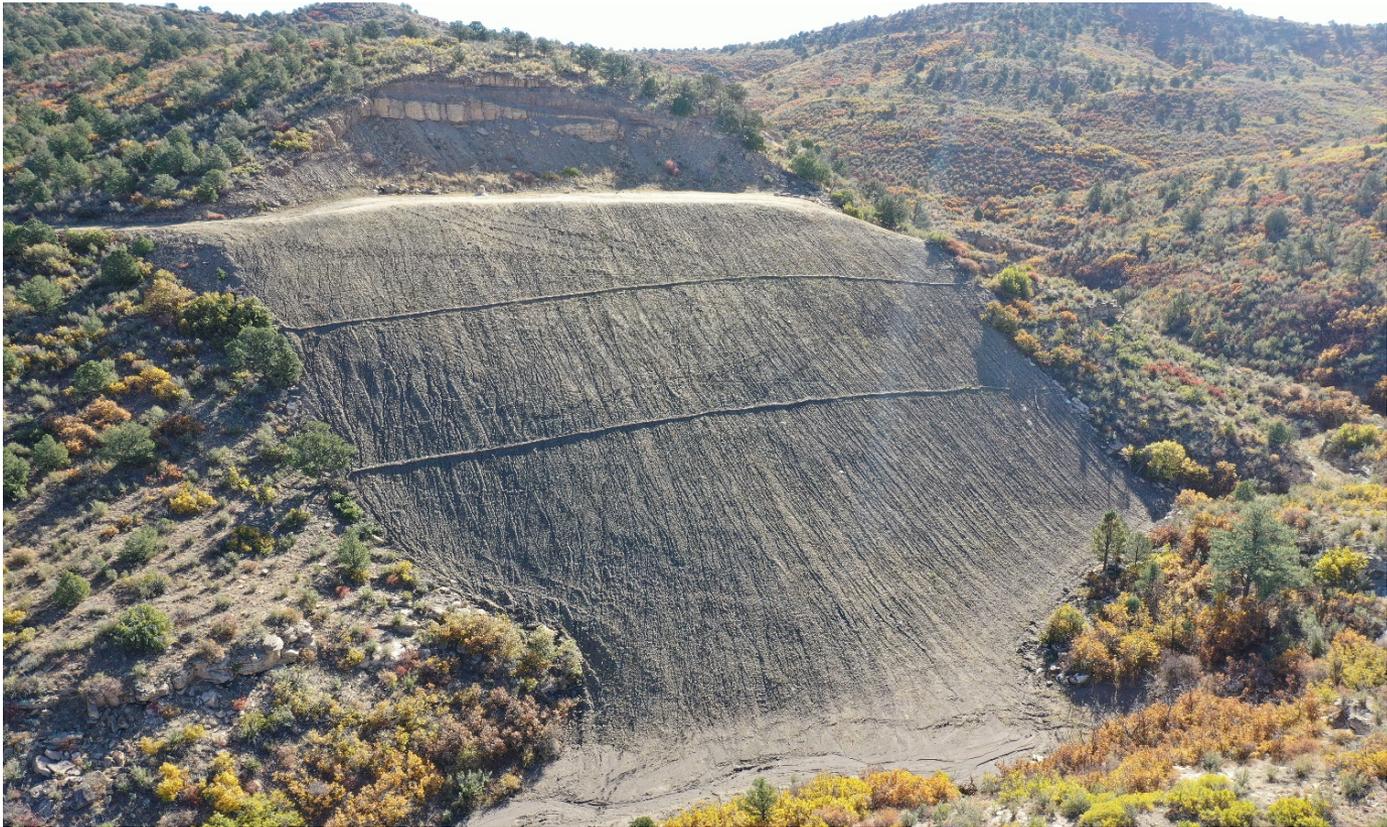
Photo 1. Drone aerial photo facing east toward the well site location. The access road and pad remain and were not recontoured back to the original condition per the rules.

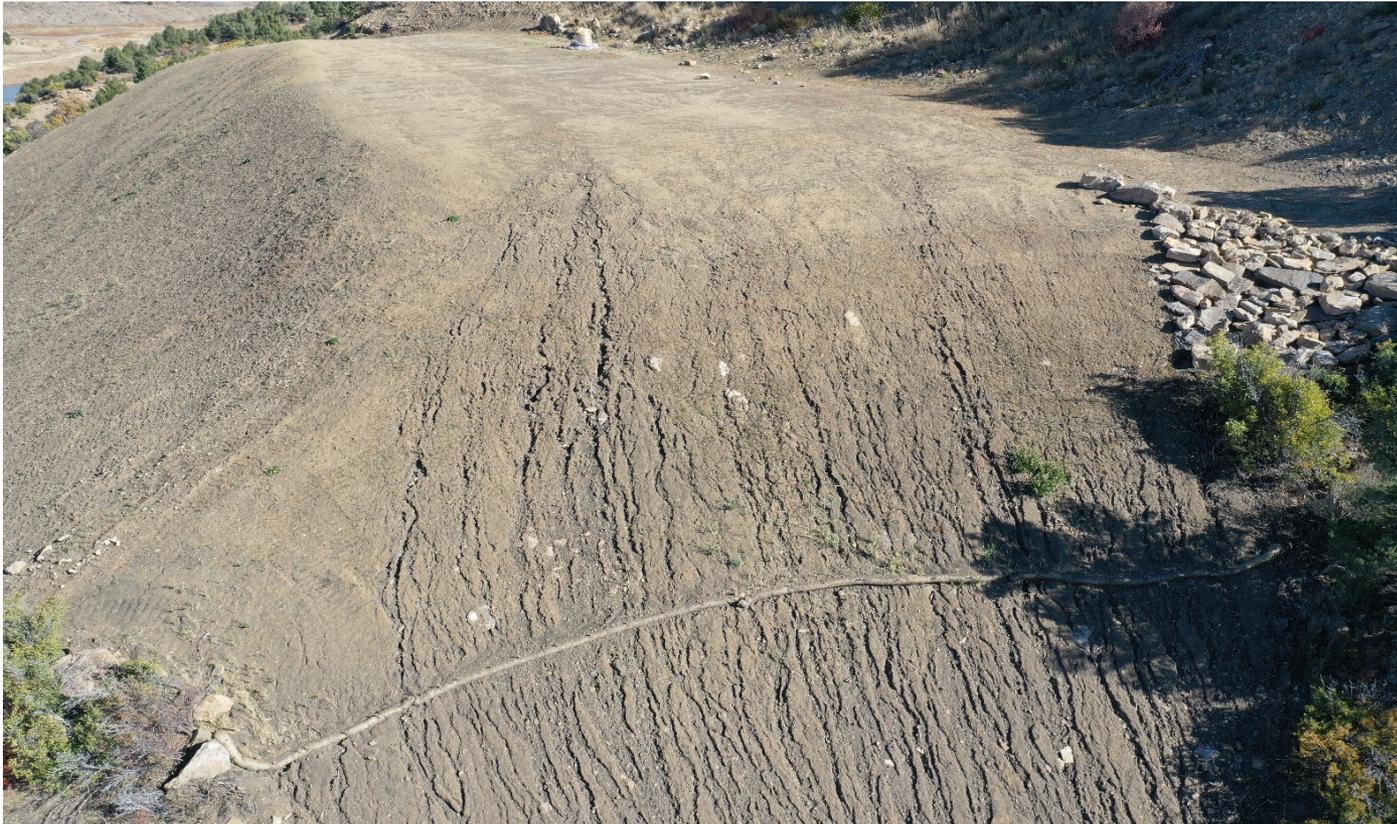
Photo 2. Facing north toward the location. There is now rilling erosion that occurred along the fill slope since the previous inspection. The stormwater BMP's are not sufficient as previously indicated and have not been maintained.

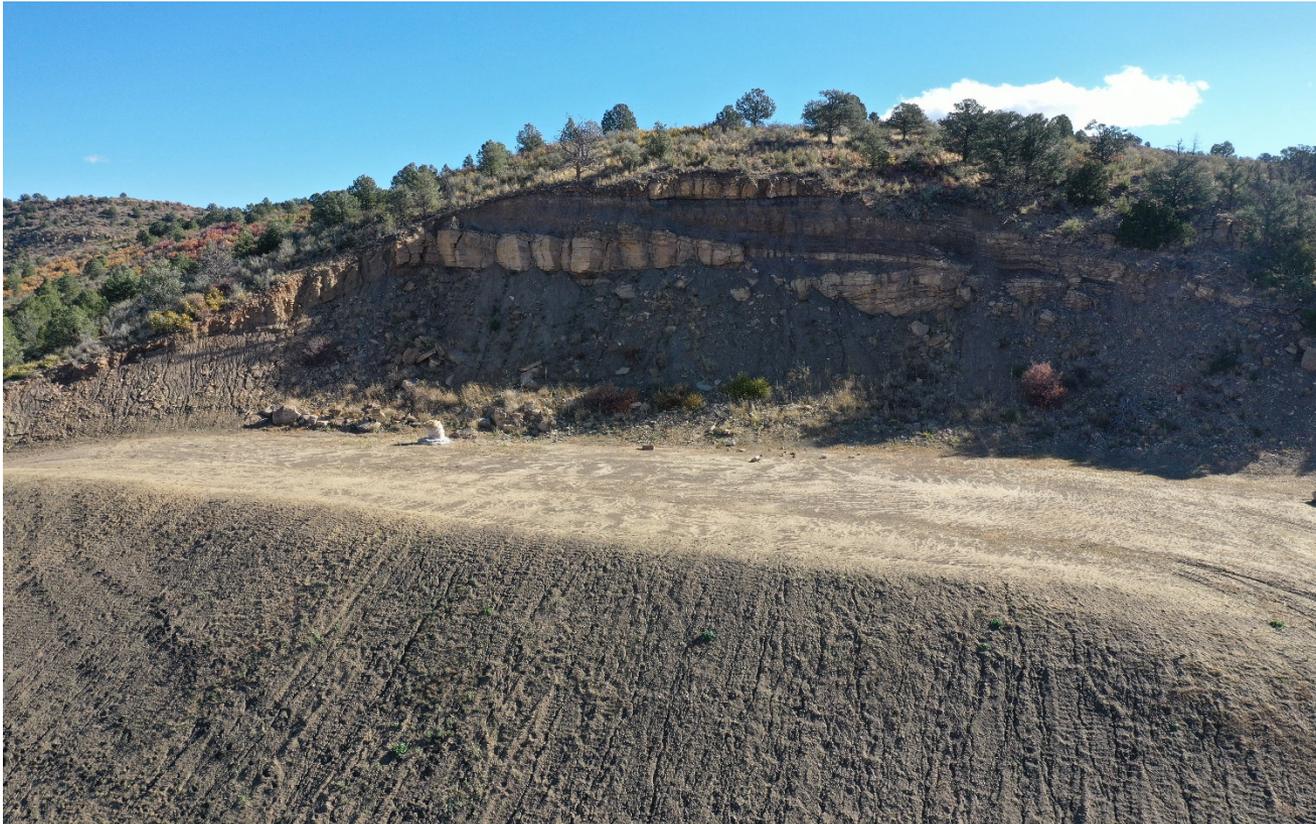
Photo 3. Facing northeast toward the location. A vertical unstable cut slope still remains. The fill slope material was not resloped back to the cut slope.

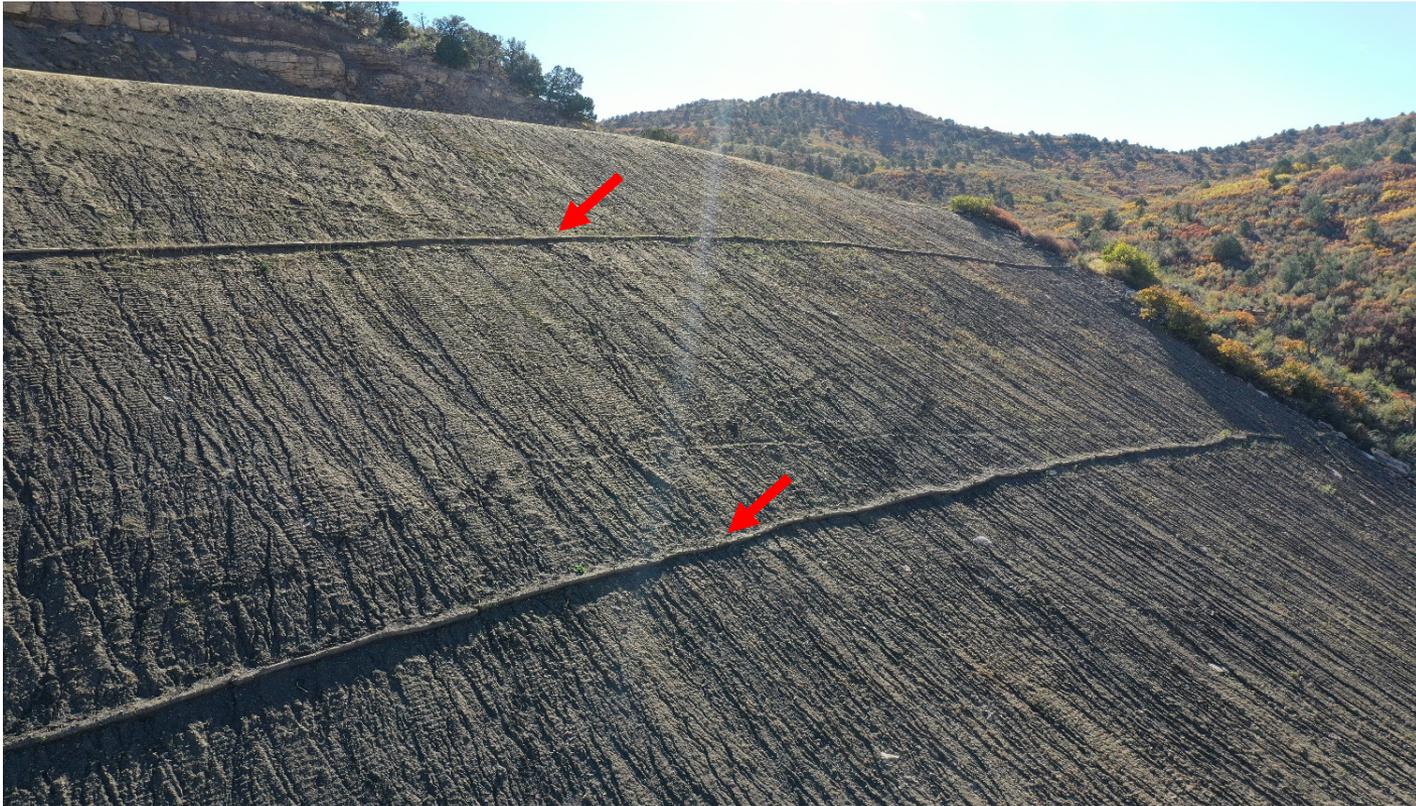
Photo 4. Facing east toward the fill slope. Stormwater controls were not sufficient and erosion has since occurred along the fill slope. The red arrows point to the two rows of wattles that are now filled in with sediment since previous inspection.

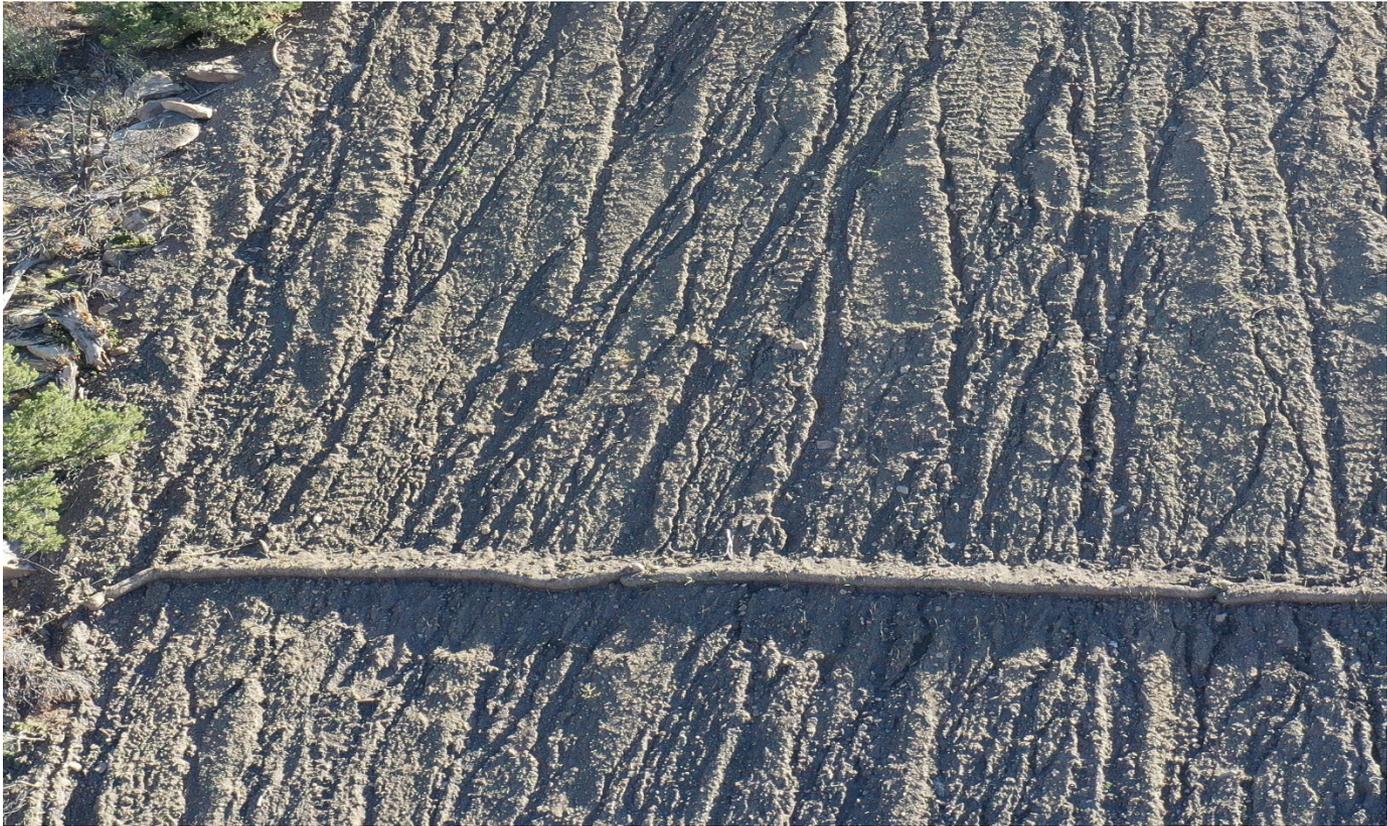
Photo 5. Facing closer to the fill slope shows the rilling erosion that has occurred. The wattles are not maintained and have filled in with sediment.

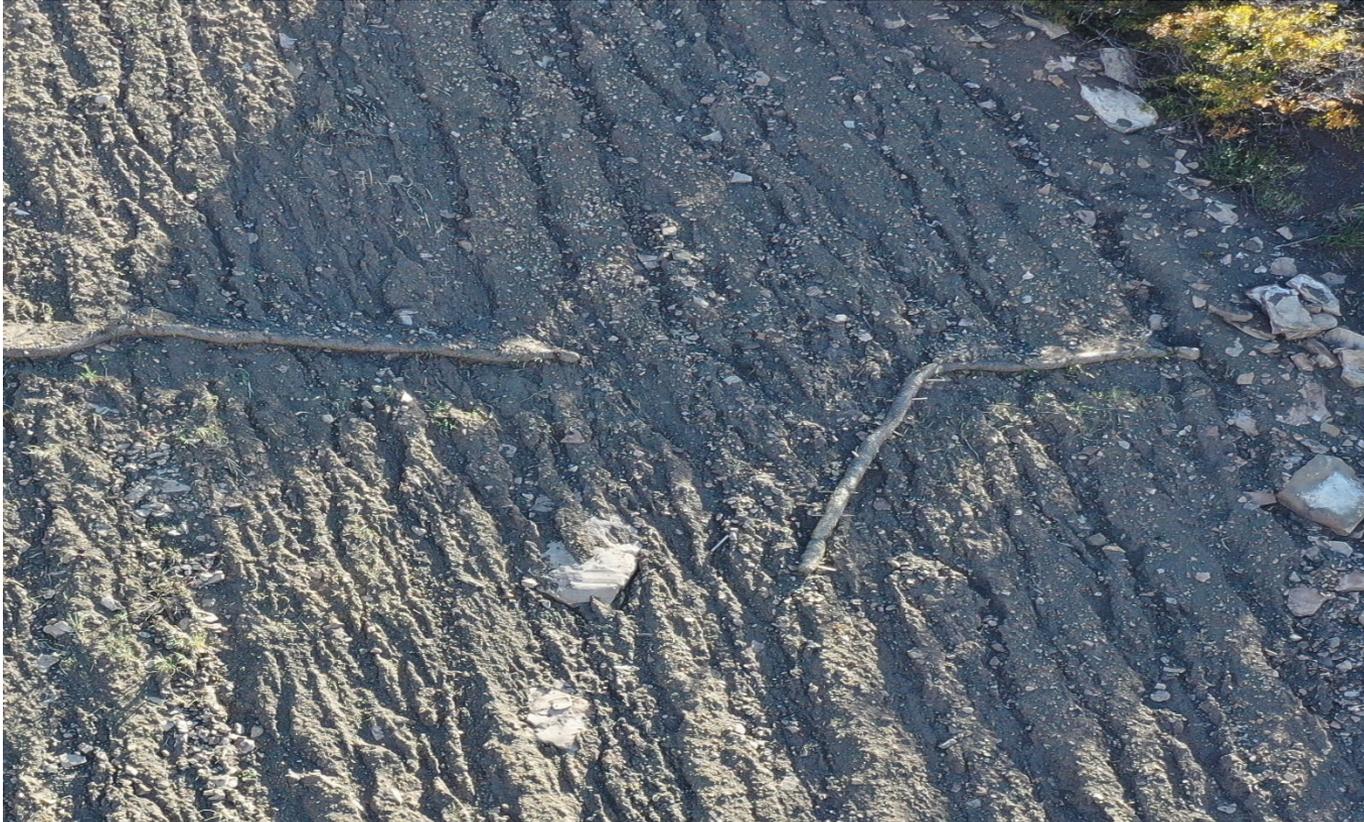
Photo 6. The straw wattles along the cut slope are displaced and not maintained. Previous corrective action was not performed.

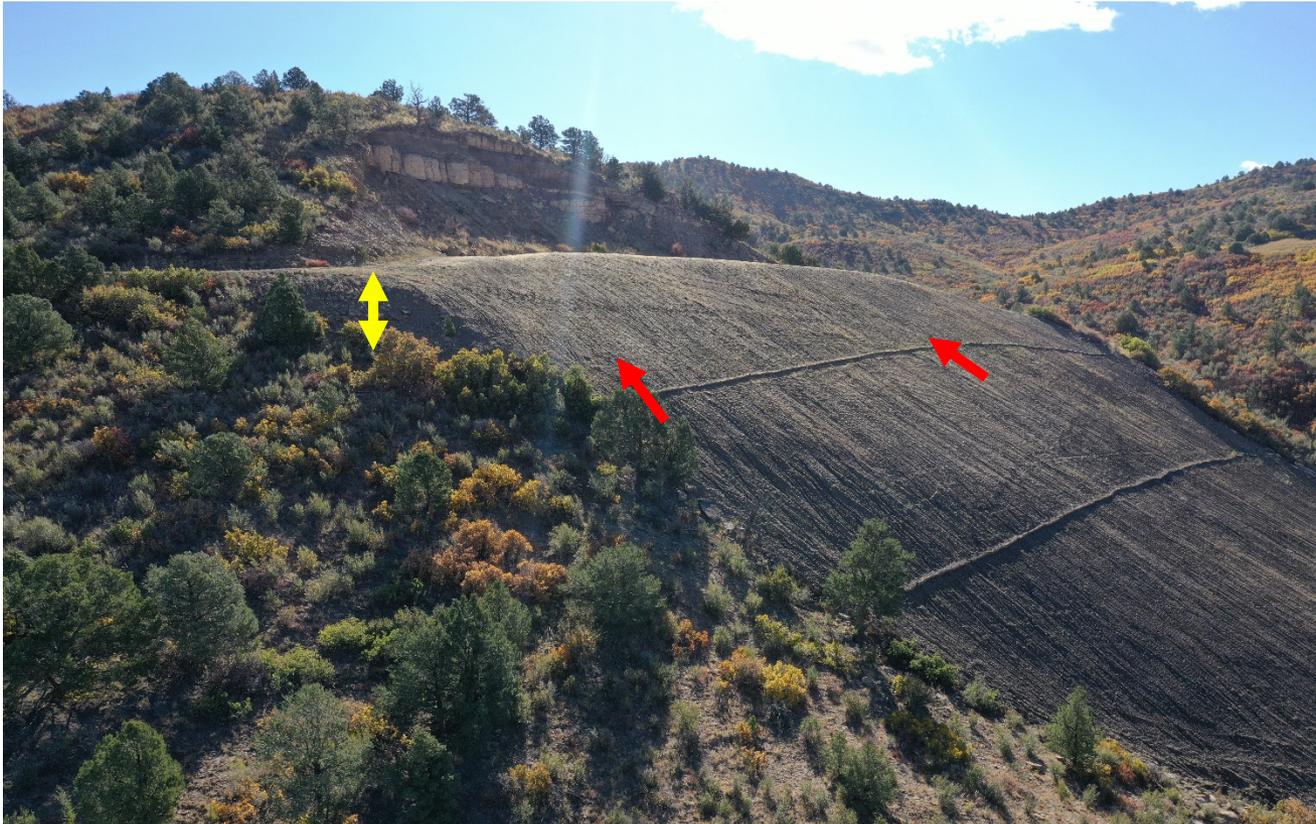
Photo 7. Facing east toward the location which was not recontoured per the rules. The red arrows point to fill material which could have been pushed back to original contour. The yellow arrow shows fill material which is about 20ft. from the original grade.

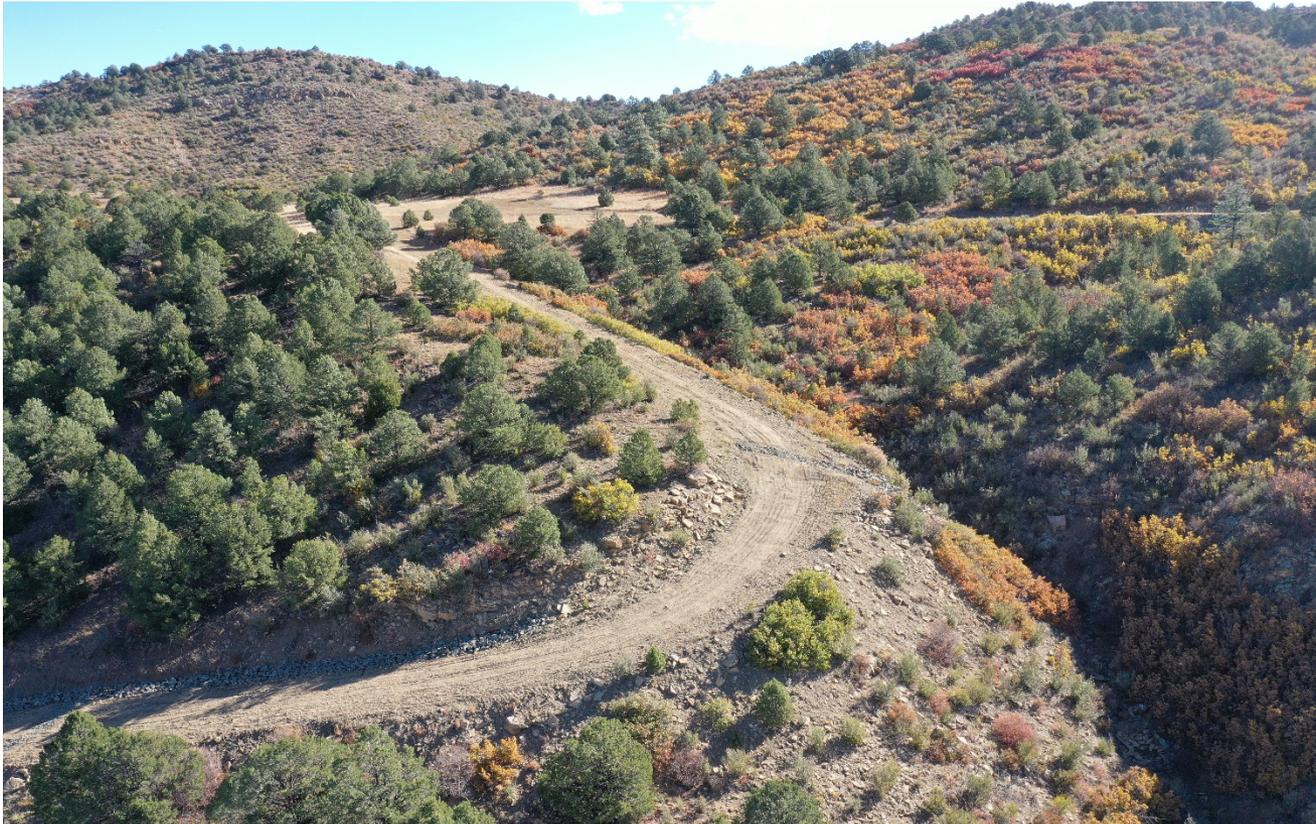
Photo 8. Facing northeast toward the access road which was not recontoured and reclaimed. The access road switches back and dead ends at the location.

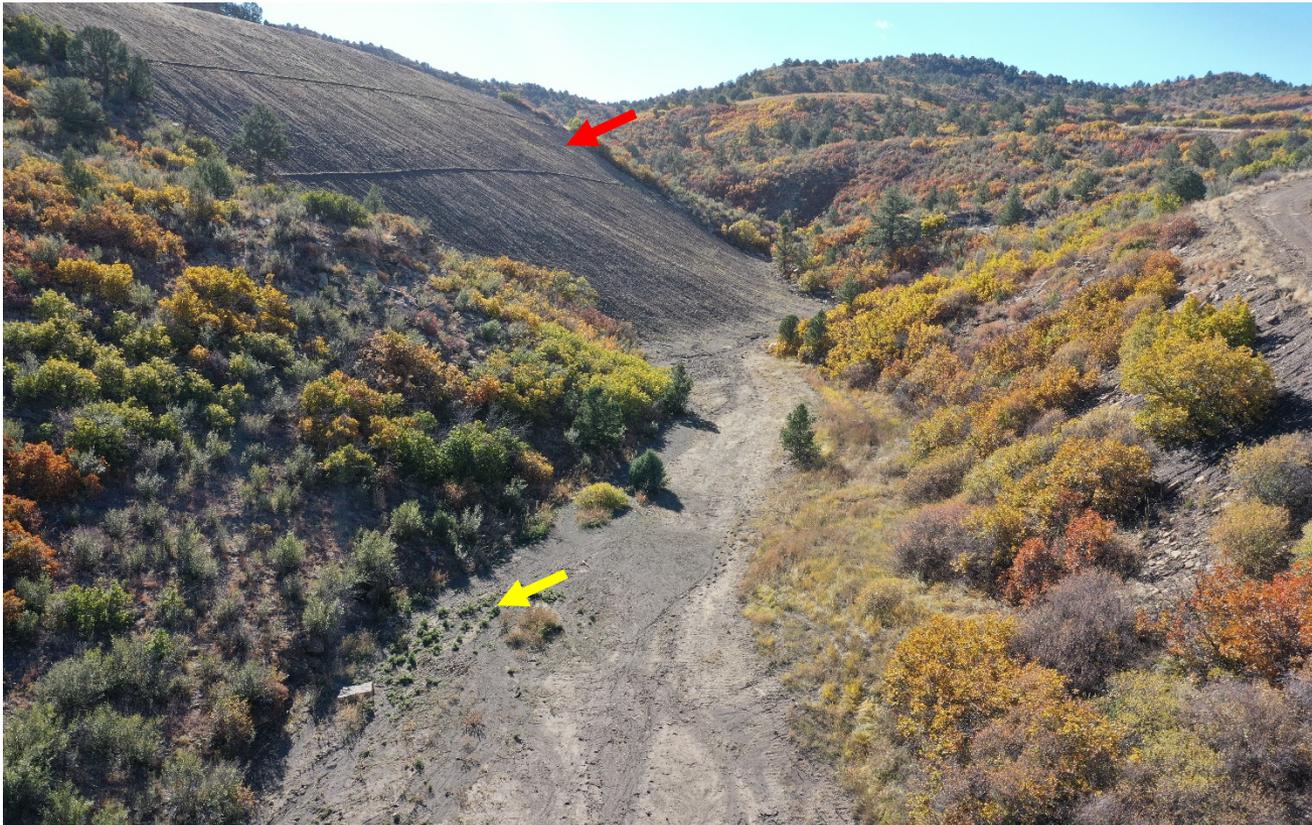
Photo 9. Facing south toward the drainage bottom which was disturbed to access the location shown at red arrow. There were noxious weeds observed in the area shown at yellow arrow. See previous inspection details.

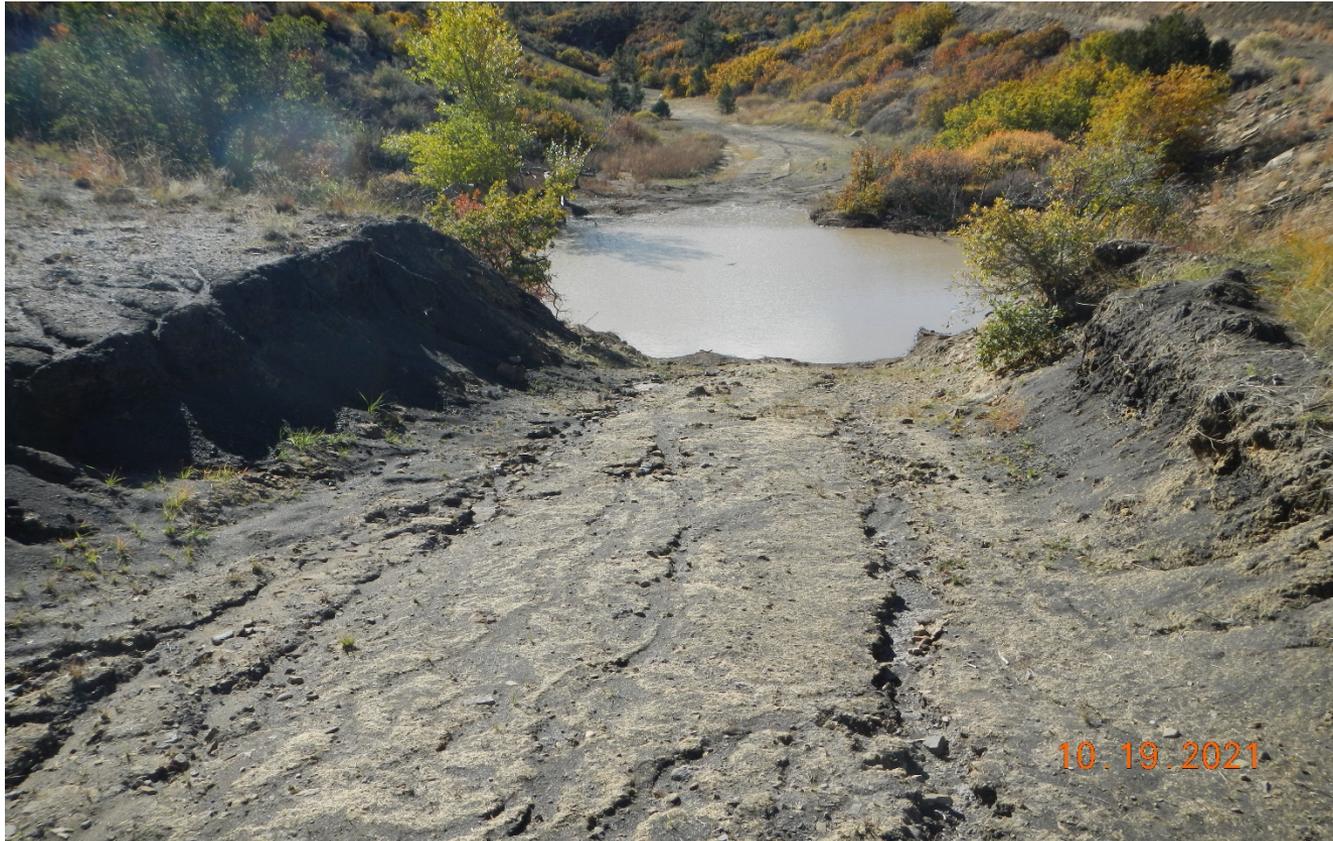
Photo 10. Facing south toward the road that was built to access the canyon bottom. There is erosion beginning to occur along this area which was not recontoured and reclaimed.

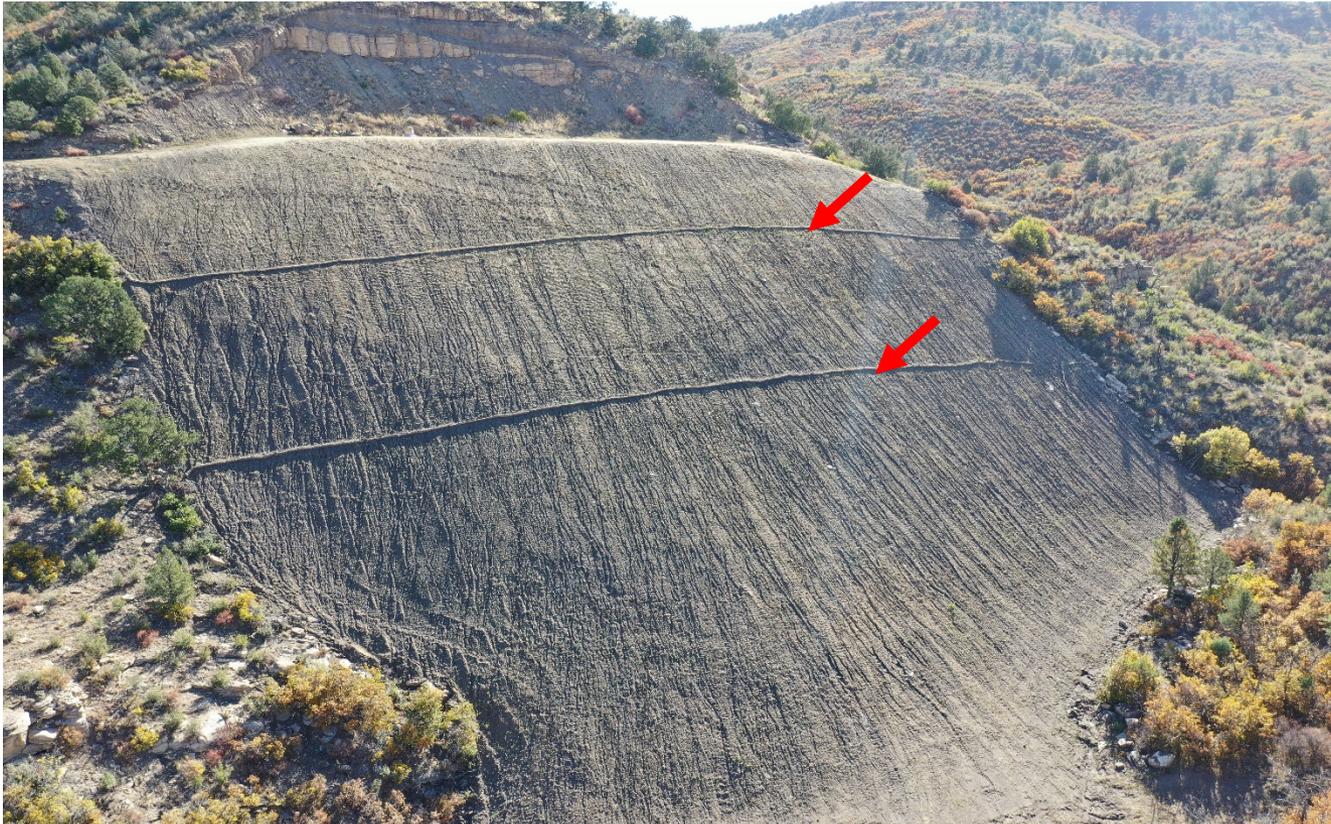
Photo 11. Facing east toward the location from across the canyon. There is not sufficient stormwater controls along the fill slope. The red arrows point to two rows of wattles along the approximate 250 ft. slope. Substantial erosion has occurred along the fill slope since the previous inspection. Corrective action was not performed.
