# Inspection Photos

API: 071-06902

Operator: EVERGREEN NATURAL RESOURCES

Inspection Date: 10/19/2021

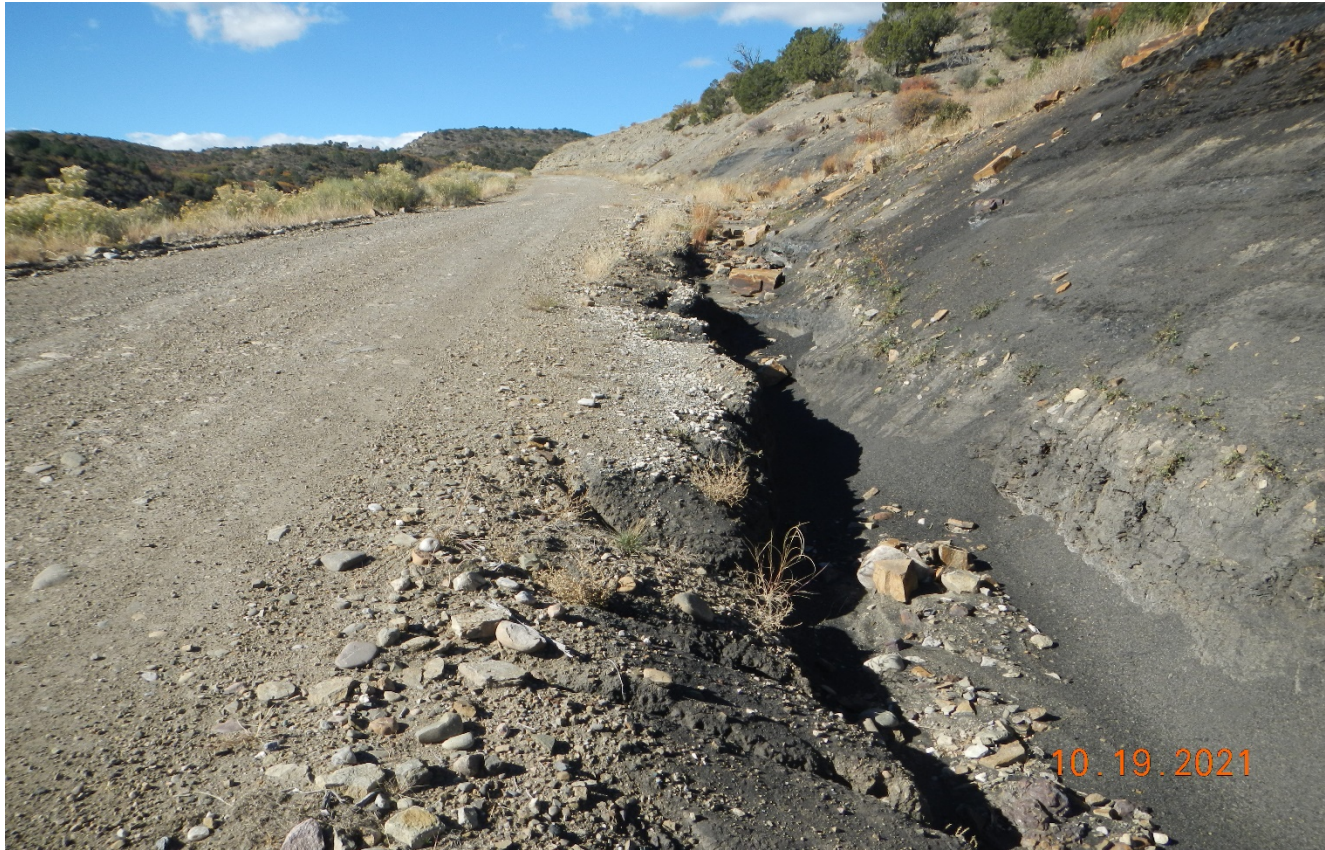
**Photo 1.** Facing southwest along the main road to the well site. There is erosion along the road which is causing sediment accumulation at the culvert and at the main road in Lorencito Canyon. Previous corrective action was not performed.

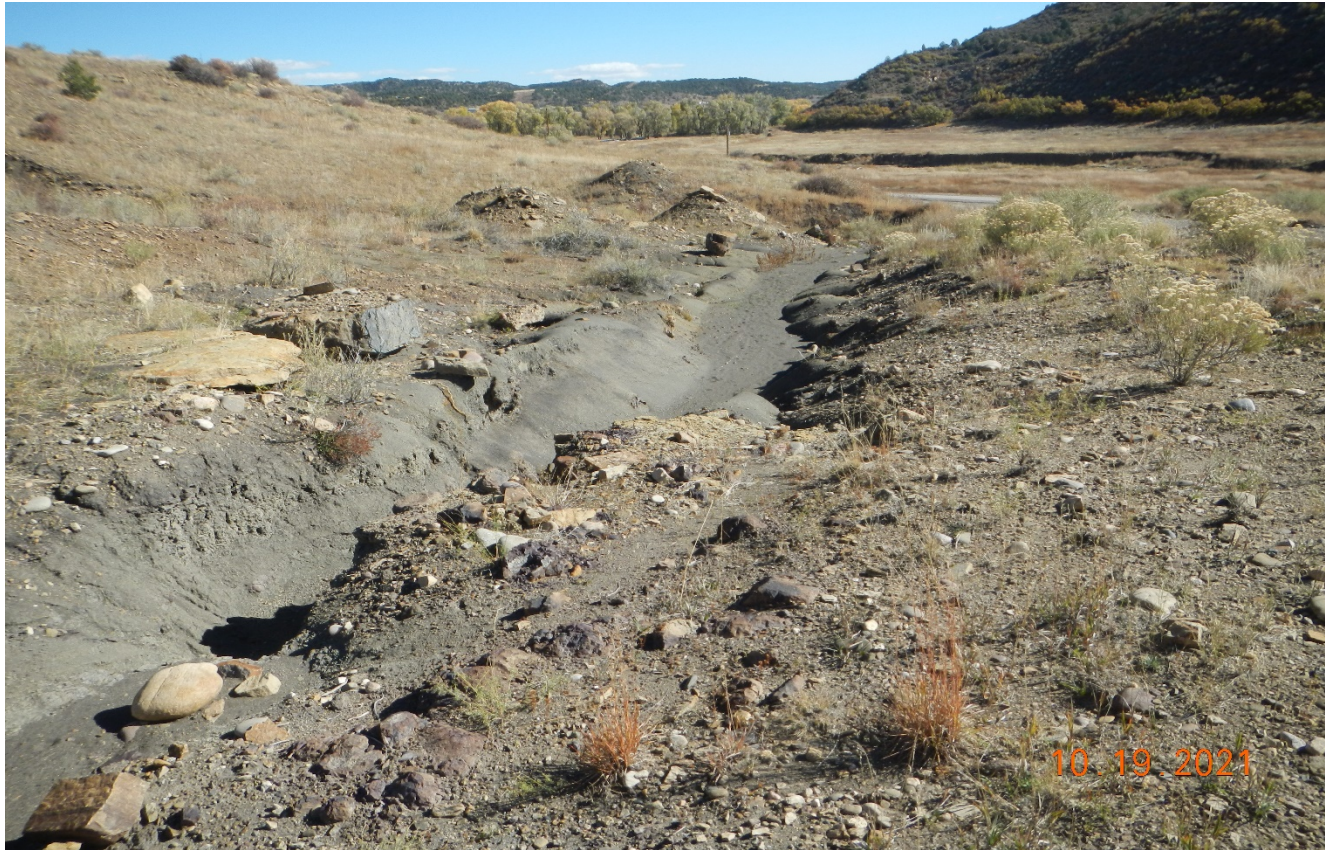
**Photo 2.** Facing back down from the previous photos shows the stormwater erosion which is directed toward the culvert and towards the main Lorencito road.

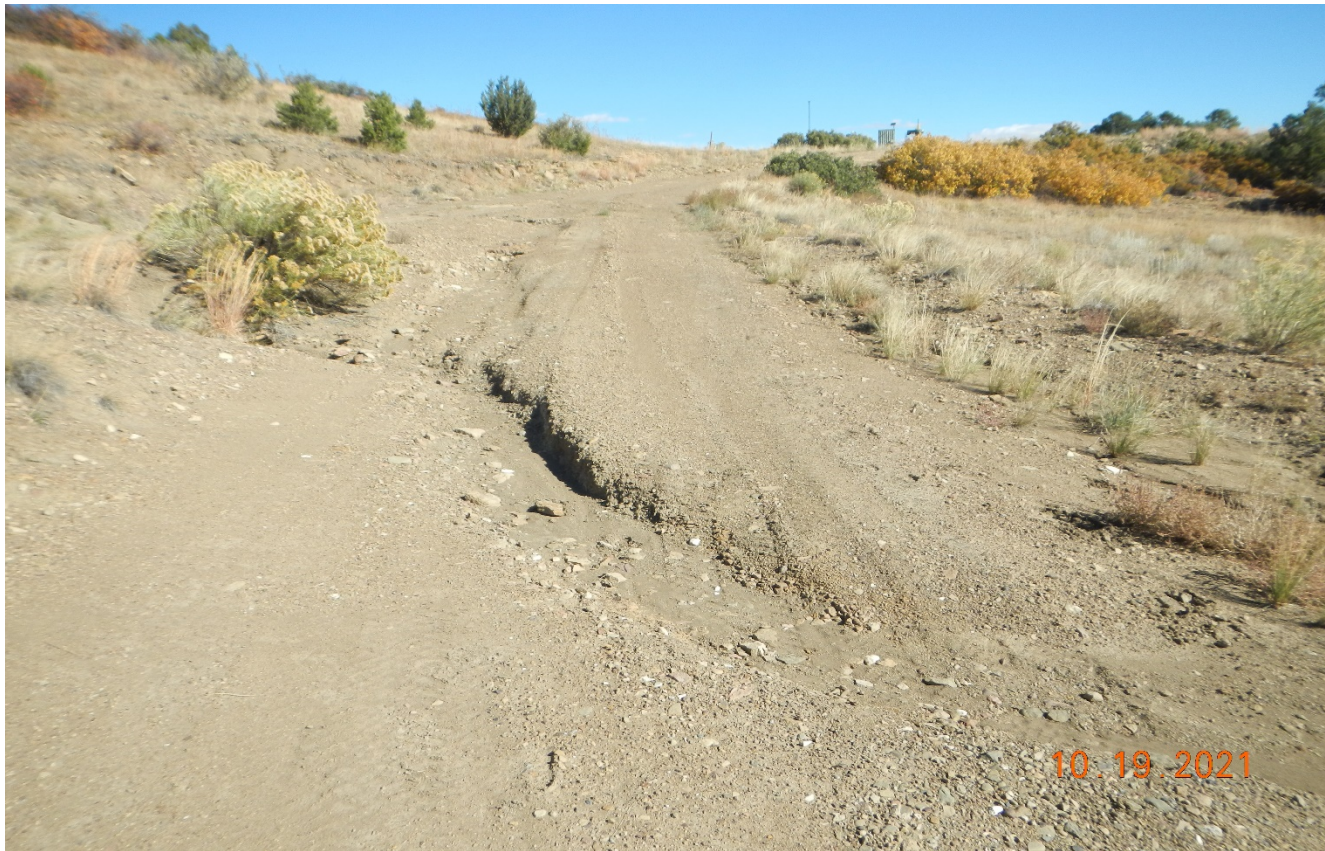
**Photo 3.** Facing northeast along the access road to the well site. There is an erosion channel across the access road.
