**Inspection Photos**  
**Operator: Hilcorp Energy**  
**API: 067-08479**  
**Date: 10/19/2021**

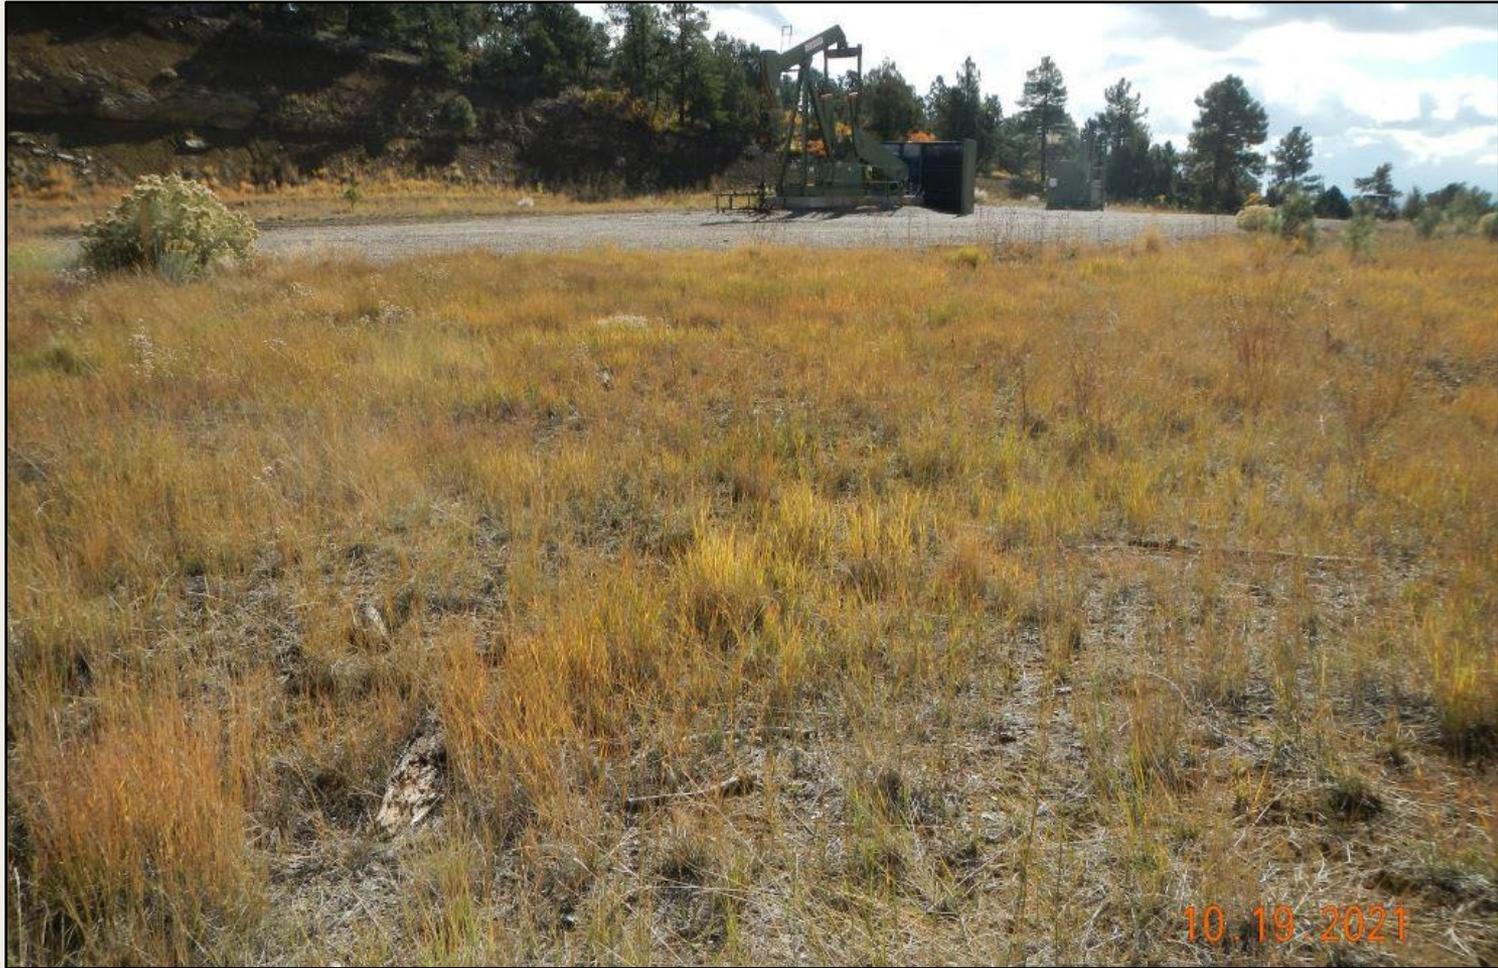
Photo 1. View of the project area from the northwestern corner facing center facing center.

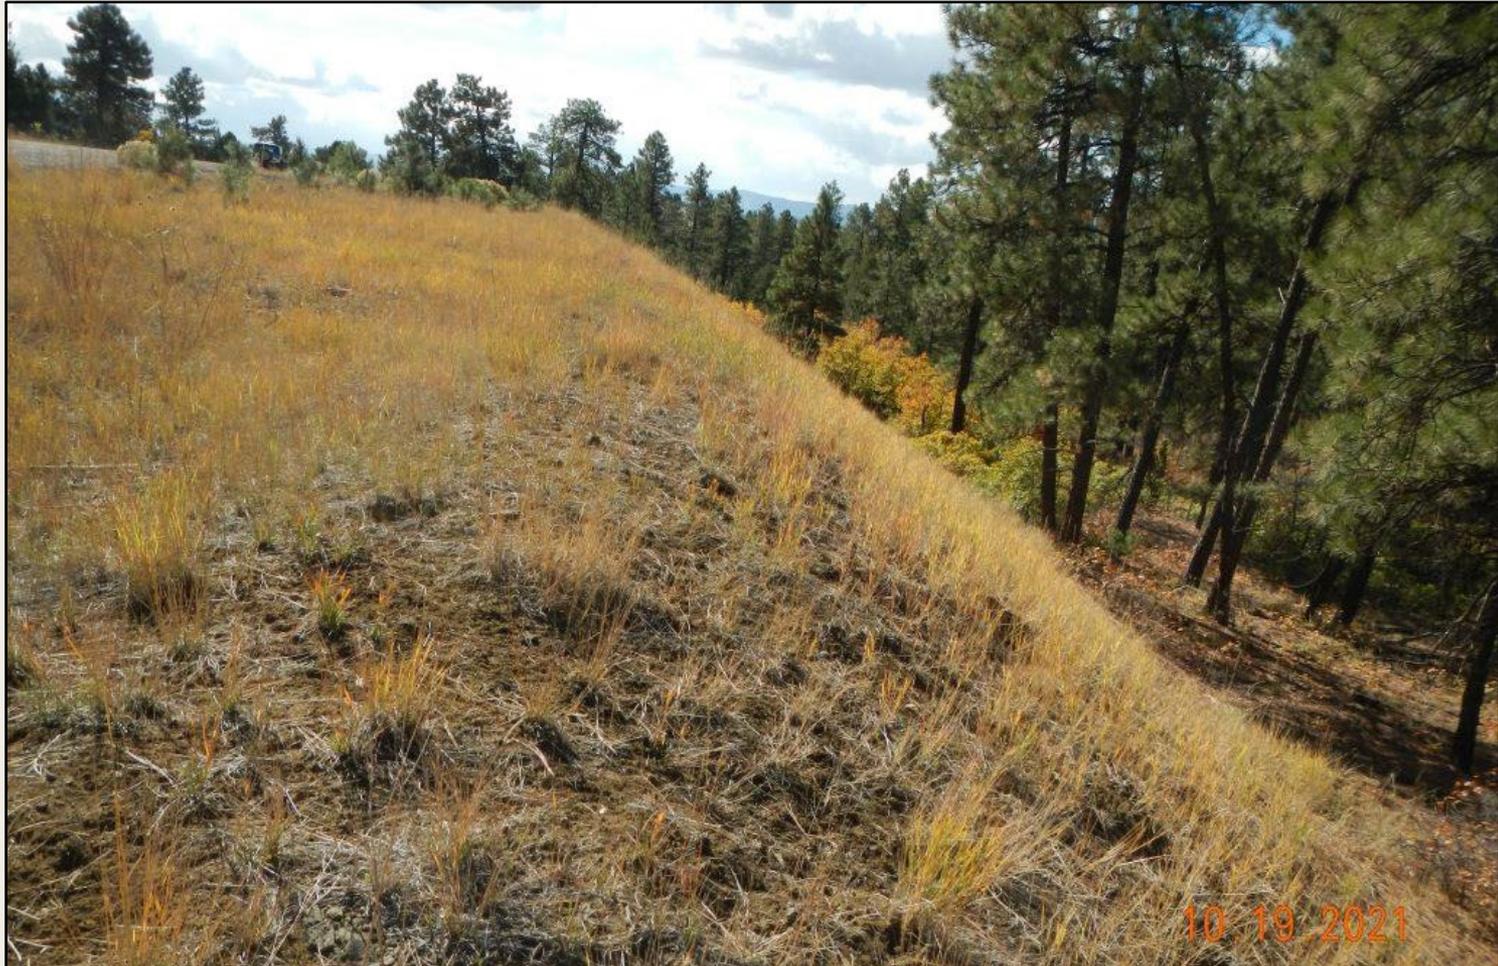
Photo 2. View of the western fill slope from the northwestern corner facing southward. Revegetation is progressing largely with western wheatgrass.

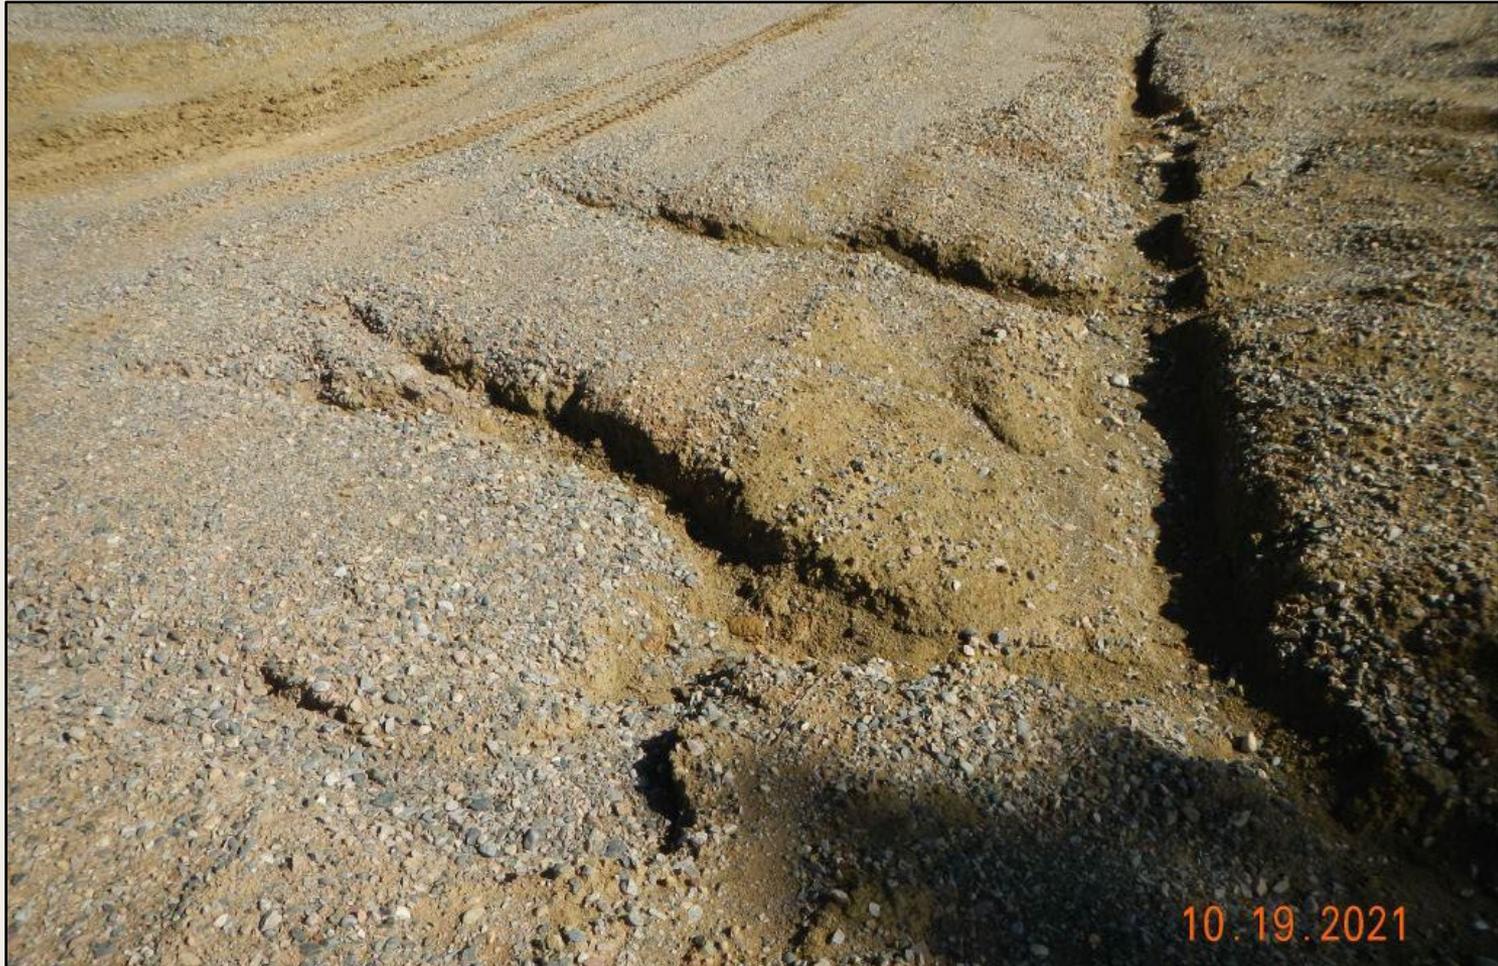
Photo 3. View of erosional rilling and channeling, approx. 1-2ft wide and deep at the well pad entrance, facing up-slope. This occurs where concentrated stormwater flows off of the well pad.

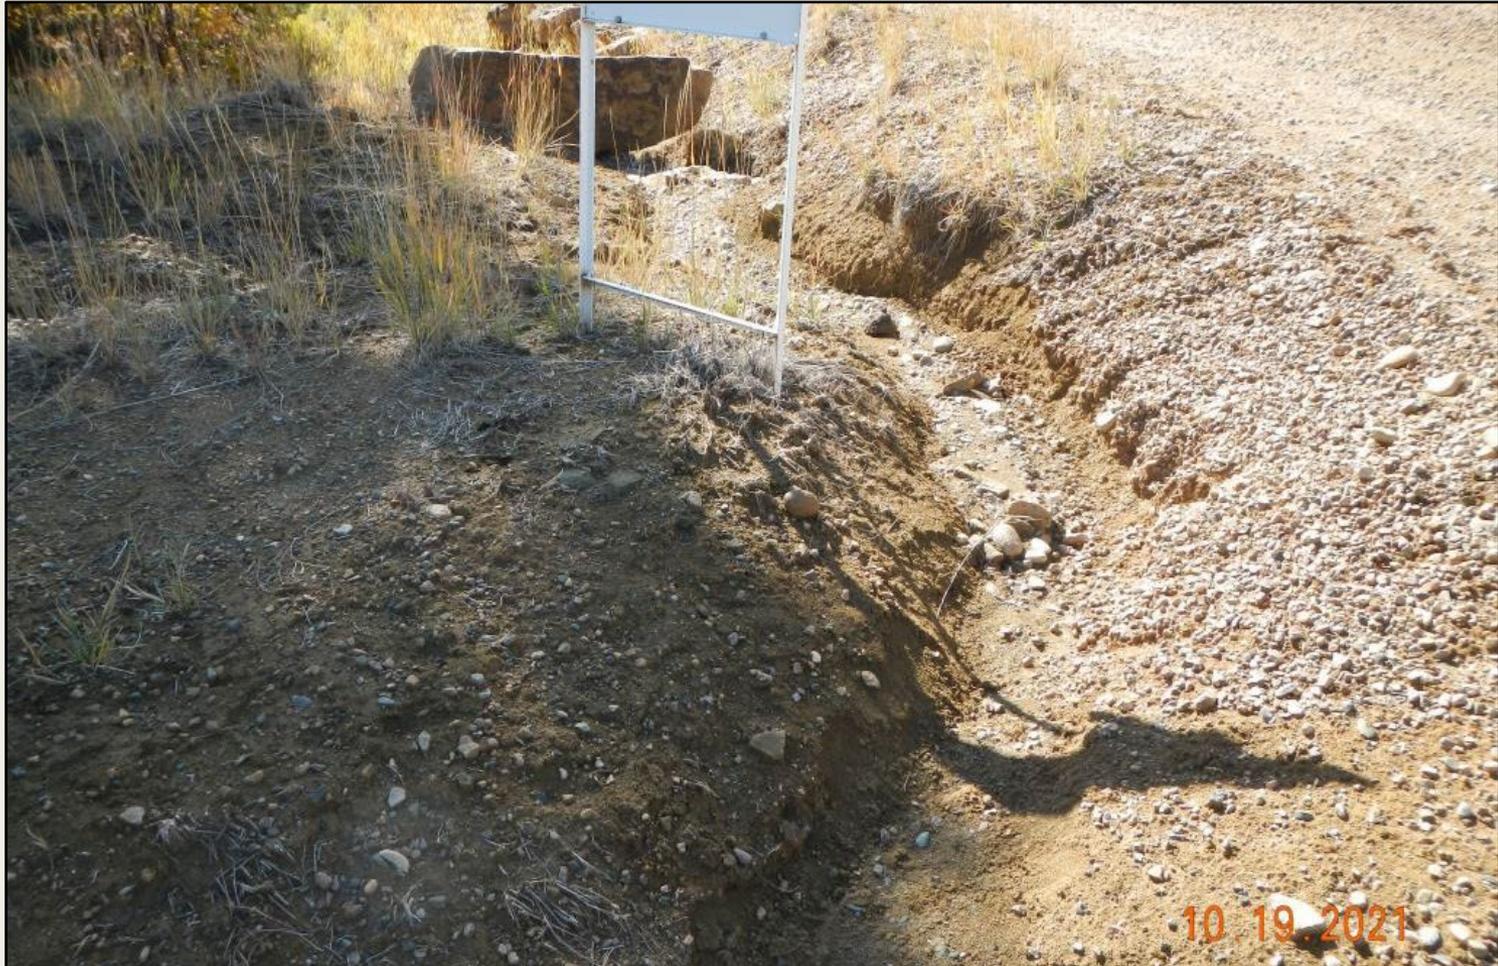
Photo 4. View of erosional channel, facing down-slope from photo 3, approx. 2ft wide and deep.

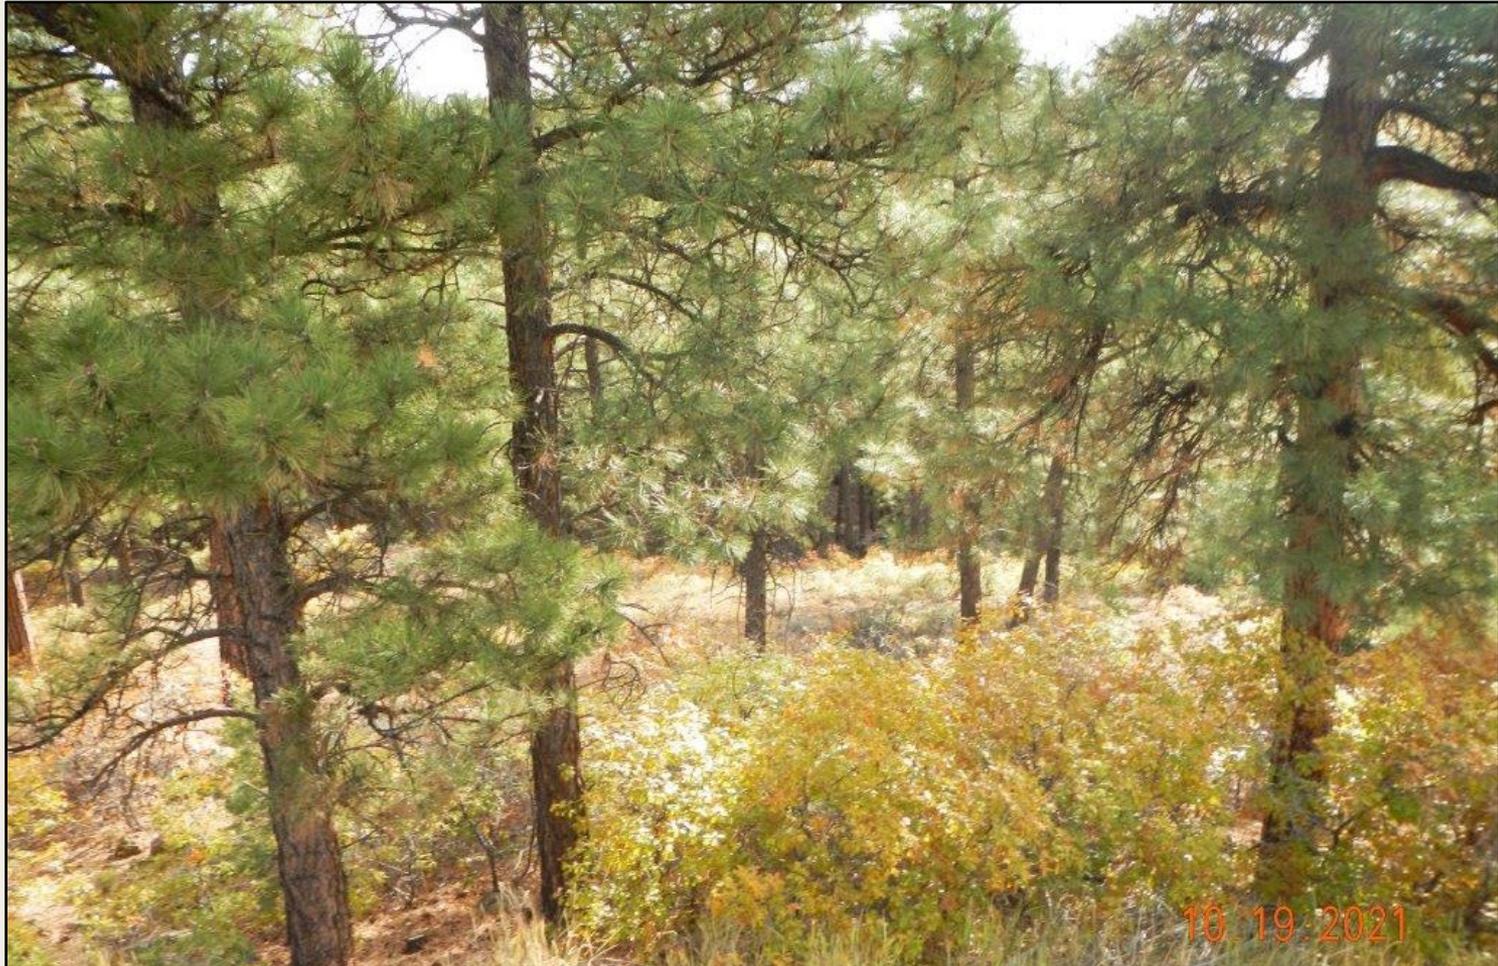
Photo 5. View of the reference area comprised of ponderosa pine forest with understory of gambel oak, serviceberry, Oregon grape, western wheatgrass, and muttongrass.
