Inspection Photos
Operator: Hilcorp Energy
API: 067-07683
Date: 10/19/2021

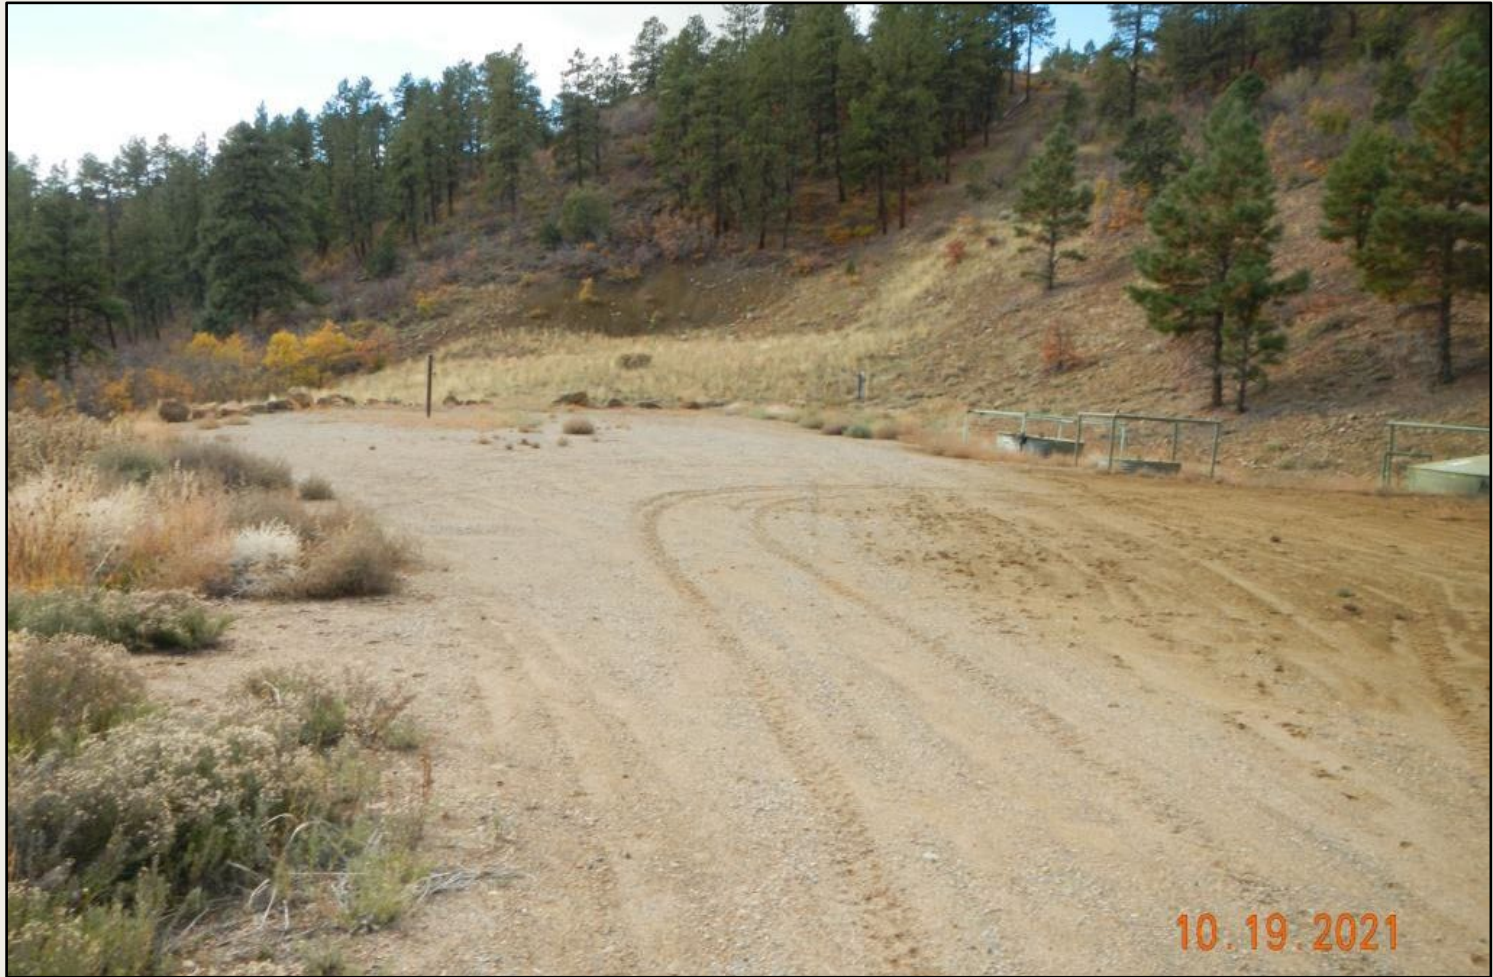
Photo 1. View of unreclaimed well pad from the well pad entrance facing center.

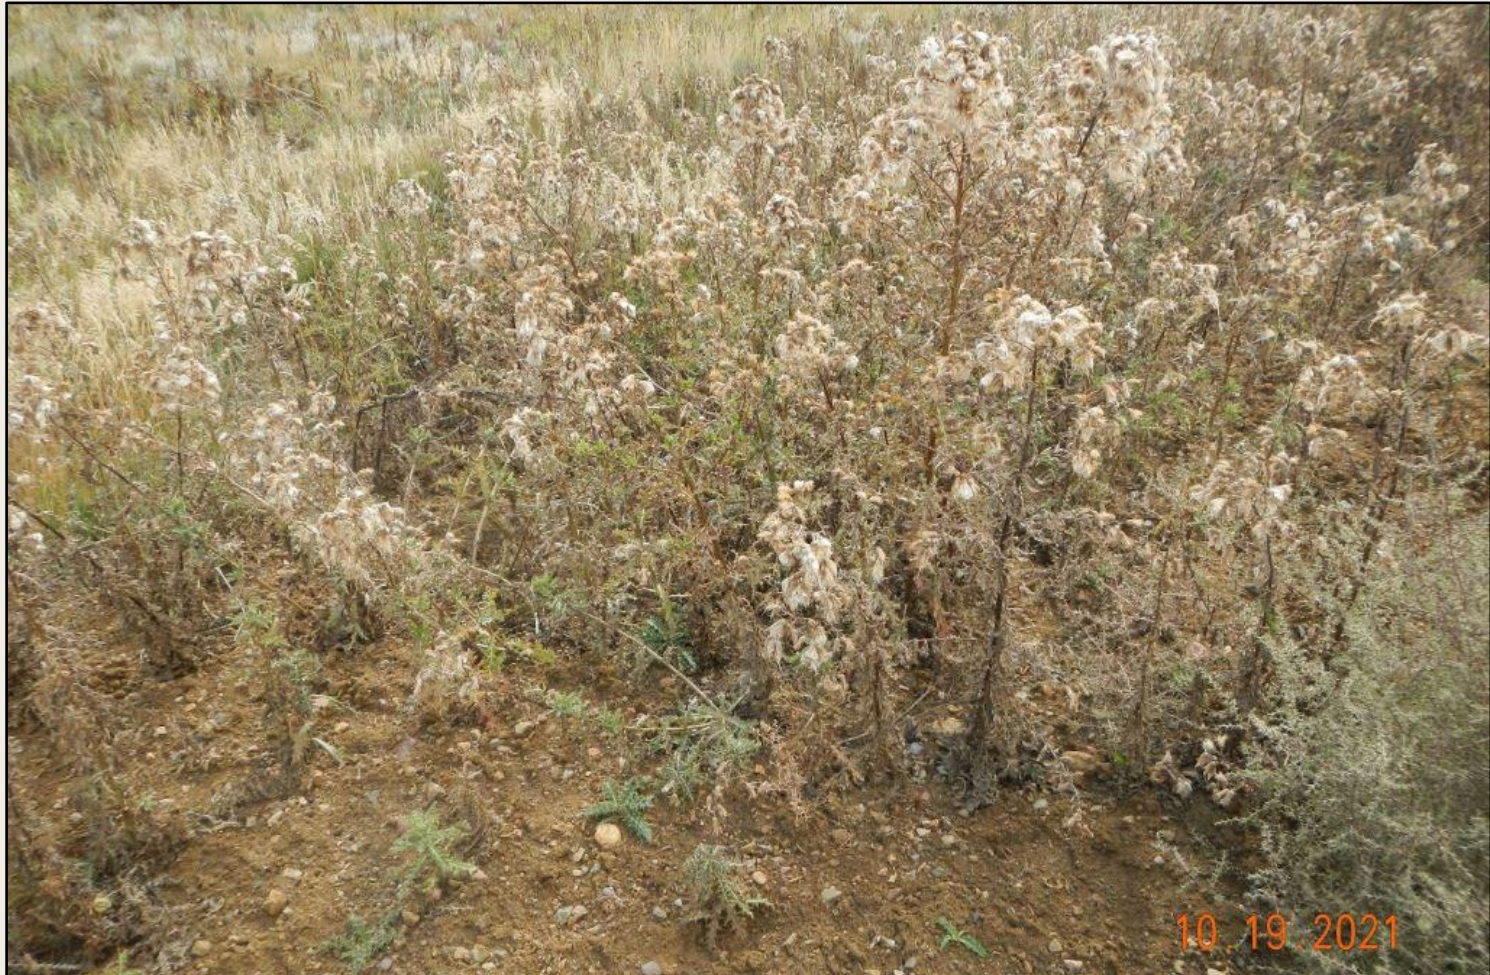
Photo 2. View of dense Canada thistles within the eastern project area. Approximately 2000 individuals observed.

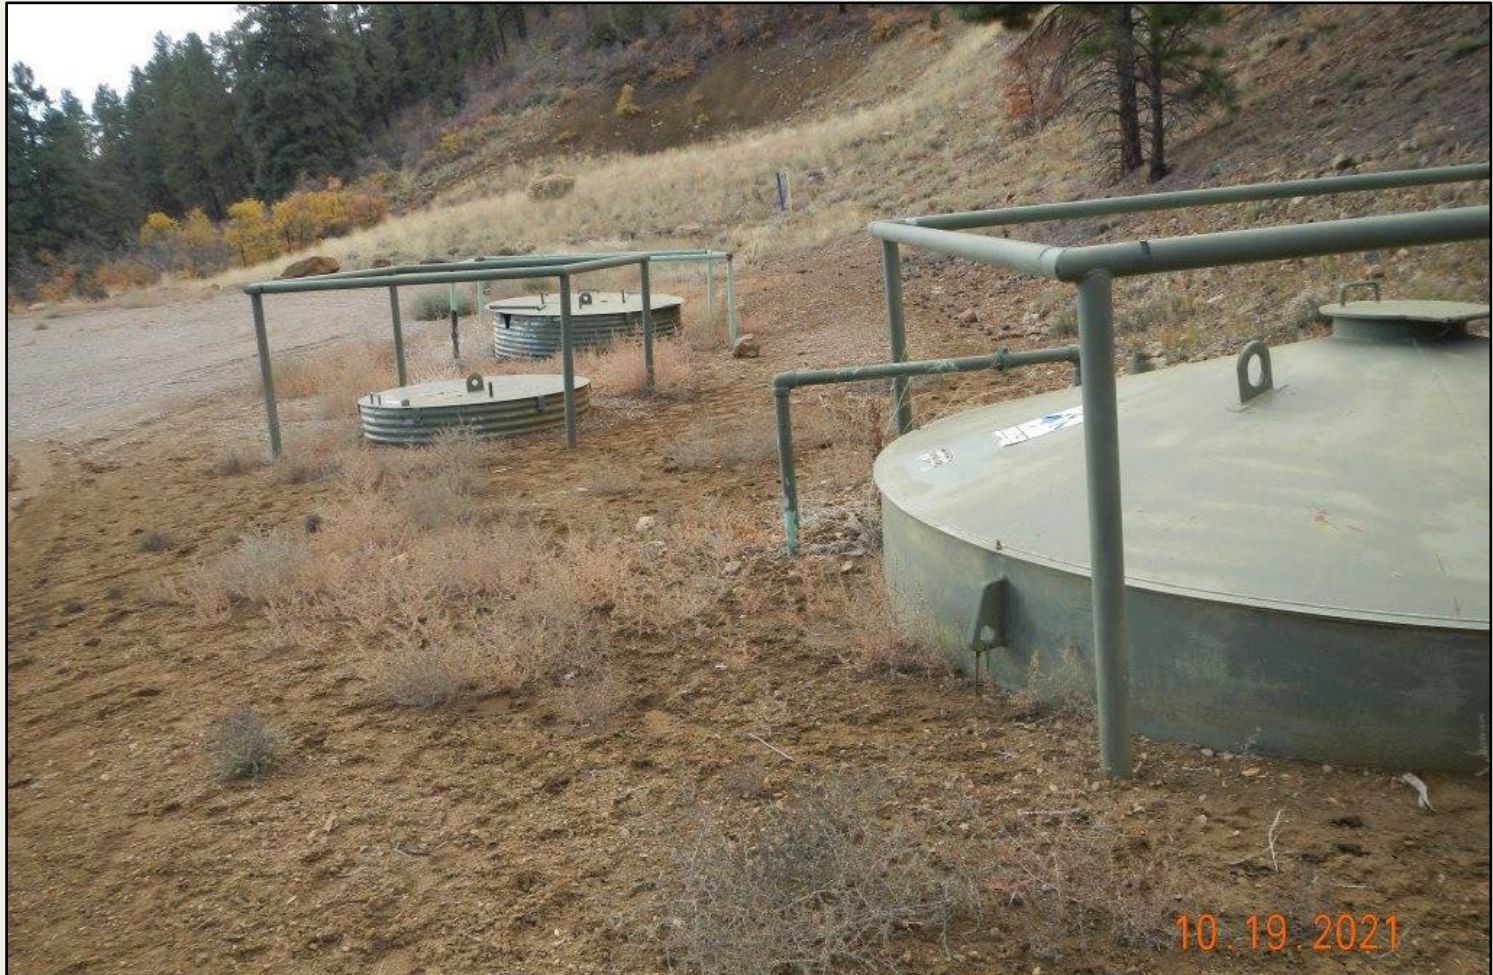
Photo 3. View of project equipment that remains on the well pad.

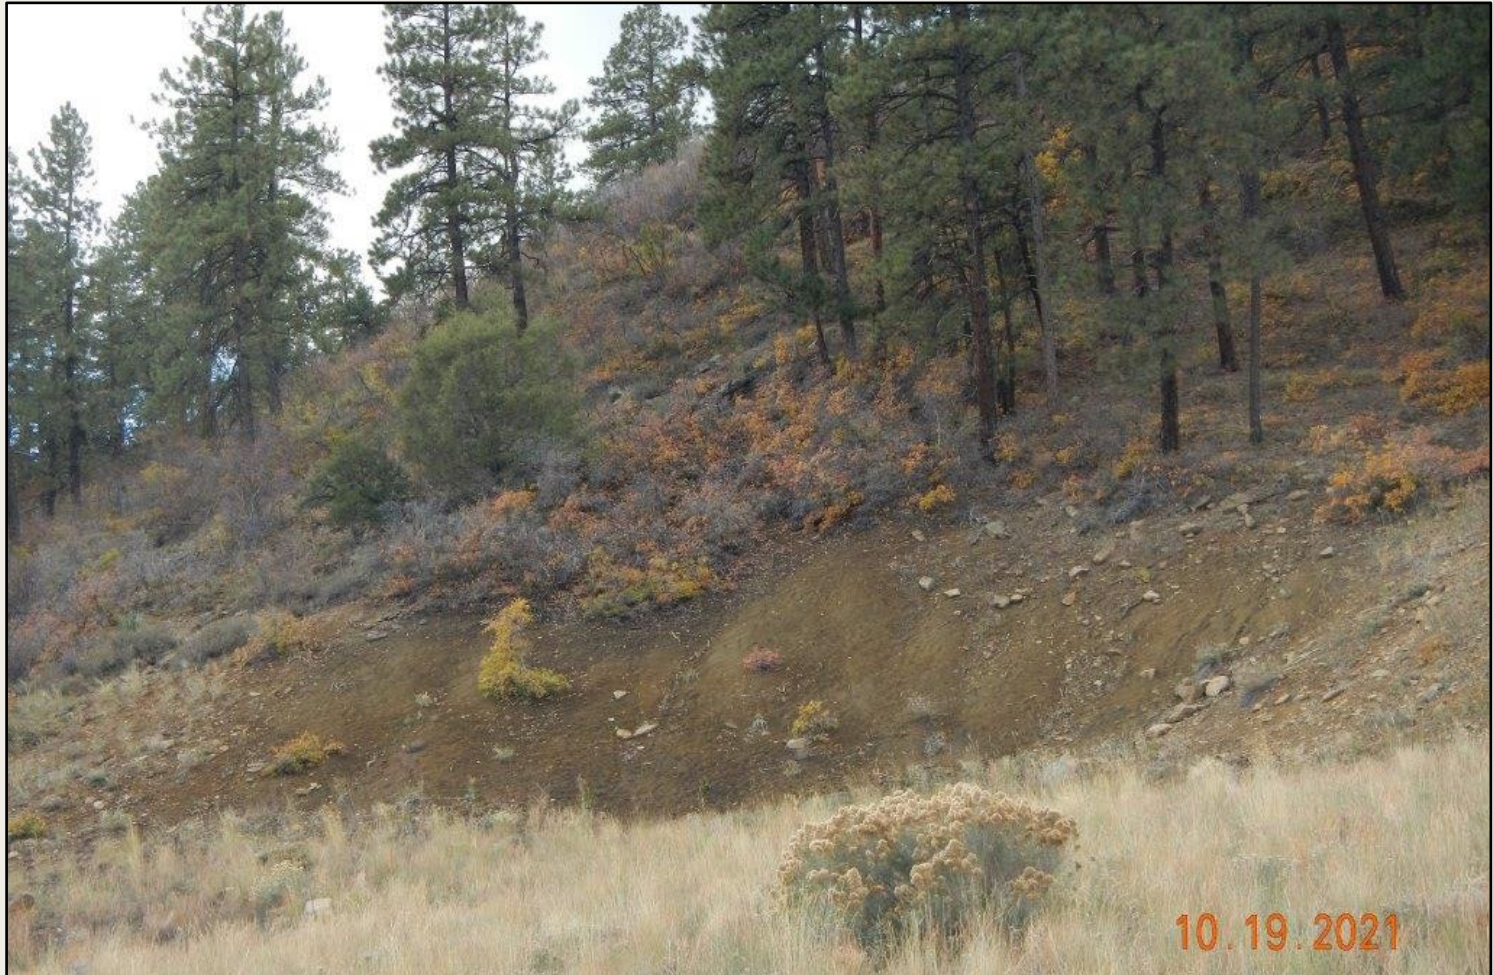
Photo 4. View of bare soils on the southern cut-slope, project area needs recontouring and stabilization.

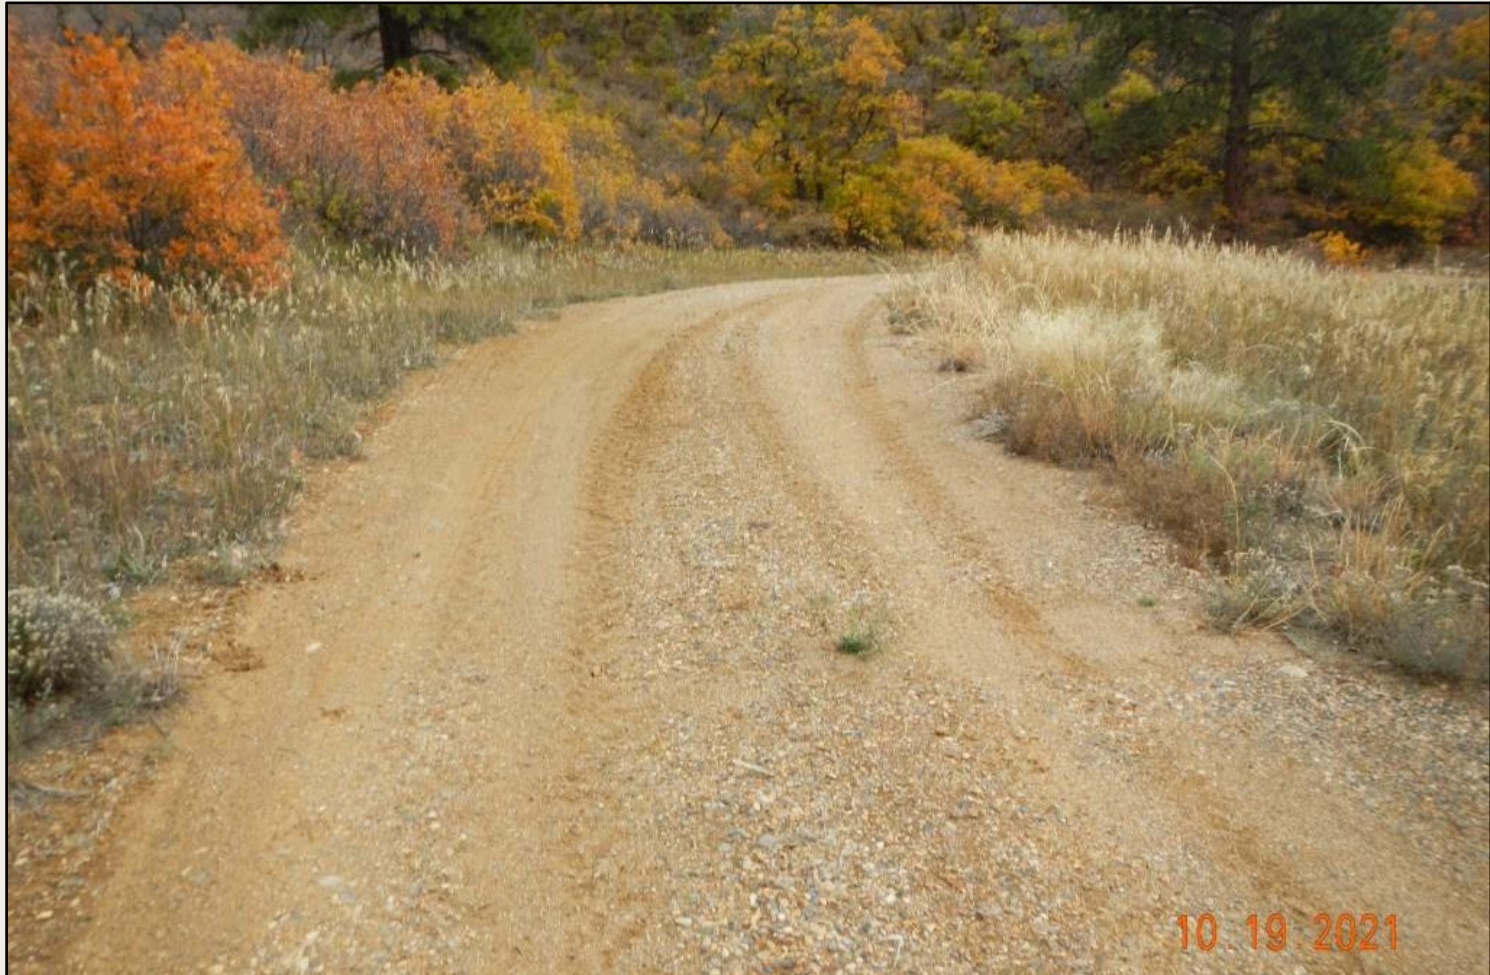
Photo 5. View of access road that remains in place.

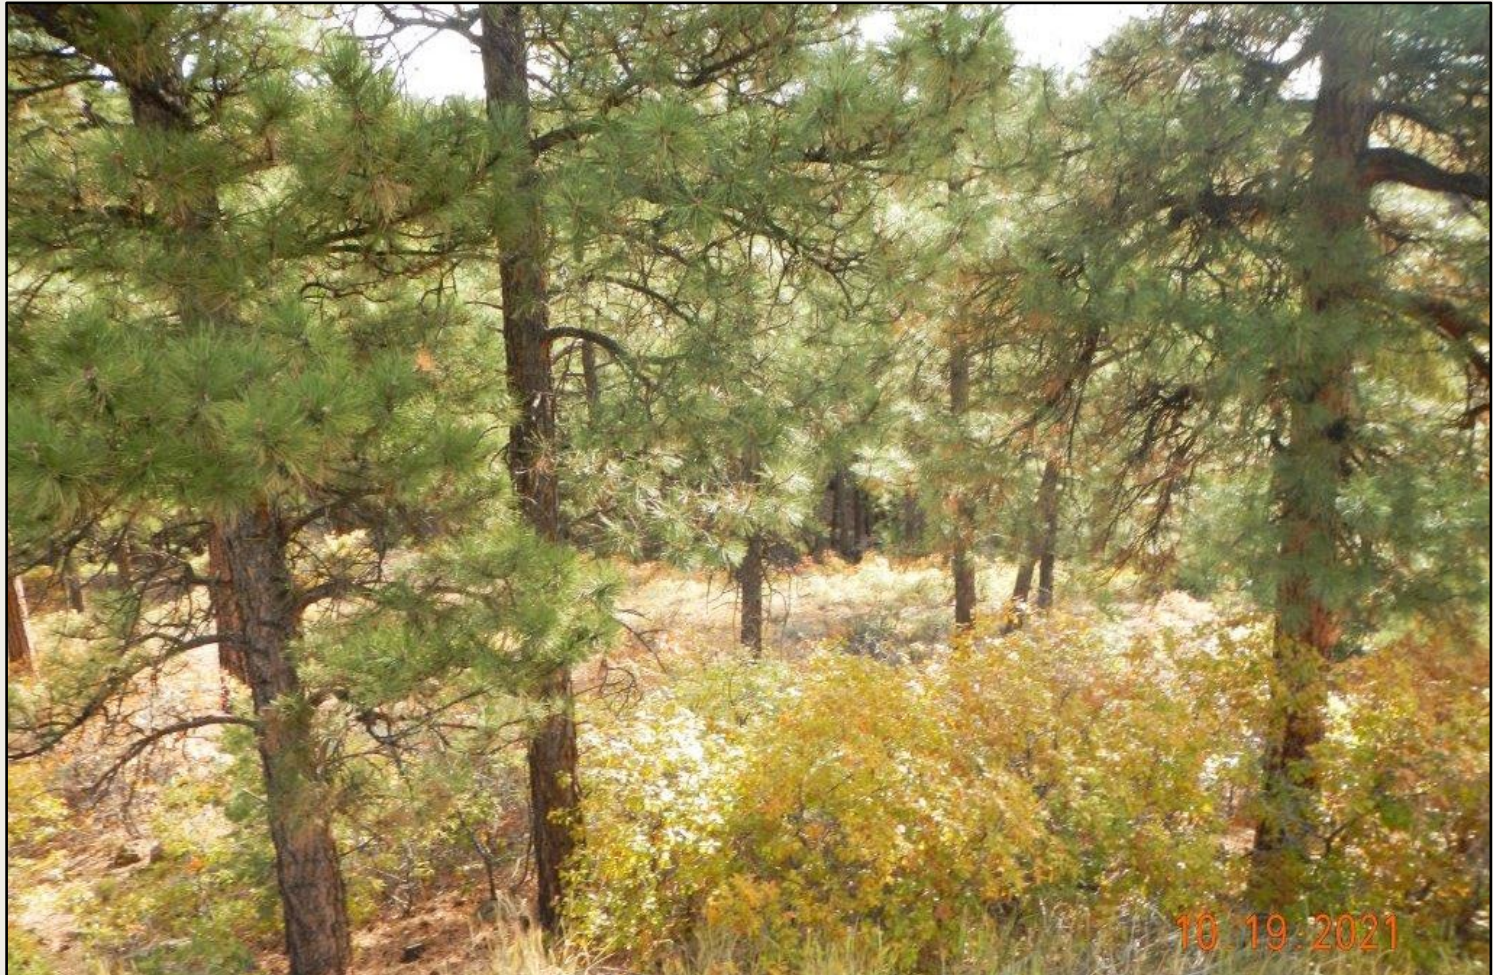
Photo 6. View of the reference area comprised of ponderosa pine forest with understory of gambel oak, serviceberry, Oregon grape, western wheatgrass, and muttongrass.
