Inspection Photos

Operator: Hilcorp Energy
API: 067-07645
Date: 10/19/2021

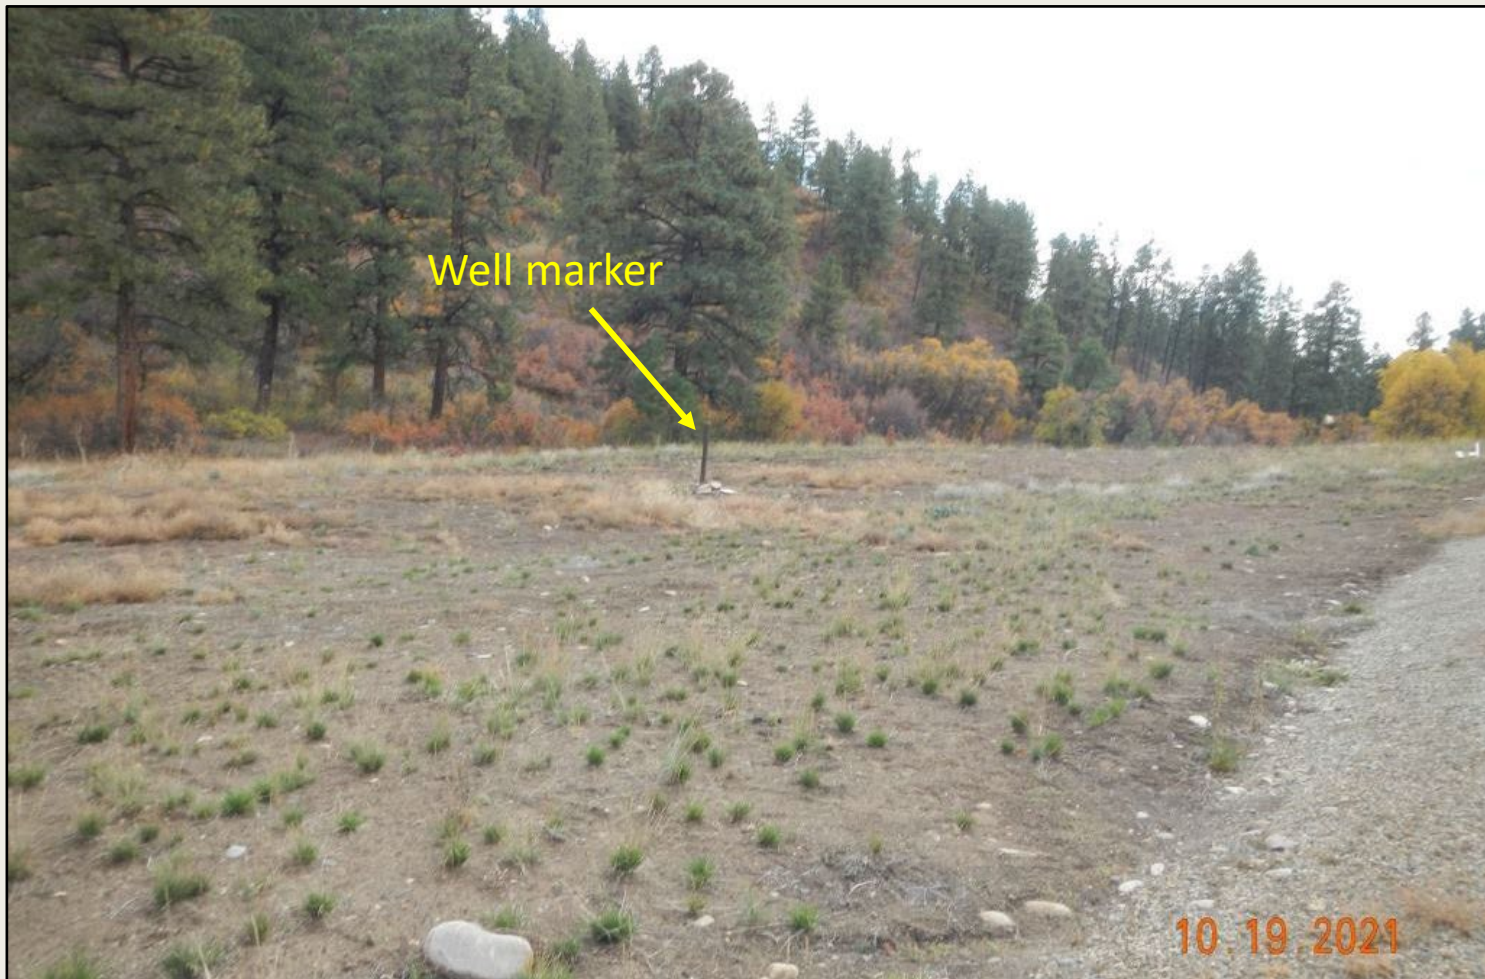
Photo 1. View of the project area from the northern portion of the bisecting road, facing center. Well marker present in the center of photo.

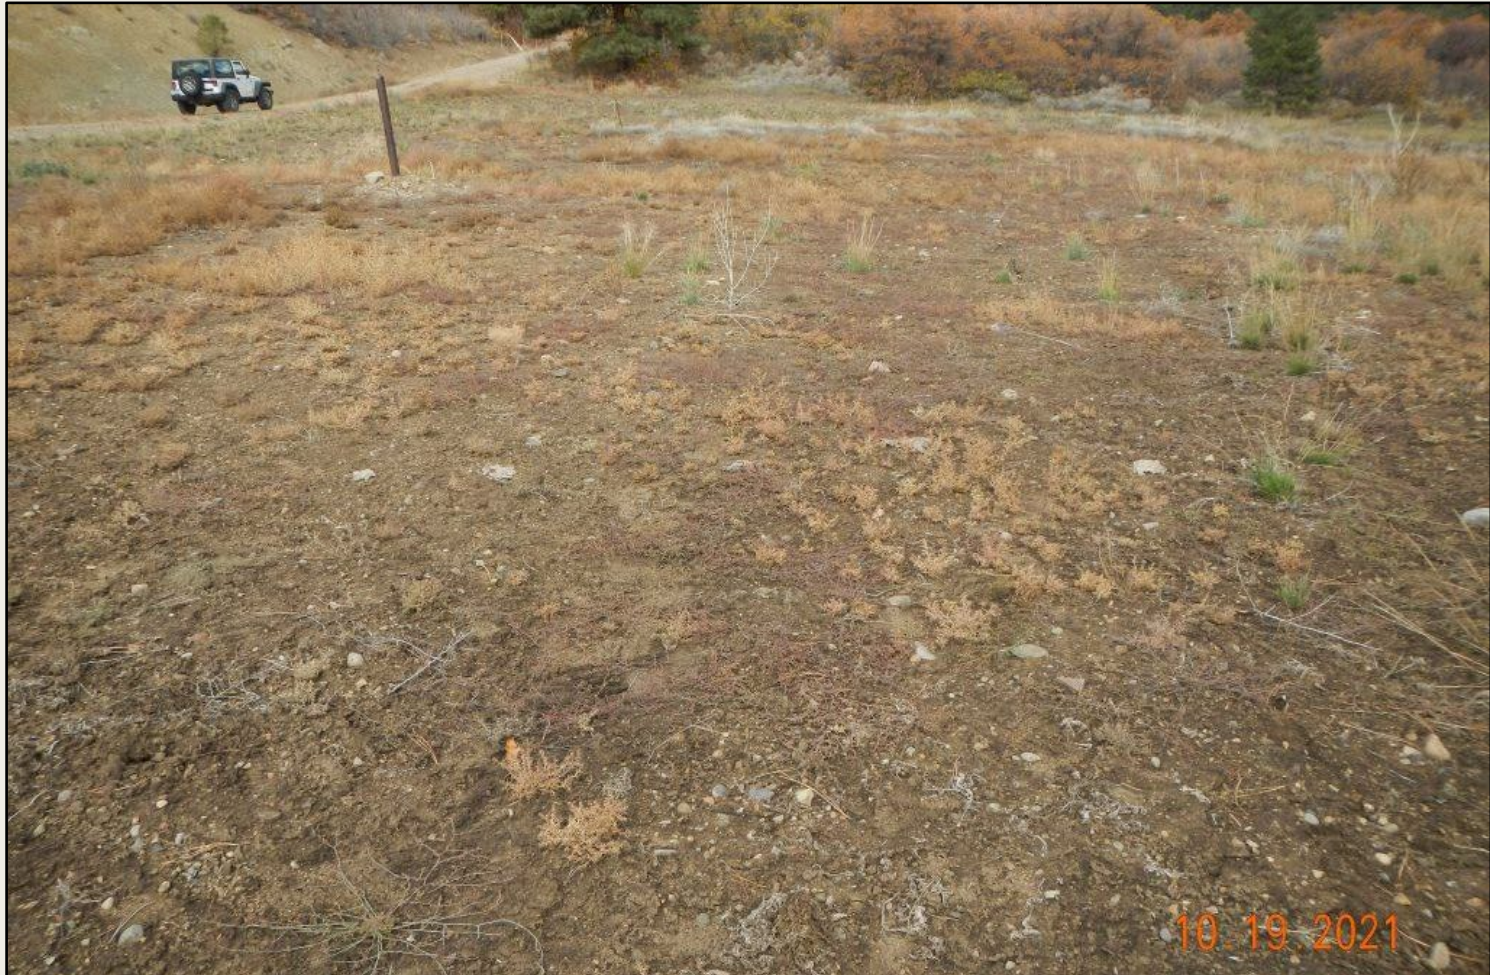
Photo 2. View of View of the eastern project area facing northward. Little desirable vegetation present. Vegetation is largely comprised of weeds such as Russian thistle and knotweed.

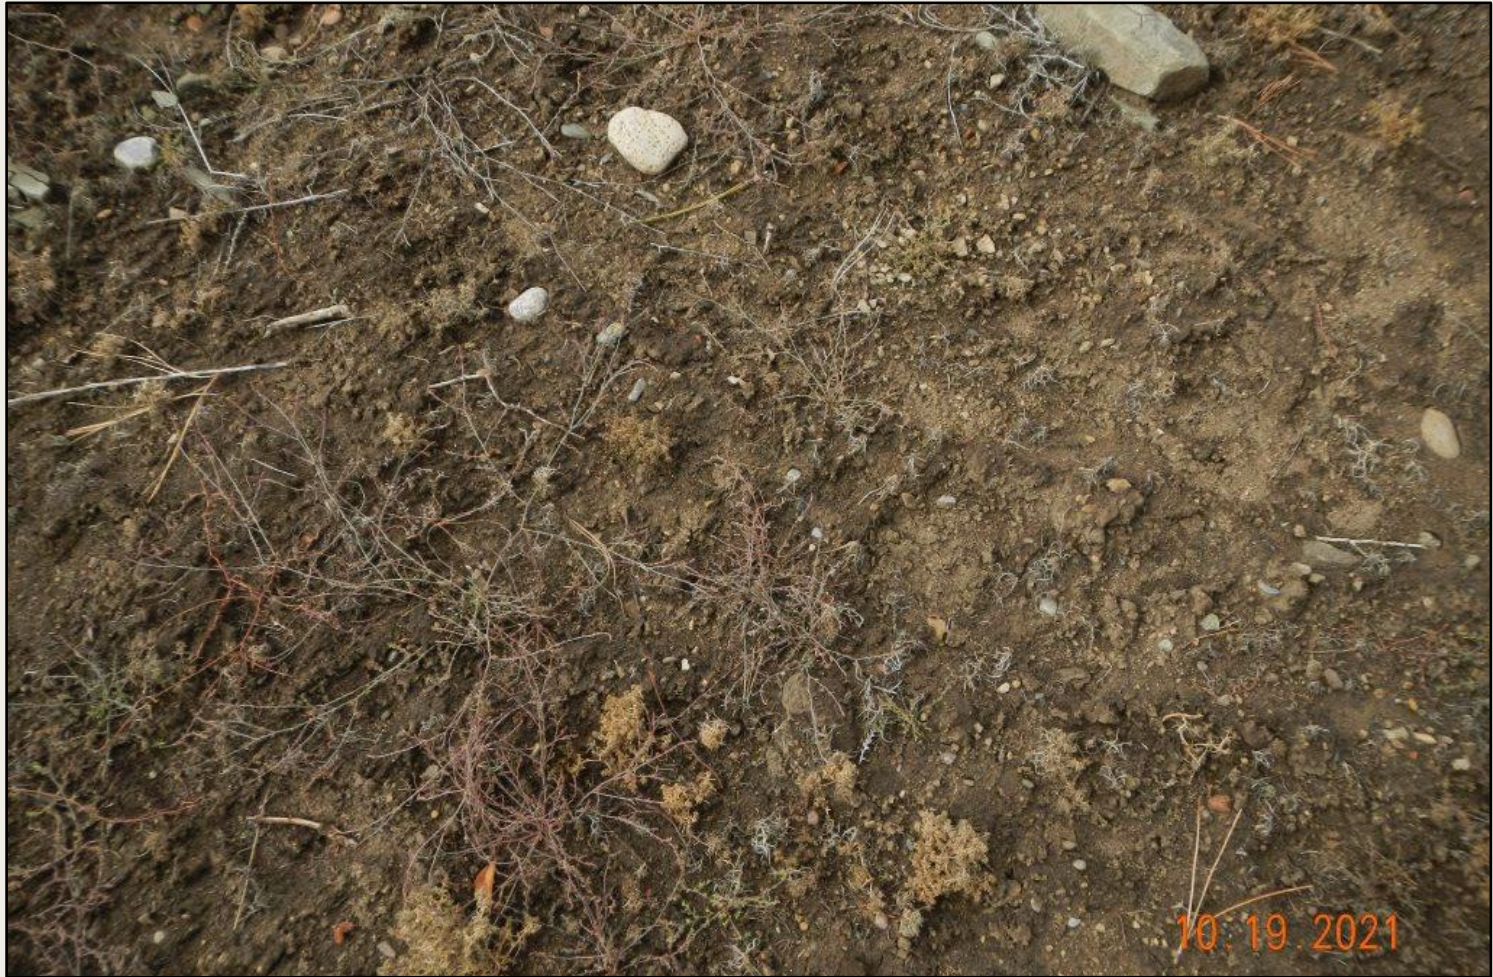
Photo 3. Birdseye view of typical revegetation within the project area.

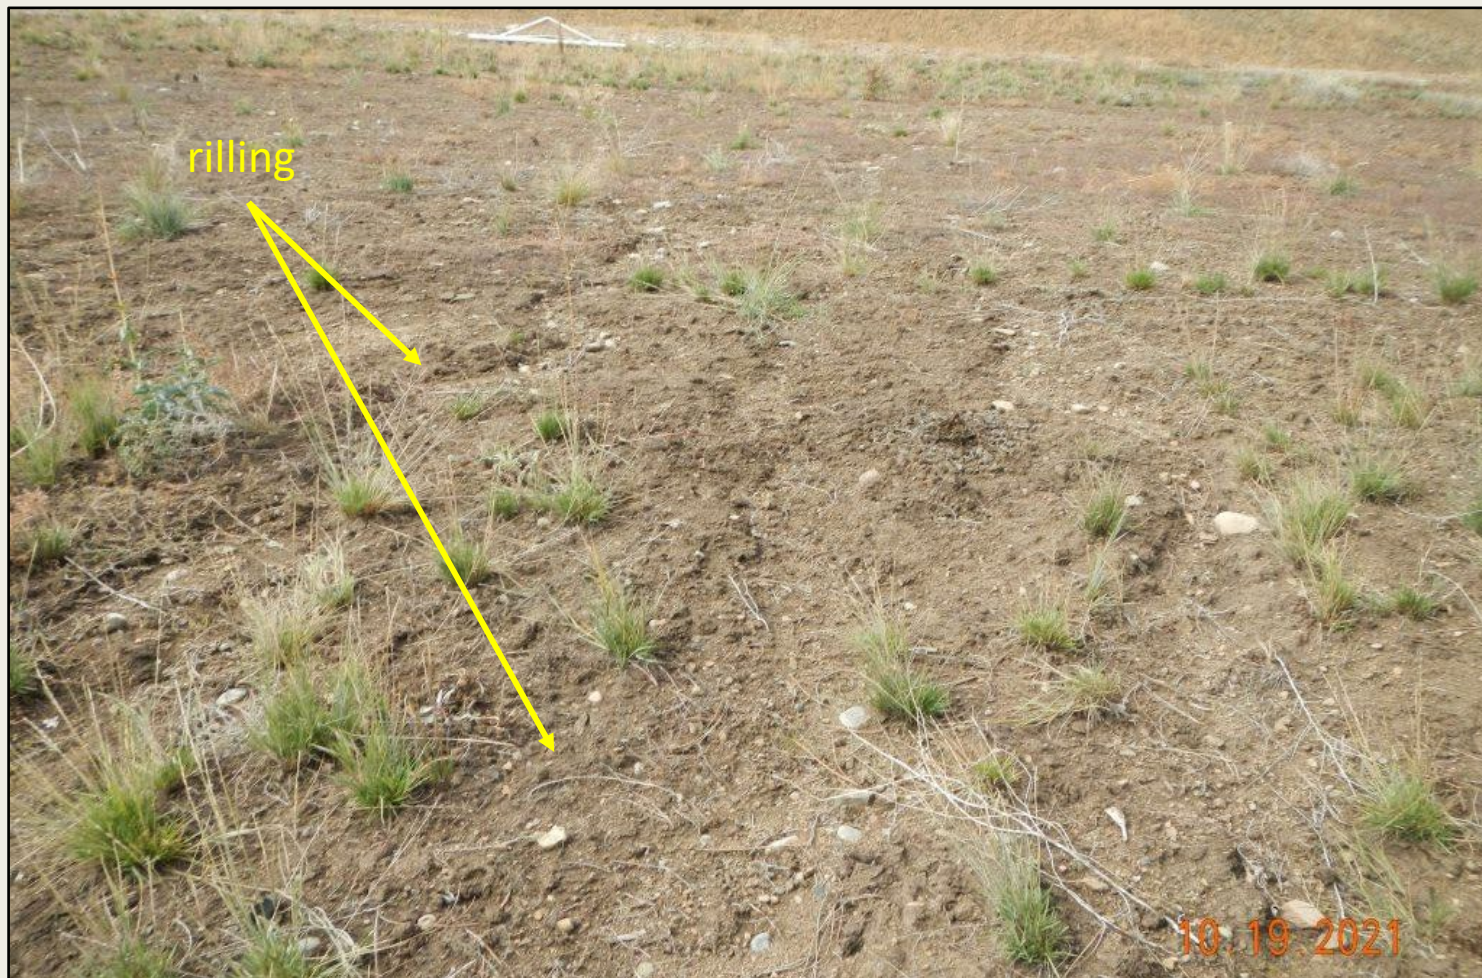
Photo 4. View of area in the southeastern well pad area where sparse grasses are becoming established. Rilling is occurring on bare soils that are not stabilized.

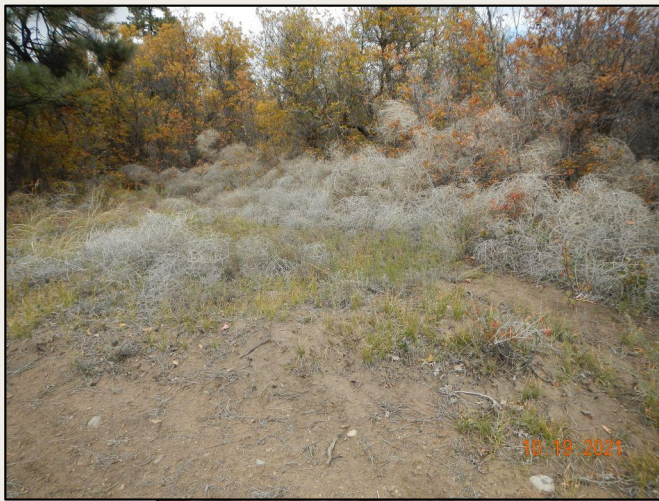
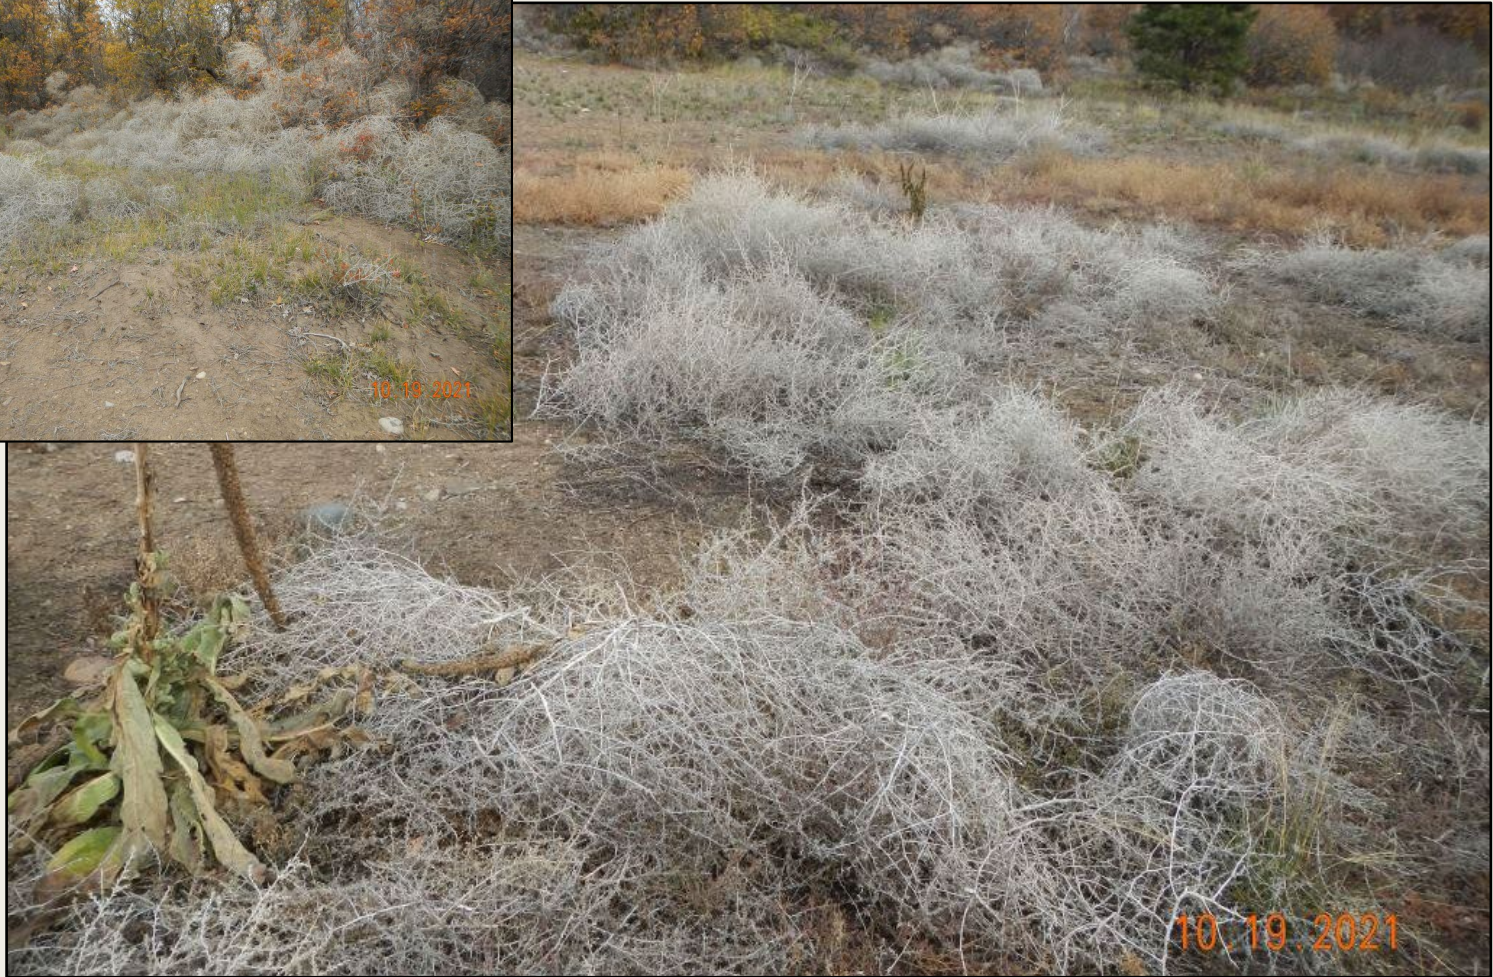
Photo 5. View of Russian thistle debris observed on the well pad and along the northern boundary of the well pad (inset). Needs to be removed.

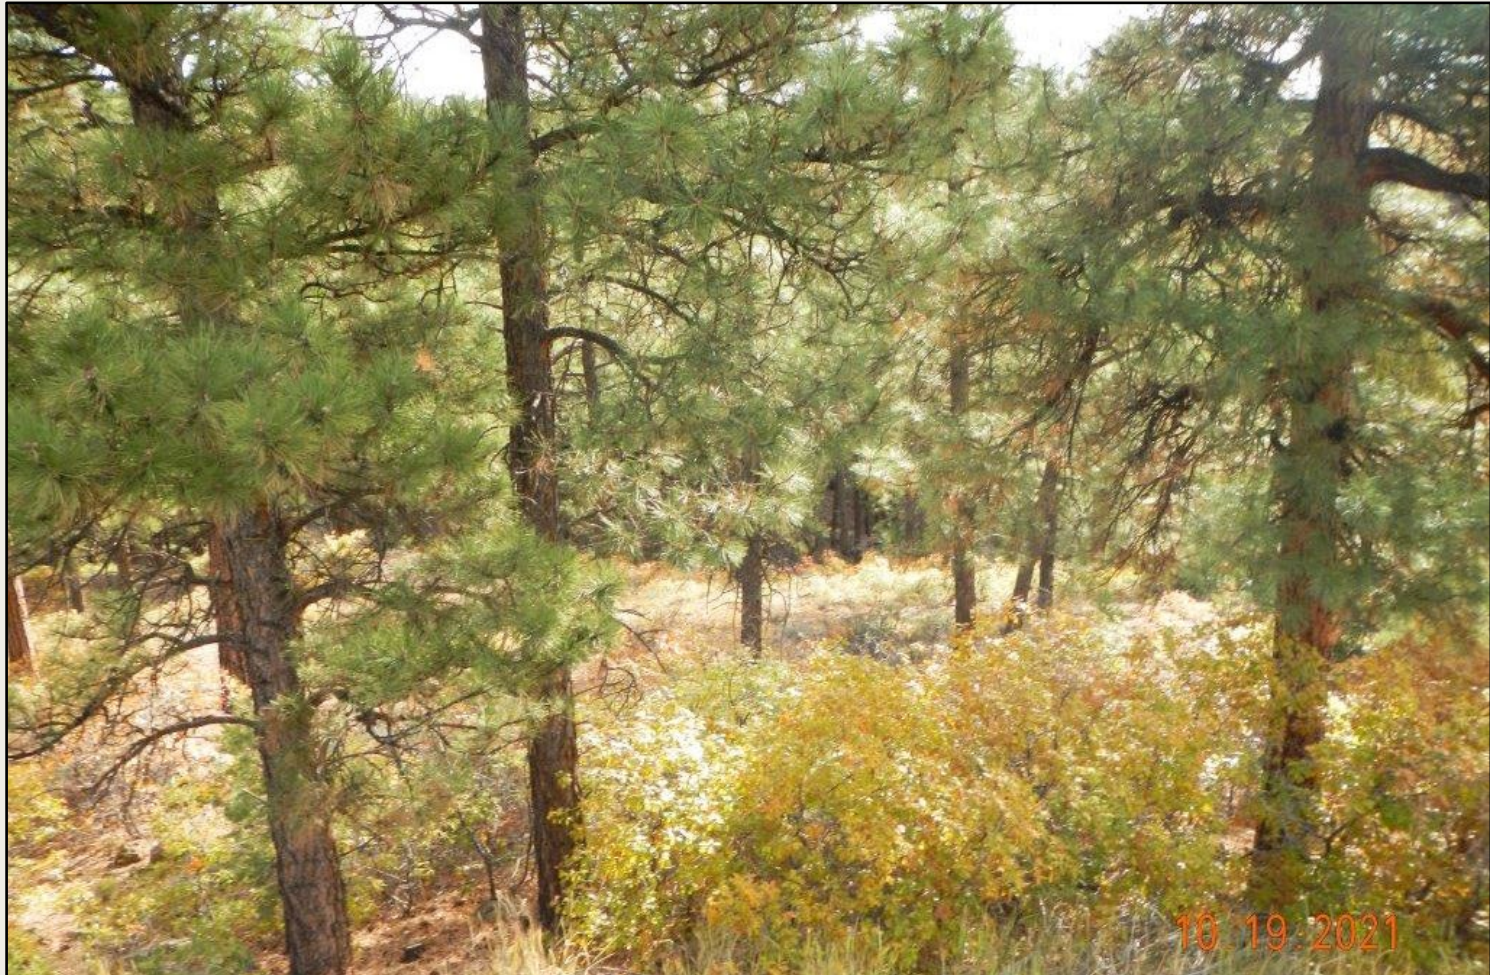
Photo 6. View of the reference area comprised of ponderosa pine forest with understory of gambel oak, serviceberry, Oregon grape, western wheatgrass, and muttongrass.
