**Inspection Photos**  
**Location Name: UPRR 42 Pan AM I #5**  
**Location ID: 318212**

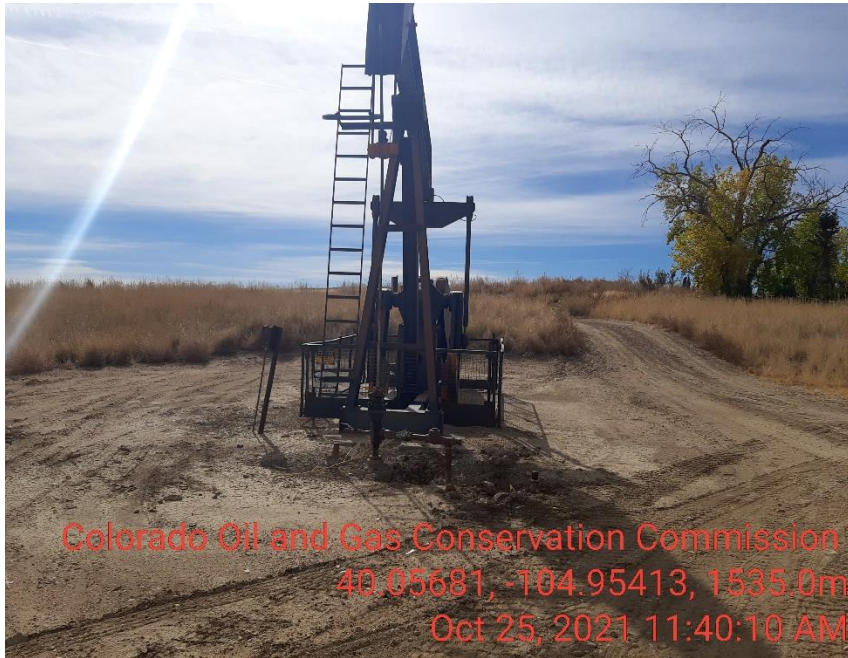
**Photo 1 Well head.**

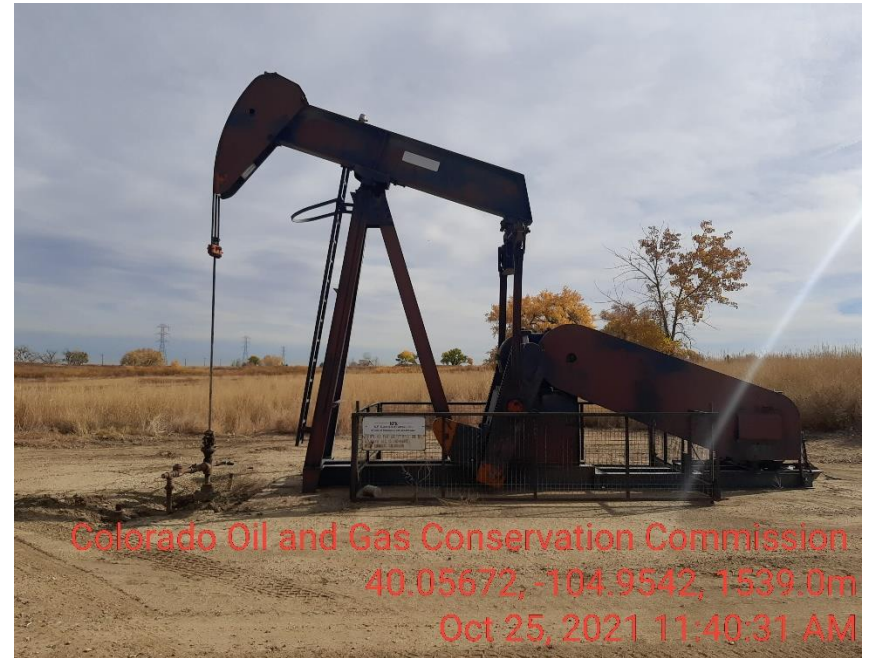
**Photo 2 Well head**

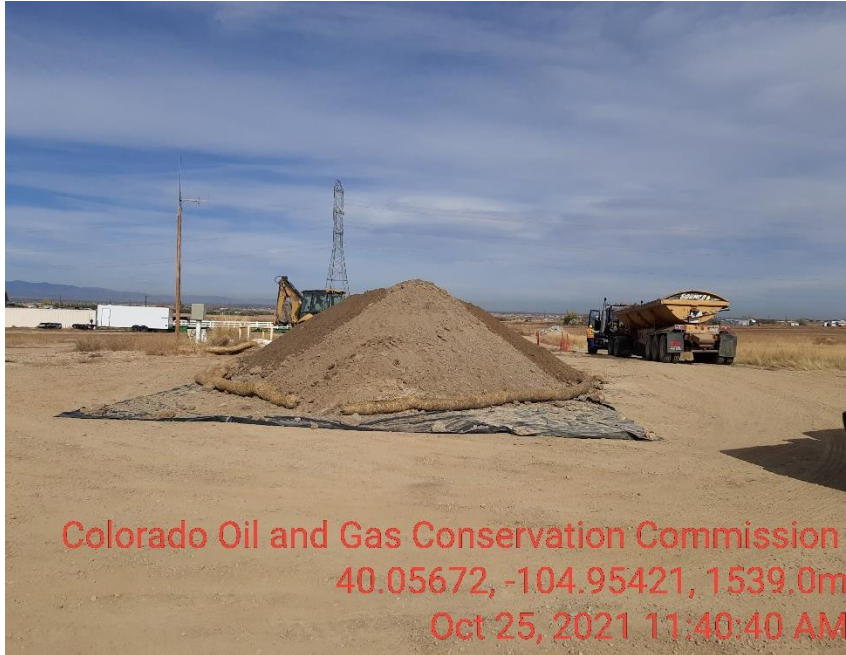
**Photo 3 Straw waddles not properly installed.**

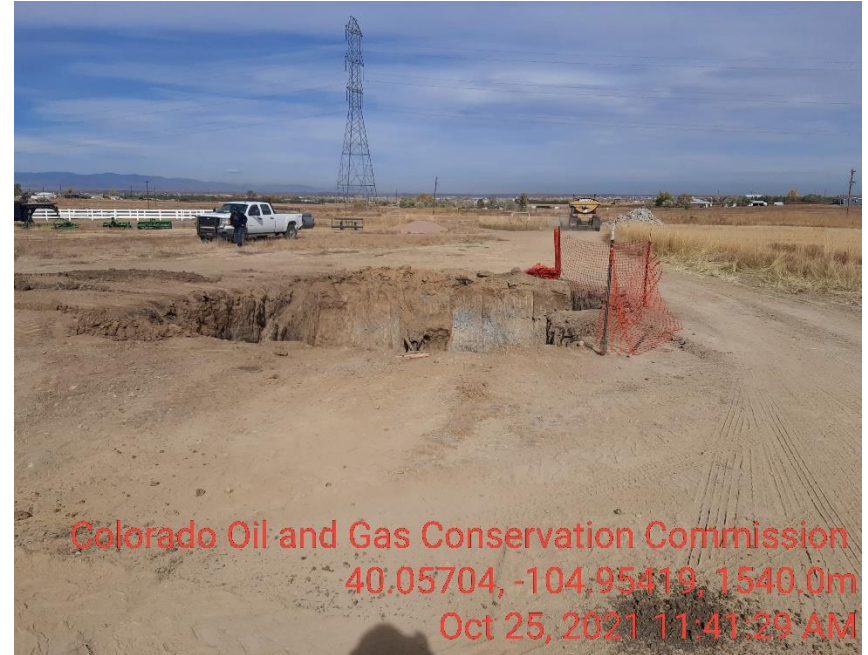
**Photo 4 no excavation BMP's. No Disturbed area BMP's**

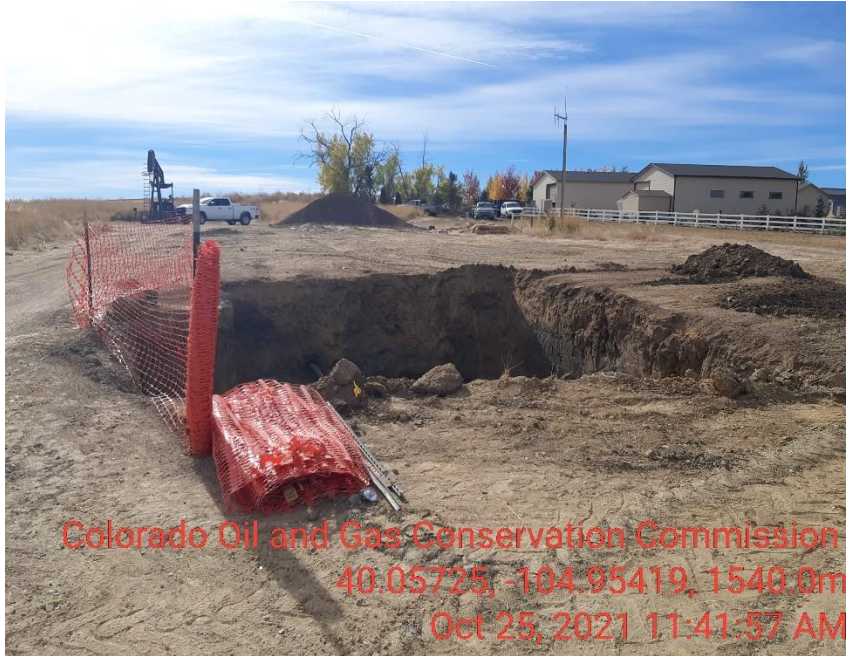
**Photo 5 No location or excavation BMP's**

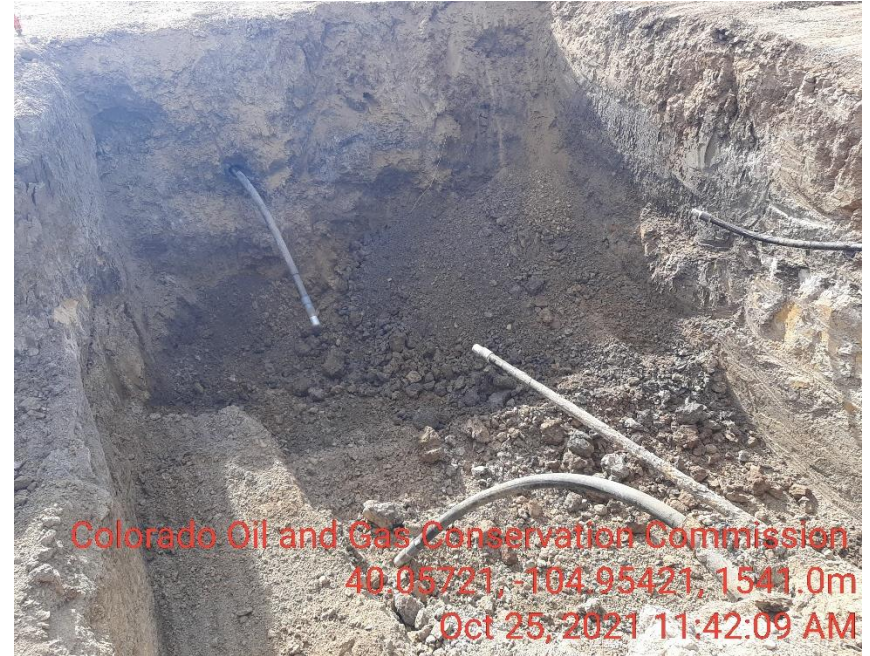
**Photo 6 open excavation**

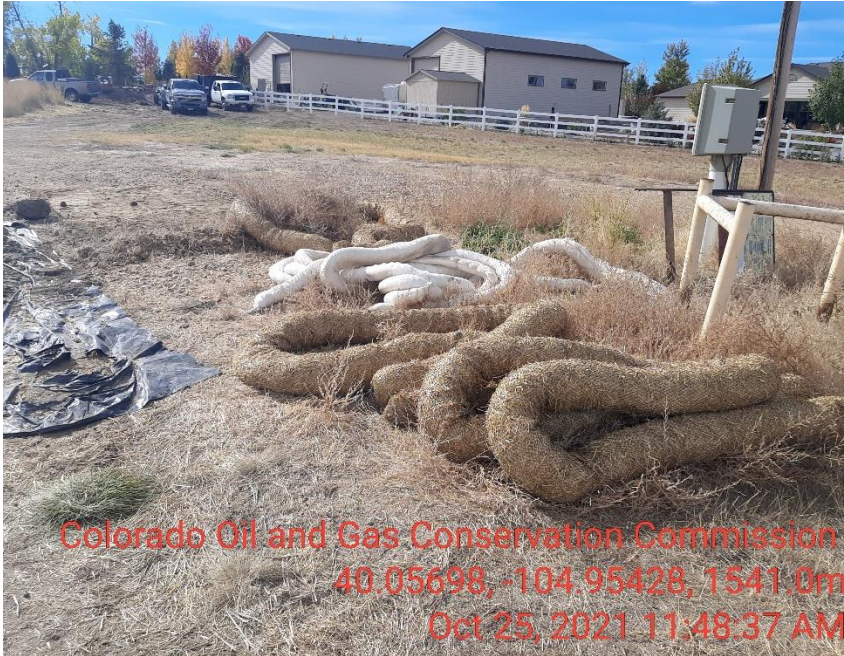
**Photo 7 Waddles removed to haul off contaminated soil not staking material on site.**
