Inspection Photos
Operator: Simcoe
API: 067-06328
Date: 10/22/2021

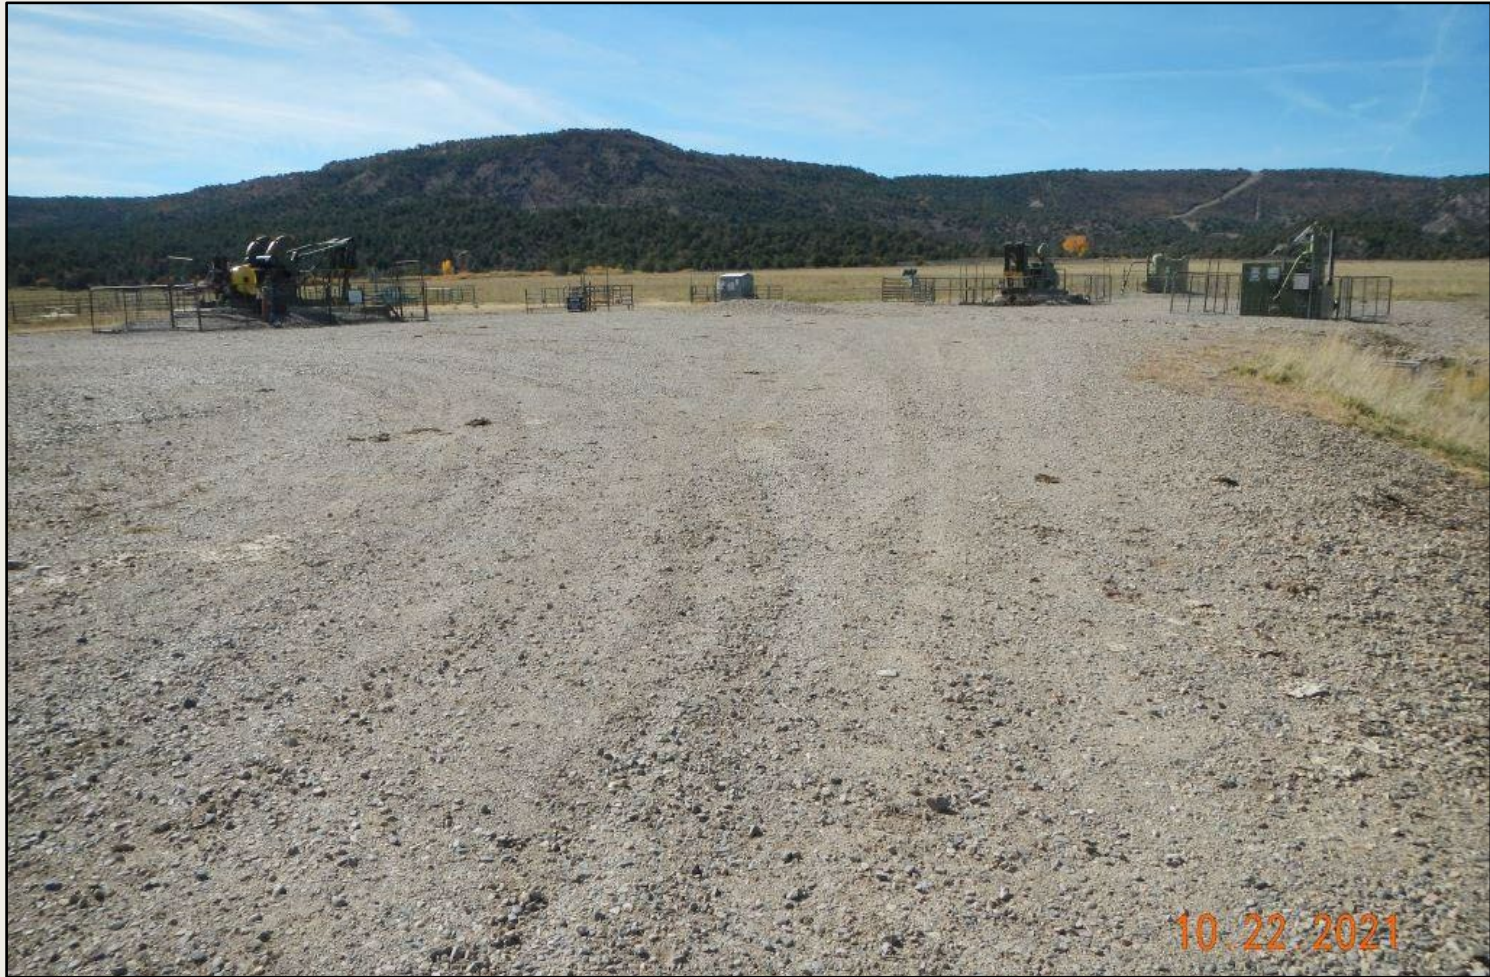
Photo 1. View of the project area from the well pad entrance facing center.

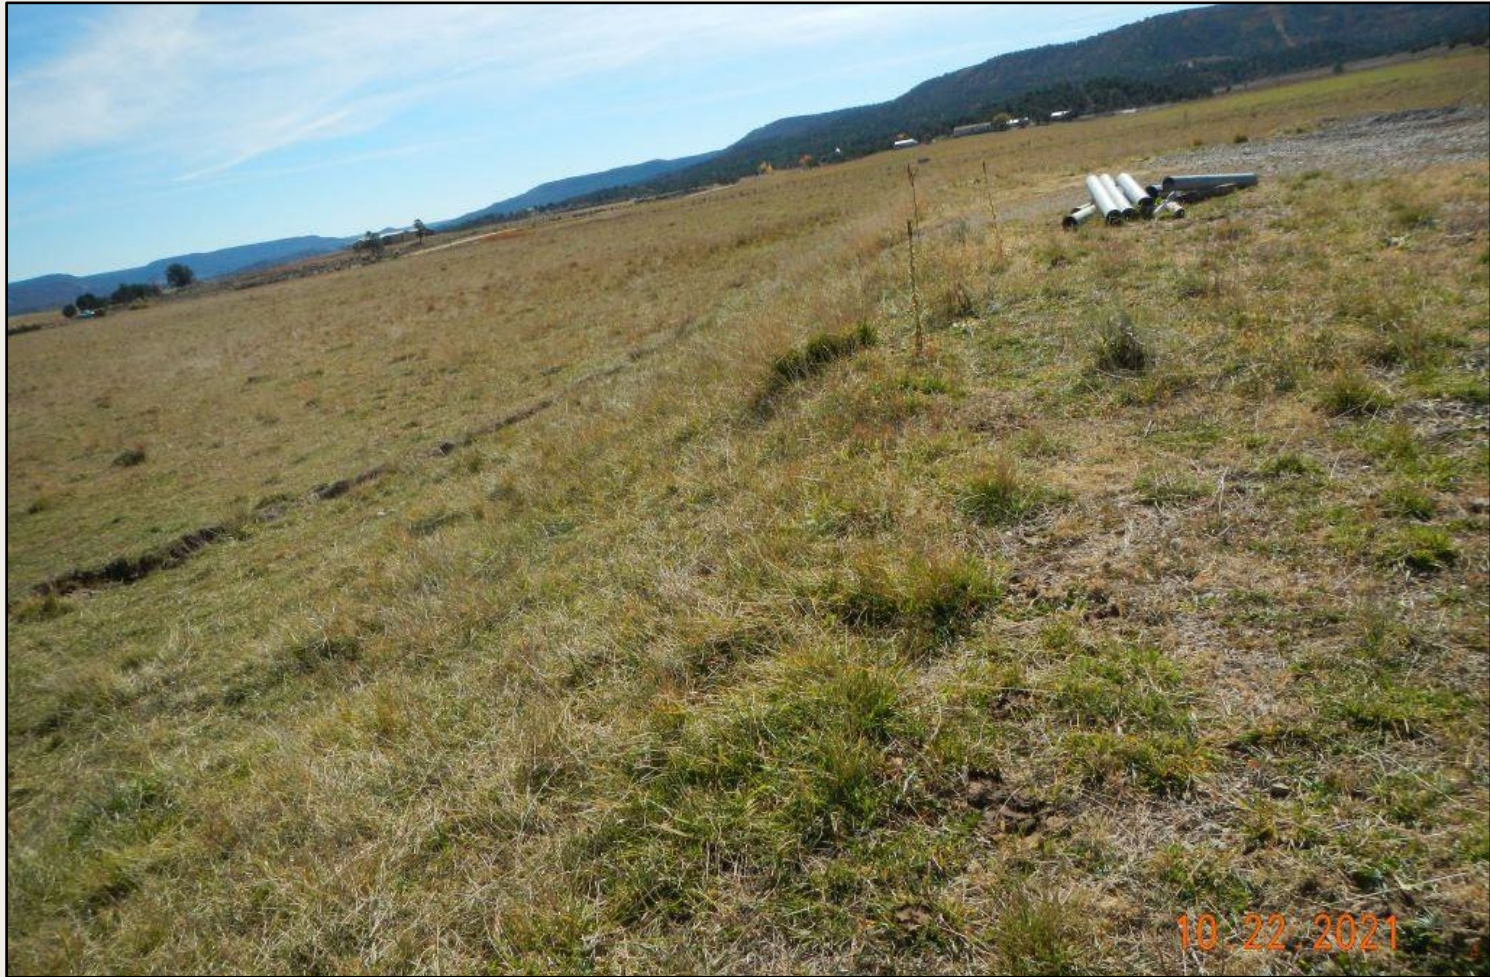
Photo 2. View of the eastern project area from the northeastern corner facing southward. Revegetation is progressing with a mixture of wheatgrasses and irrigated grasses such as orchard grass.

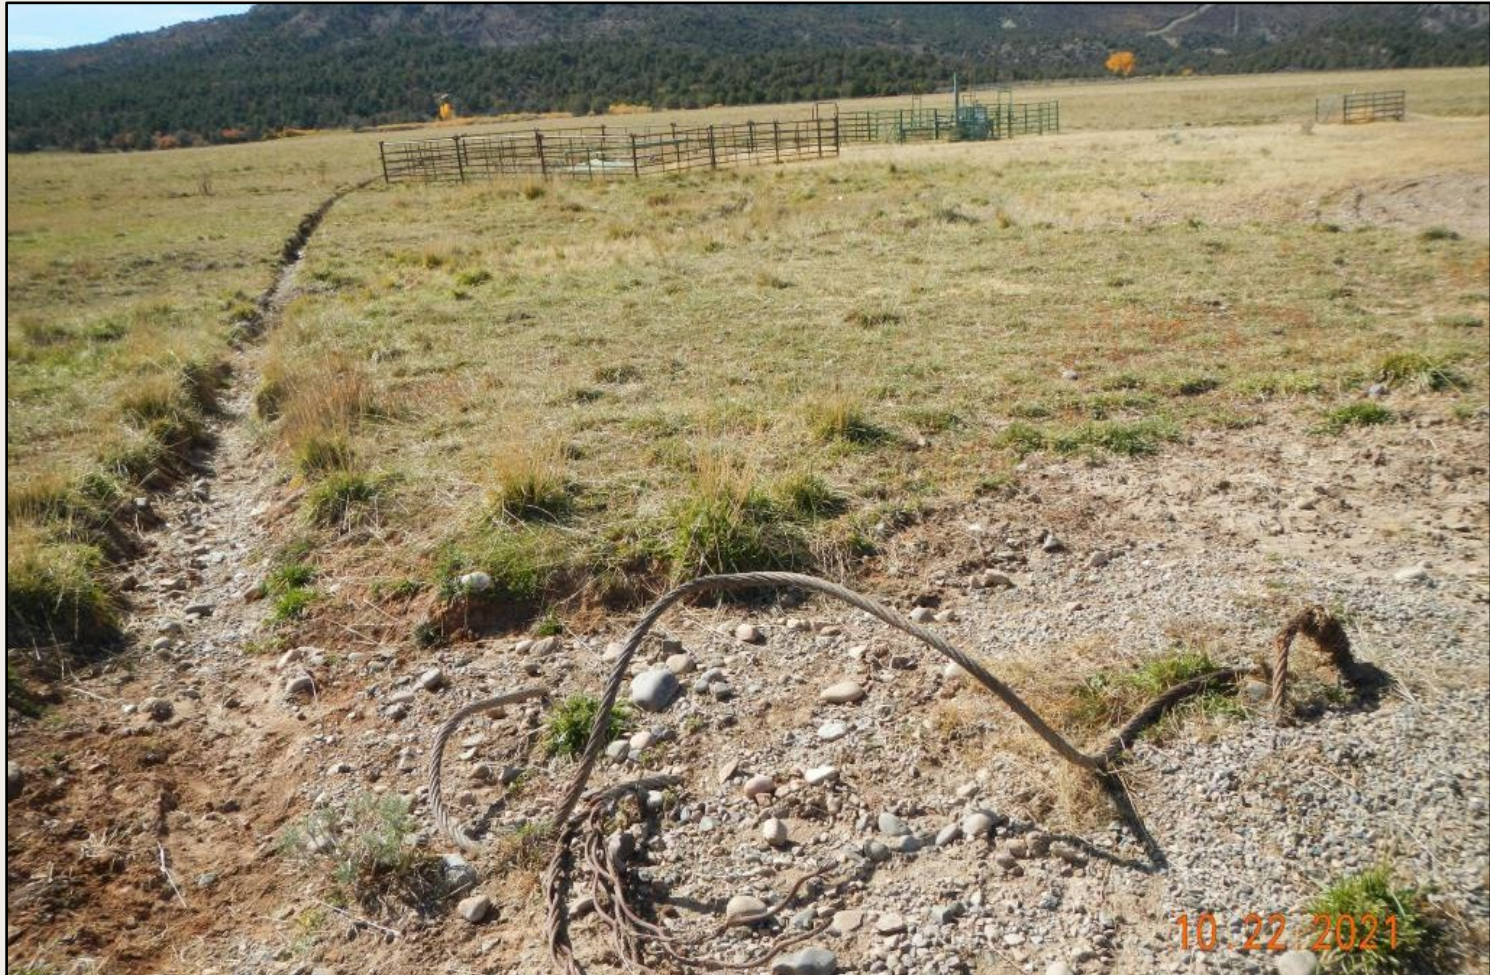
Photo 3. View of cable debris in the southeastern portion of the project area, needs to be removed.

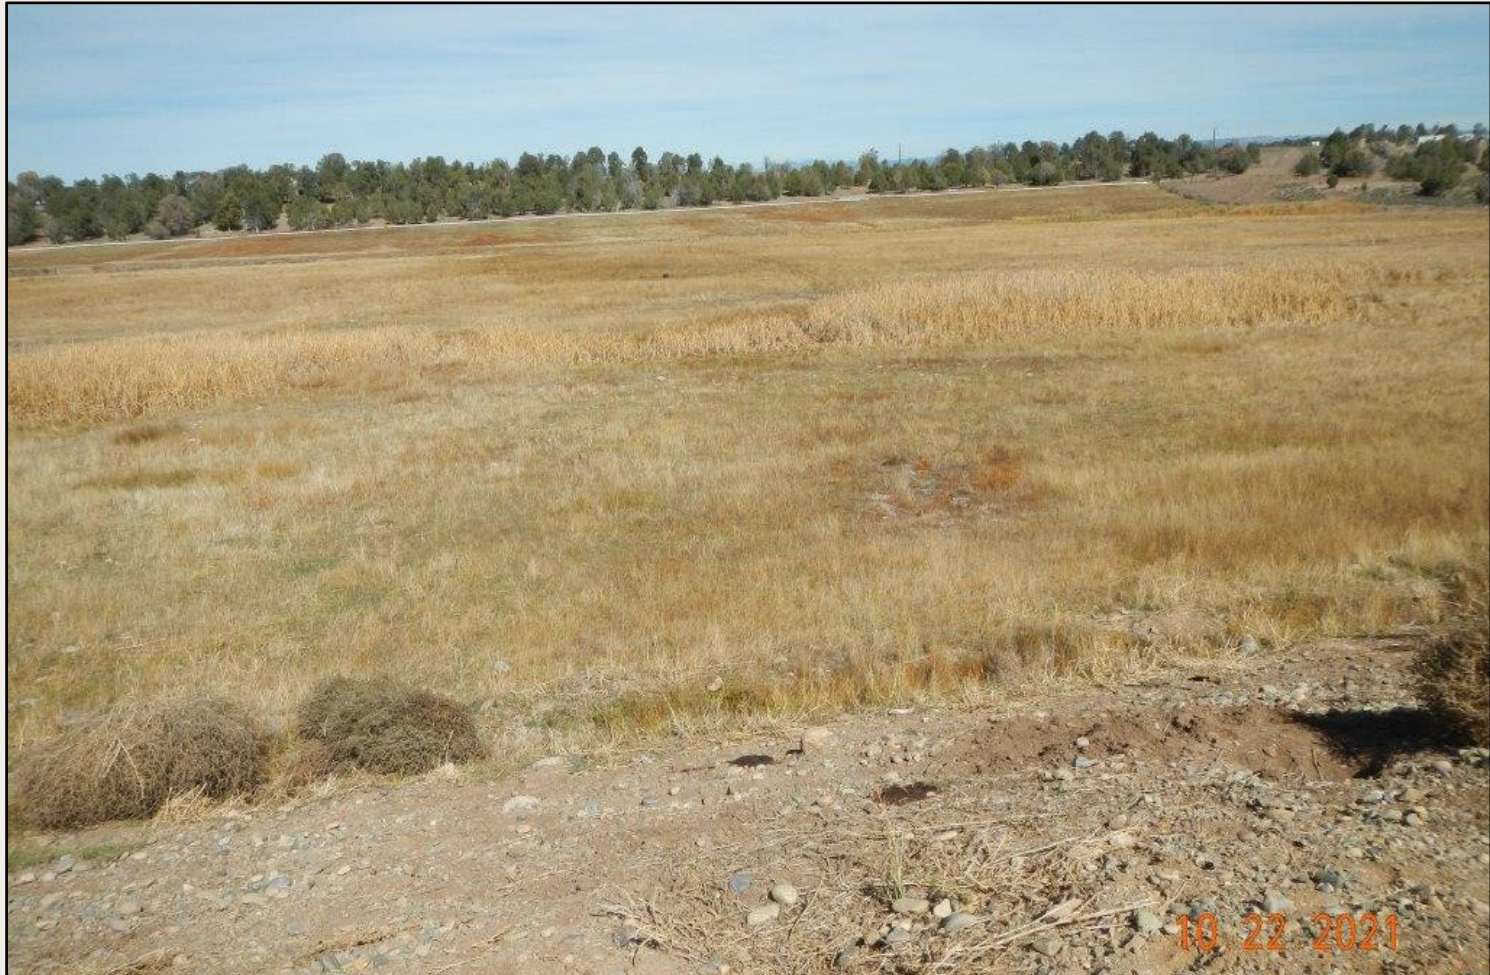
Photo 4. View of the reference area comprised of irrigated grass field with grasses such as smooth brome, orchard grass, and foxtail barley, as well as scattered wetland vegetation such as cattails and rushes.
