Inspection Photos

Location Name: CAERUS PICEANCE LLC ST. PARACHUTE TBI-67S96W /36NESW

Location ID: 334084

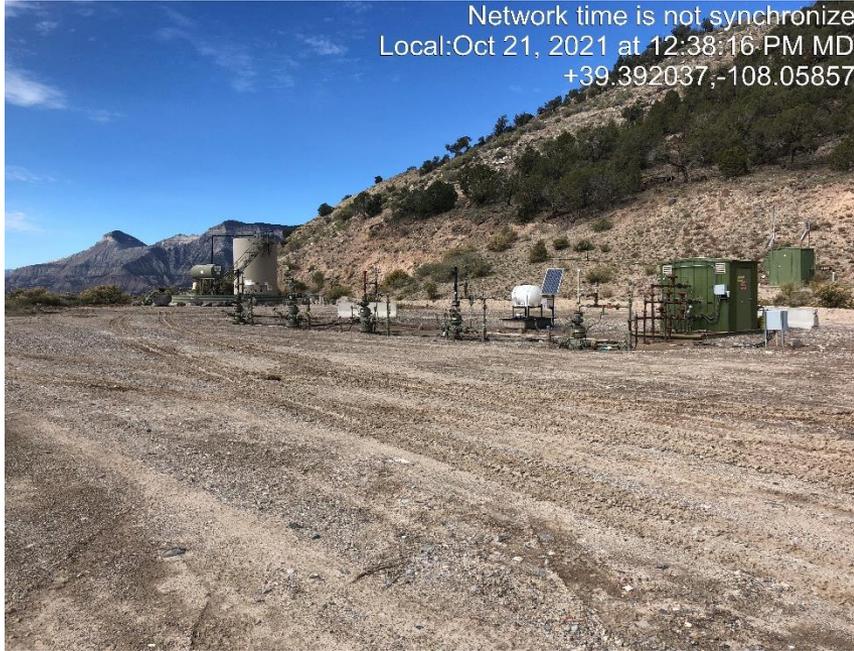
Photo #5122 from entrance to location.

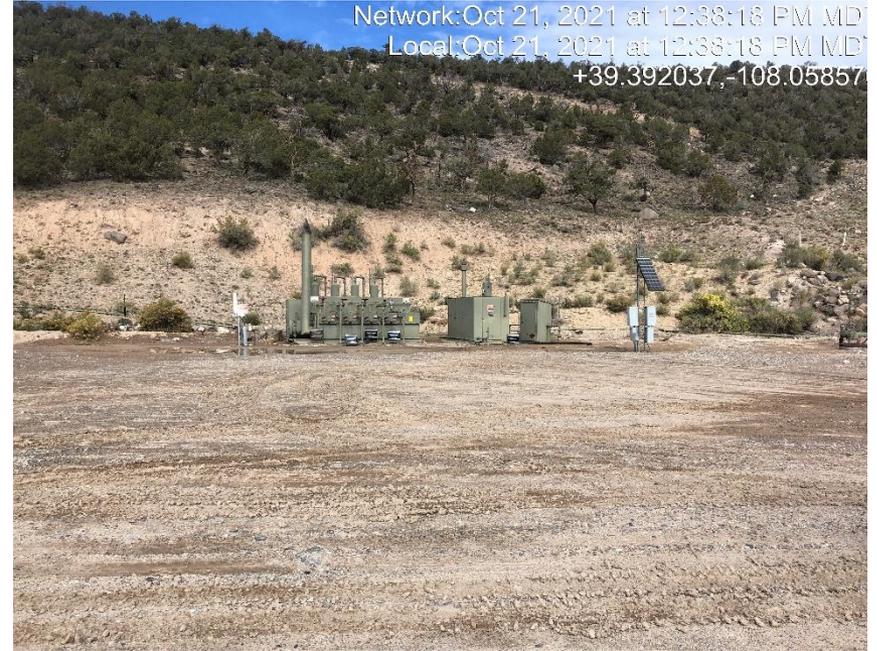
Photo #5123 from entrance to location.

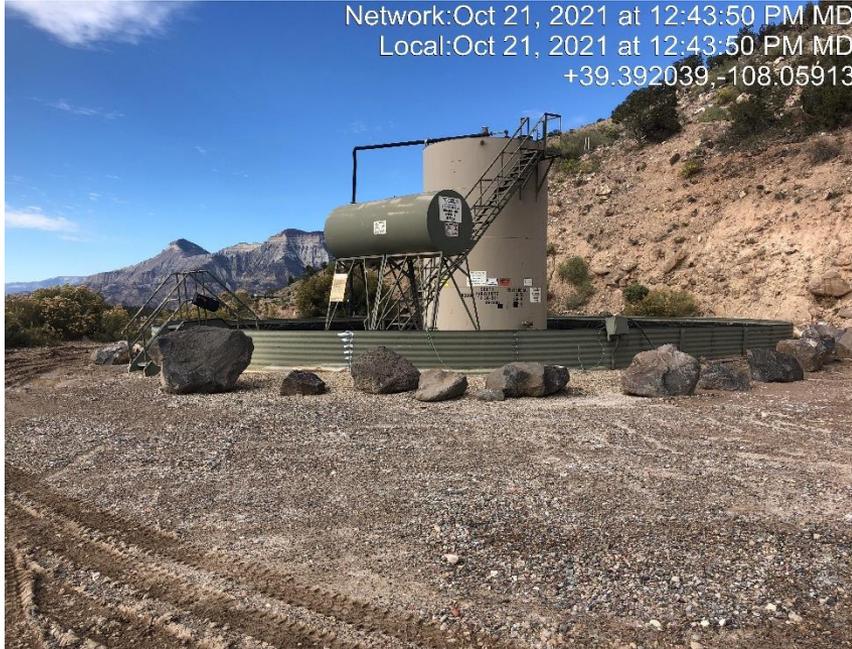
Photo #5124 No battery sign located at the tank battery.

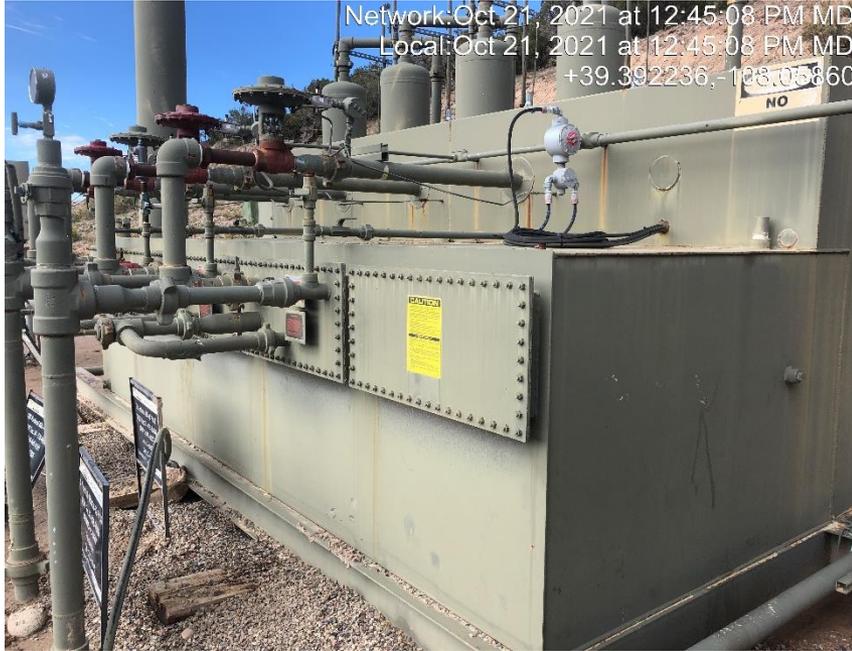
Photo #5125 Glycol tank missing required information.

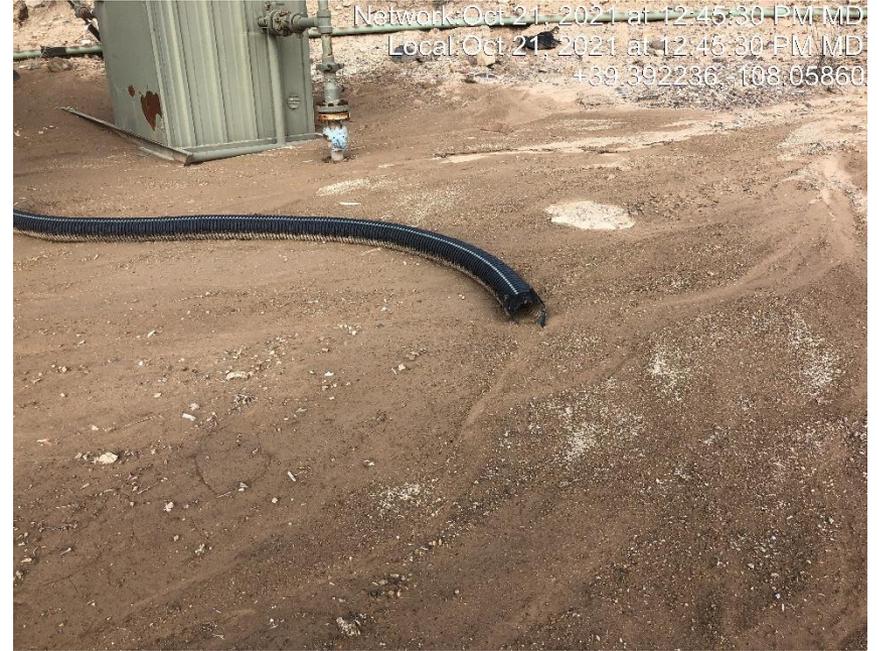
Photo #5126 Heating insulation open ended and not capped.

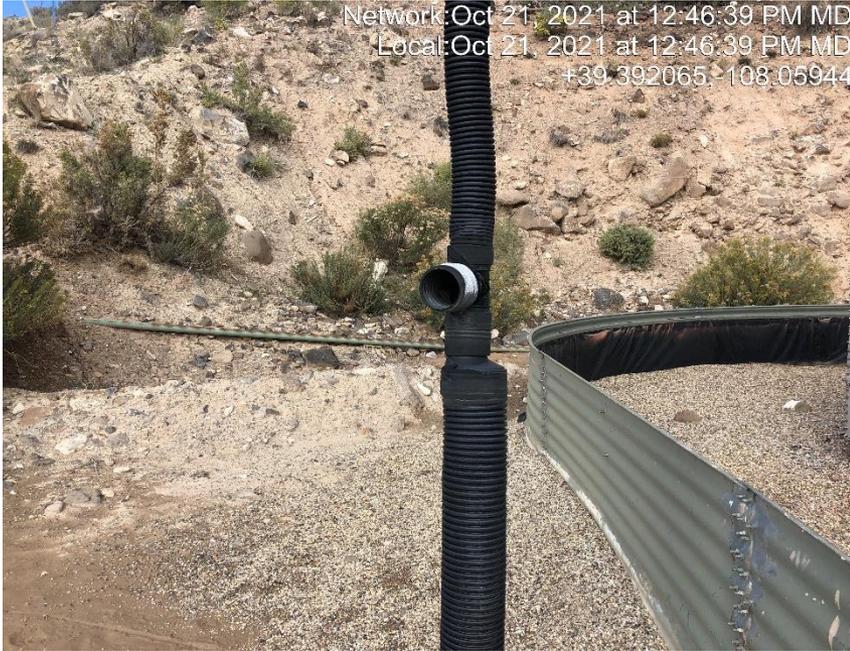
Photo #5127 Heating insulation open ended and not capped.

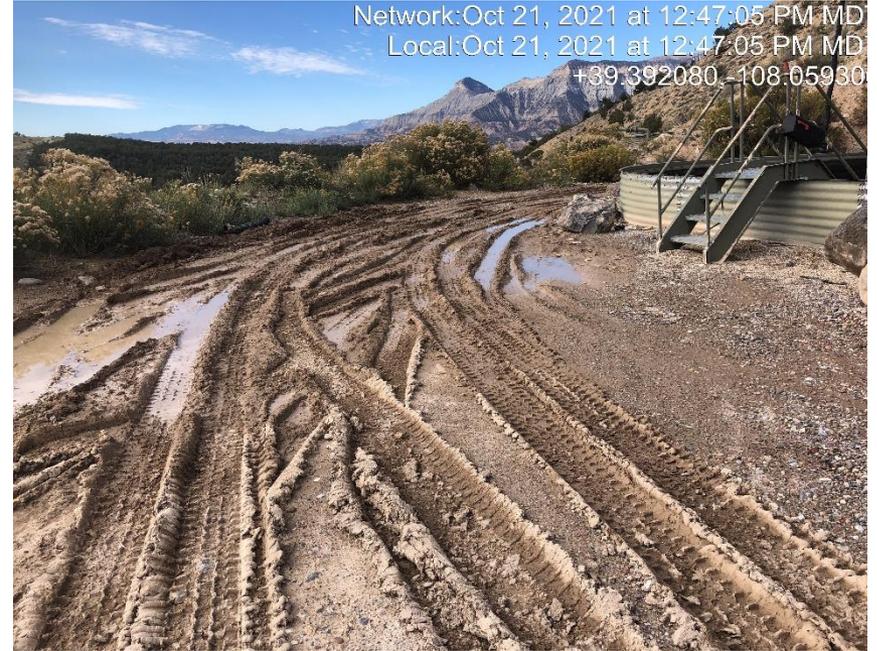
Photo #5128 Location lacks stabilization.

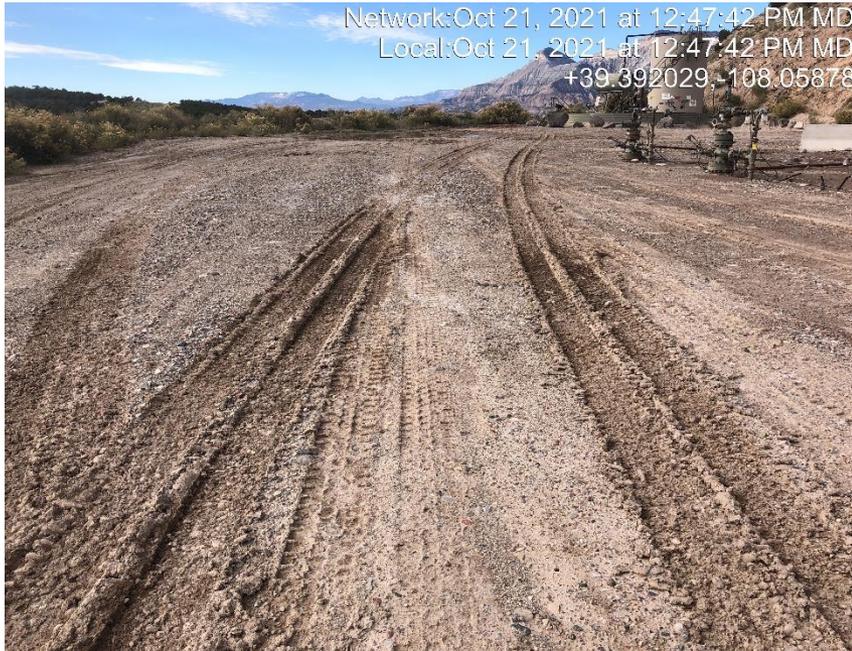
Photo #5129 Location lacks stabilization.

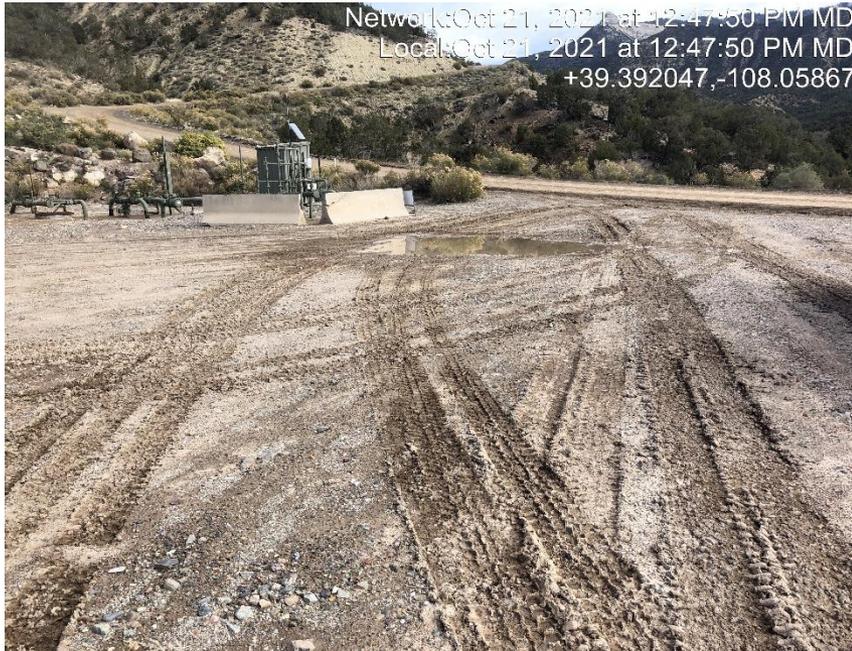
Photo #5130 No form of tracking BMP located at entrance to location.

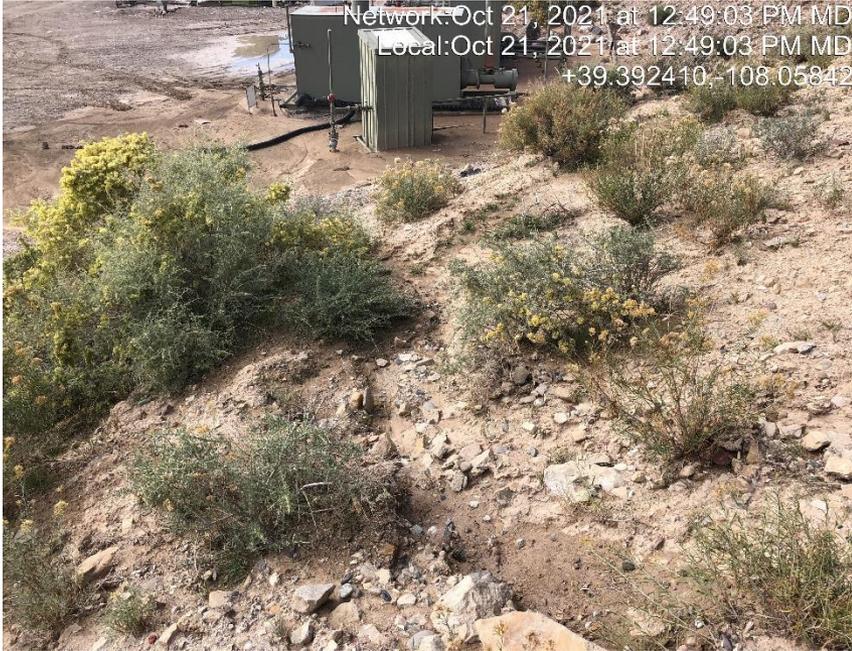
Photo #5131 Rill erosion occurring on cut slope.

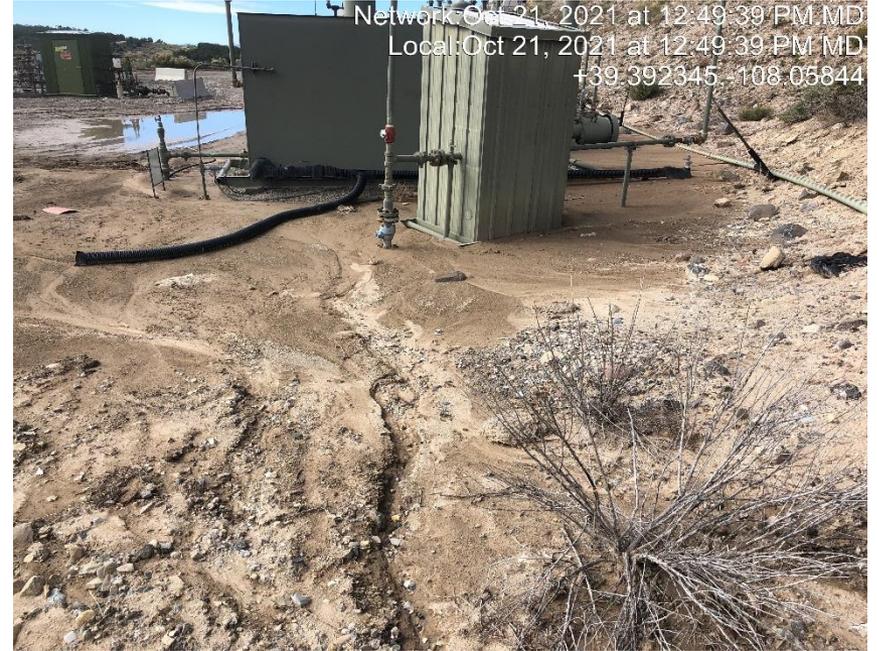
Photo #5132 Run on to location is not being controlled.

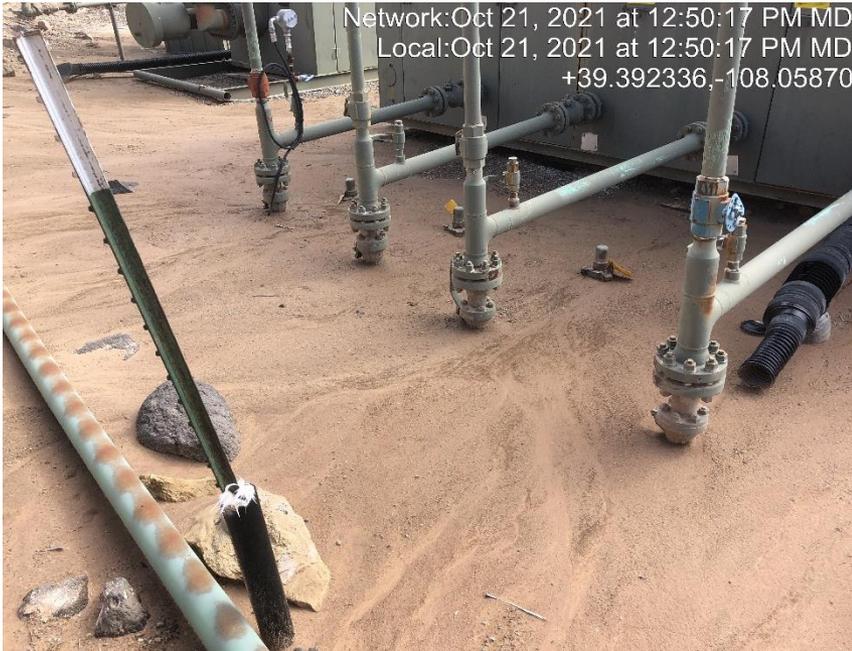
Photo #5133 Sediment encroaching on equipment.
