Inspection Photos

API: 061-05138

Operator: WESTERN OPERATING COMPANY

Inspection Date: 10/27/2021

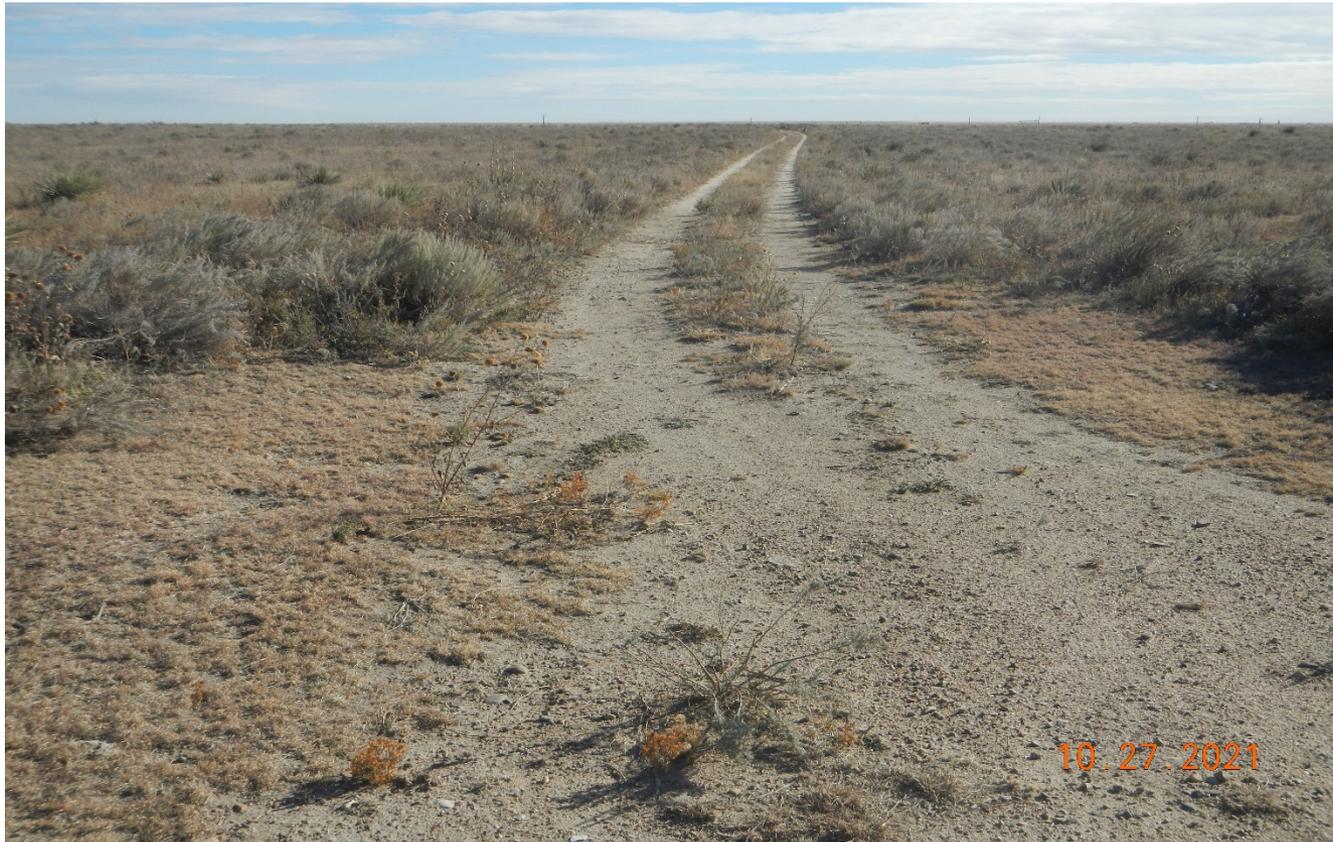
Photo 1. Facing east at the beginning of the access road. The two track road remains with compacted soils. The access road needs to be recontoured and reclaimed.

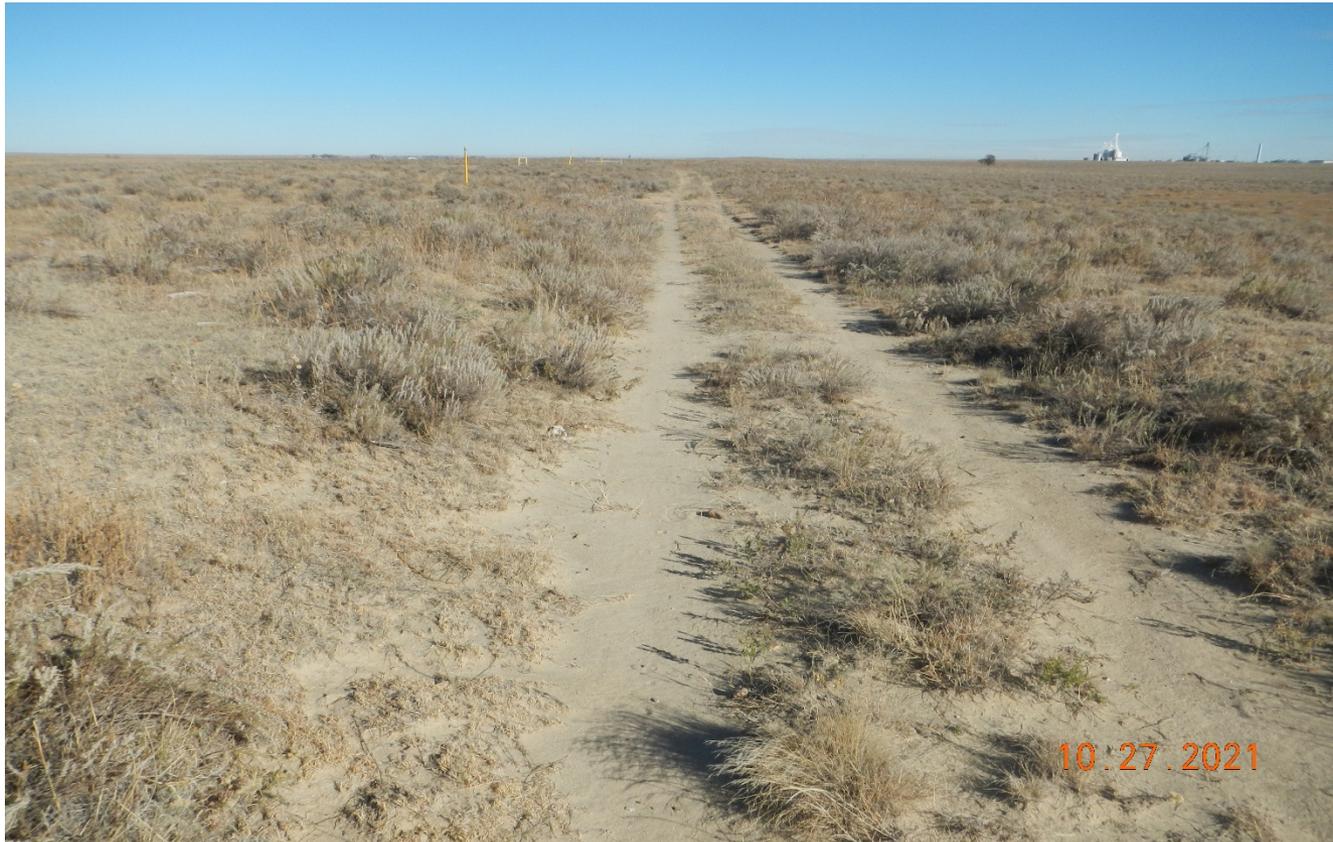
Photo 2. Facing north along the access road which has not been reclaimed.

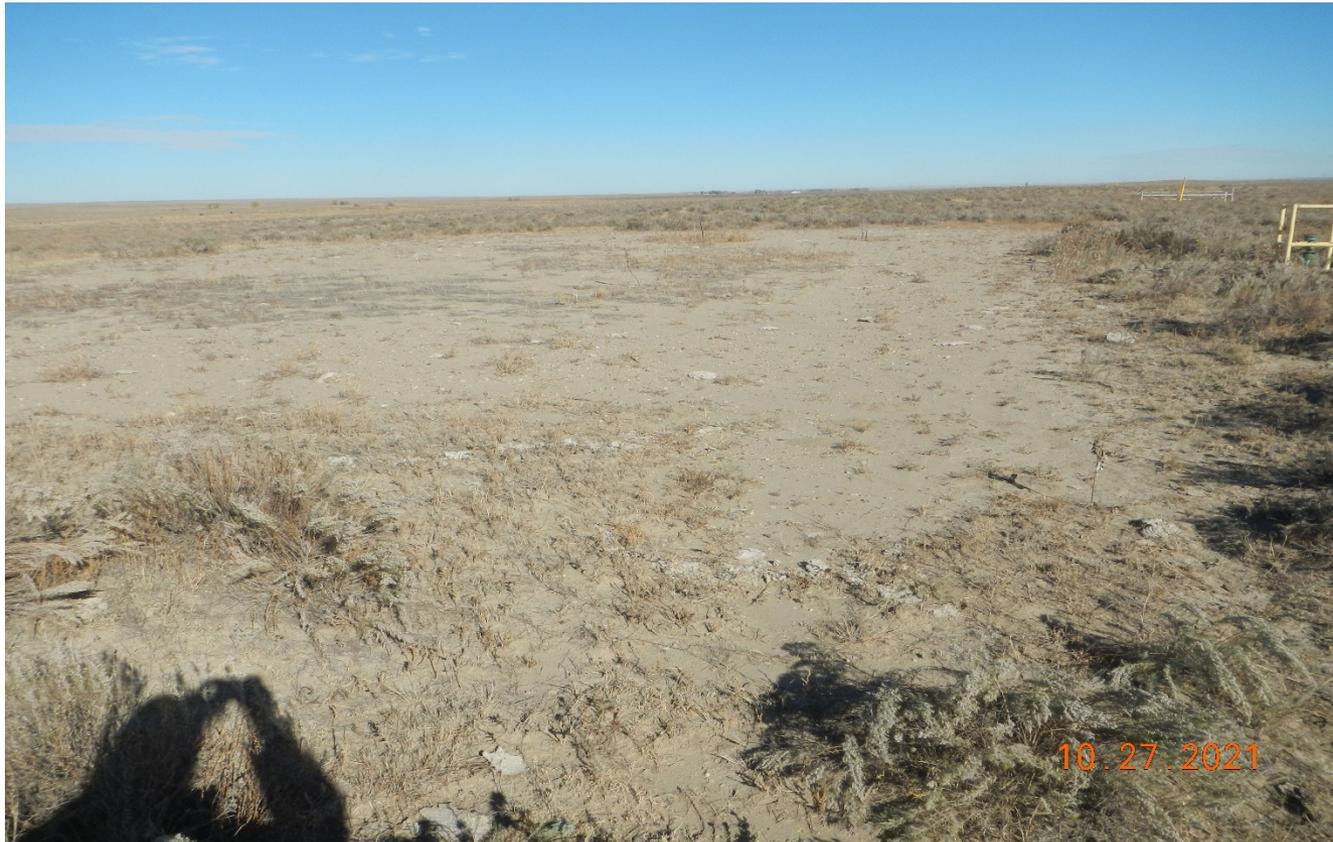
Photo 3. Facing northwest toward the former tank battery site located 300' southwest of the well site. This area has not been reclaimed. Bare soils that are not stabilized and are susceptible to further erosion.

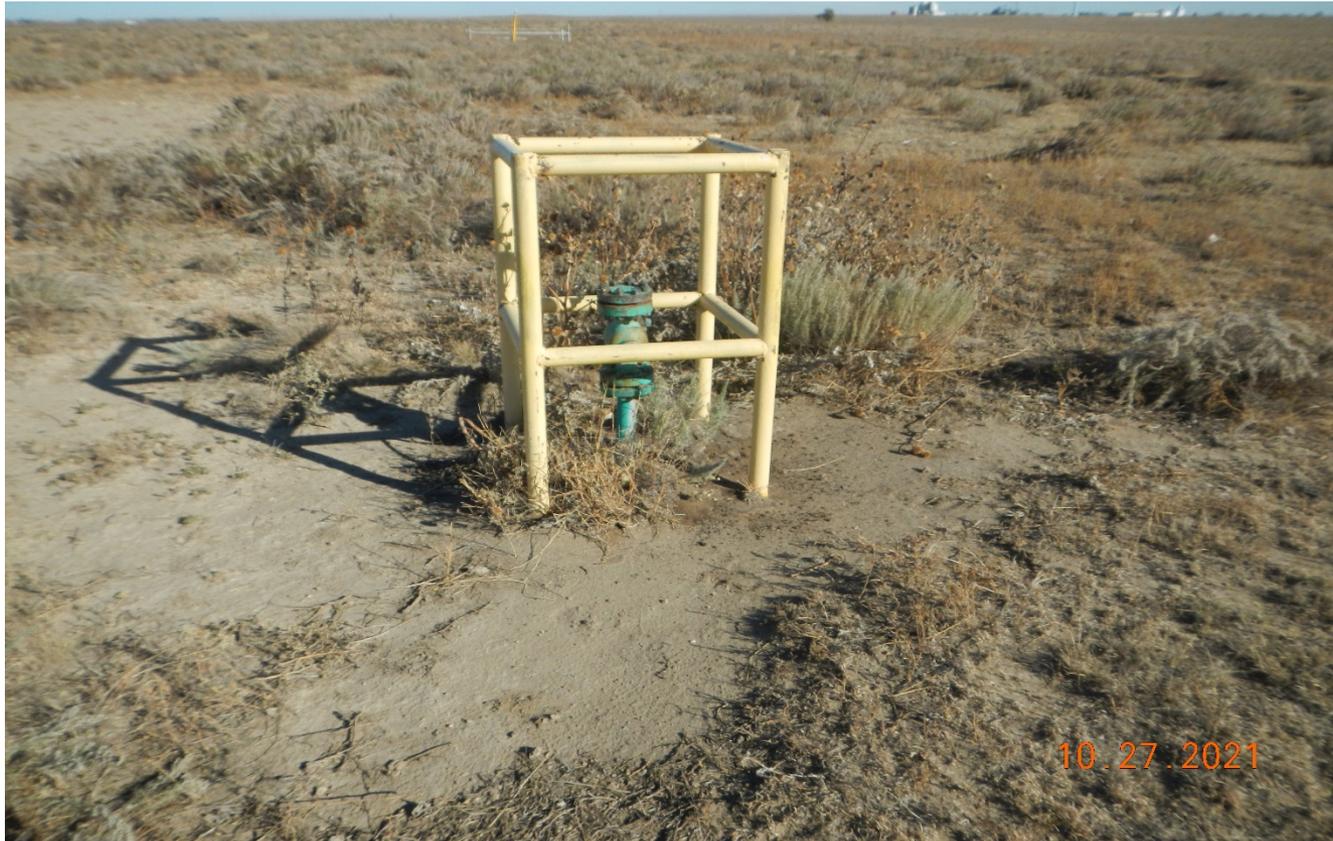
Photo 4. There is a pipe riser that remains at the battery site. All abandoned risers need to be removed.

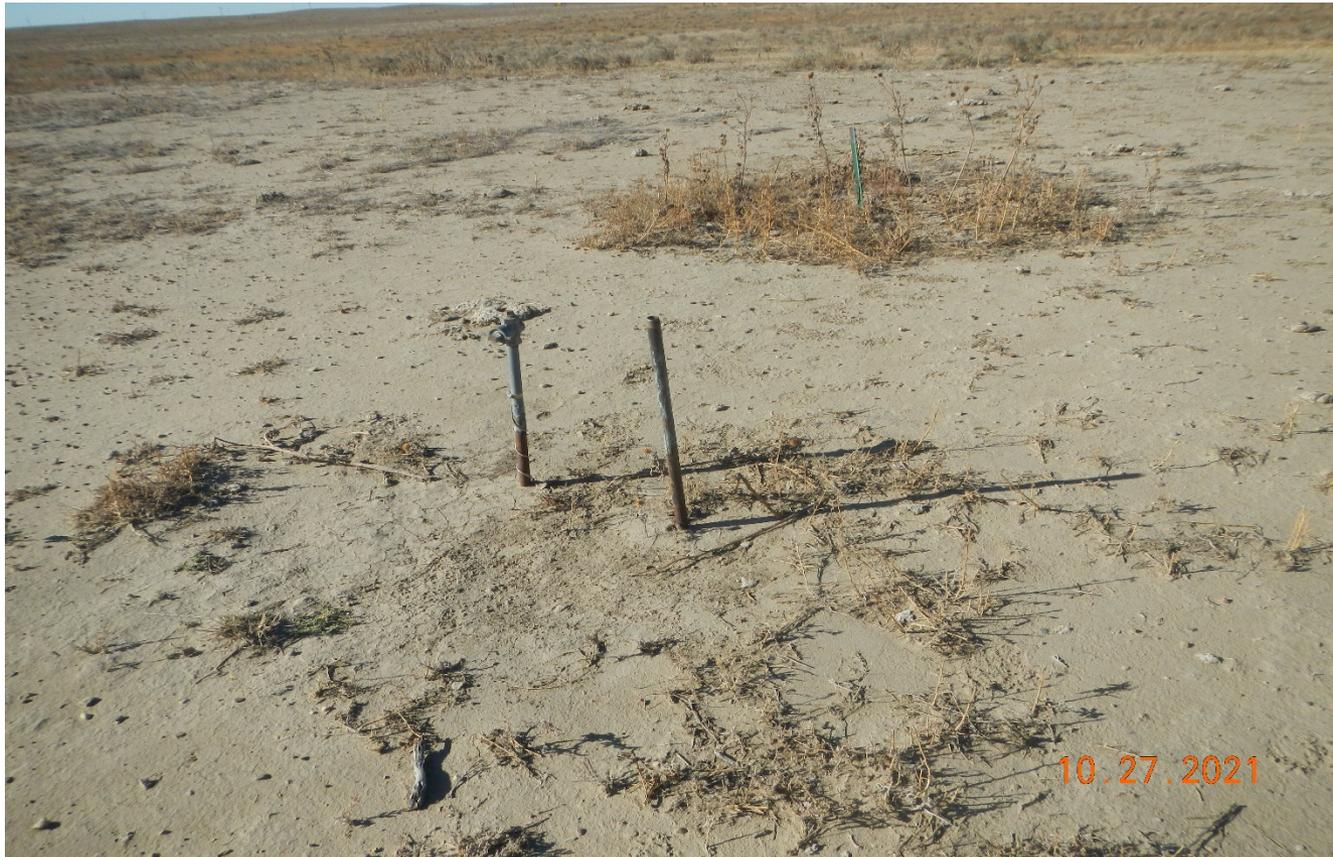
Photo 5. There are two pipes that remain at the battery site that need to be removed.

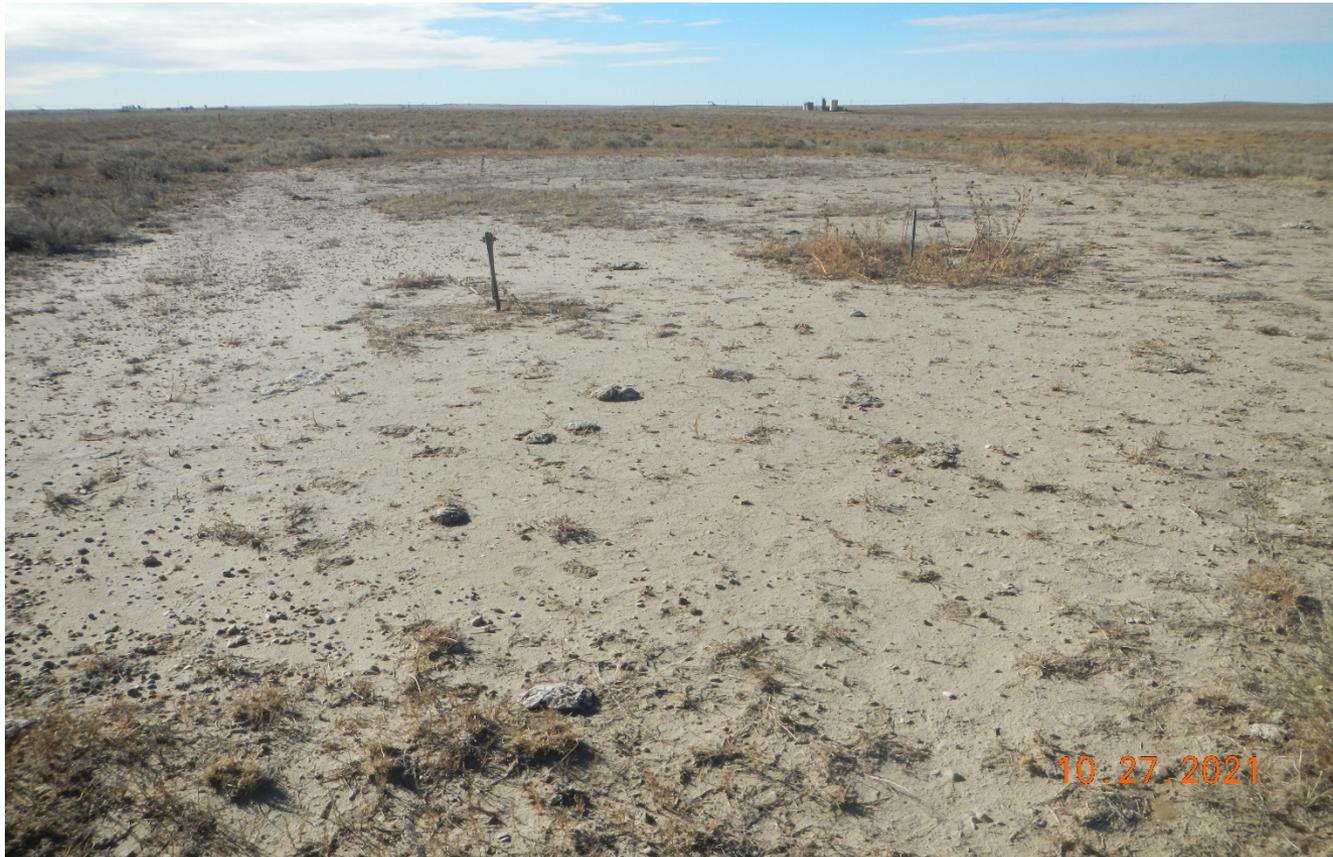
Photo 6. Facing southwest toward the abandoned battery site which was never reclaimed. Bare soils that are not stabilized and are susceptible to further erosion.

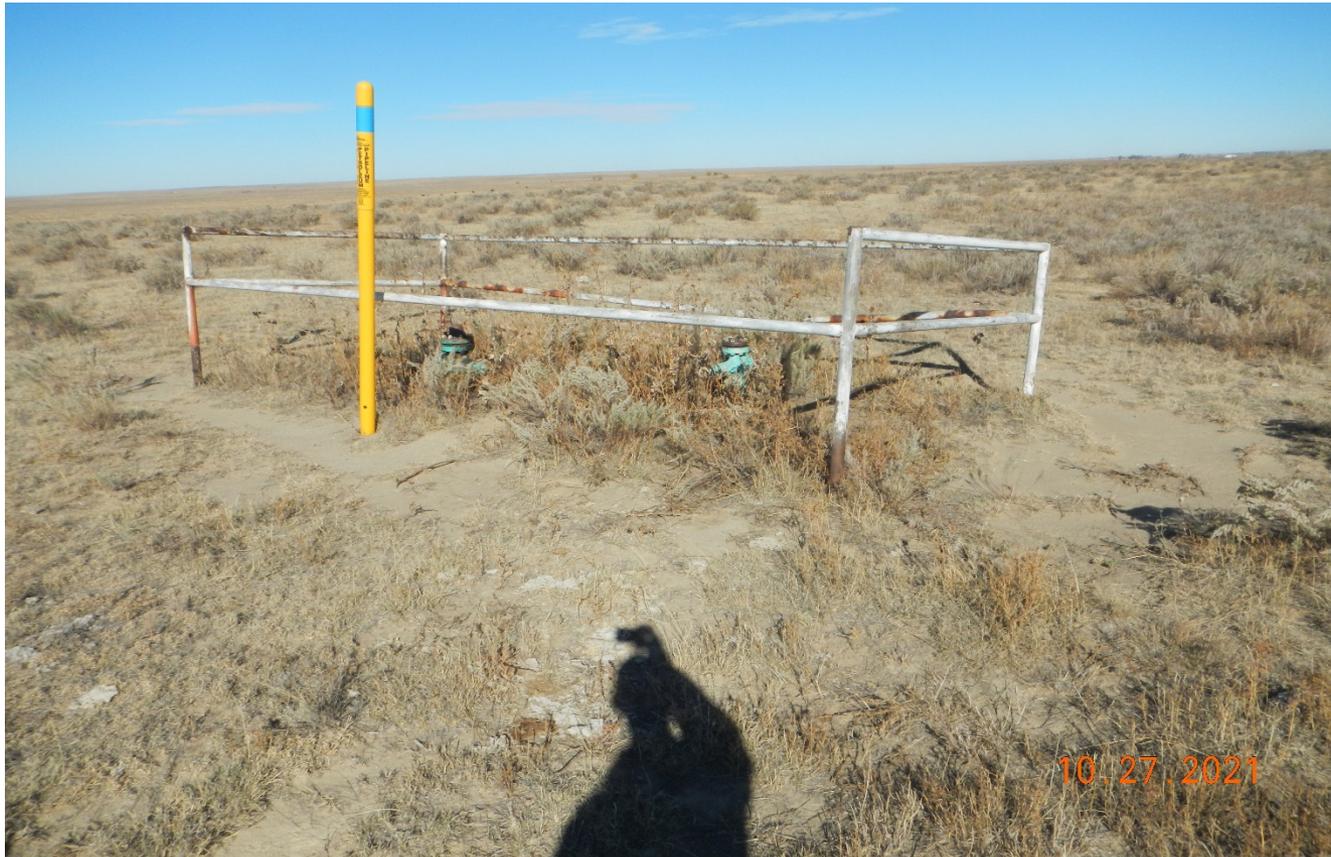
Photo 7. There are additional abandoned risers that remain at the tank battery site. All abandoned risers need to be removed.

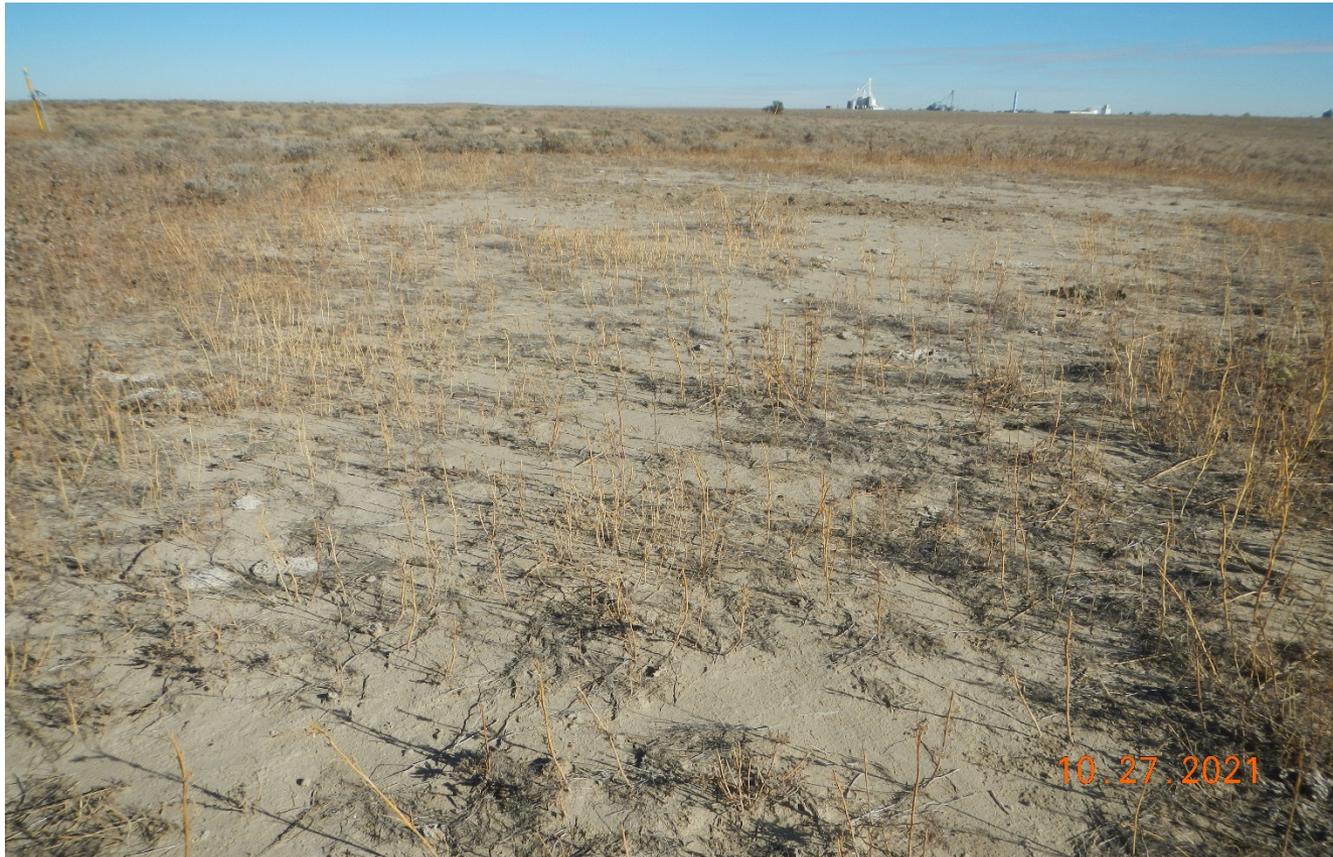
Photo 8. Facing northeast toward the abandoned well site. This area has not been reclaimed. Bare soils that are not stabilized and are susceptible to further erosion.

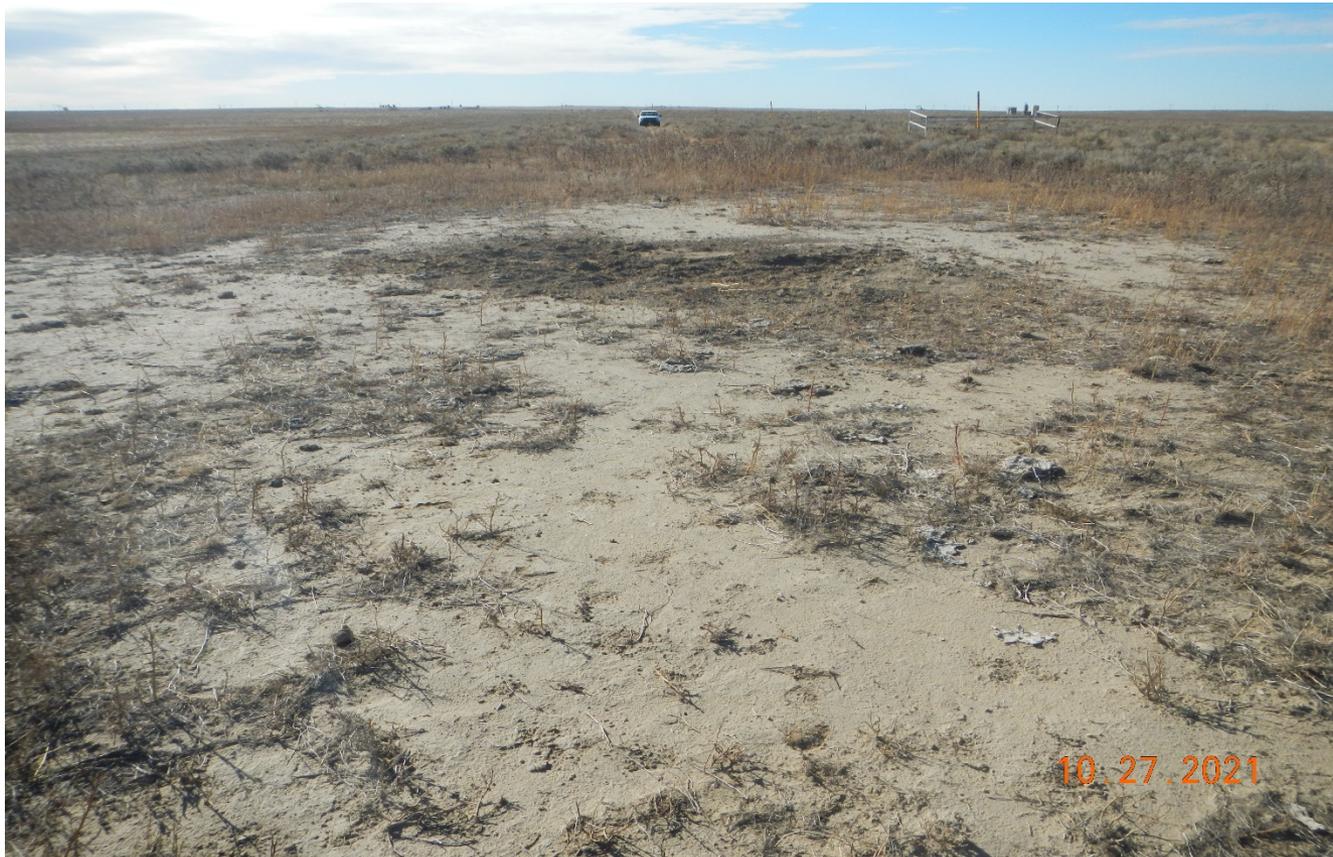
Photo 9. Facing south toward the abandoned well site. This area has not been reclaimed. Bare soils that are not stabilized and are susceptible to further erosion.
