Inspection Photos
Operator: Simcoe
API: 067-07858
Date: 10/27/2021

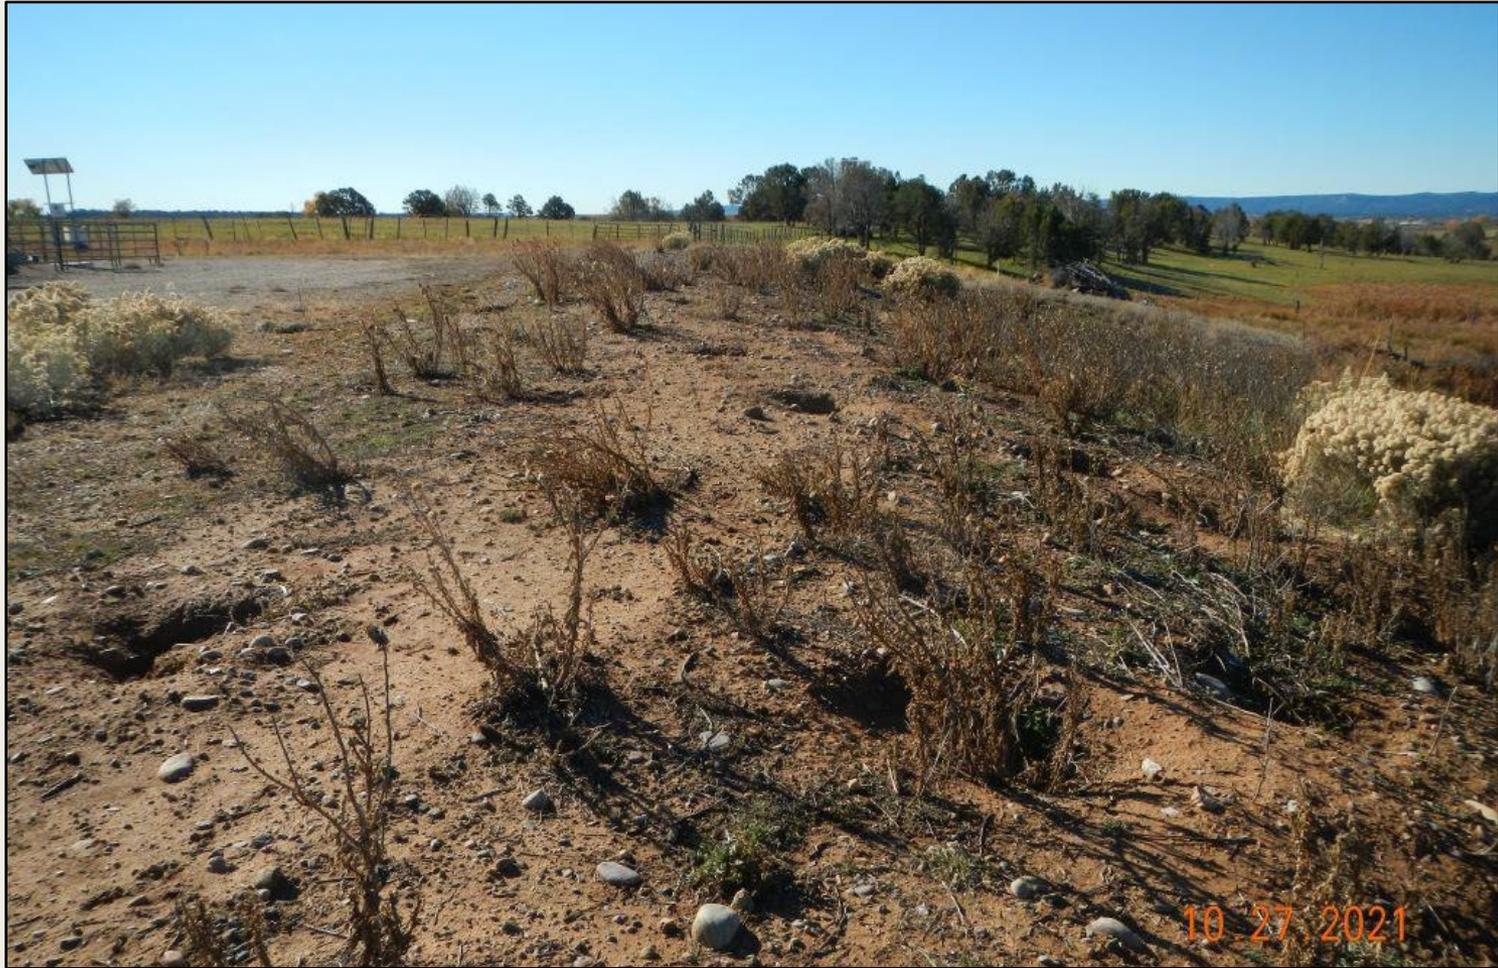
Photo 2. View of the western project area from the northwestern corner facing southward. Revegetation is failed here, and infested with musk thistle. Approx. 2000 musk thistles observed. Reclamation is needed.

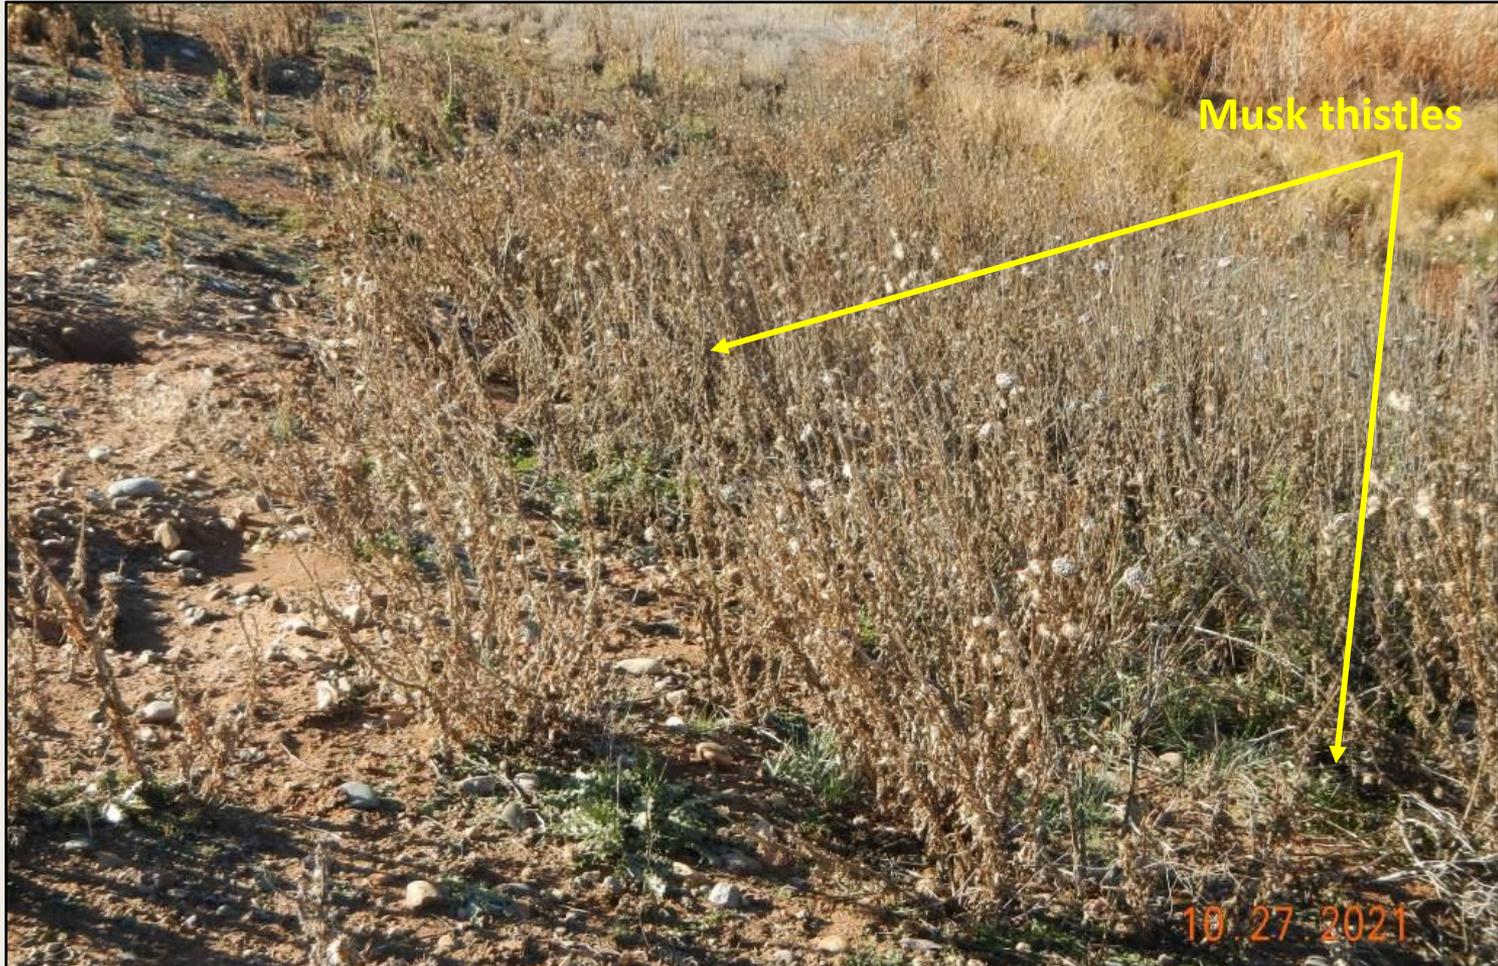
Photo 3. View of dense musk thistles in post-flowering condition, as well as rosettes.
