Inspection Photos

API: 017-06098

Operator: PRONGHORN OPERATING

Inspection Date: 10/26/2021

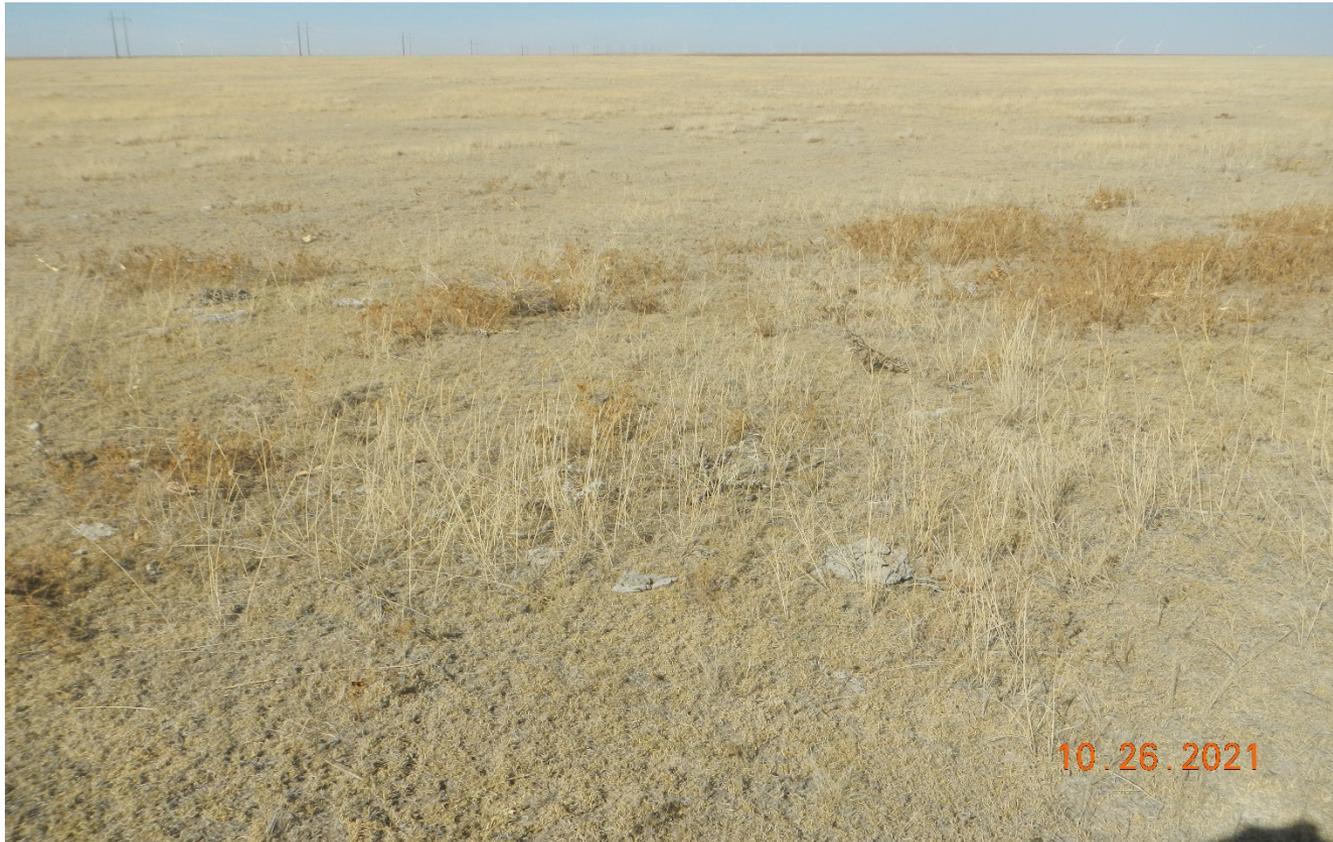
Photo 1. Center of the location facing north. The desirable vegetation has established to reflect reference area levels.

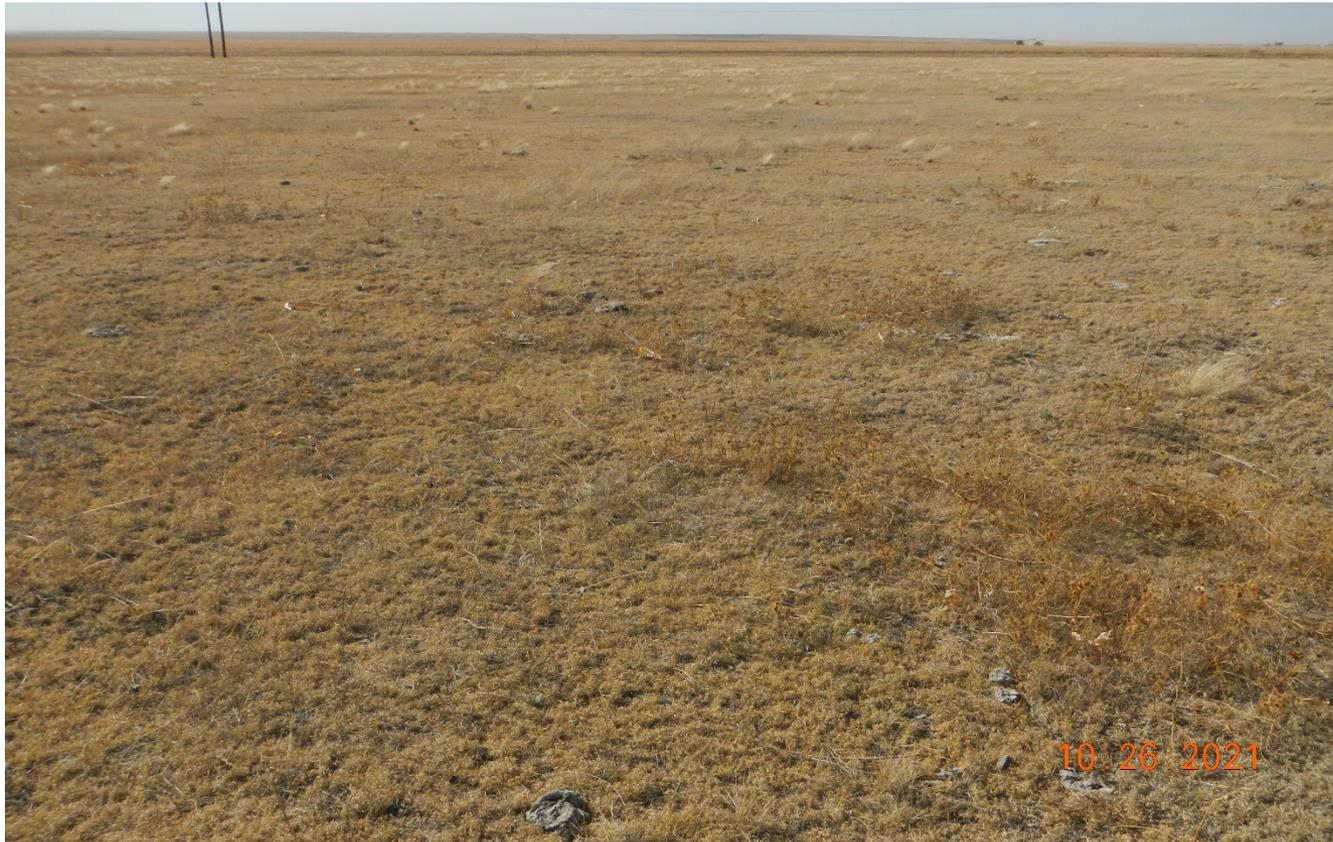
Photo 2. Center of the location facing west. The desirable vegetation has established to reflect reference area levels.

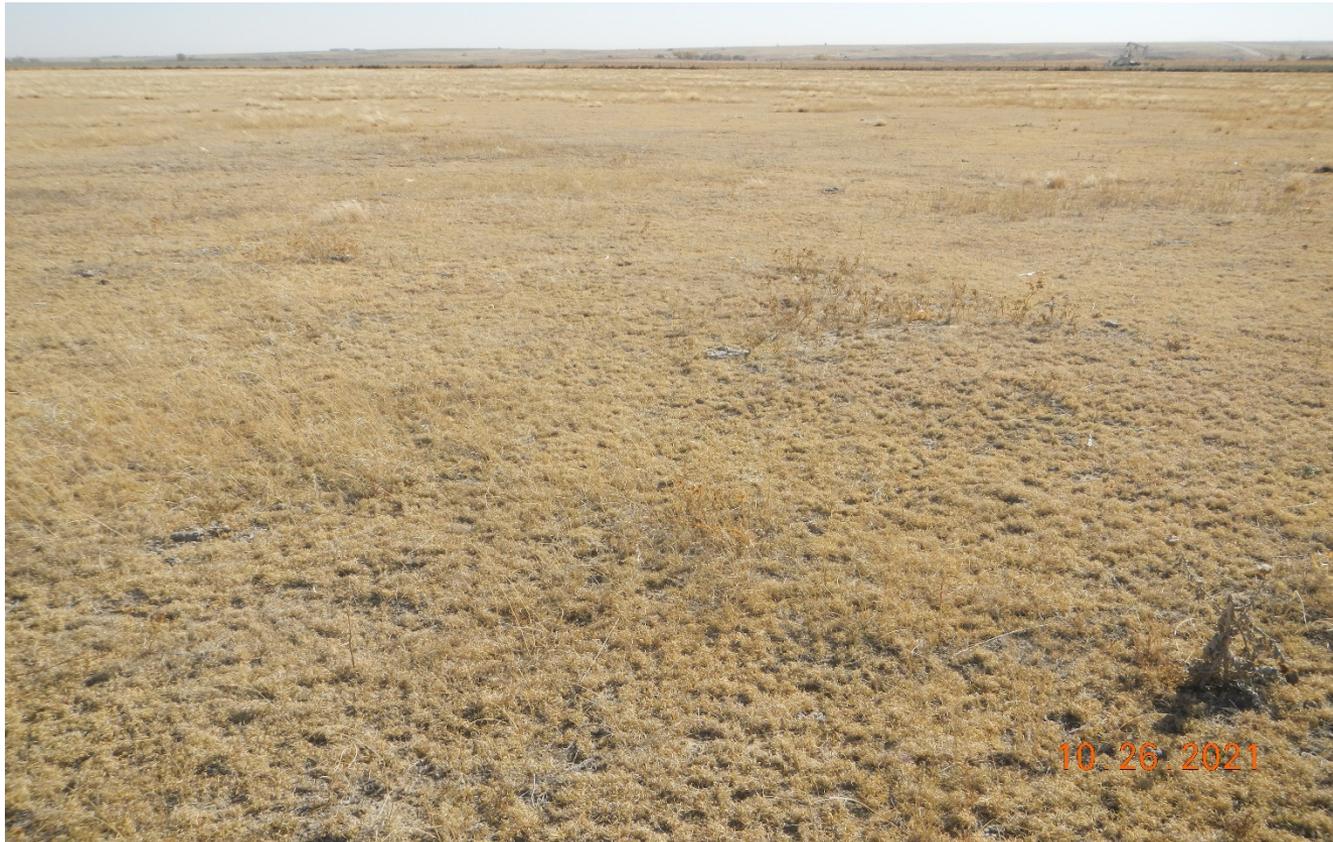
Photo 3. Center of the location facing south. The desirable vegetation has established to reflect reference area levels.

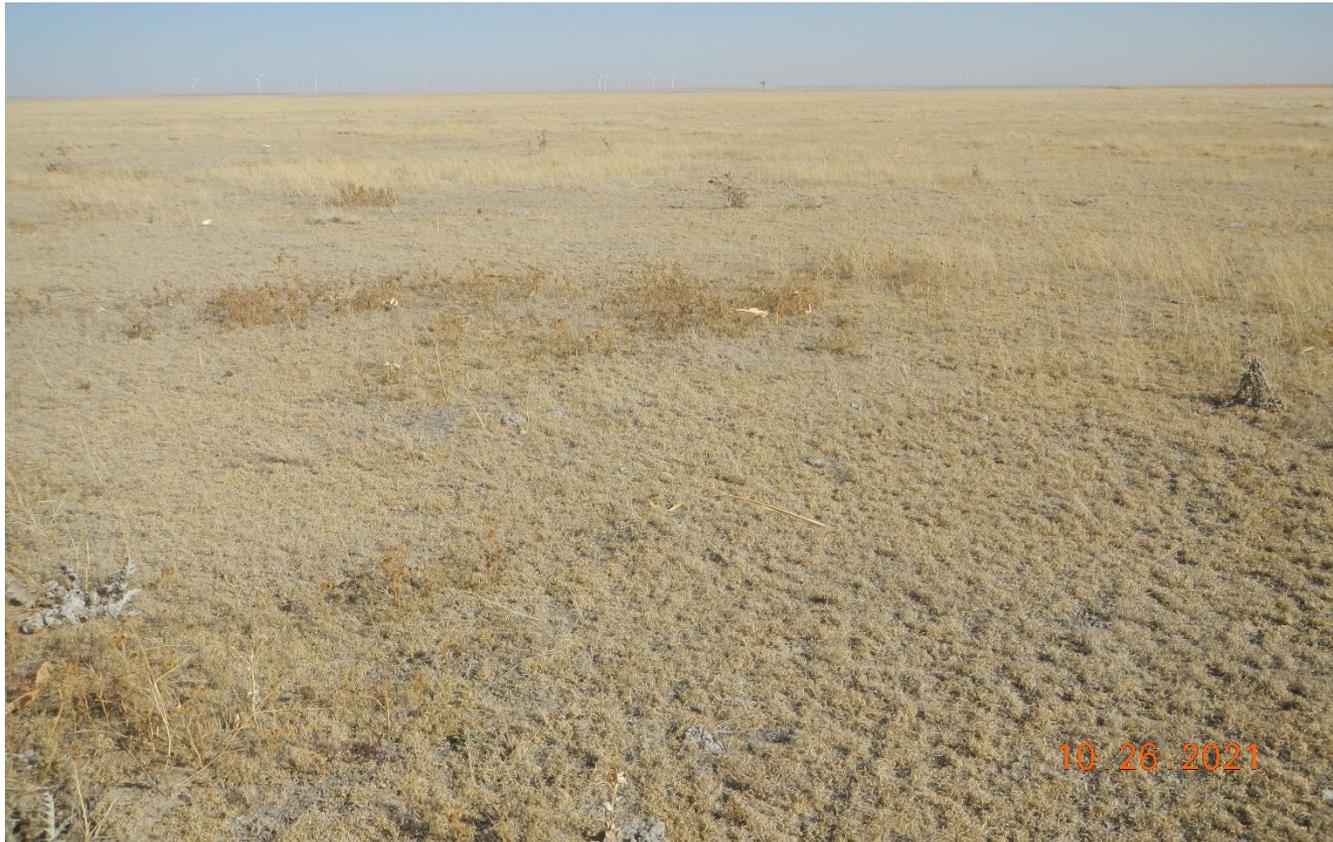
Photo 4. Center of the location facing east. The desirable vegetation has established to reflect reference area levels.

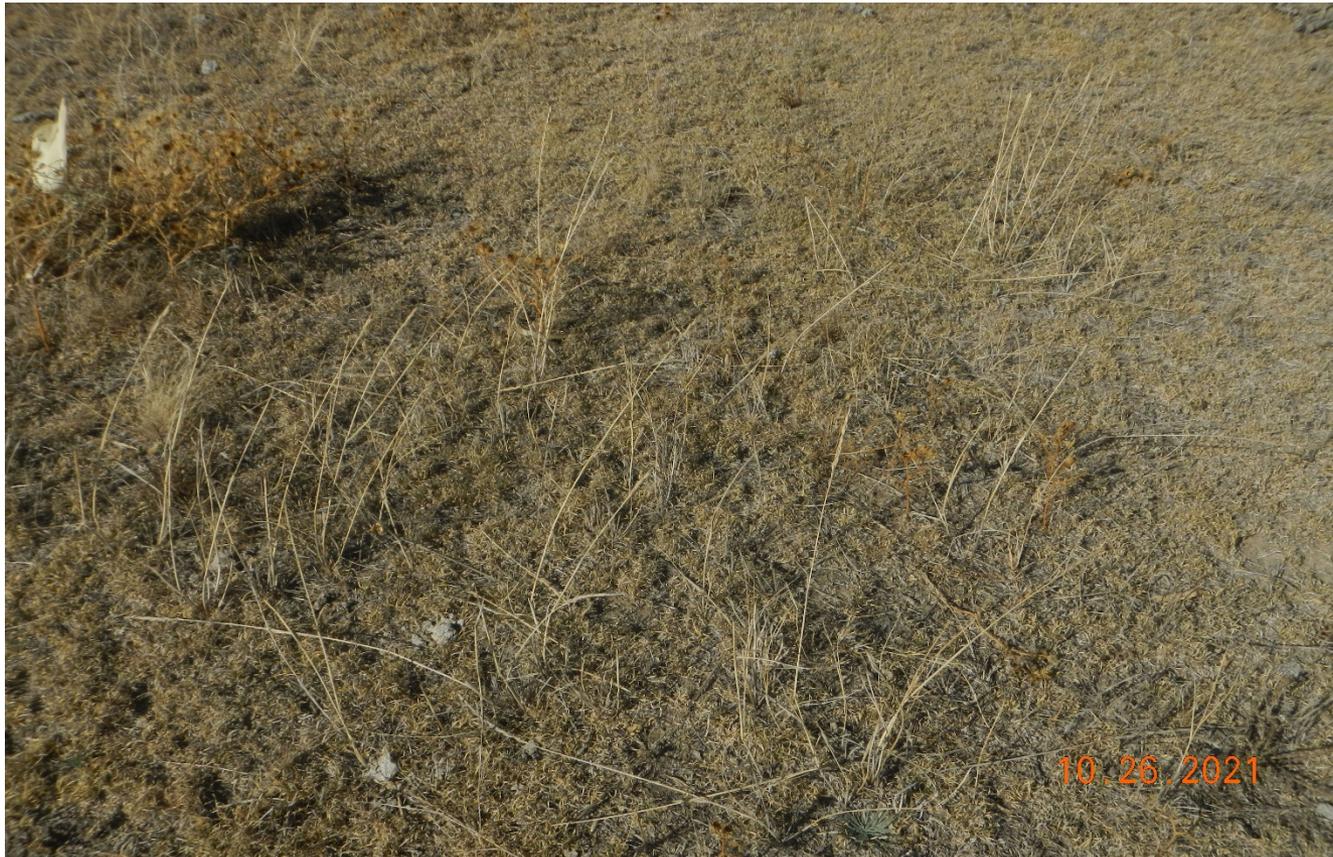
Photo 5. View of groundcover at the location shows perennial desirable vegetation consisting of Buffalo grass, Western wheat grass, among other native species.
