Inspection Photos
Operator: Simcoe
API: 067-09325
Date: 10/27/2021

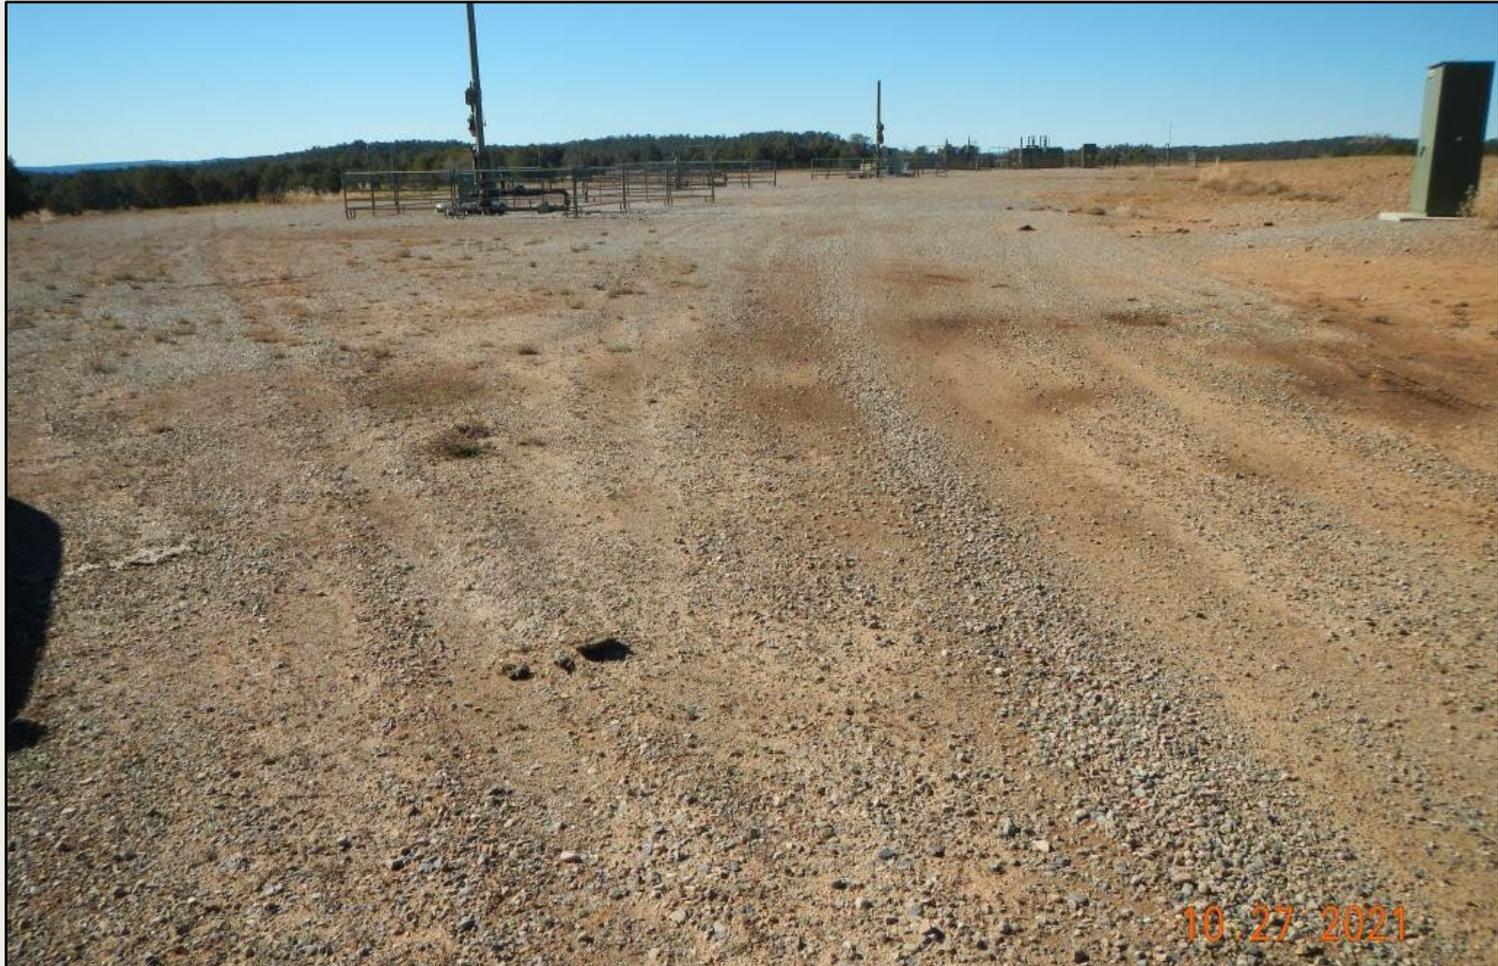
Photo 1. View of the project area from the well pad entrance facing center.

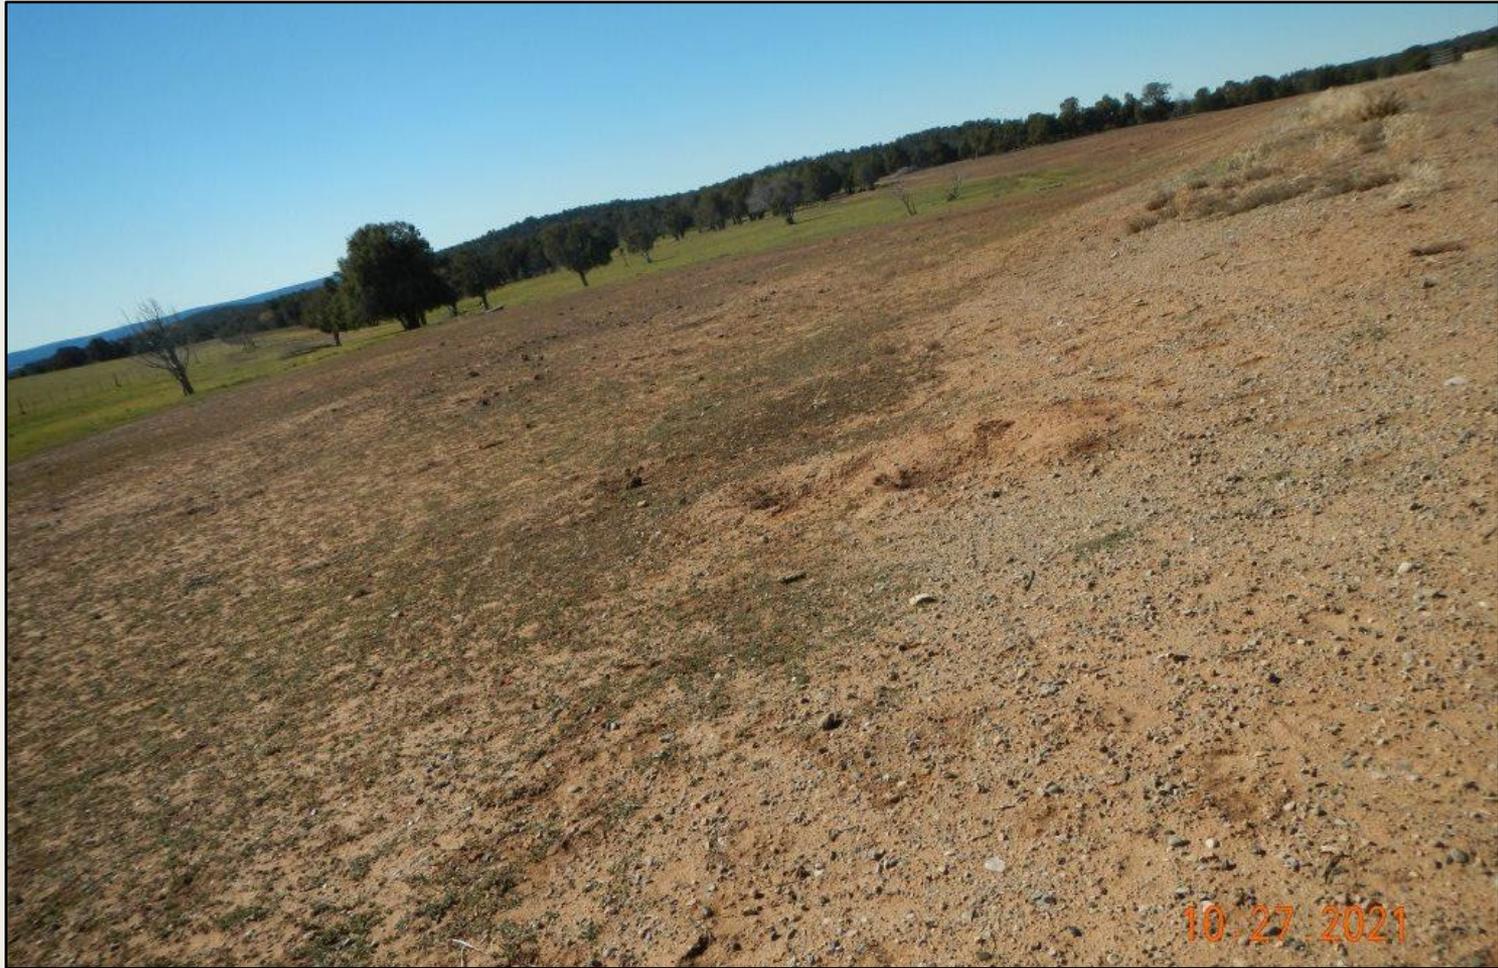
Photo 2. View of the southern project area from the southeastern corner facing westward. Revegetation is sparse and progressing similar to surrounding grazed pasture. Revegetation should be assessed during the active growing season.

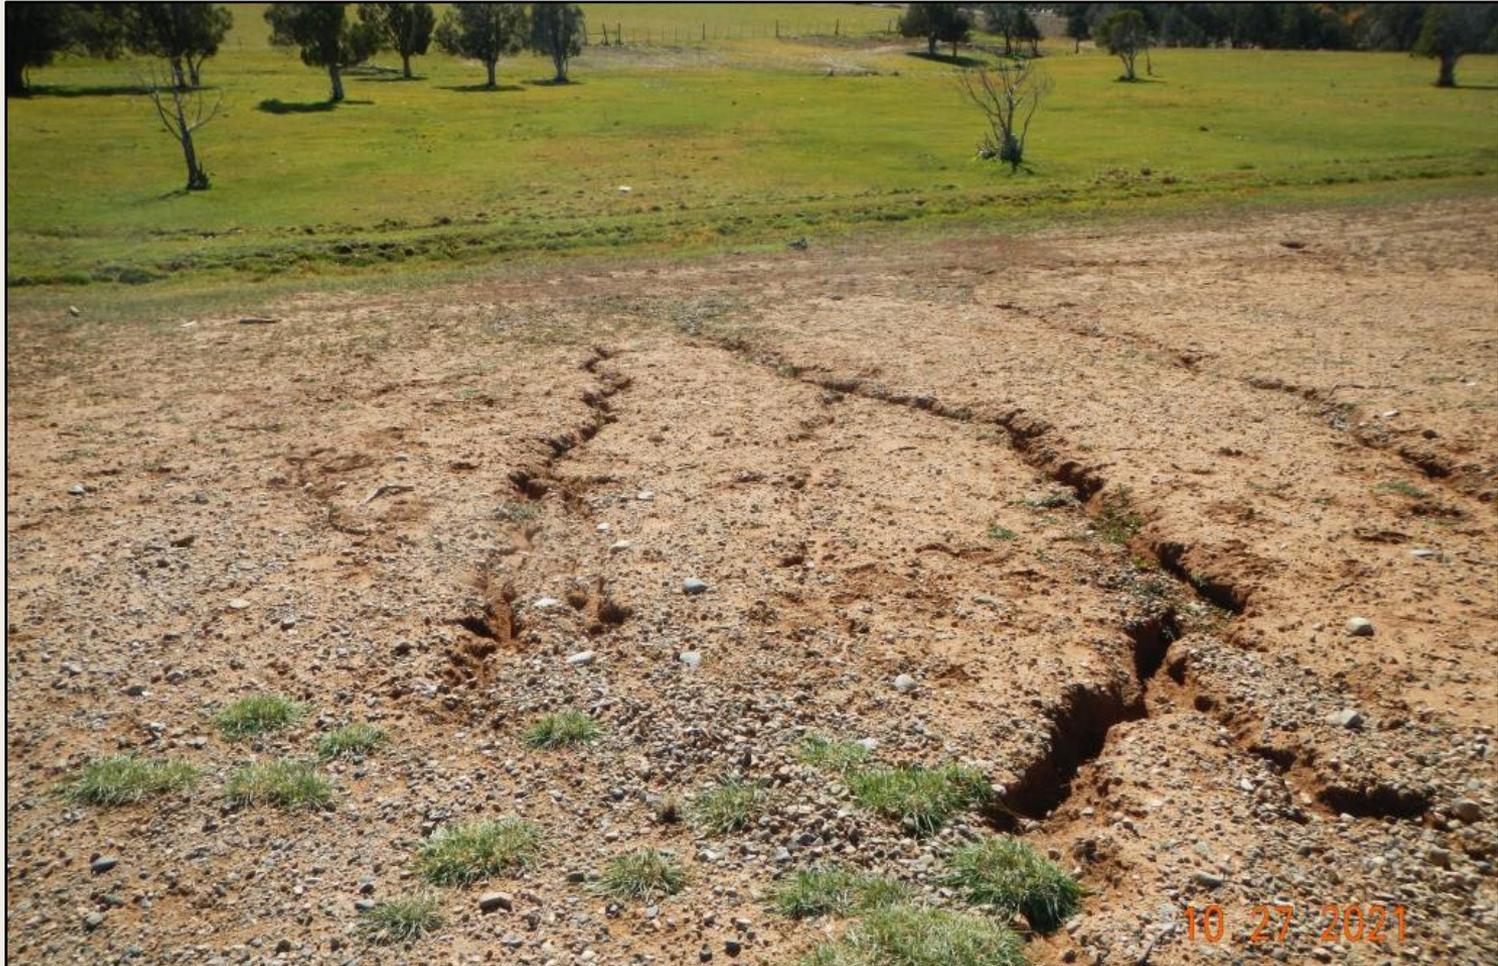
Photo 3. View of erosional rilling, approximately 8-10 inches wide and deep, within the southern project area.

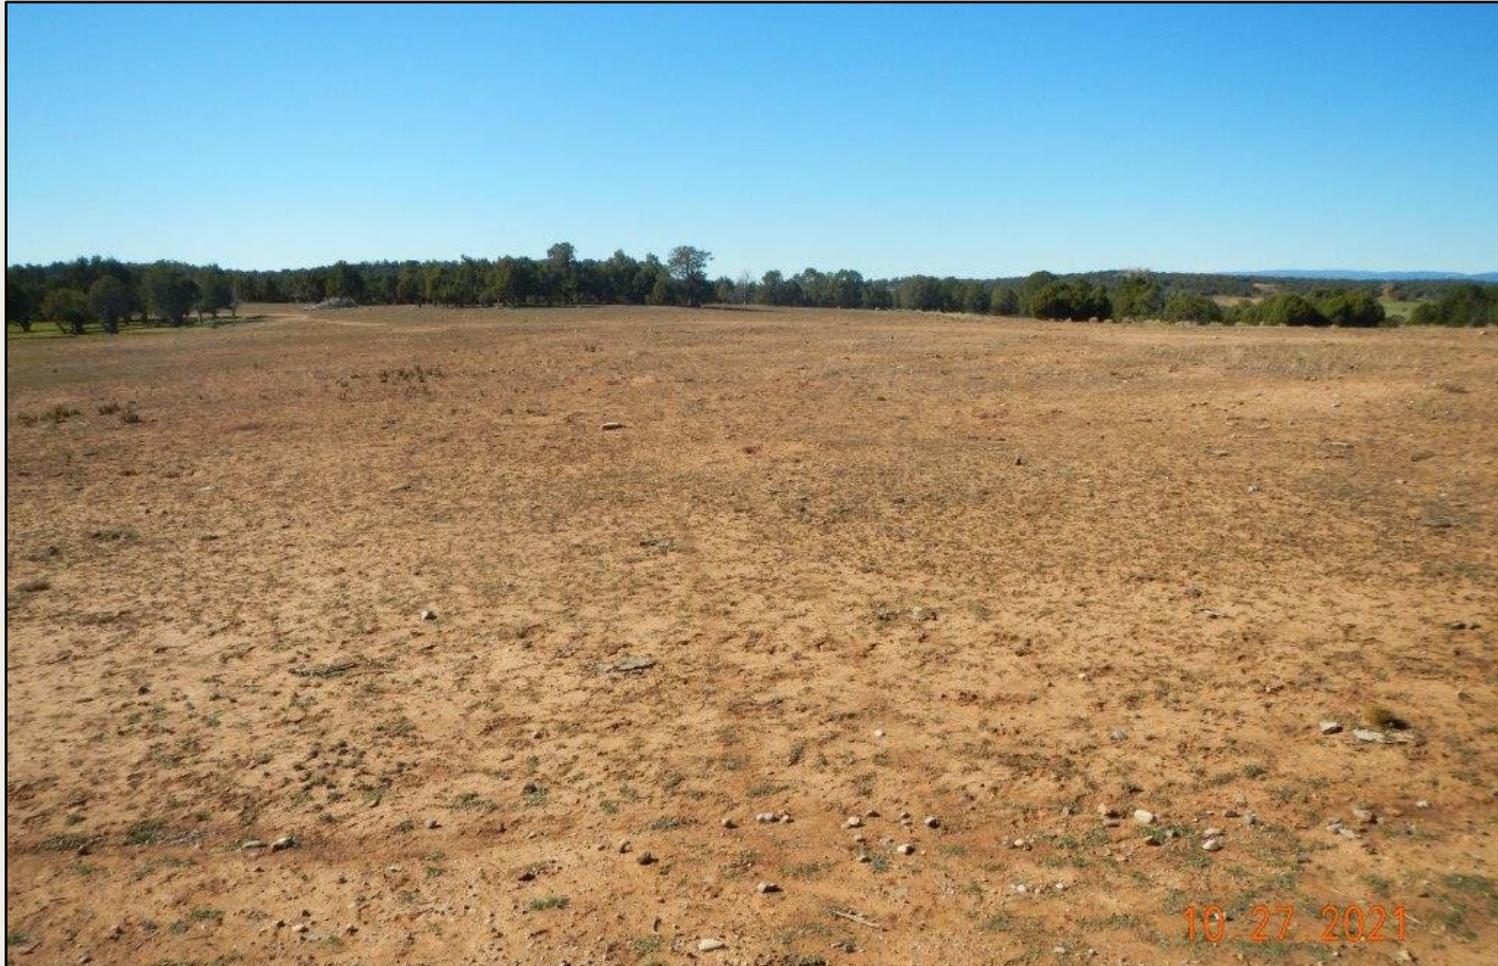
Photo 4. View of the reference area comprised of open field, upslope from irrigation ditch, in grazed vegetative condition at this time.
