Inspection Photos

11/01/2021

Operator: NONSUCH NATURAL GAS INC

Location ID: 324169

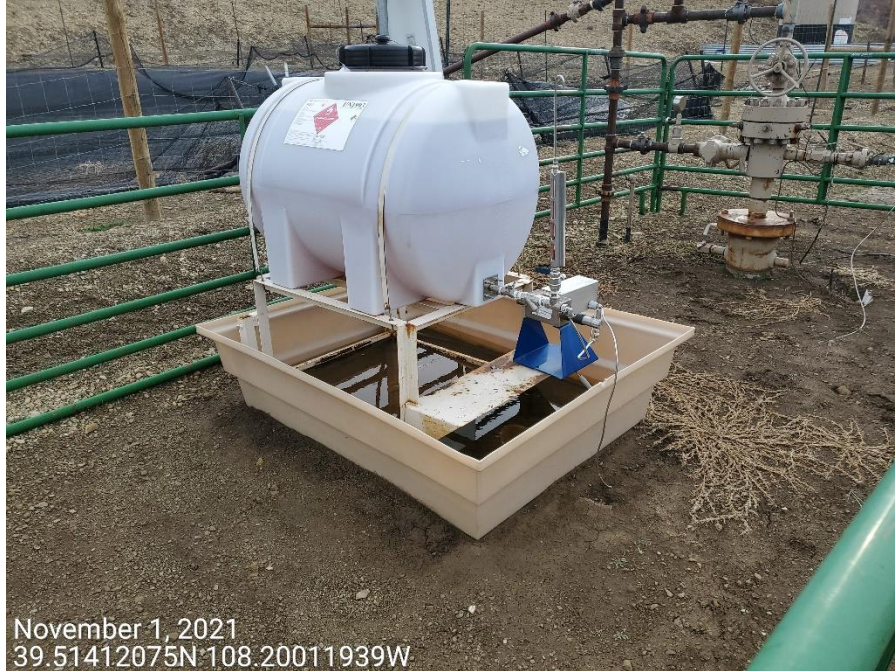
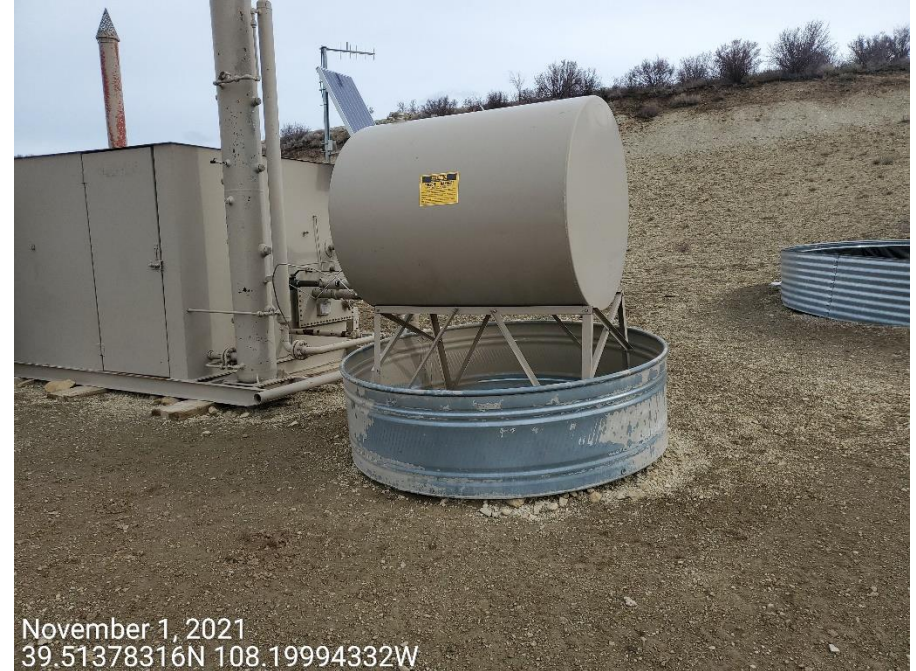
Photo 1: Photo show wildlife protection devices to prevent wildlife access to the secondary containment BMPs are missing.

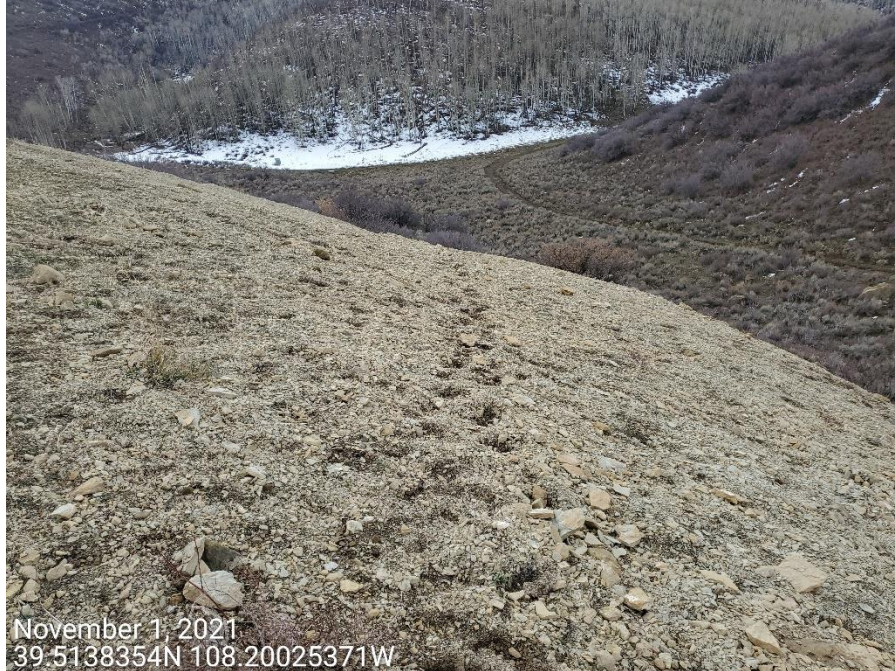
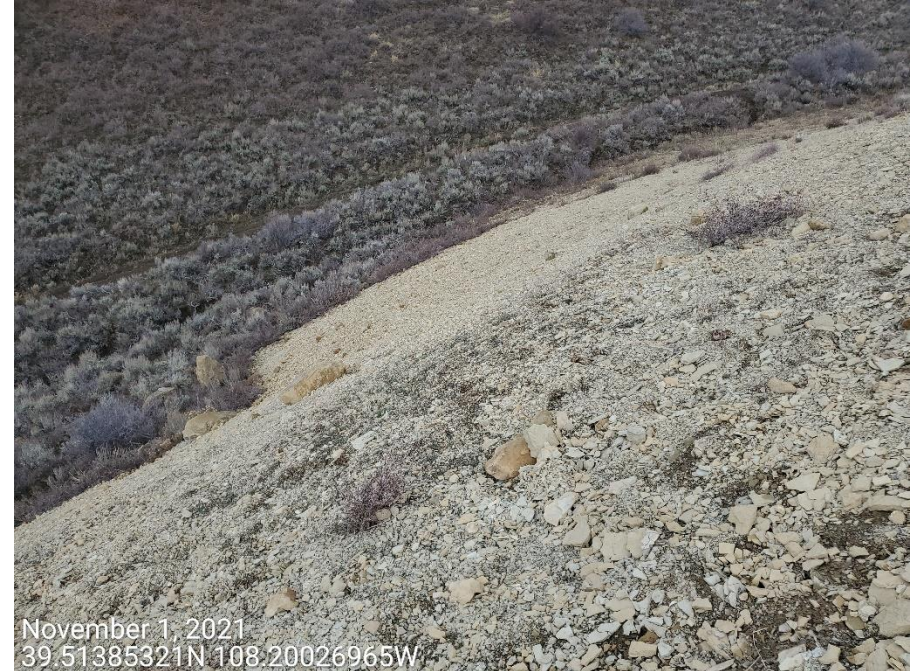
Photo 2: Photo taken from the interim areas on the west end of the Location. Unable to find evidence that additional reclamation was performed; reclamation not progressing towards 1003 standards. Photo also shows control measures to protect/stabilize the cut/fill slopes of the Location, and to prevent offsite sediment transport remains missing or insufficient.

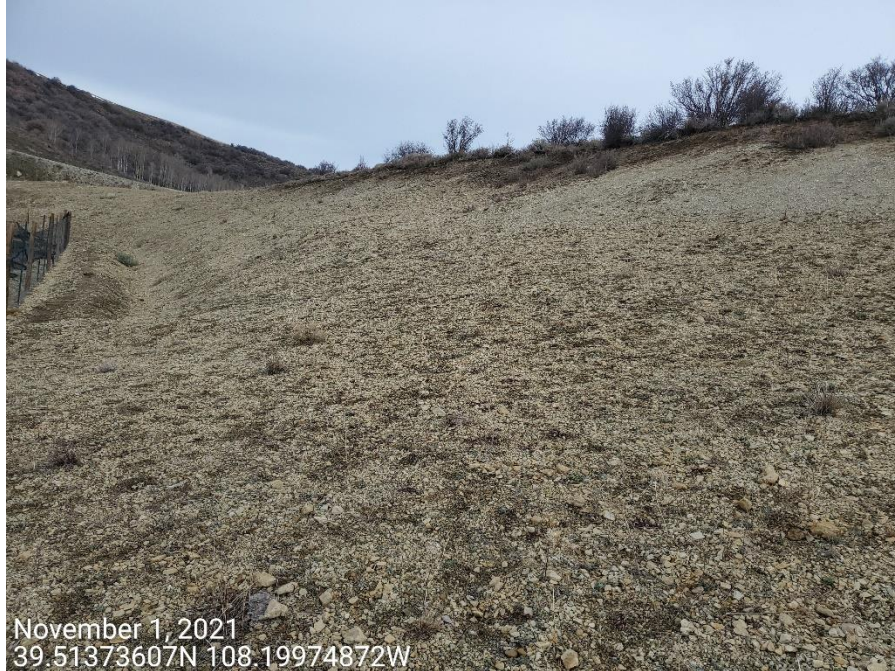
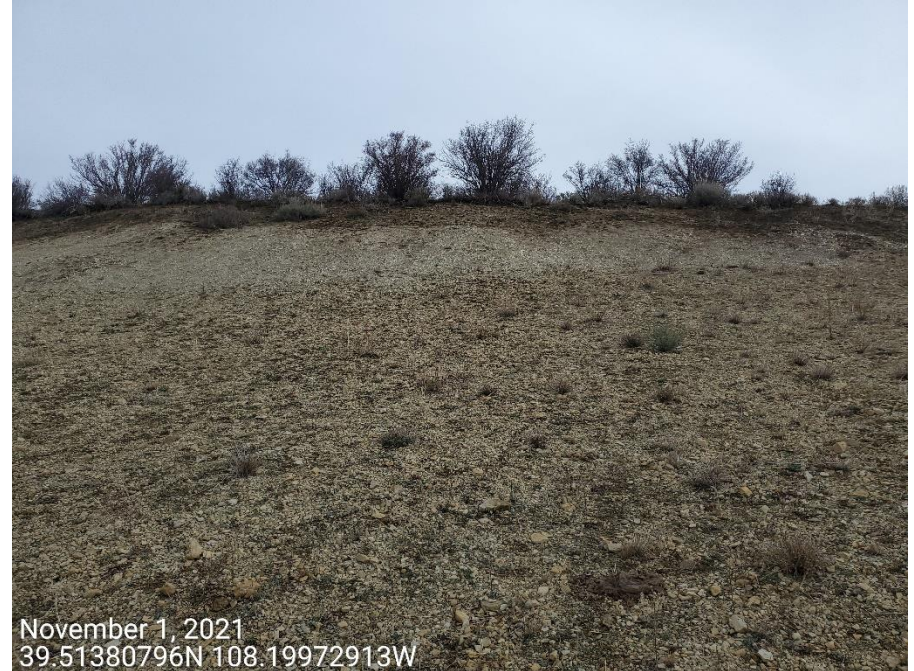
Photo 3: Photo taken from the interim areas on the east end of the Location. Unable to find evidence that additional reclamation was performed; reclamation not progressing towards 1003 standards. Photo also shows control measures to protect/stabilize the cut/fill slopes of the Location, and to prevent offsite sediment transport remains missing or insufficient.

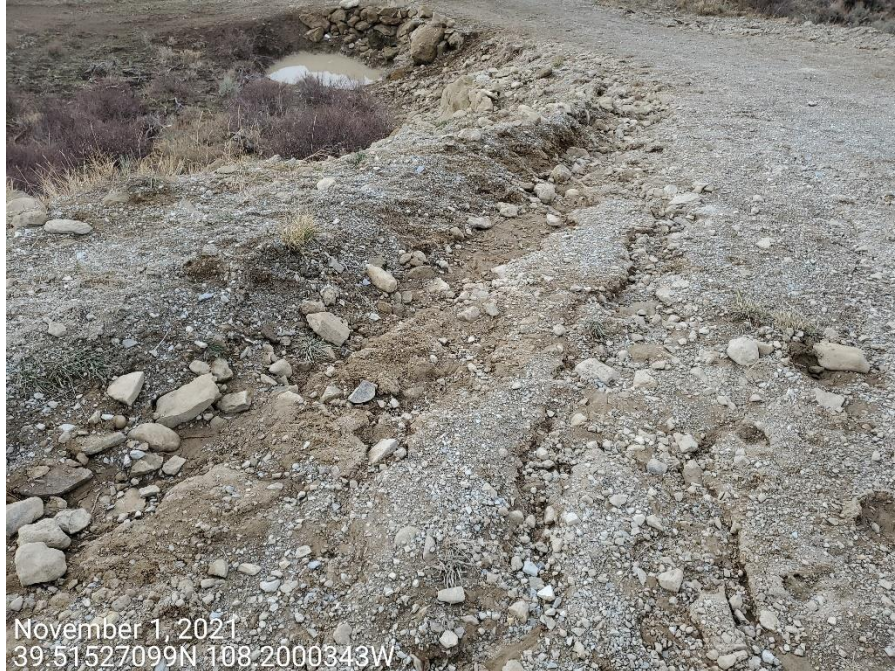
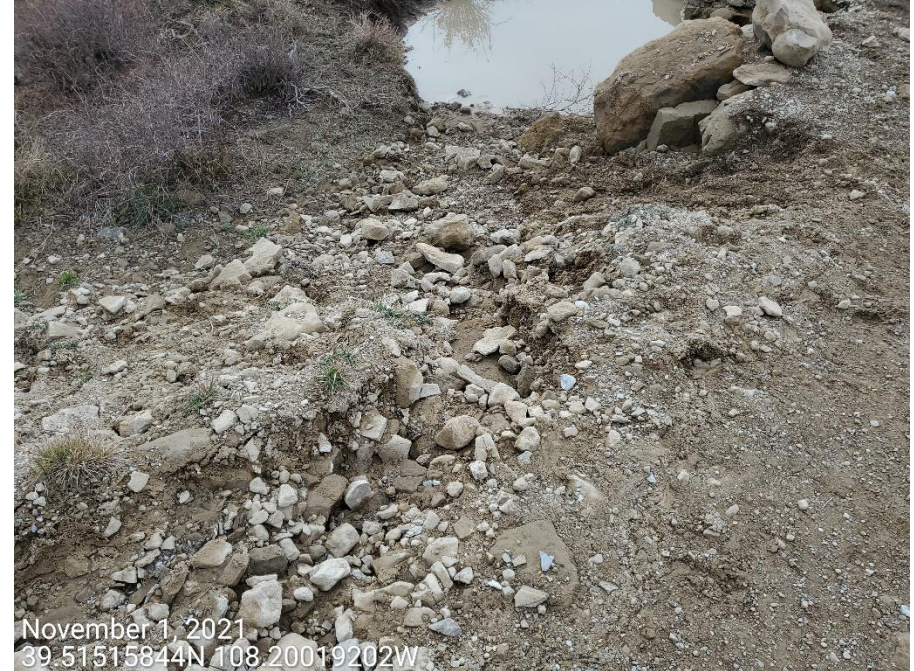
Photo 4: Photos show erosion degradation along the access road; control measures to stabilize, manage runoff, and minimize erosion remain missing or insufficient at the access road; erosion degradation and offsite sediment transport observed.

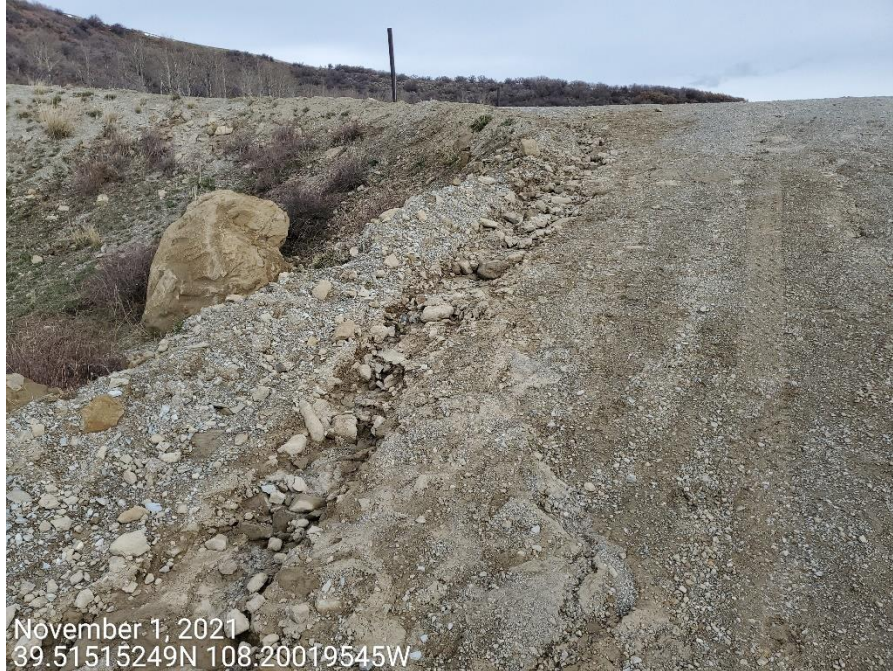
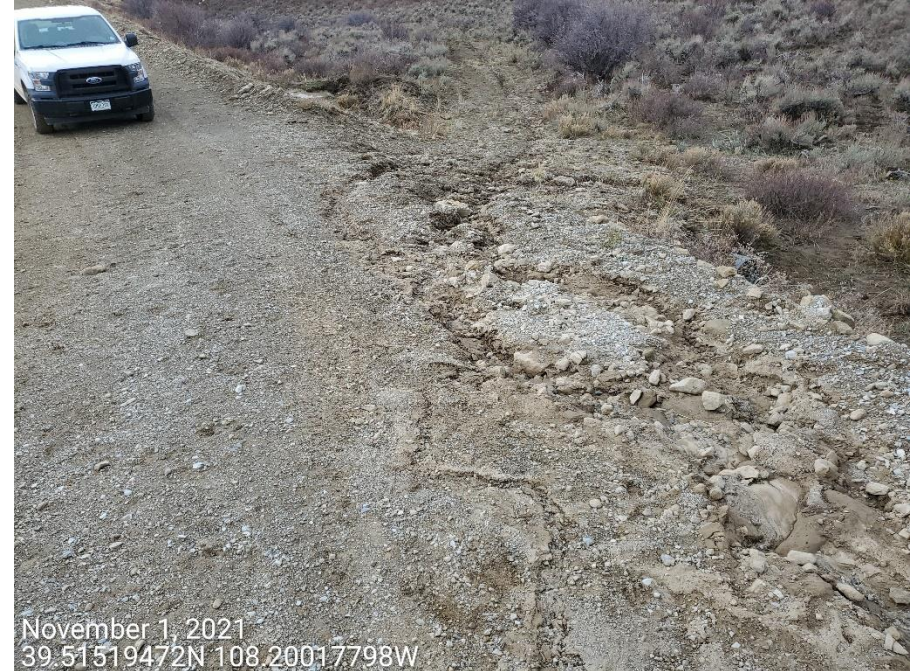
Photo 5. Photos show erosion degradation along the access road; control measures to stabilize, manage runoff, and minimize erosion remain missing or insufficient at the access road; erosion degradation and offsite sediment transport observed.
