Inspection Photos
Location Name: UPRR 43 Pan AM #6
Location ID: 318576

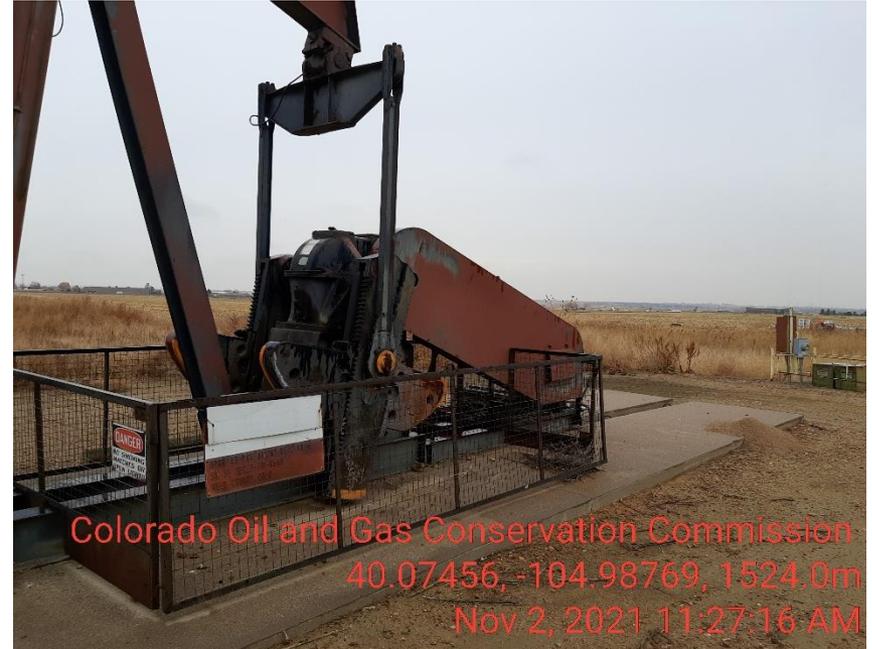
Photo 2 Well head sign faded not legible
