Inspection Photos
Location Name: UPRR 43 Pan AM I #19
Location ID: 332976

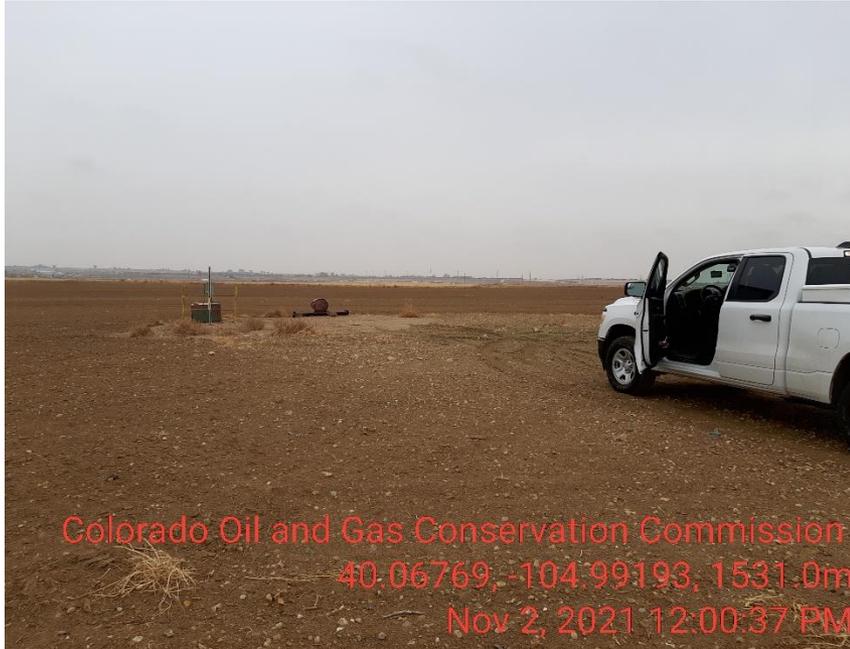
Photo 1 loc pic Unused equipment electric panel and road leveler

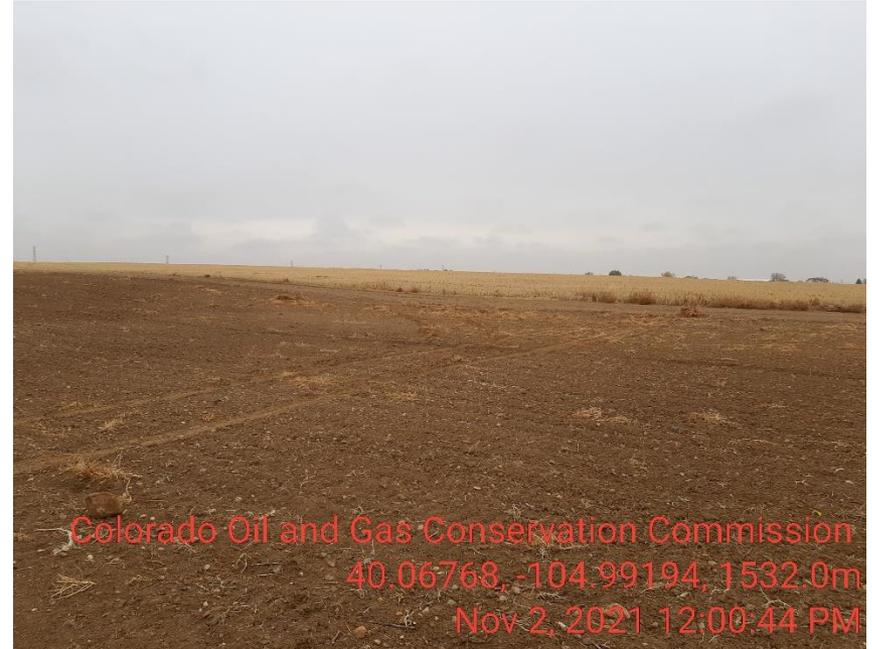
Photo 2 Access road appears to be plowed over by farmer

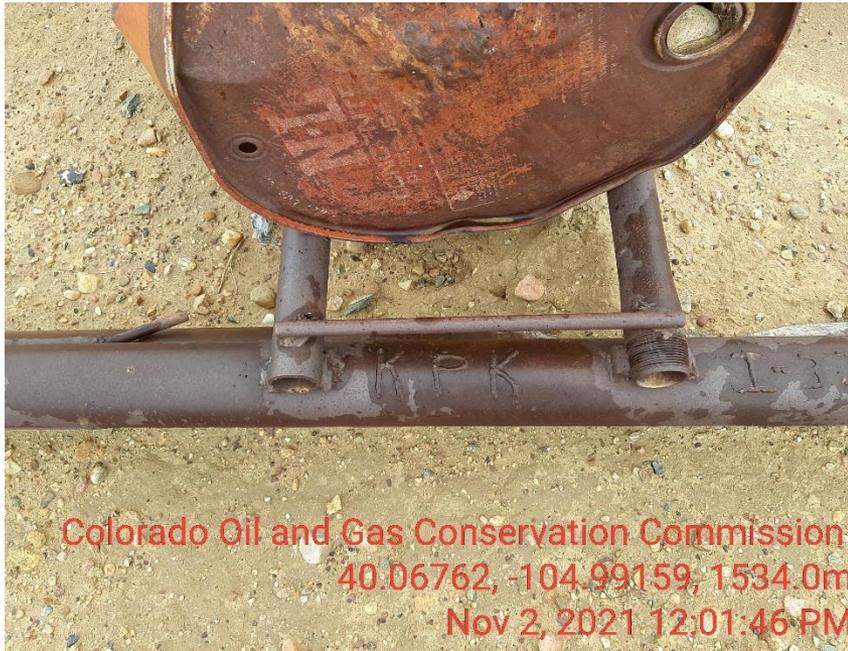
Photo 3 Unused equipment road leveler clearly says KPK
