Inspection Photos

11/01/2021

Operator: LARAMIE ENERGY LLC - 10433

Location ID: 452807

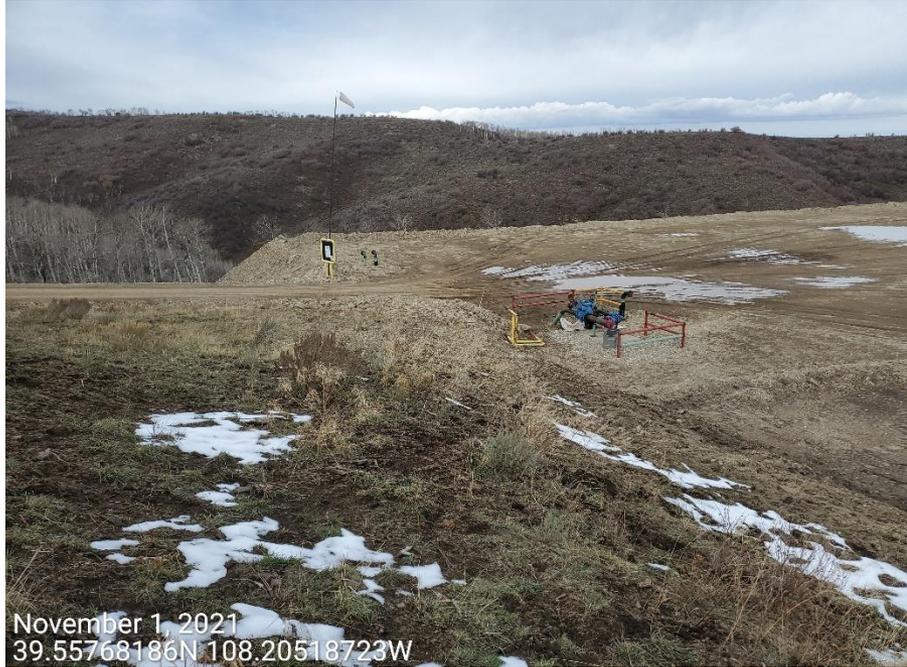
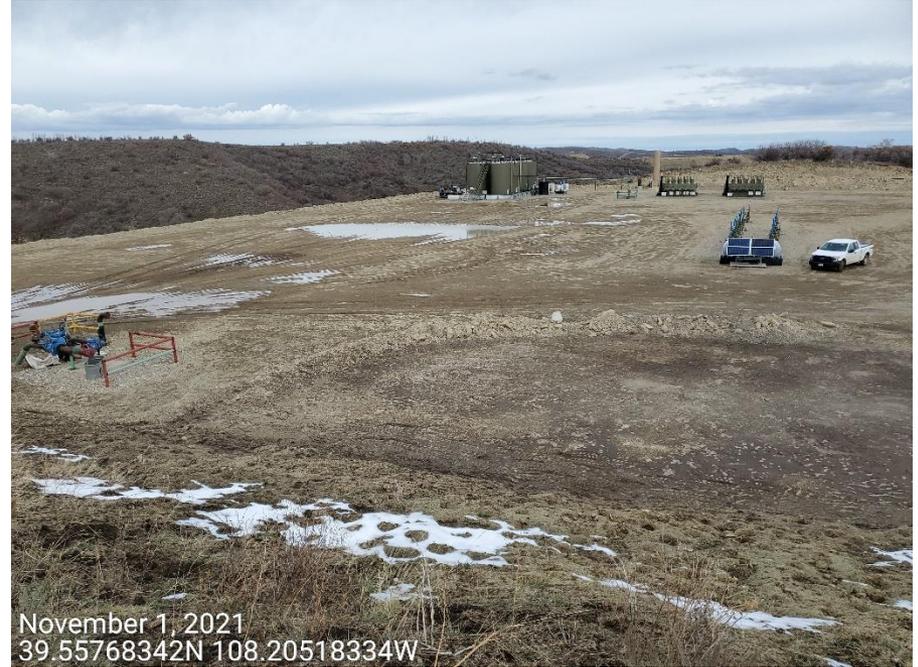
Photo 1: Photos 1-2 taken from the south end of the Location. Photos provide an overview of the Location from west, northwest, northeast to east. Photos also show interim reclamation has not been conducted on the location in accordance with 1003 rules.

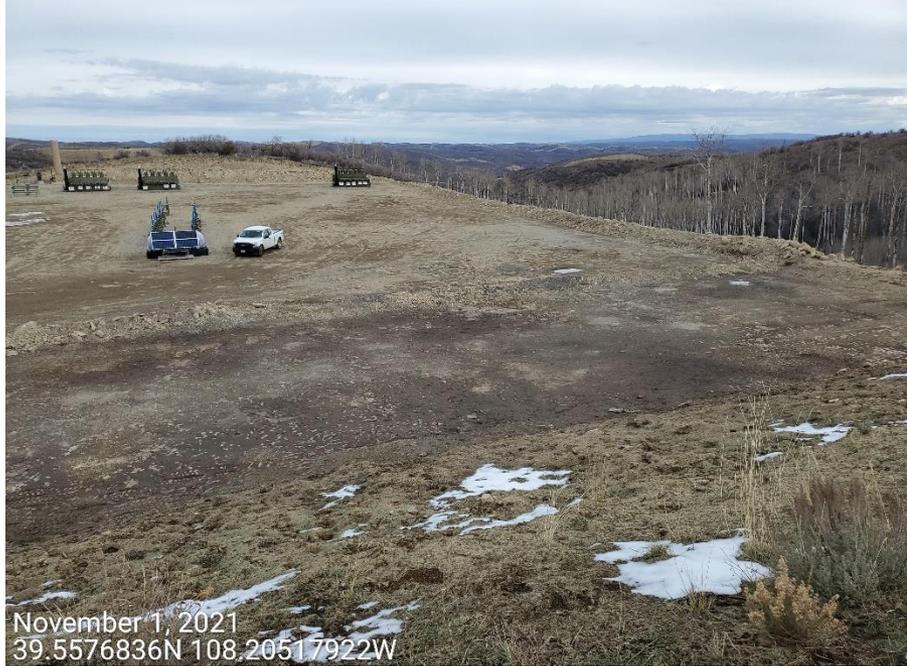
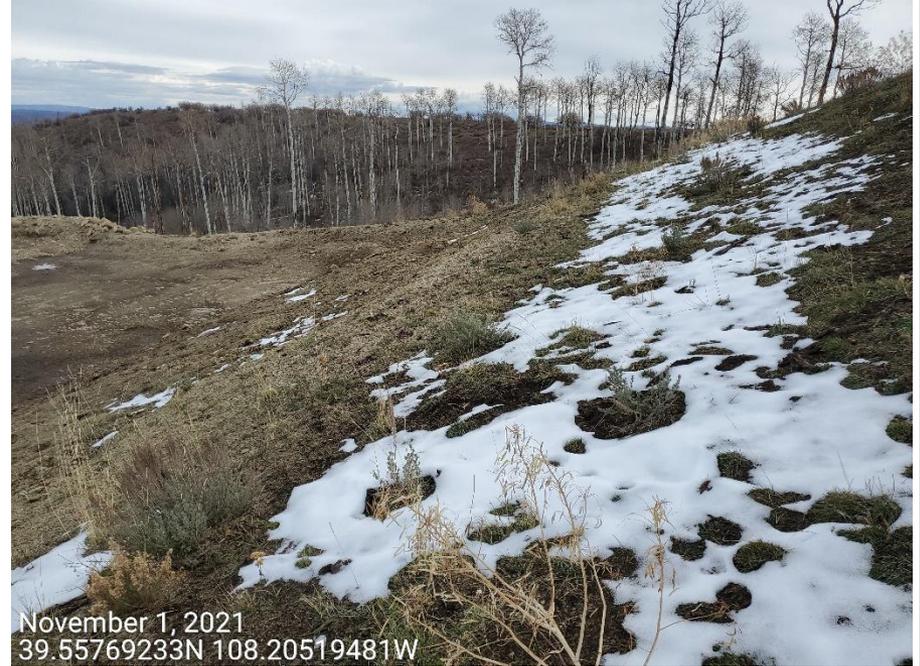
Photo 2: See comments under photo 1.

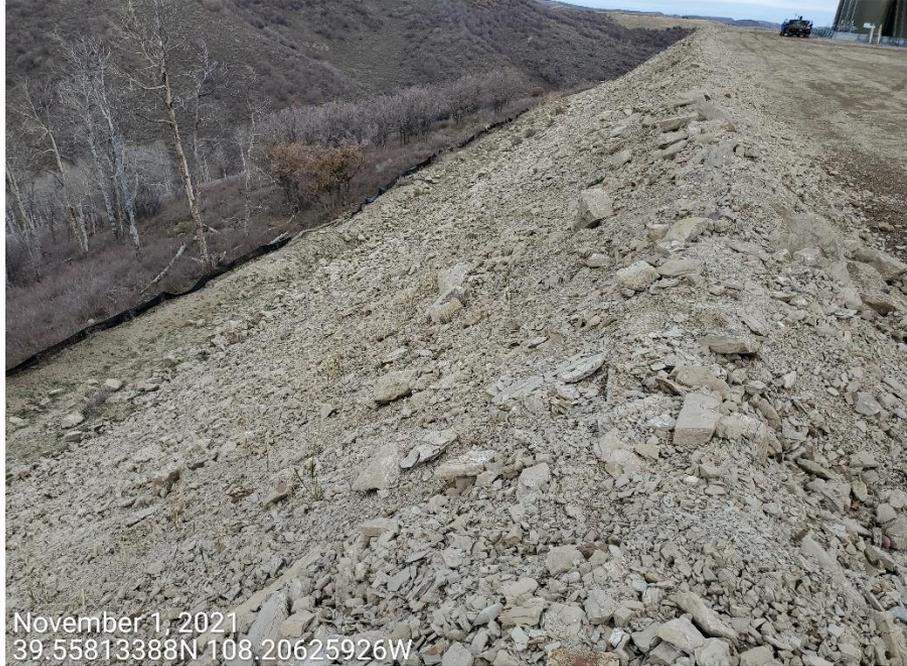
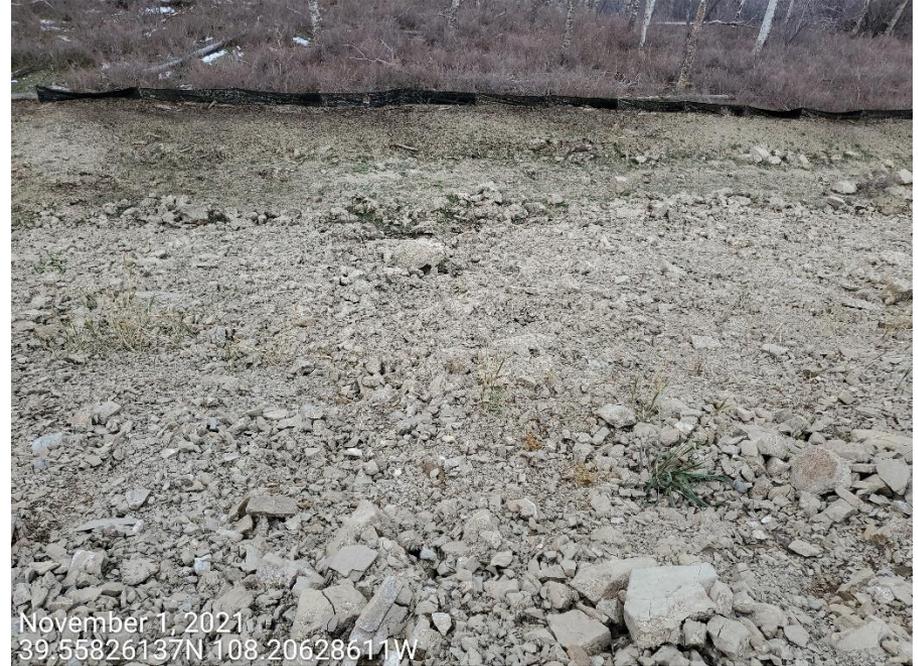
Photo 3: Photos provide examples of the steep, rocky fill slopes on the Location. Previous inspections required Operator to implement control measures to protect and stabilize the slopes of the Location; Operator implemented hydromulch on the slopes of the Location. Hydromulch is inadequate to stabilize the fill slopes due to the Location's steep grade and rocky conditions; BMP inadequate per the site's conditions.

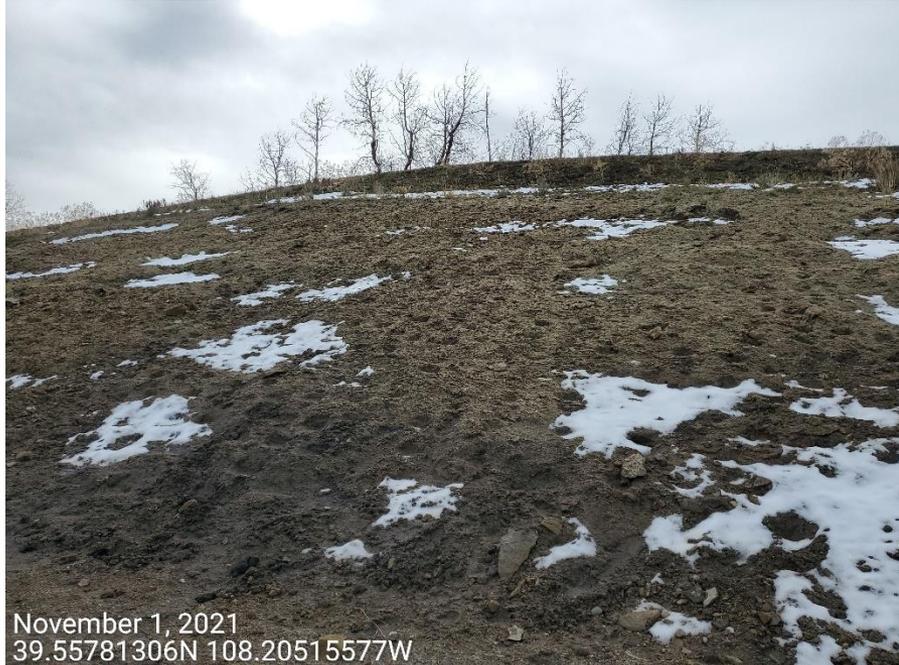
November 1, 2021
39.55781306N 108.20515577W

Photo 4: Photo taken from the cut slopes of the Location; hydromulch has been applied to the exposed soils on the cut slope. Hydromulch is a temporary control; ensure BMP is maintained in proper functioning condition.
