Inspection Photos

11/01/2021

Operator: LARAMIE ENERGY LLC - 10433

Location ID: 383337

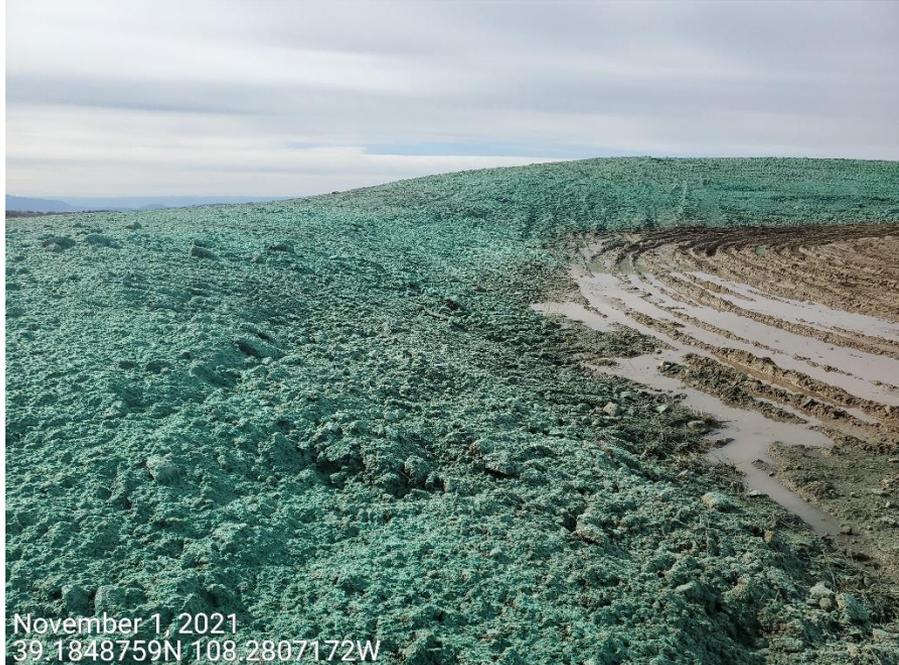
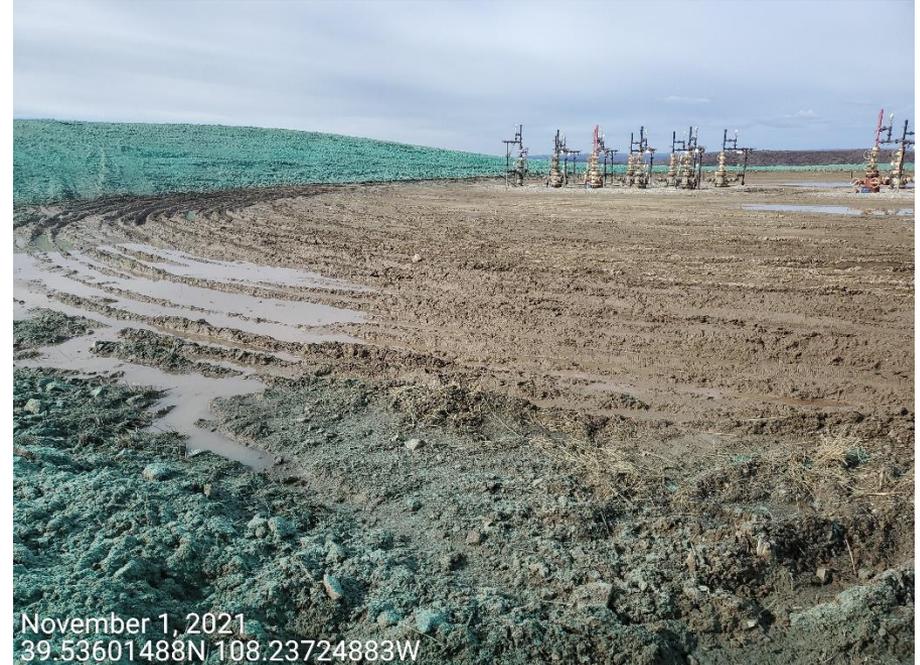
Photo 1: Photos 1-2 taken from the east end of the Location. Photos provide an overview of the Location from south, southwest, northwest to north. Photos also show interim reclamation of areas not needed for production has been performed or is in process; Operator observed applying hydromulch/hydroseed to the southern interim areas at time of inspection.

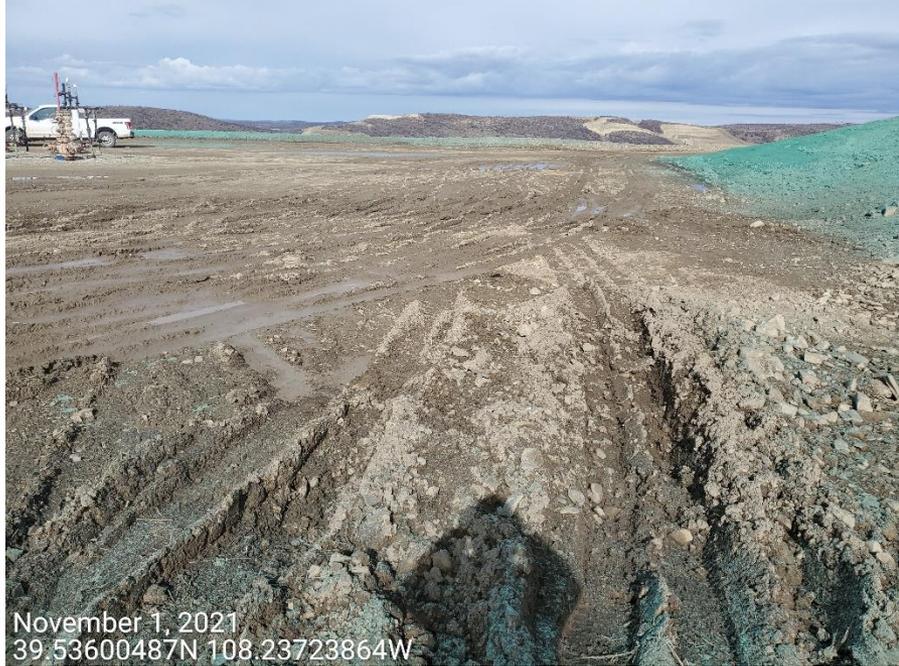
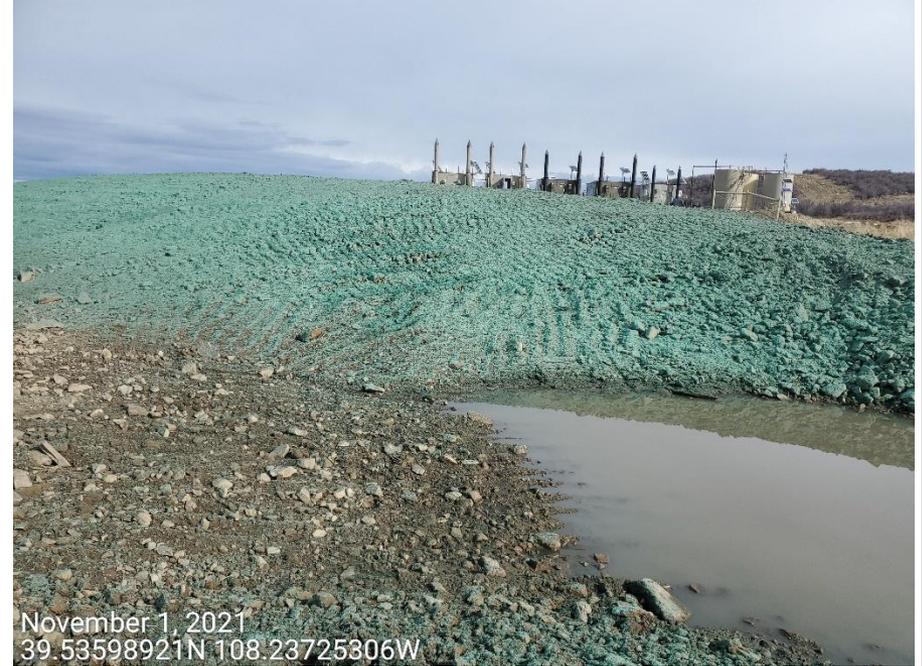
Photo 2: See comments under photo 1.

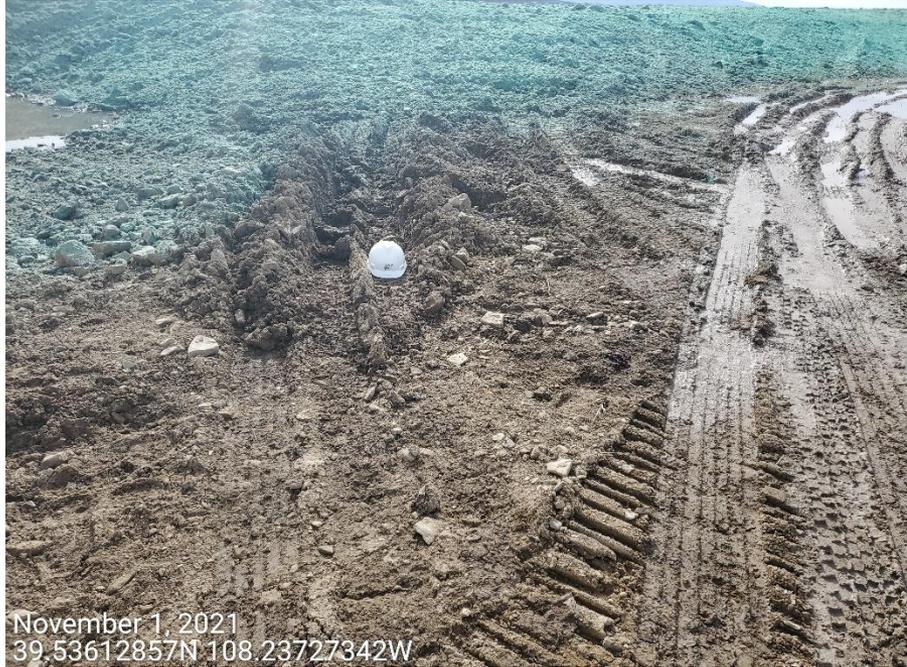
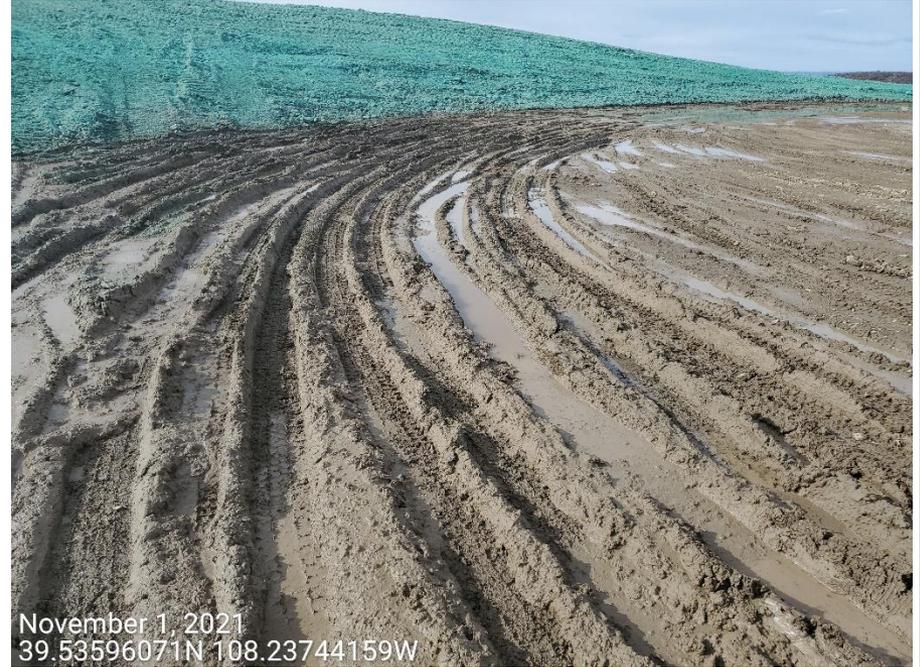
Photo 3: Photos taken from the production area and provide examples showing control measures to stabilize the Location, and mitigate tracking and offsite sediment transport are missing or insufficient.

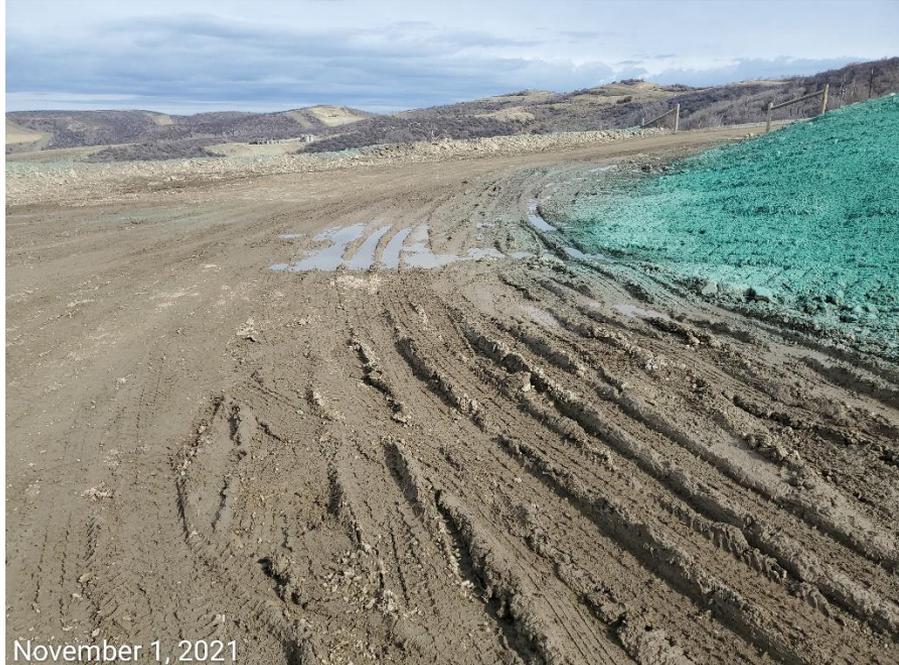
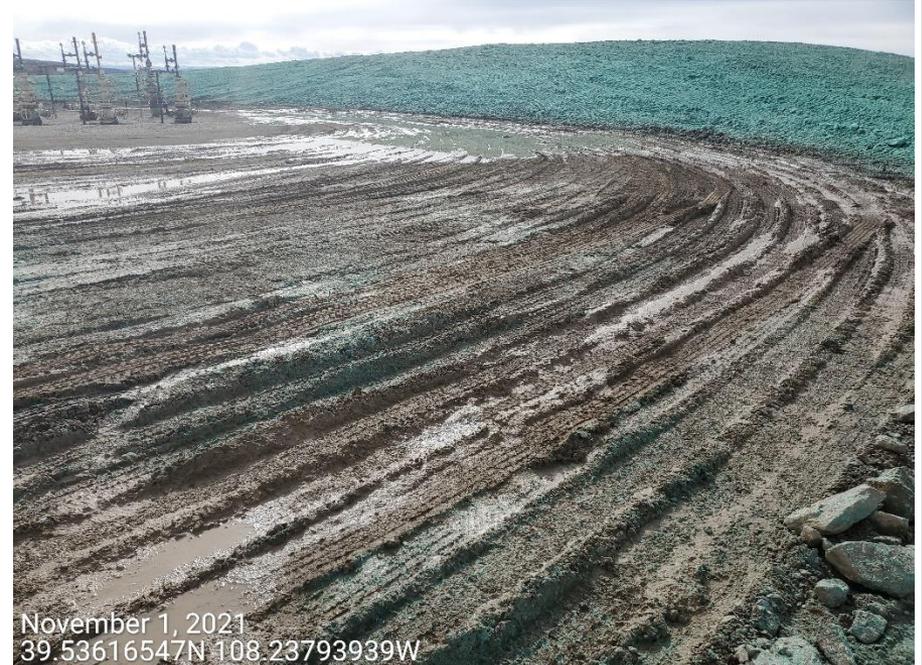
Photo 4: Photos taken from the production area and provide examples showing control measures to stabilize the Location, and mitigate tracking and offsite sediment transport are missing or insufficient. Photo on left shows Location entrance to the well pad.

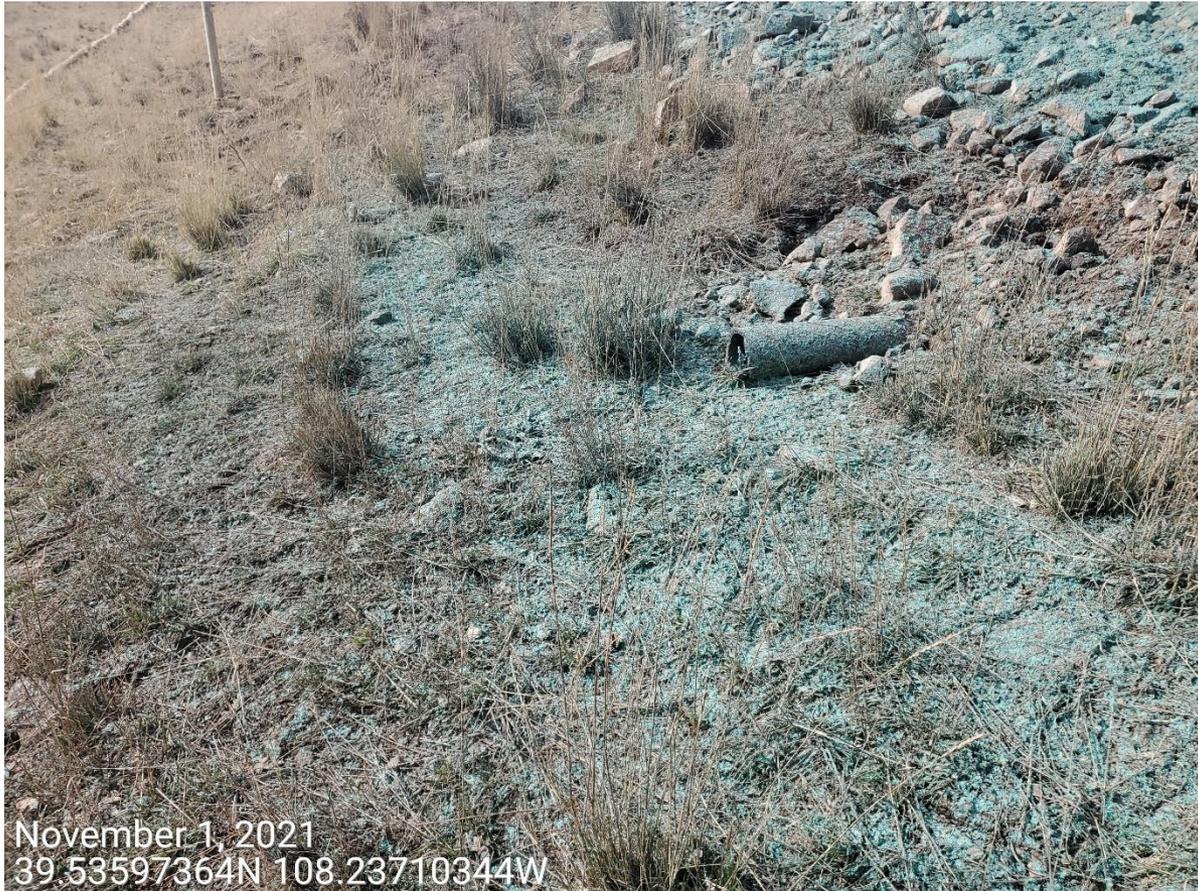
Photo 5: Photo taken from the sediment trap outlet on the east end of the Location. BMP has not been constructed in accordance with good engineering practices and is missing proper armoring and protection at the outlet spillway. Control is inadequate to allow for proper stormwater discharge.
