Inspection Photos Operator:
Logos Operating
API: 067-05780
Date: 10/29/2021

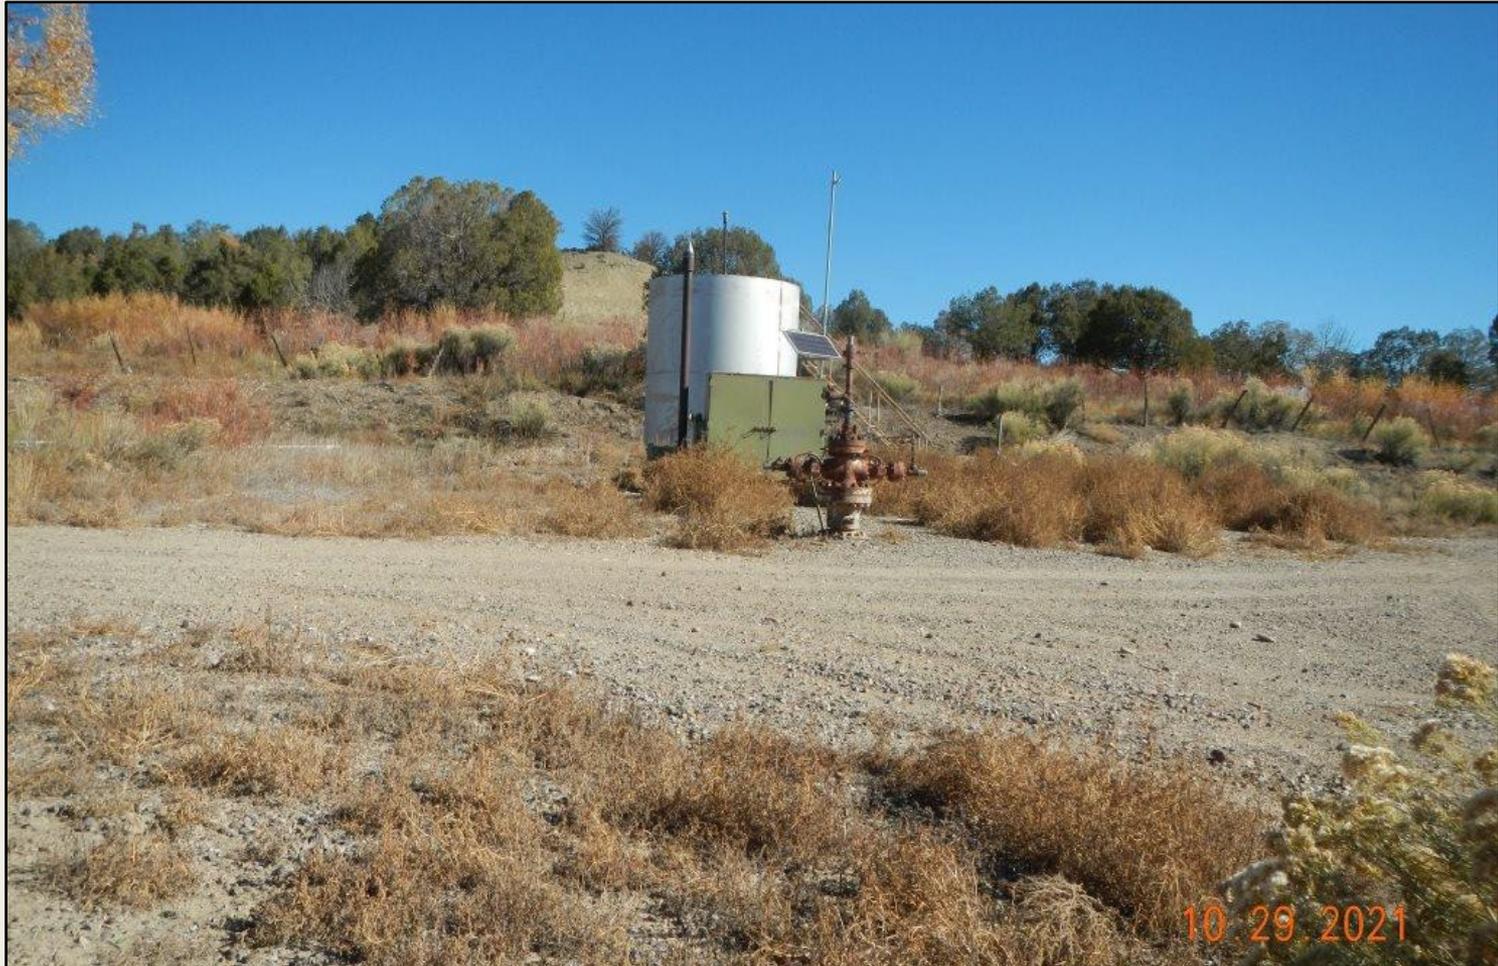
Photo 1. View of the project area from the well pad entrance facing center.

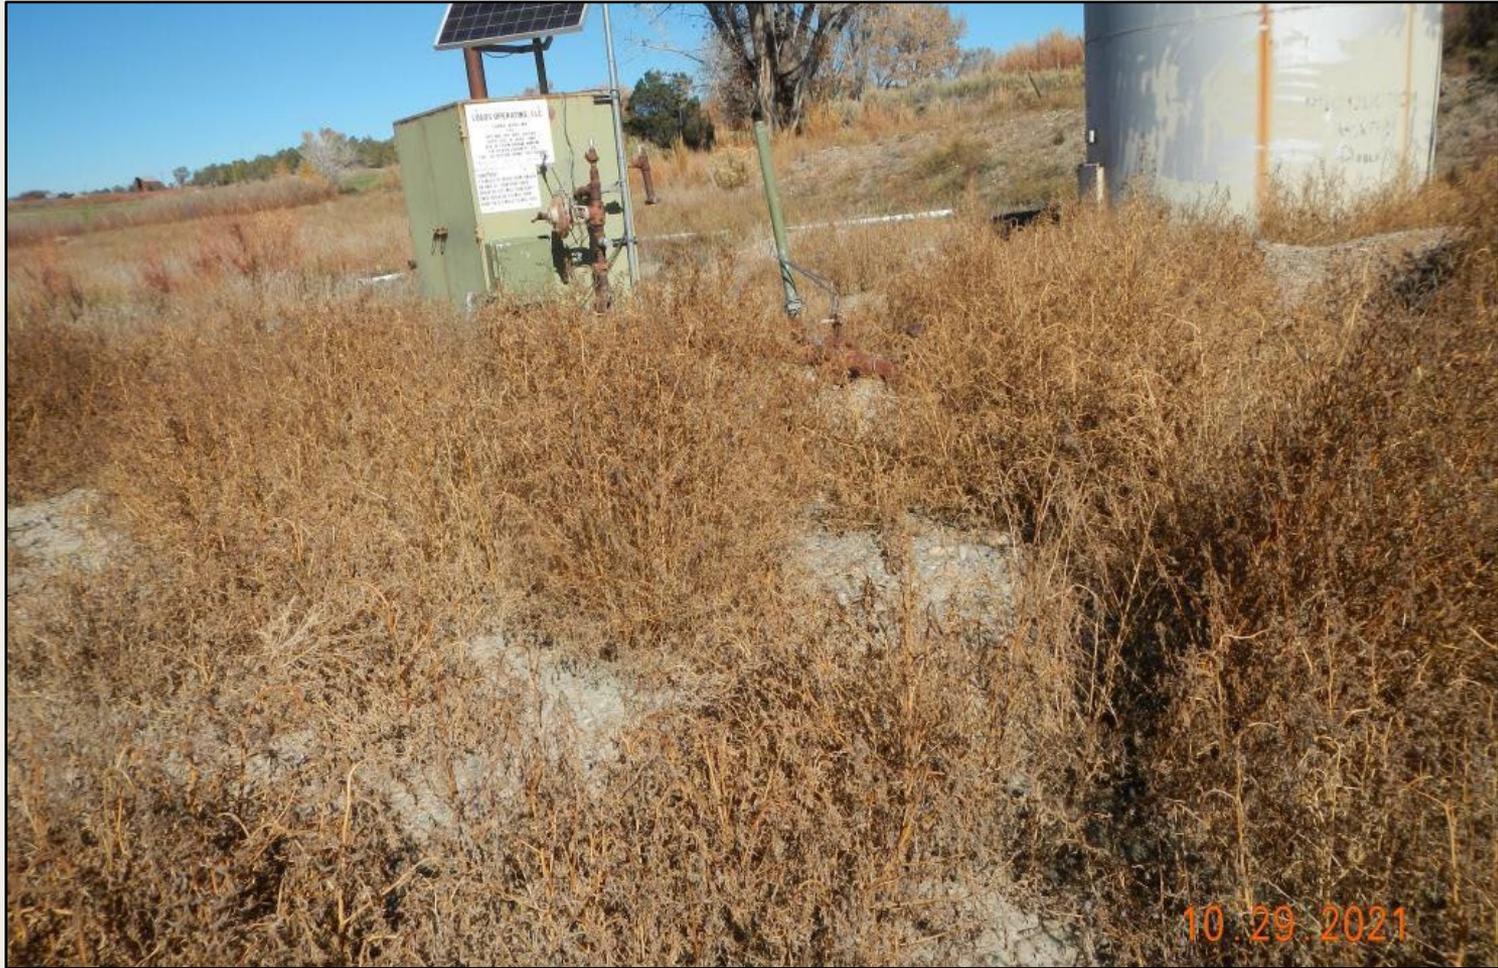
Photo 2. View of dense kochia and weed debris, up to 4 feet tall, observed throughout the working area and facilities.

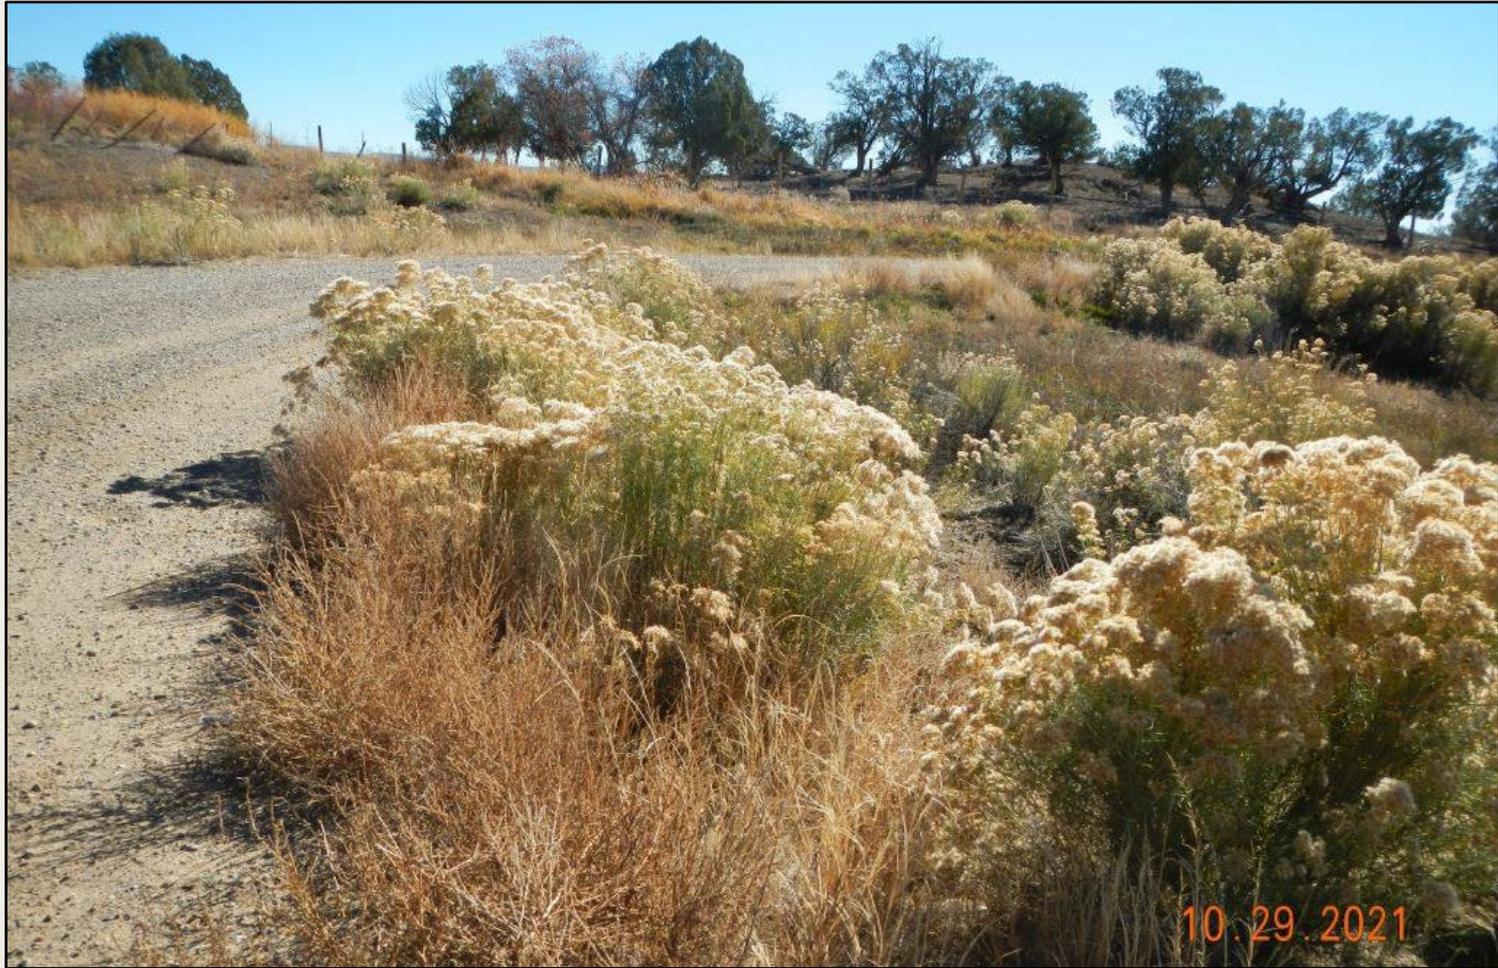
Photo 3. View of the southern fill slope from the southwestern corner facing eastward. Revegetation is progressing with rubber rabbitbrush, western wheatgrass, and sand dropseed.

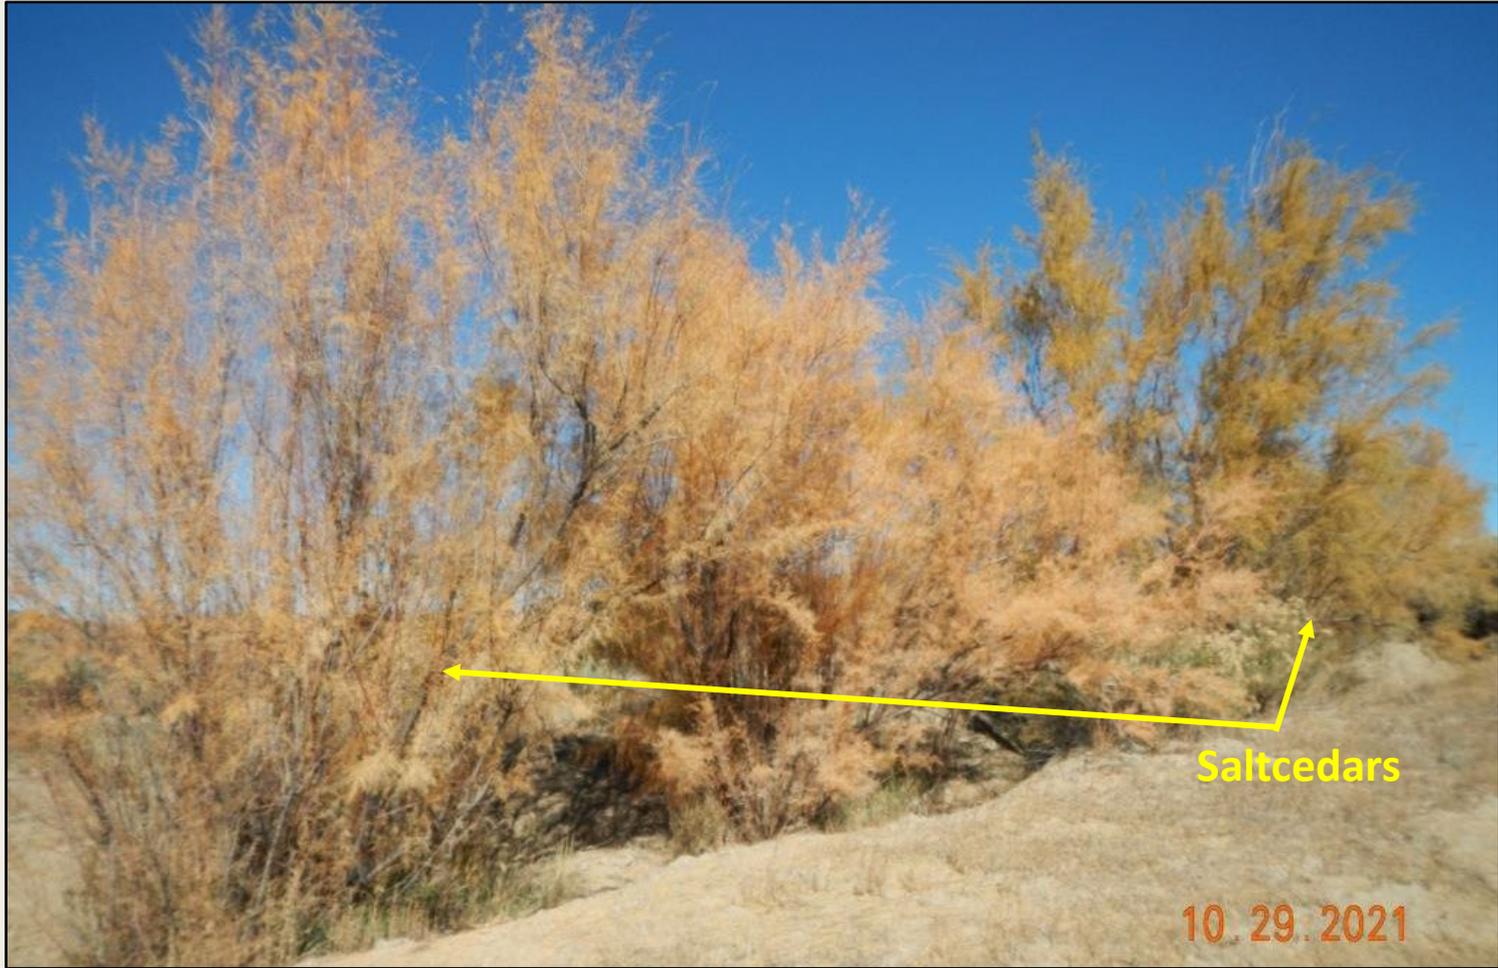
Photo 4. View of saltcedar (*Tamarisk* sp.) growing within the northern and western (inset) project area, that need to be removed. Approximately 15 individuals observed.

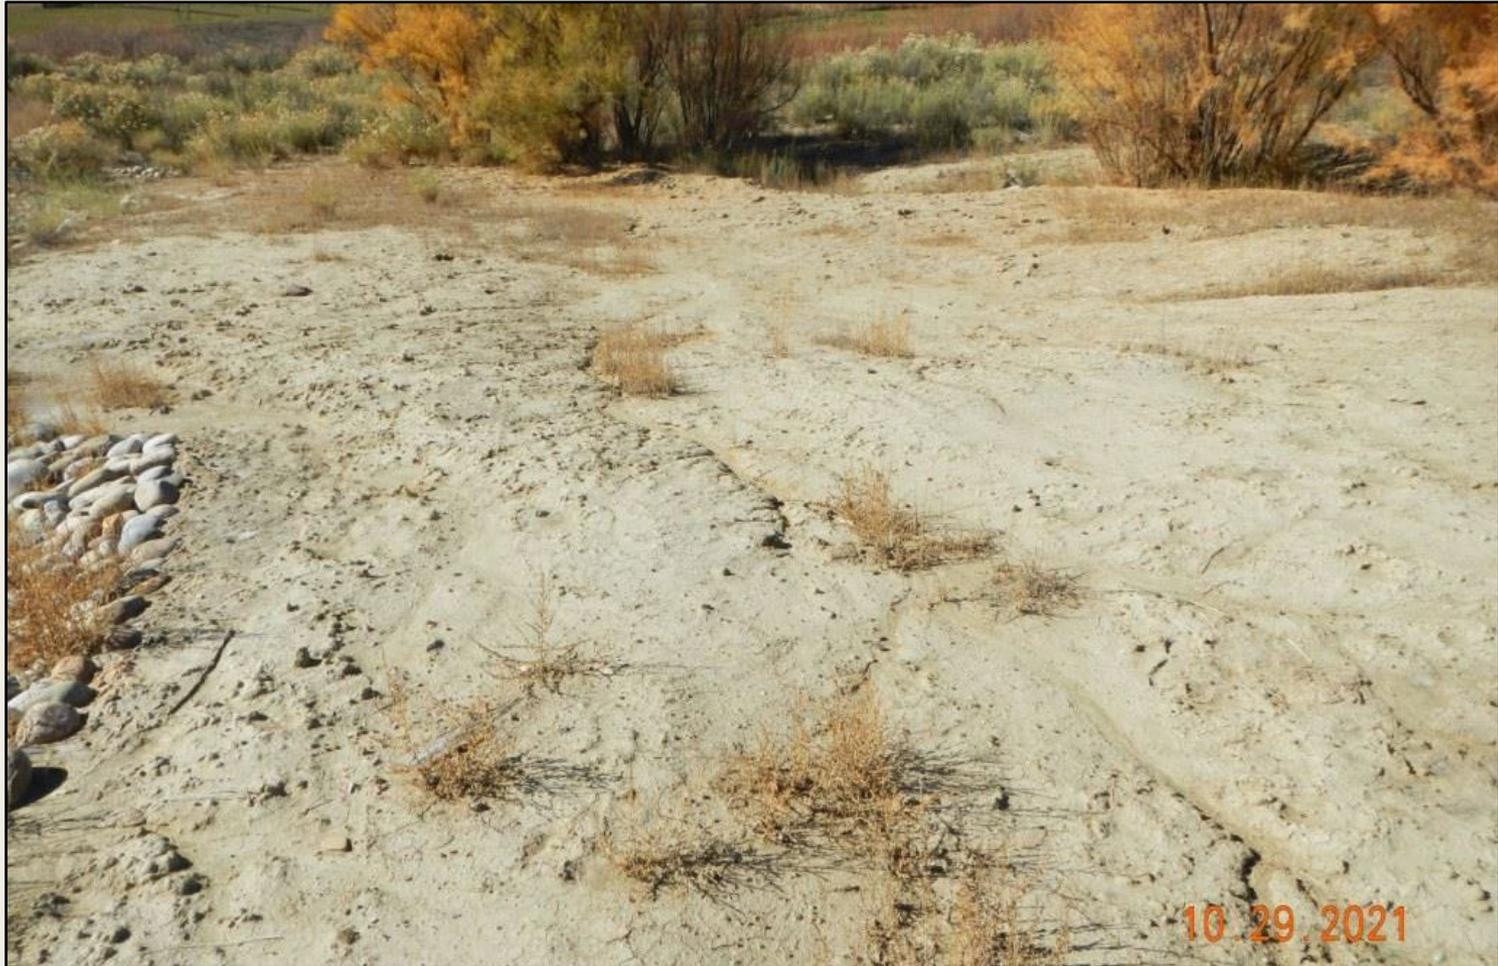
Photo 5. View of area in the western project area, approximately 50ft wide and long, where bare soils are eroding and need to be stabilized.

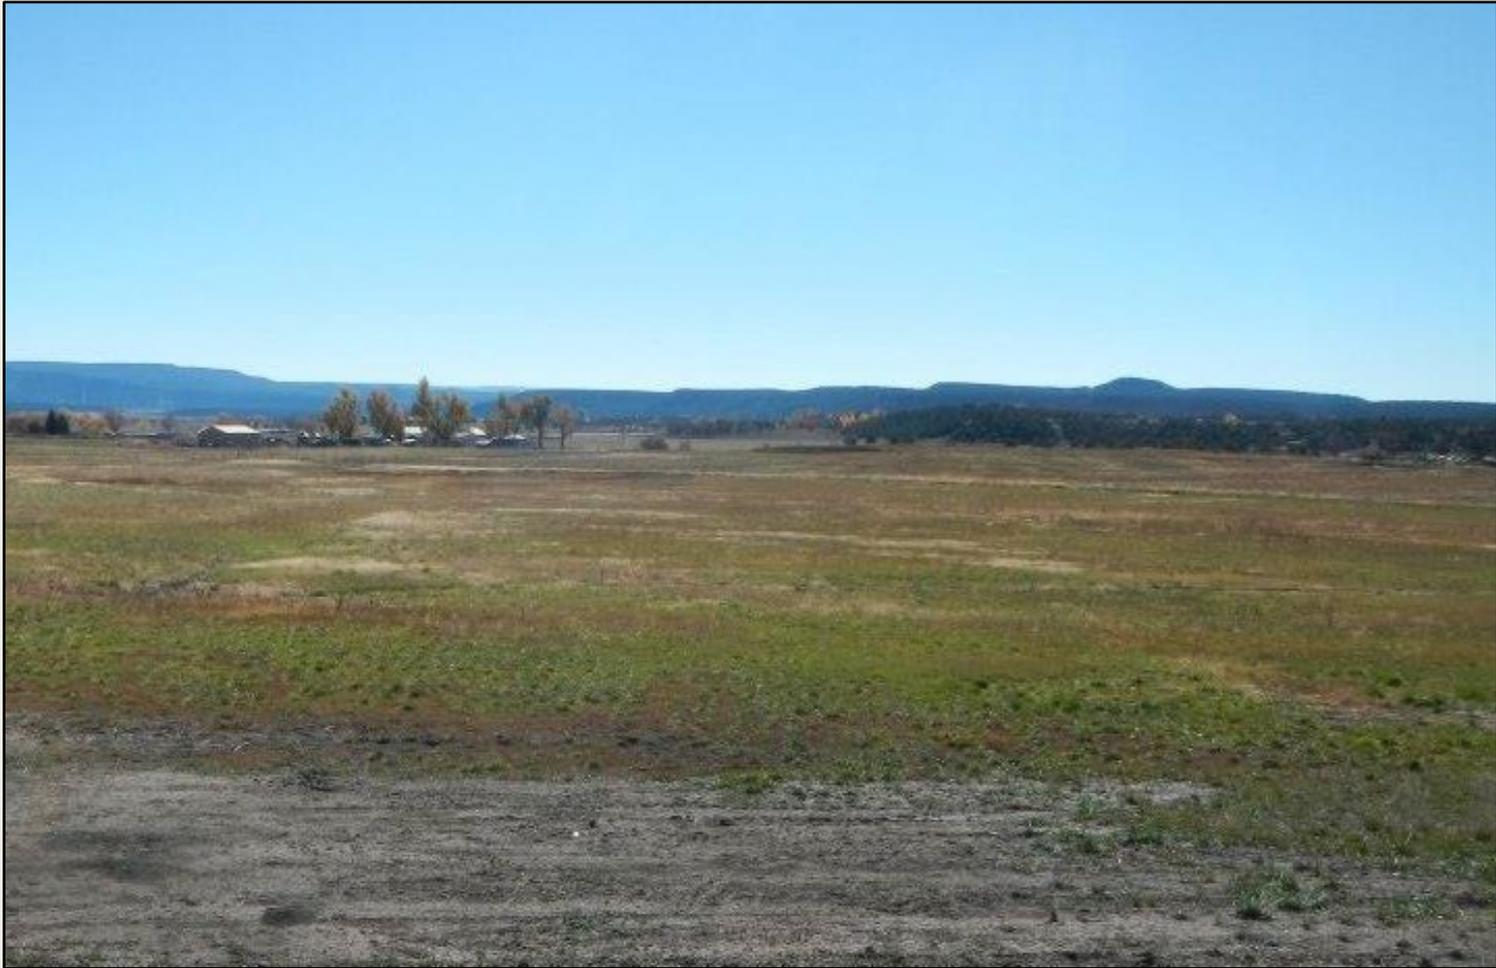
Photo 6. View of reference area comprised of open grass field, largely in a grazed vegetative condition, with grasses such as western wheatgrass and smooth brome.
