Inspection Photos
Operator: WPX
API: 067-05075
Date: 10/29/2021

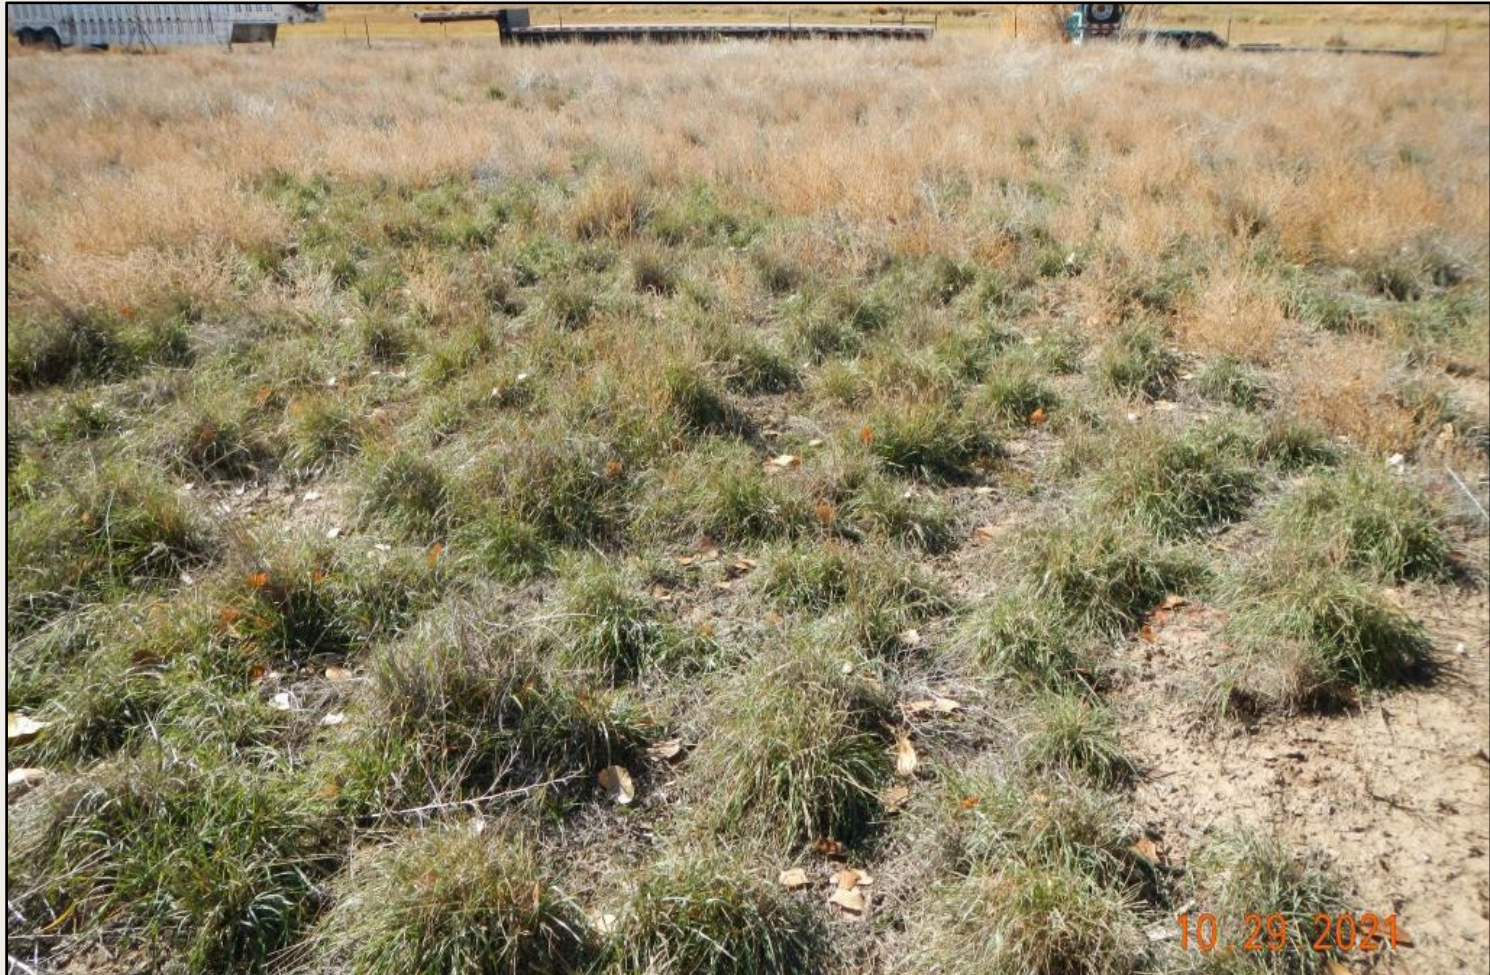
Photo 1. View of the project area from the northern edge facing center. Revegetation is progressing, largely with crested wheatgrass.

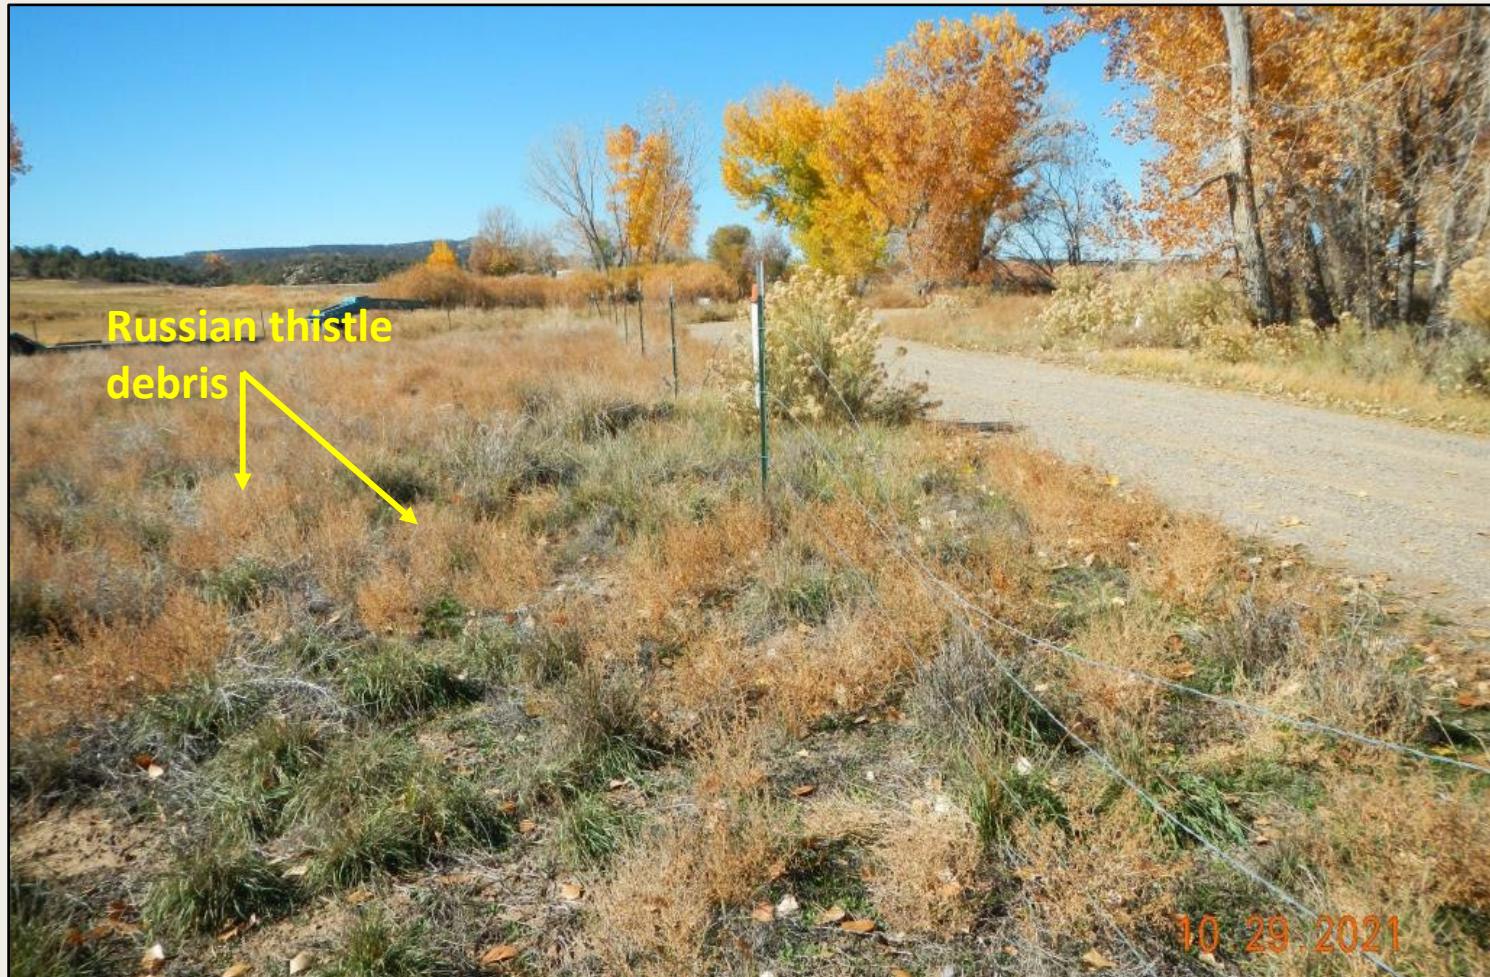
Photo 2. View of the northern project area from the northeastern corner facing westward. Fencing is in place and needs to be removed, as well as Russian thistle debris.

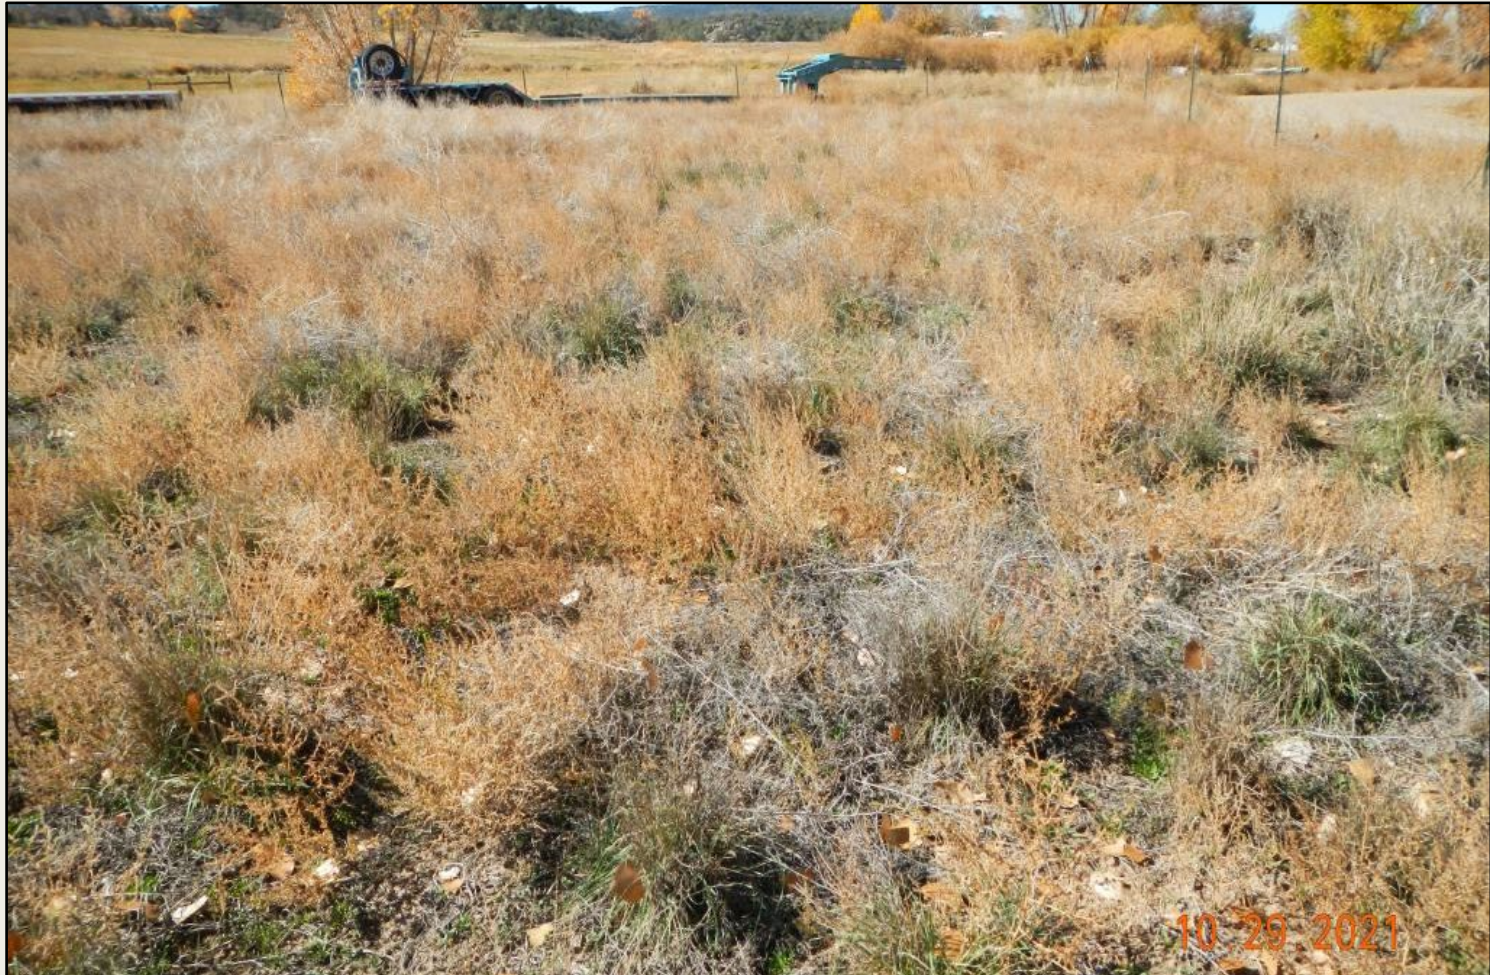
Photo 3. View of the western project area, perennial grasses established, dense Russian thistle debris needs to be removed.

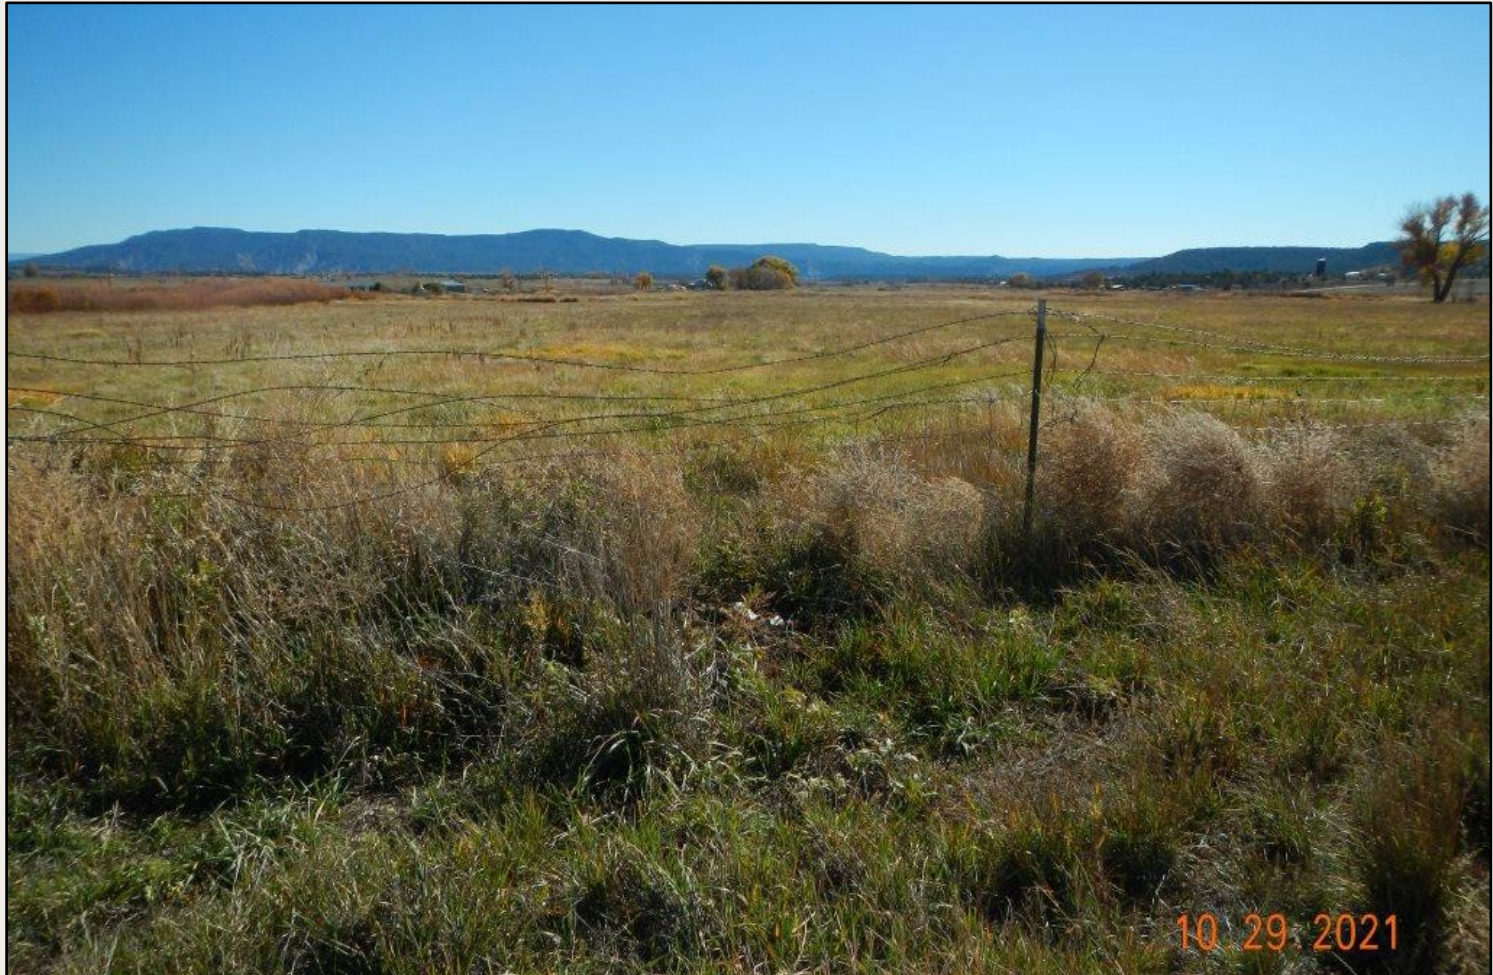
Photo 4. View of reference area comprised of open grass field with grasses such as smooth brome.
