Inspection Photos  
Operator: Hilcorp  
API: 067-07239  
Date: 10/29/2021

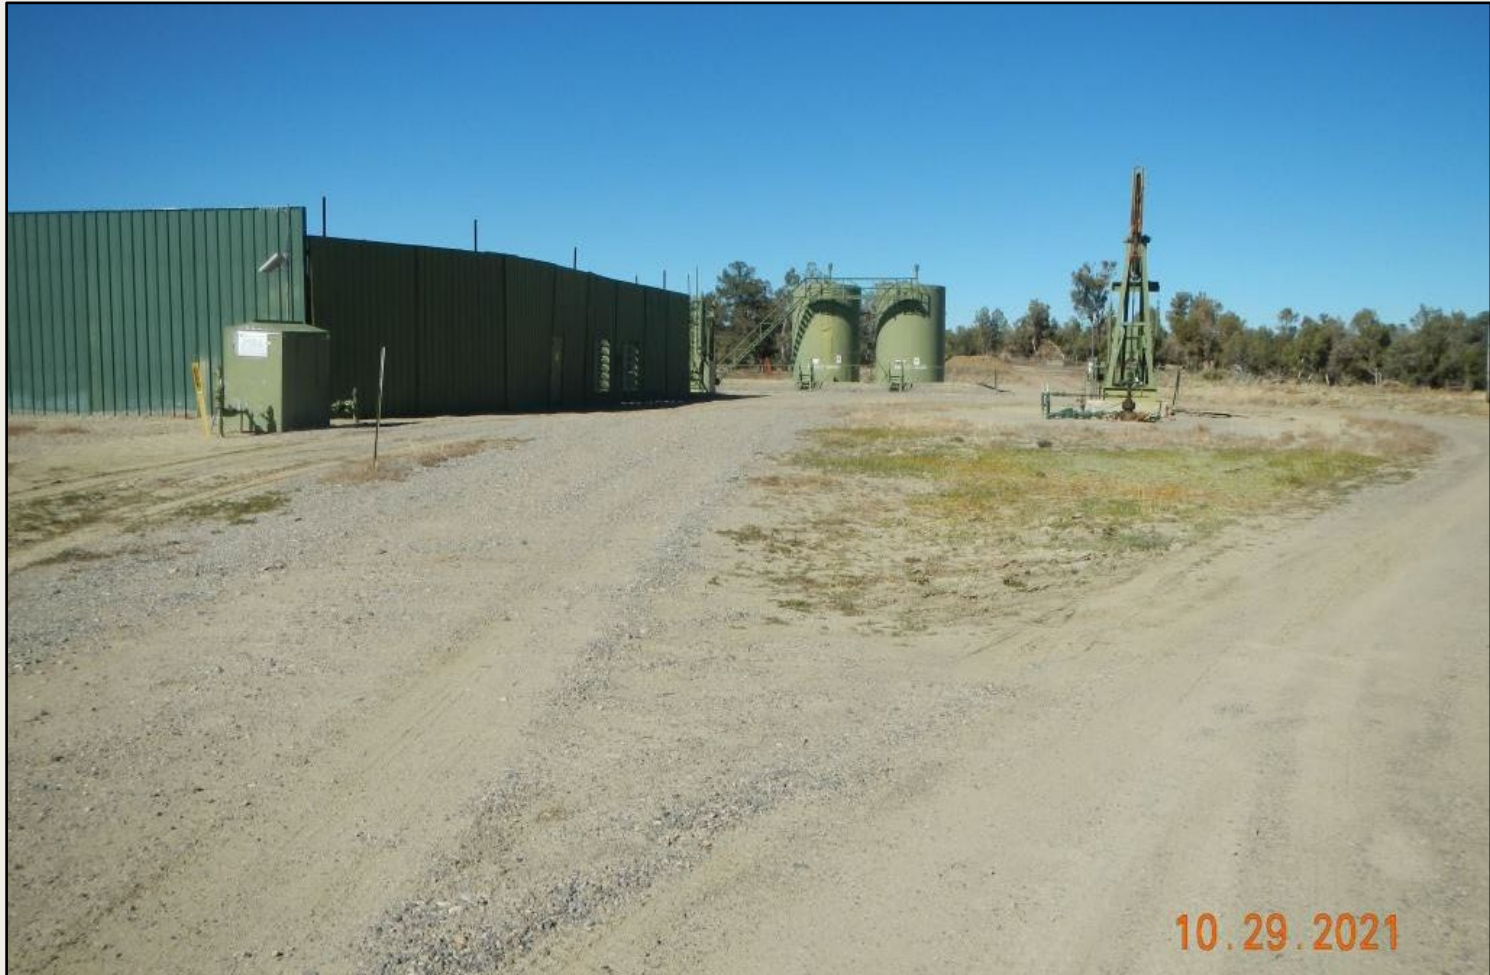
Photo 1. View of the project area from the well pad entrance facing center.

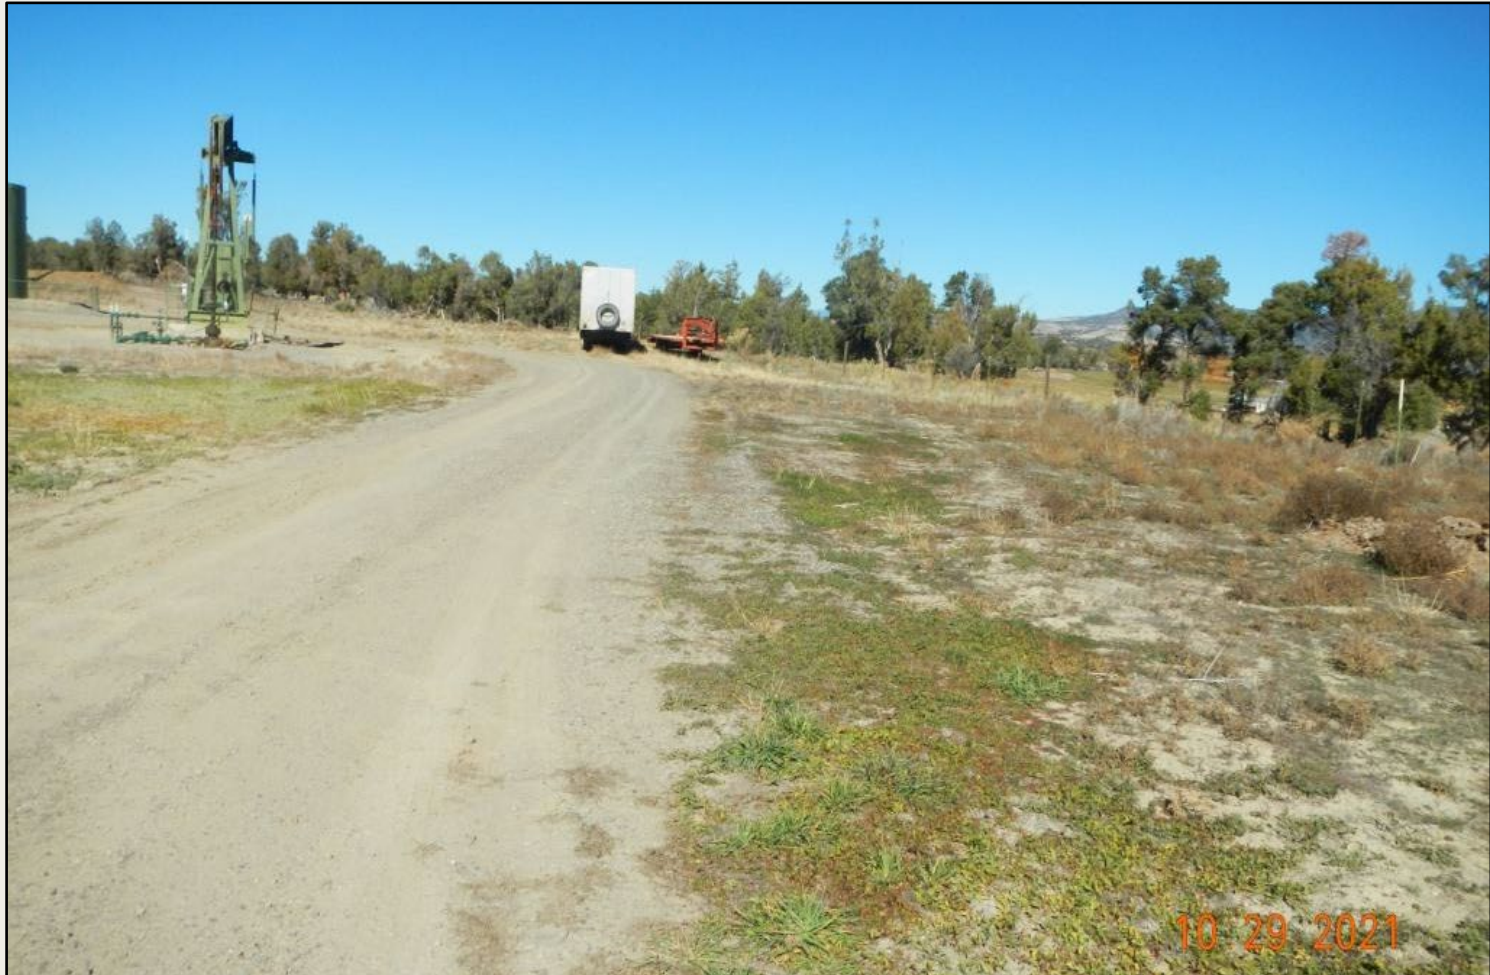
Photo 2. View of the eastern fill slope from the southeastern corner facing northward. Vegetation is sparse and needs to be assessed during the active growing season.

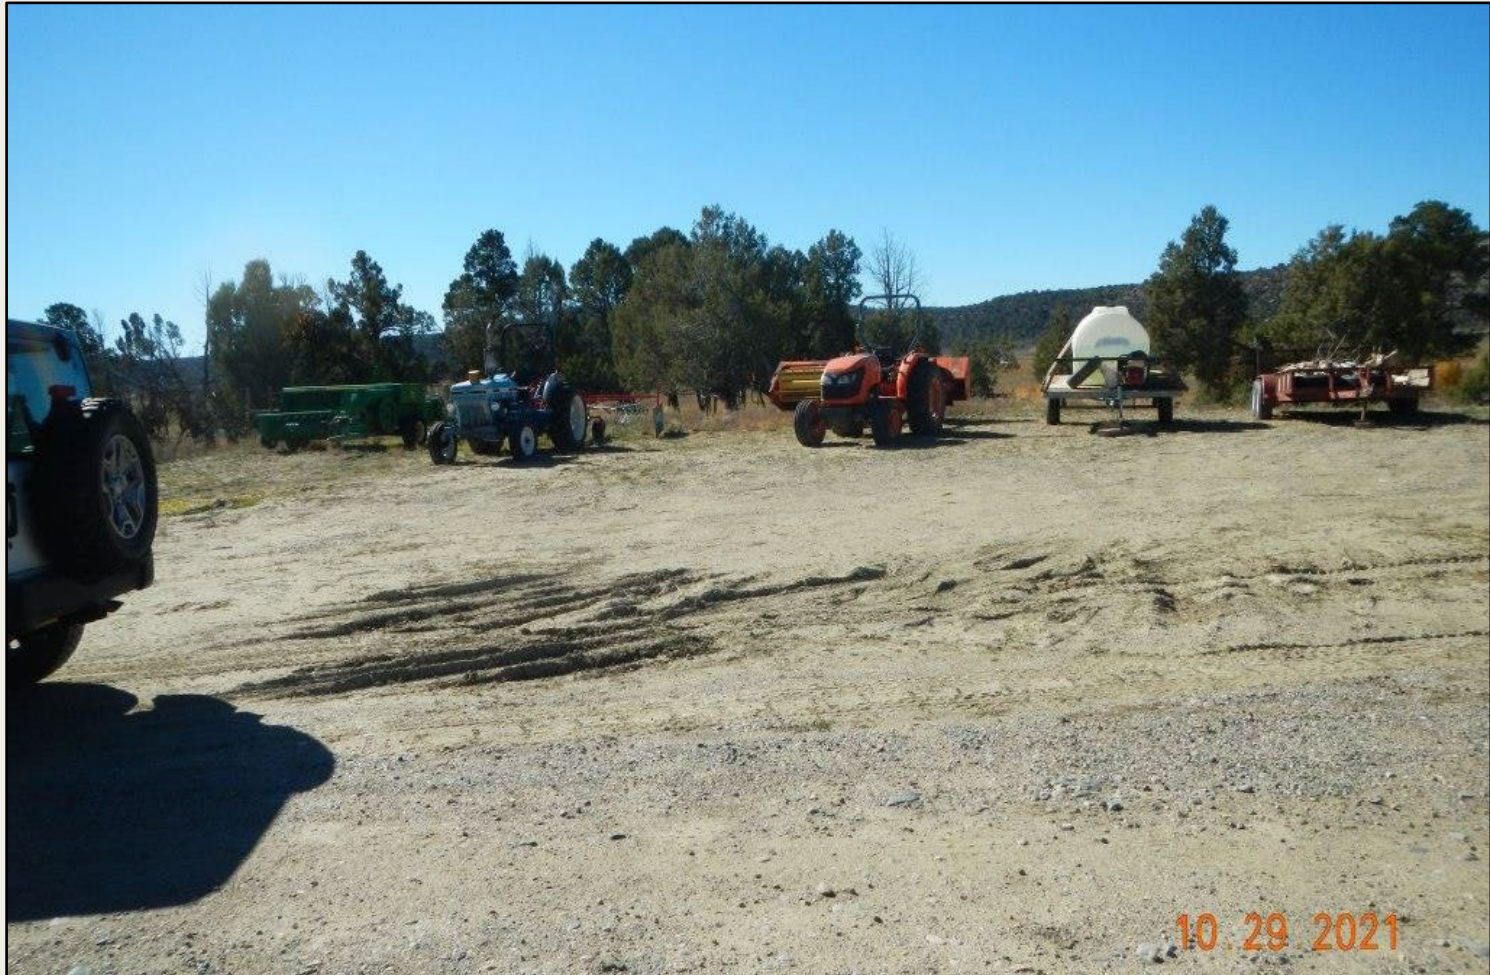
Photo 3. View of equipment within the southwestern project area.

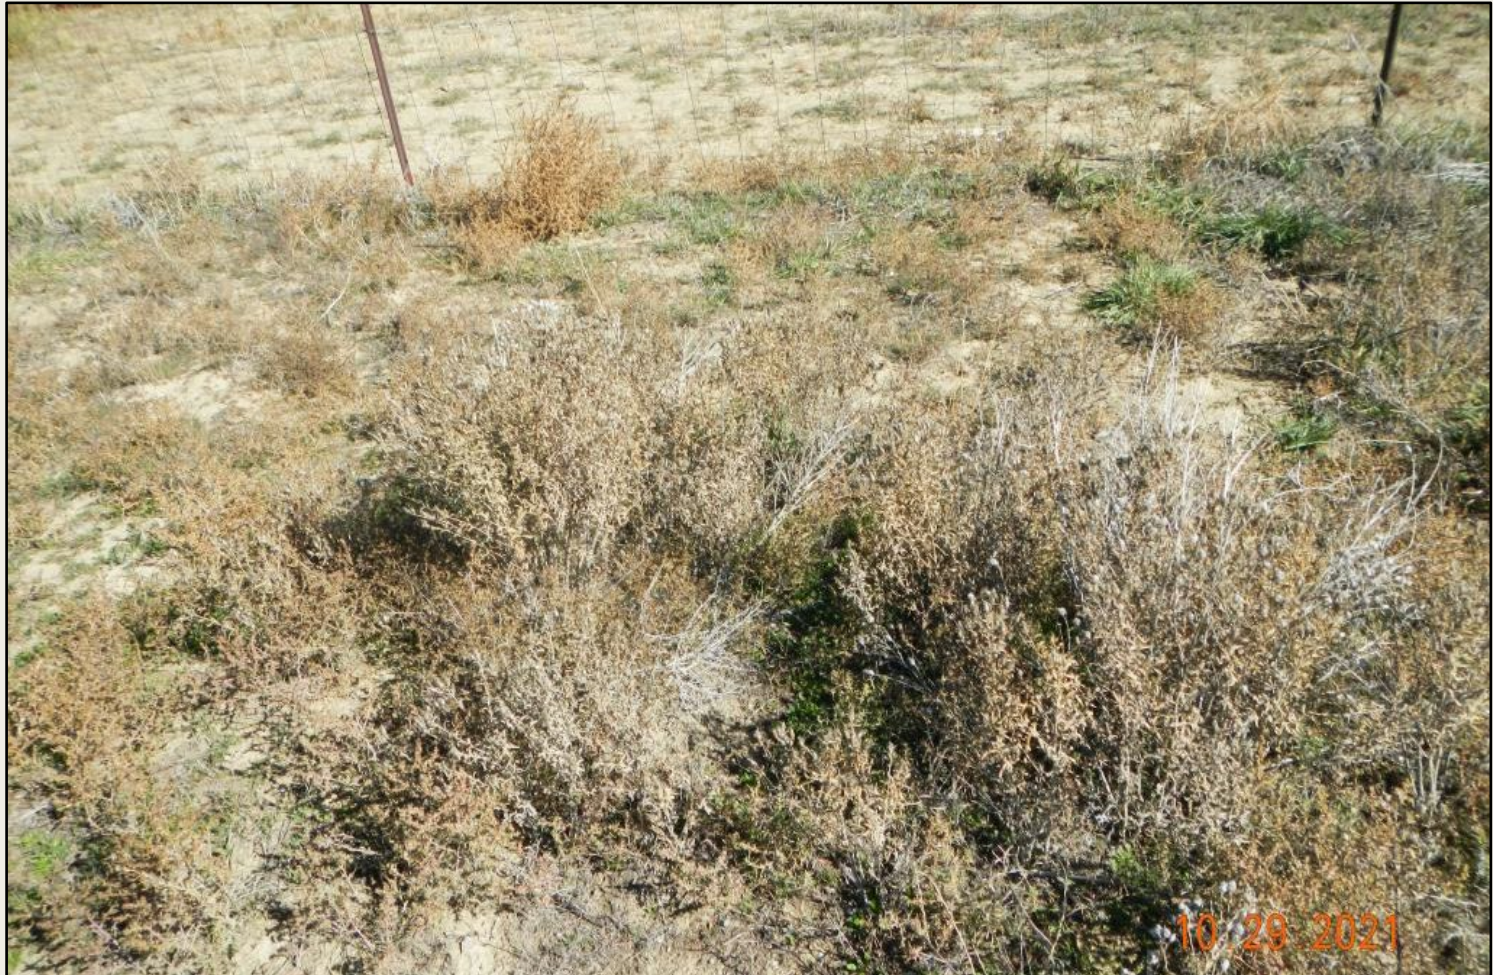
Photo 4. View of Russian knapweeds (approx. 200 individuals observed) within the eastern project area.

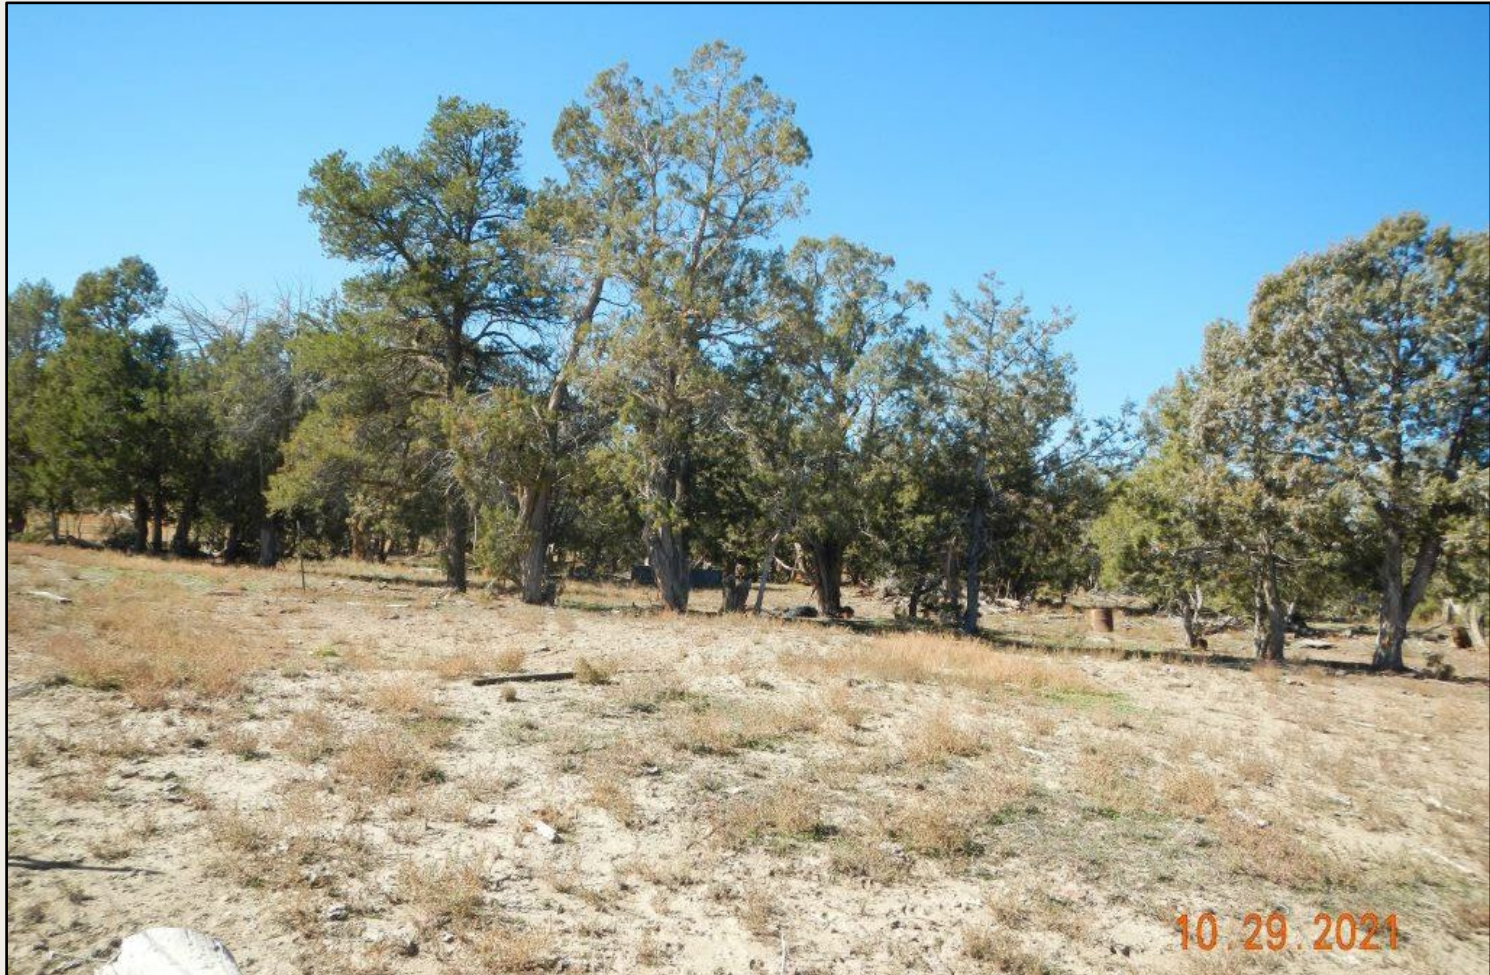
Photo 5. View of reference area comprised of pinyon and juniper woodland with understory of western wheatgrass and prickly pear.
