Location Name: Craig 8-1 Location ID/API #: 309619

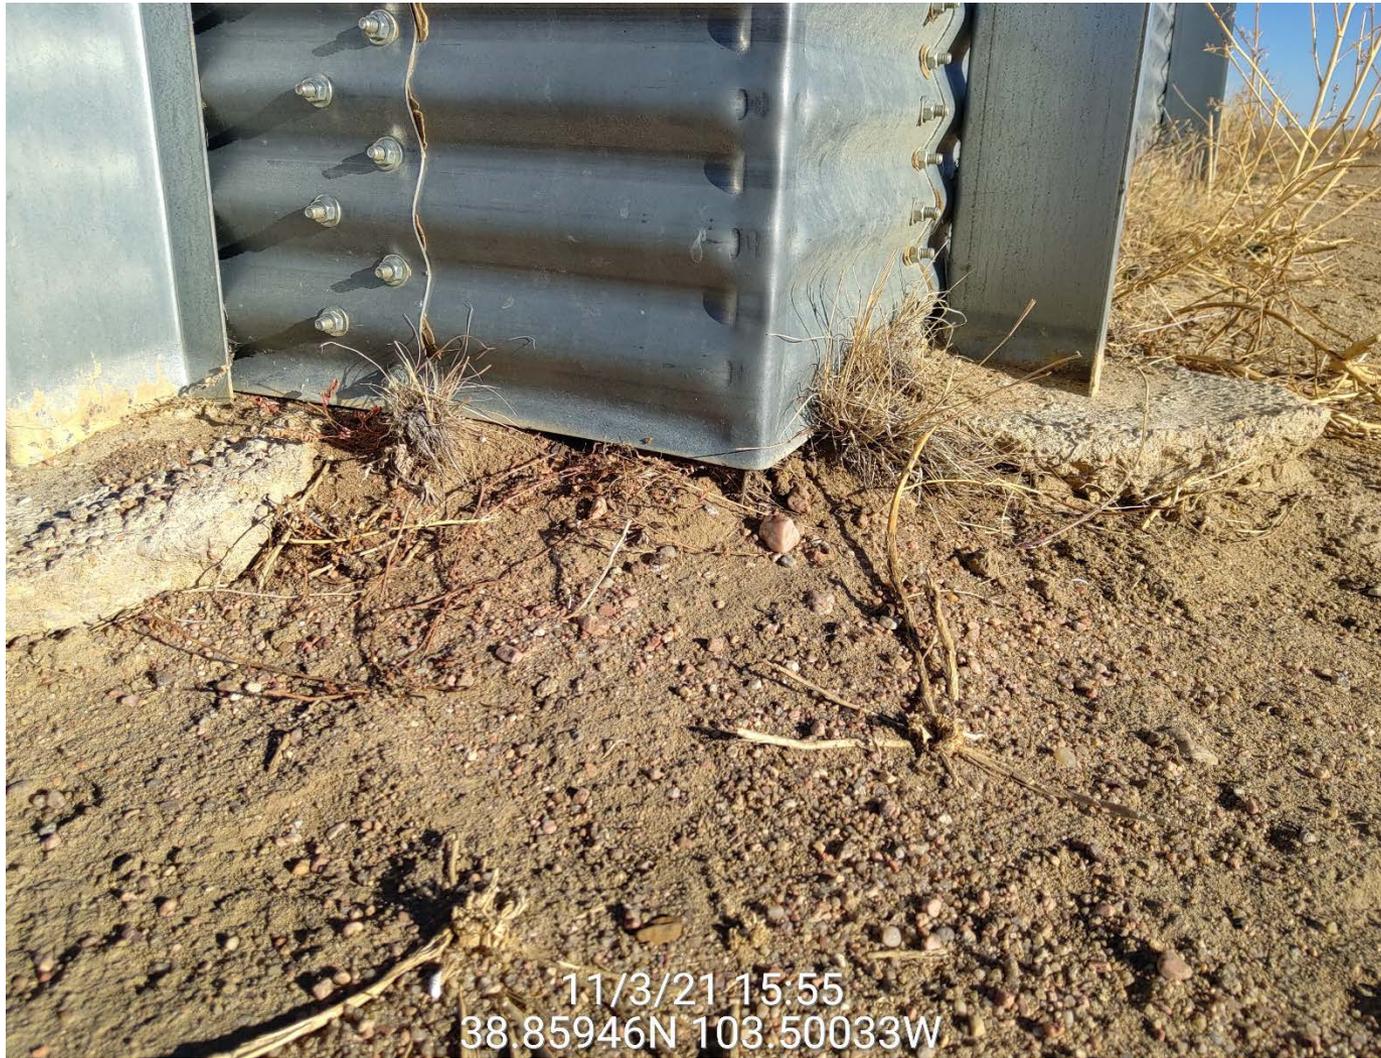
11/3/21 15:55
38.85946N 103.50033W

**Inadequate containment around tank battery. Gap between
containment wall and ground on corner of tank battery**

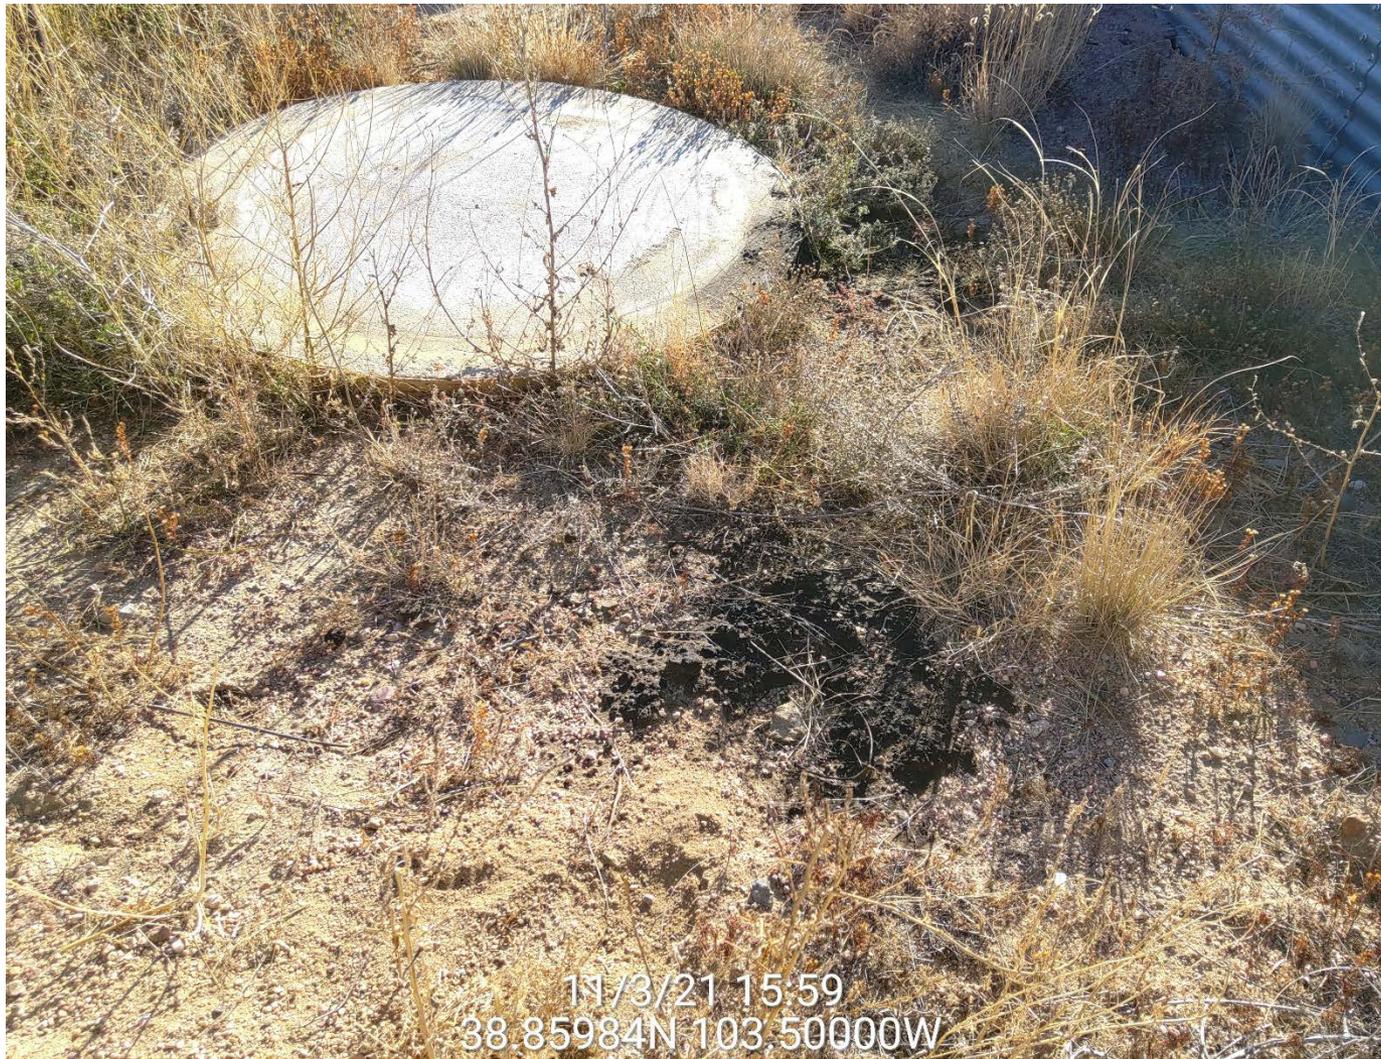
Stained soil inside containment where treater was located.
