Inspection Photos

API: 071-06703

Operator: EVERGREEN NATURAL RESOURCES

Inspection Date: 11/3/2021

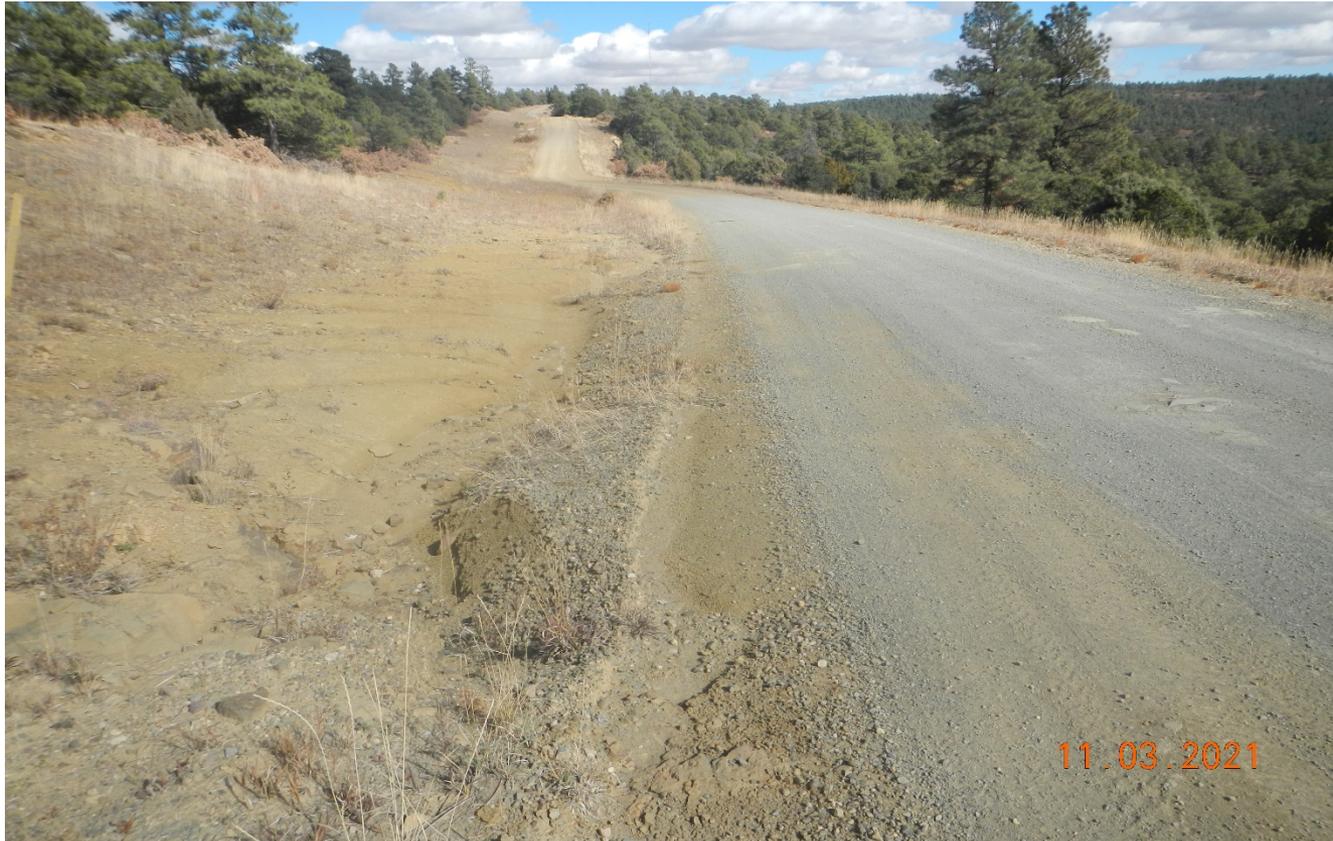
Photo 1. Facing northeast along the main access road. Stormwater erosion from this area is causing more erosion further down the road. Lat/Long:37.2354,-104.6646

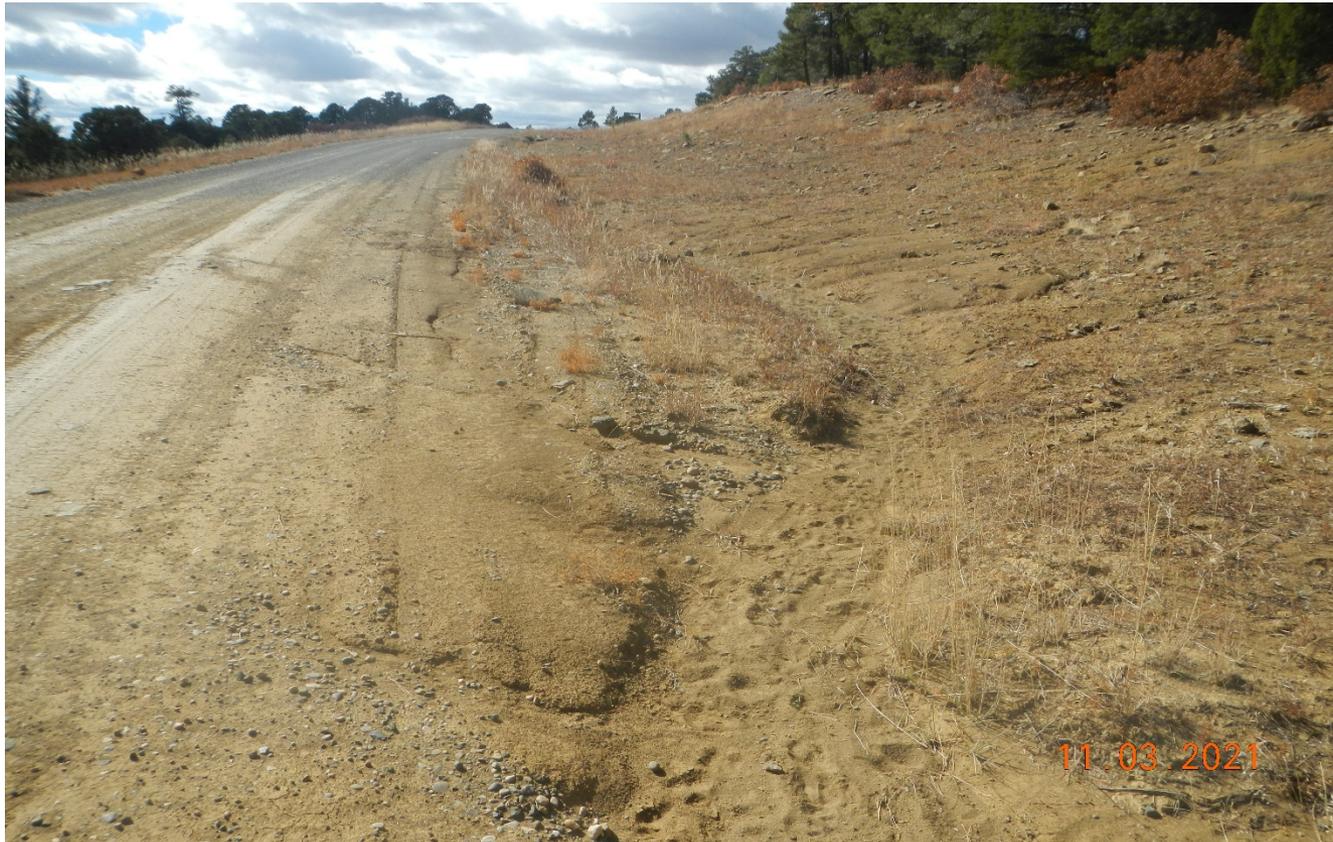
Photo 2. Facing back southwest. The road side is not stabilized and stormwater runoff is causing erosion further down the road.

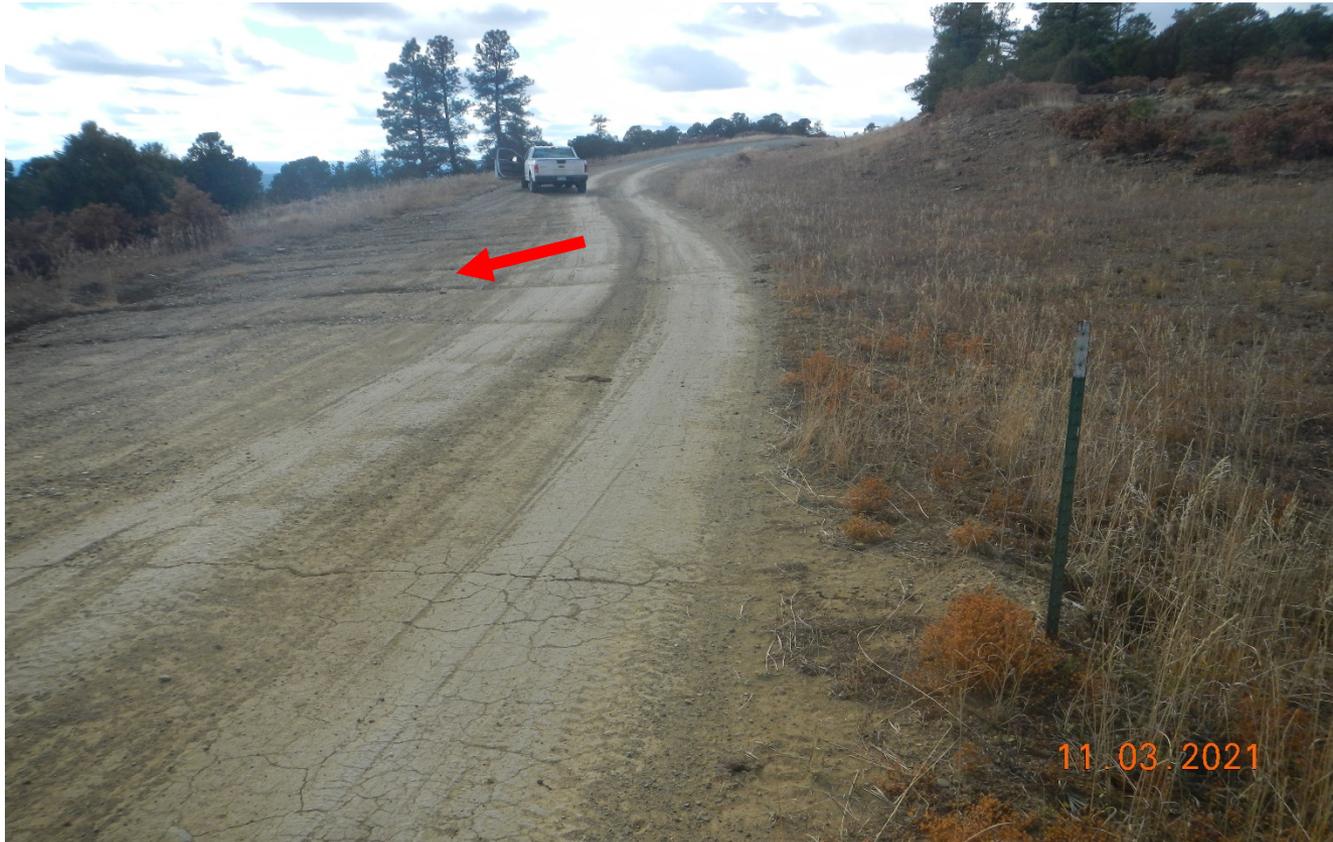
Photo 3. Facing southwest. Stormwater is flowing across the road at red arrow and is not being diverted toward the culvert.

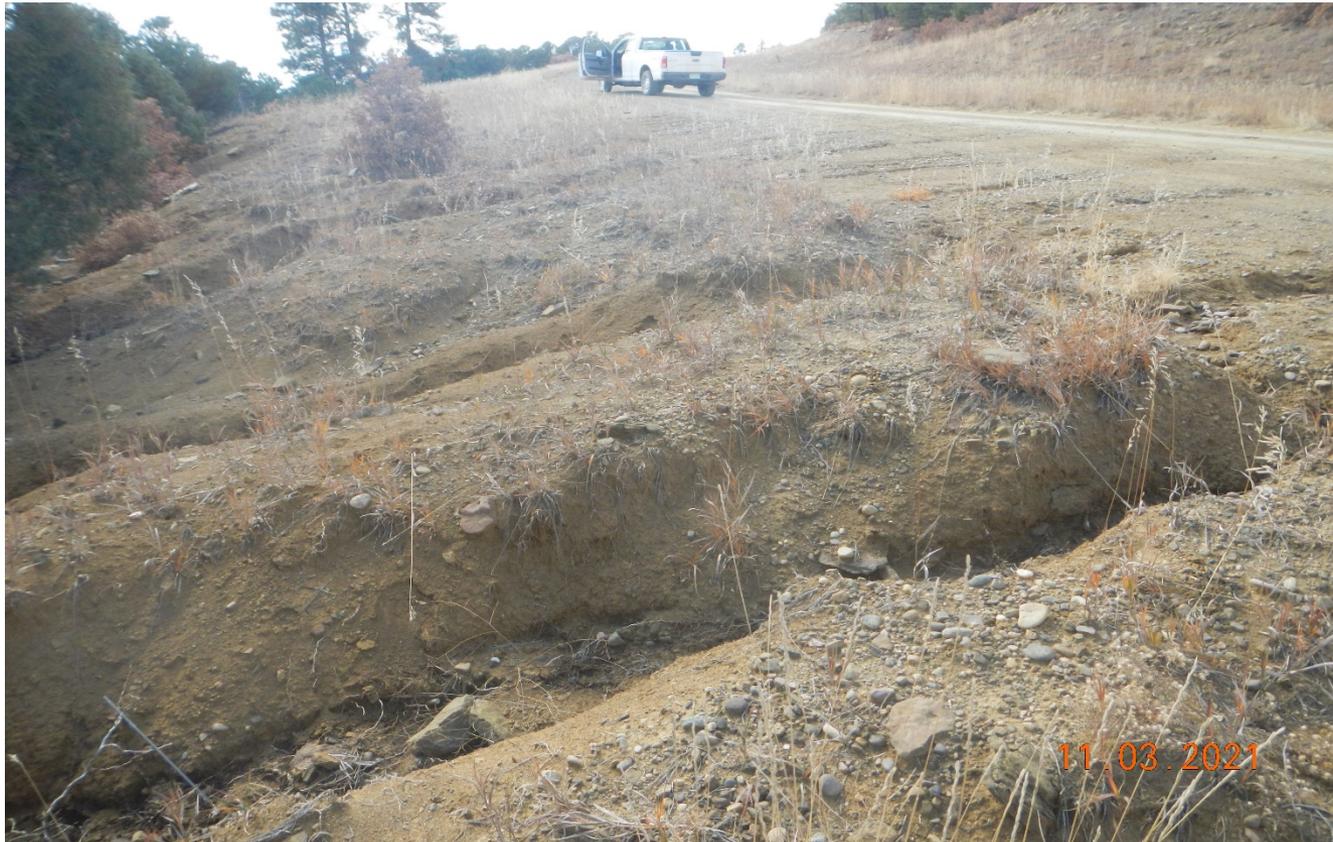
Photo 4. There is erosion along the east side of the road which needs to be repaired.
