Inspection Photos

API: 071-08723

Operator: EVERGREEN NATURAL RESOURCES

Inspection Date: 11/3/2021

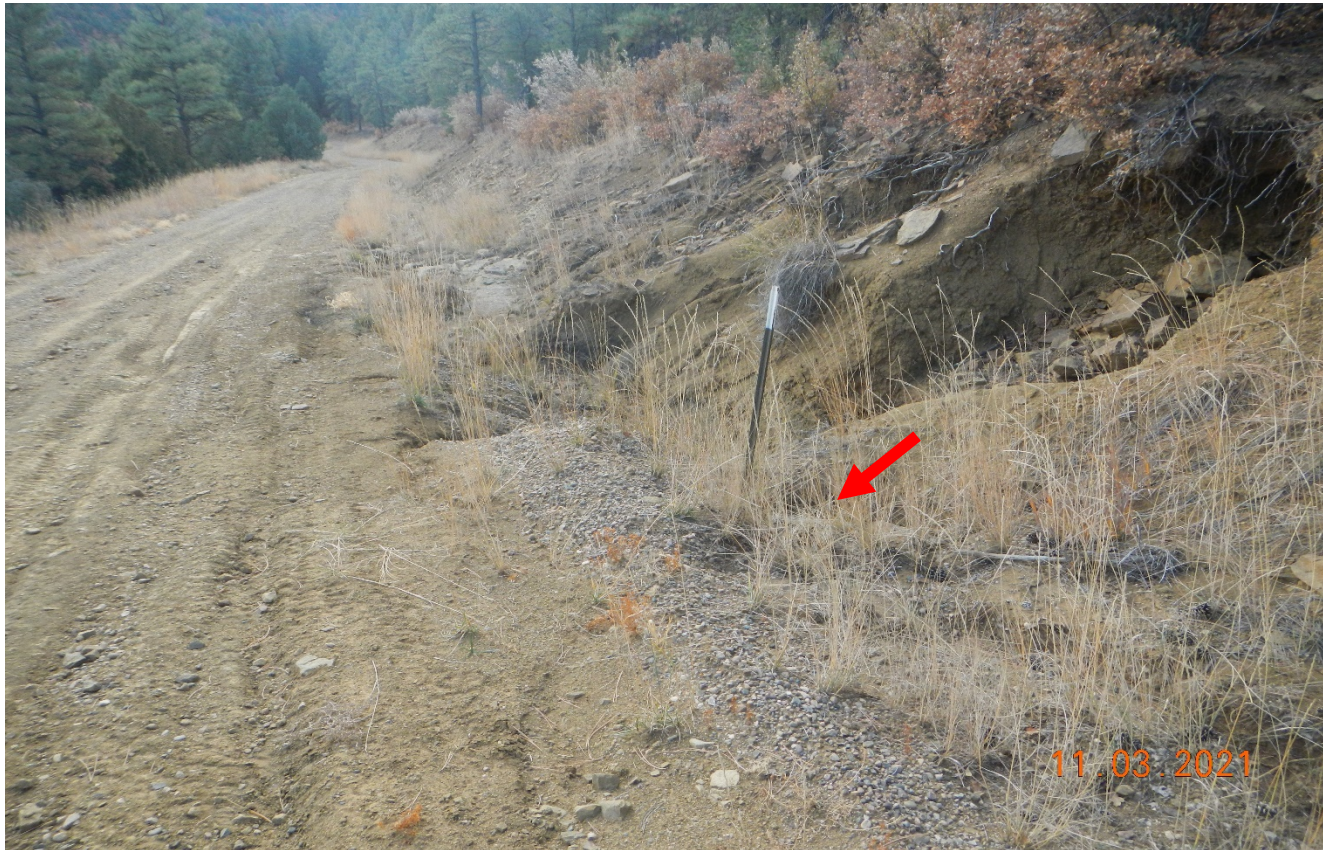
Photo 1. Facing southeast along the access road. There is an erosion gully along the road side. The culvert at red arrow is filled in with sediment and the erosion gully was measured to be 4.5 ft. deep.

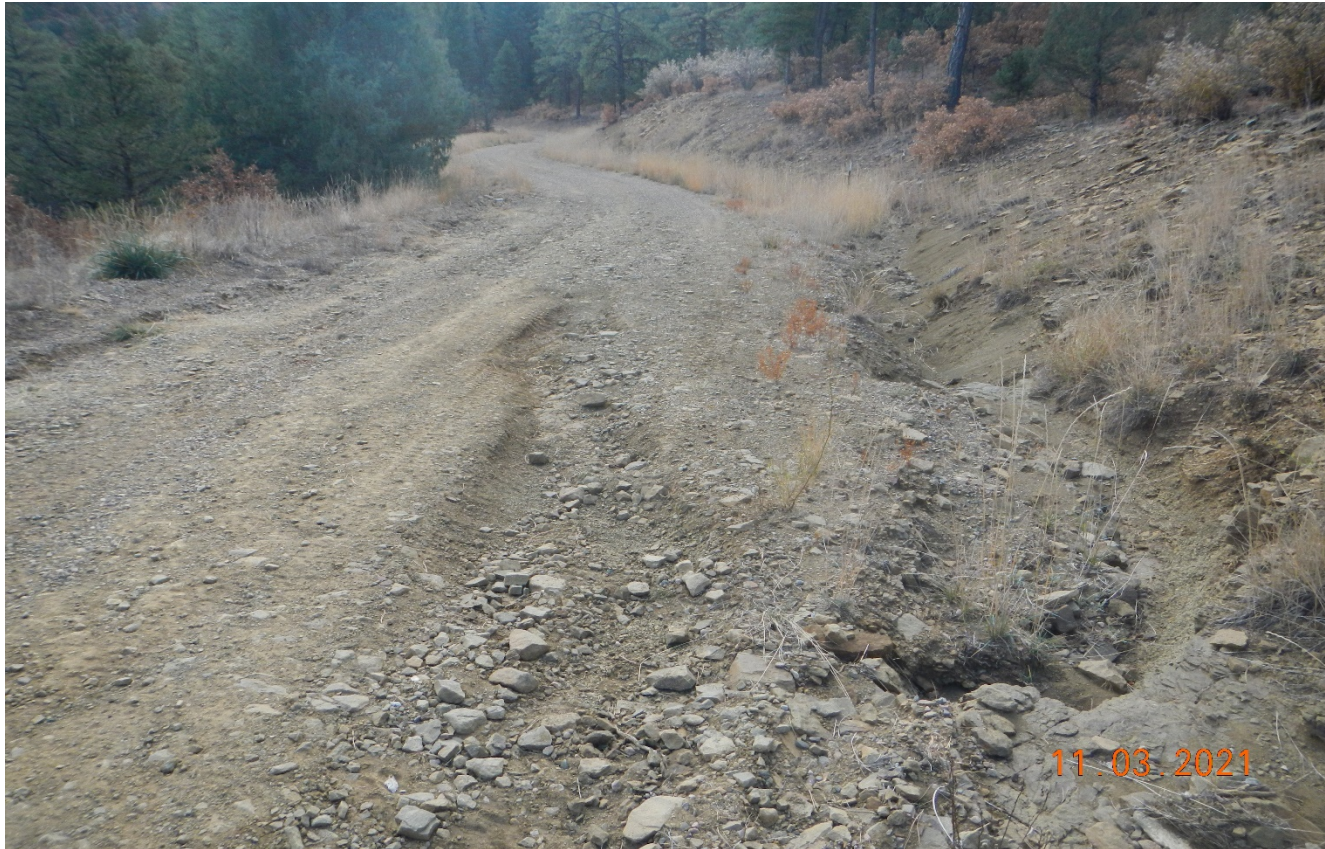
Photo 2. Facing southeast further down the road. There is erosion along the road that needs to be repaired and stabilized.

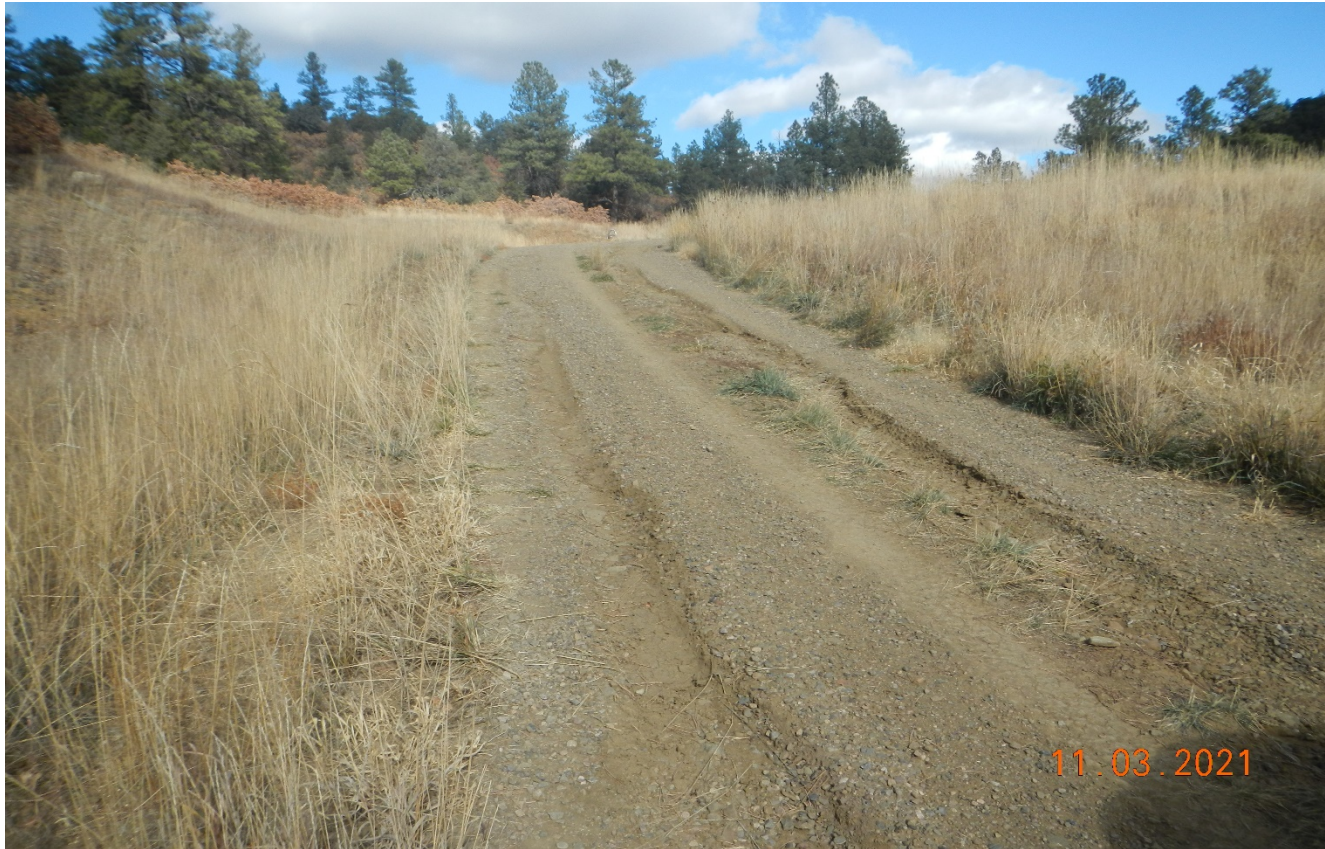
Photo 3. Facing north near the location. There is erosion along the road coming from the location.
