# Inspection Photos

API: 071-06508

Operator: EVERGREEN NATURAL RESOURCES

Inspection Date: 11/3/2021

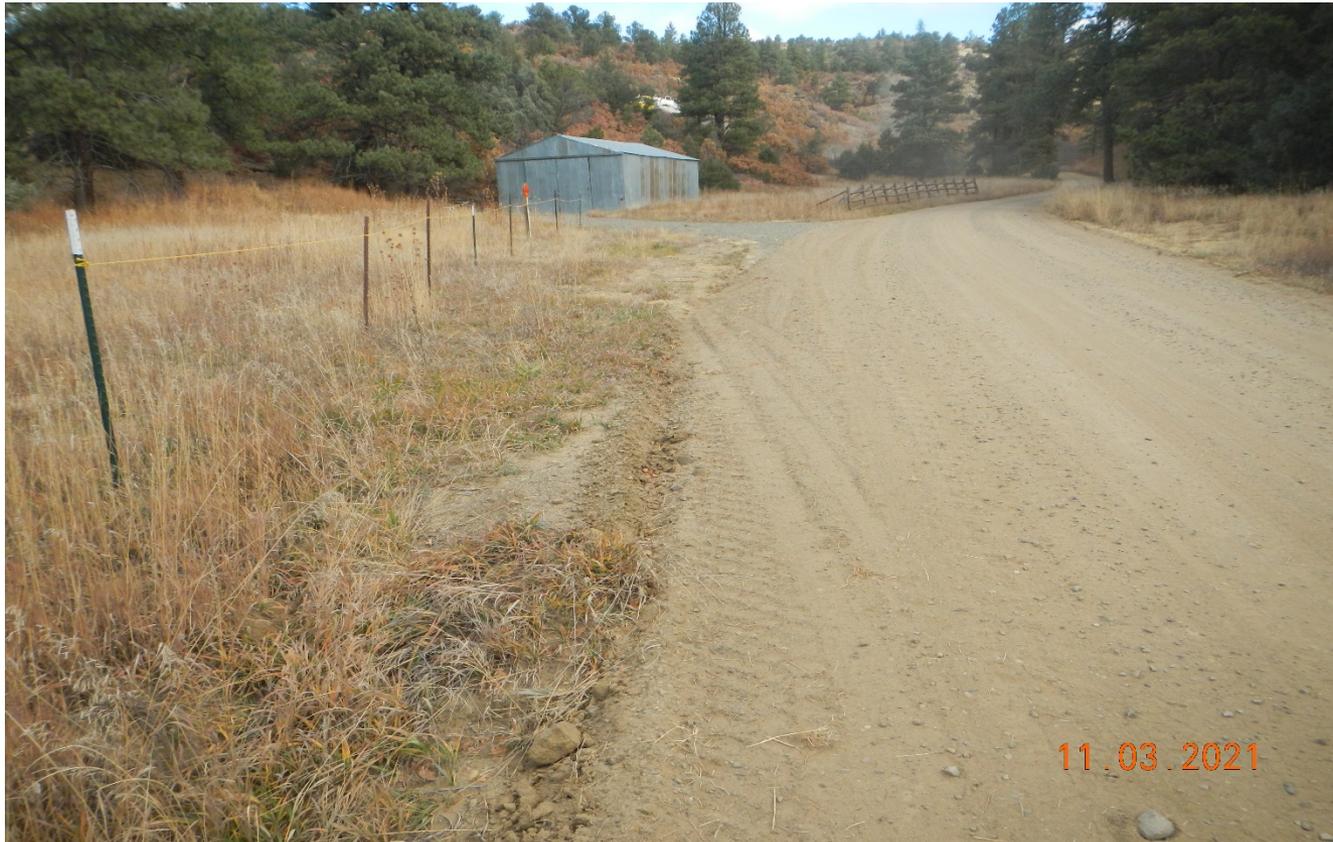
**Photo 1.** There is a metal building along the access road where oil and gas vehicles parked off the designated road way blocking this building. This area has not been restricted to prevent access by fence installation per landowner request.

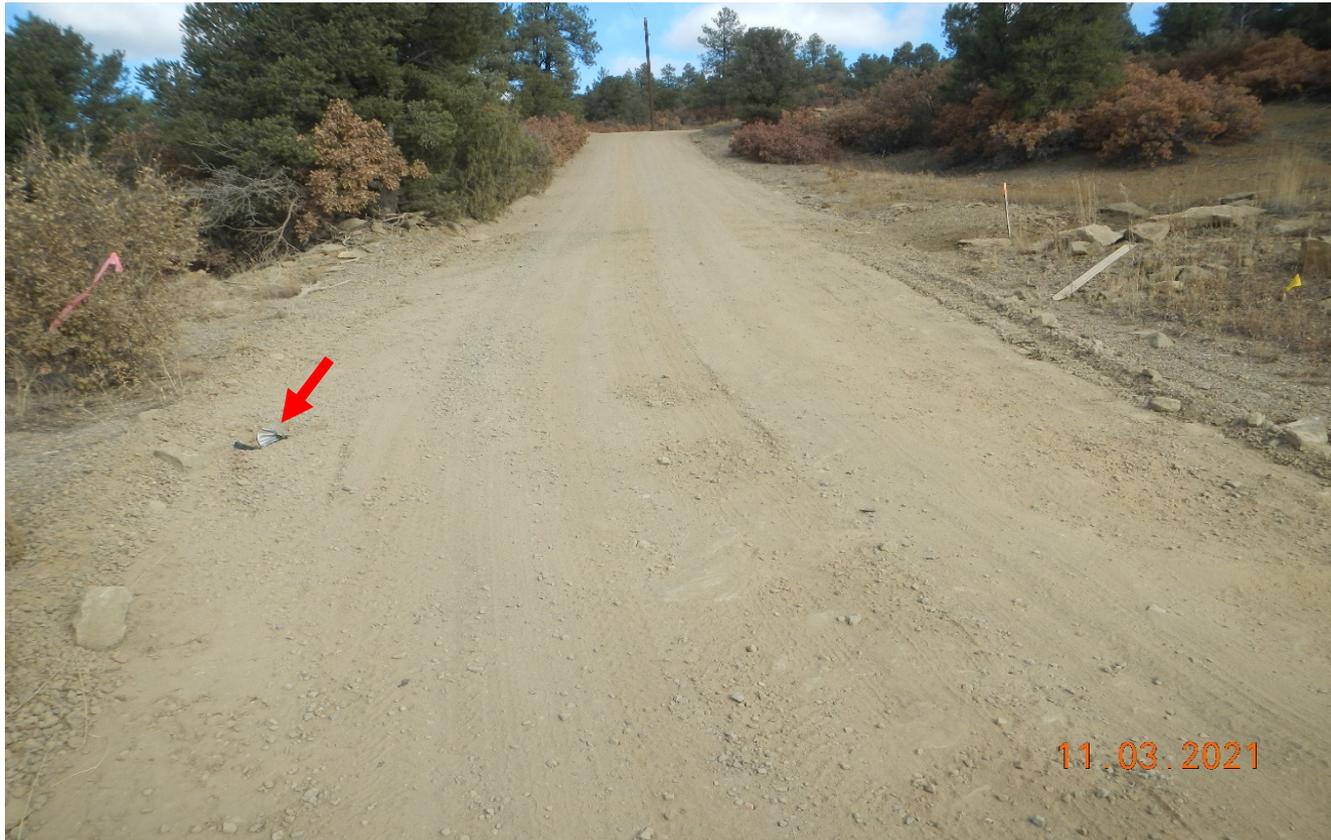
**Photo 2.** The access road has been regraded however there are steep areas with insufficient gravel and stabilization. The red arrow points to a culvert that was damaged from grading. Lat/Long:37.23640,-104.69944

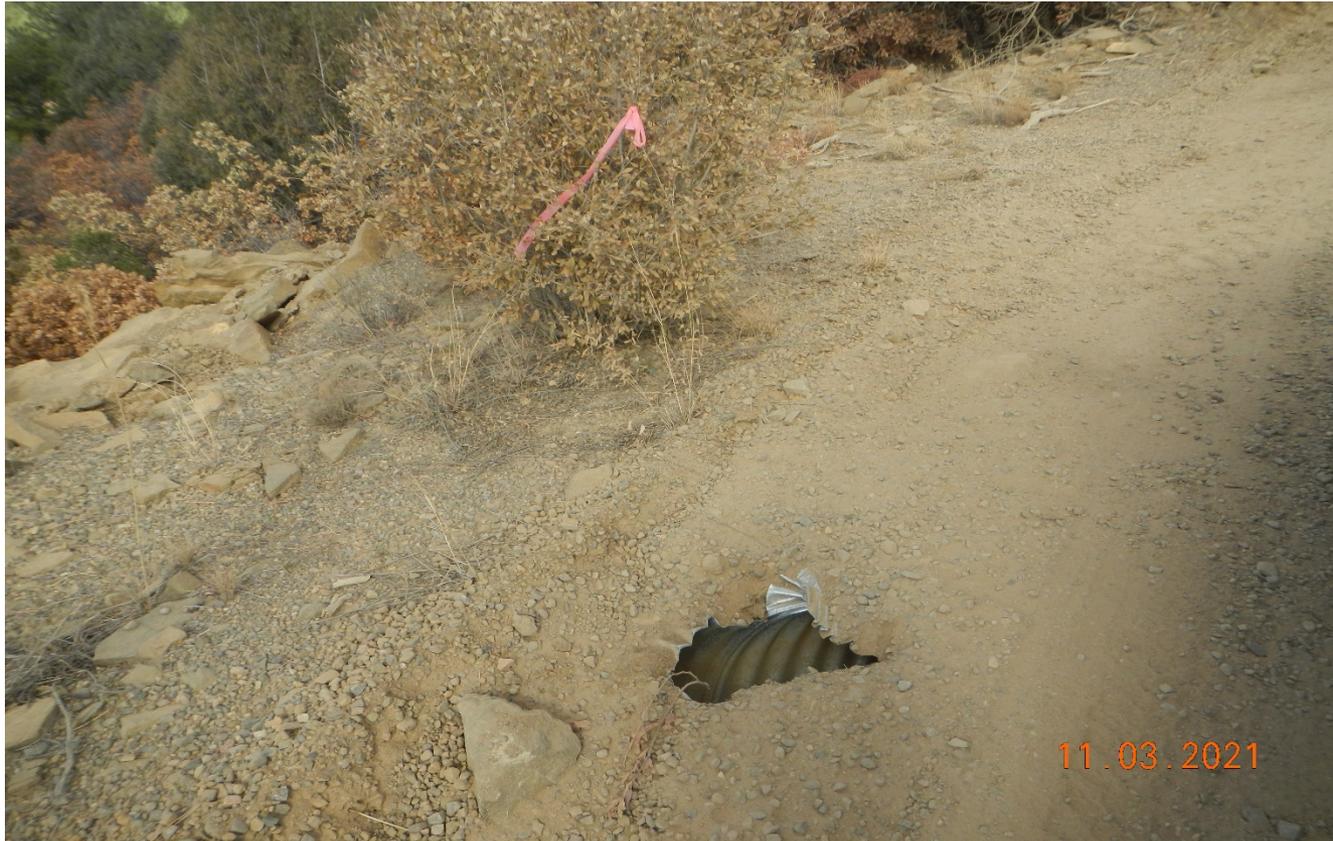
**Photo 3.** The culvert was damaged which can puncture a tire. This needs to be repaired. Additionally, the ribbon markers need to be removed once work is completed.

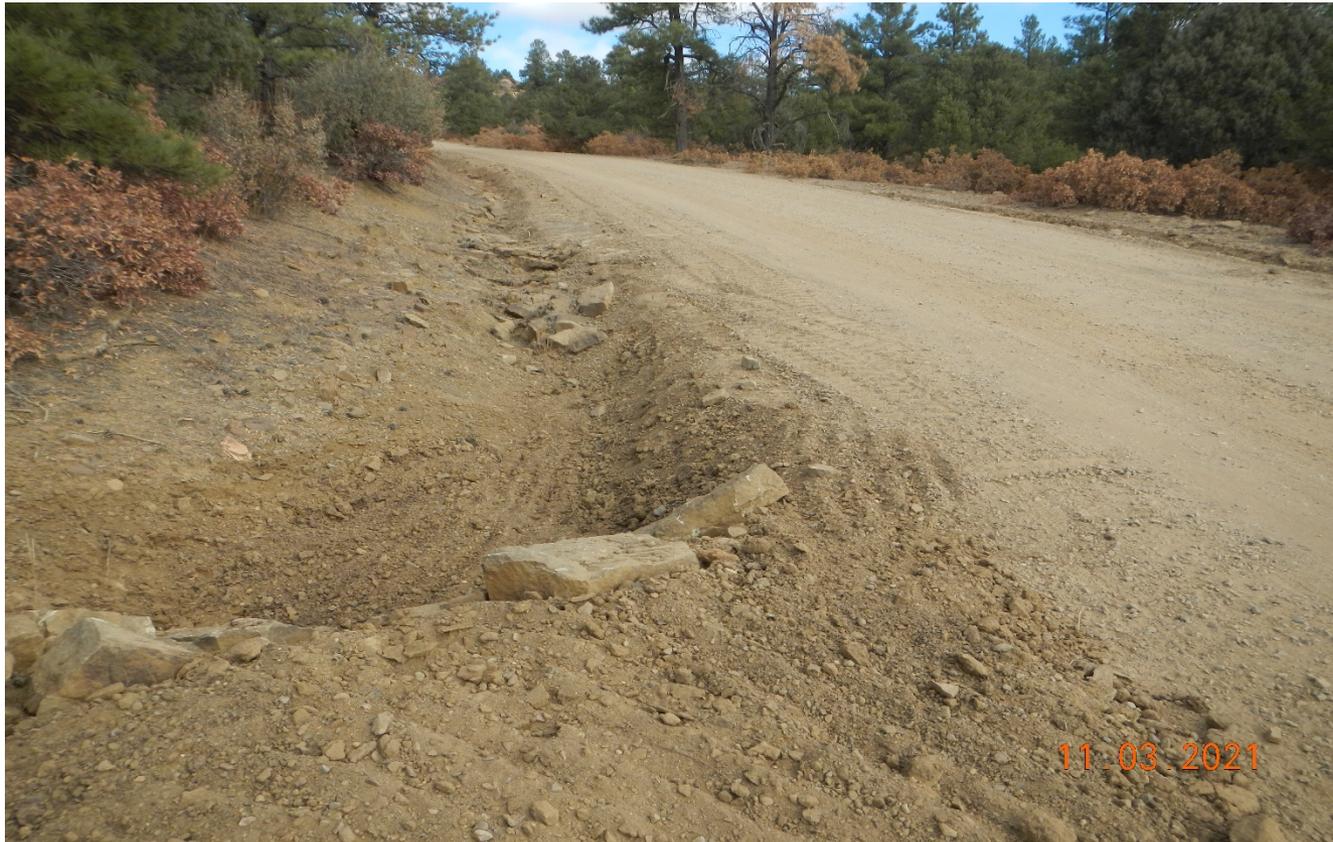
**Photo 4.** The culverts along the road have been cleaned out and repaired.

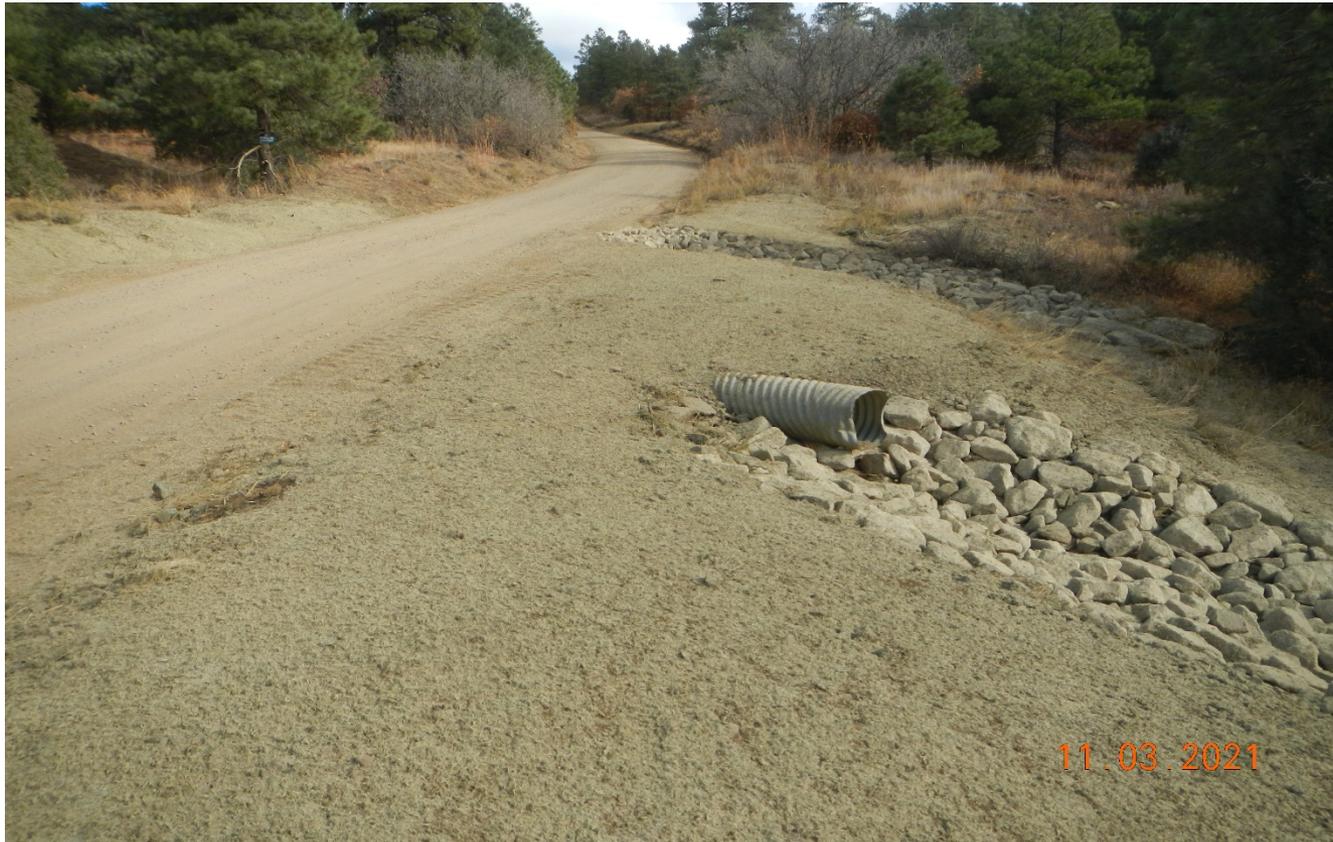
**Photo 5.** There are areas along the road that have been seeded and hydromulched. Outlet protection was installed at the culvert and stormwater diversion.

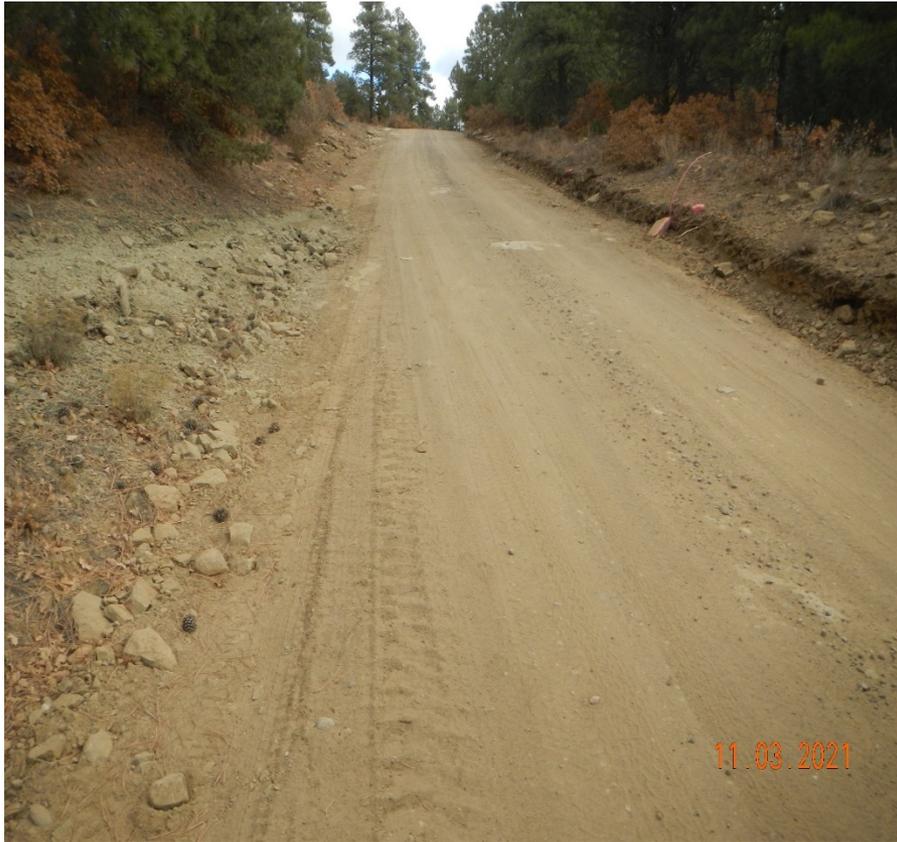
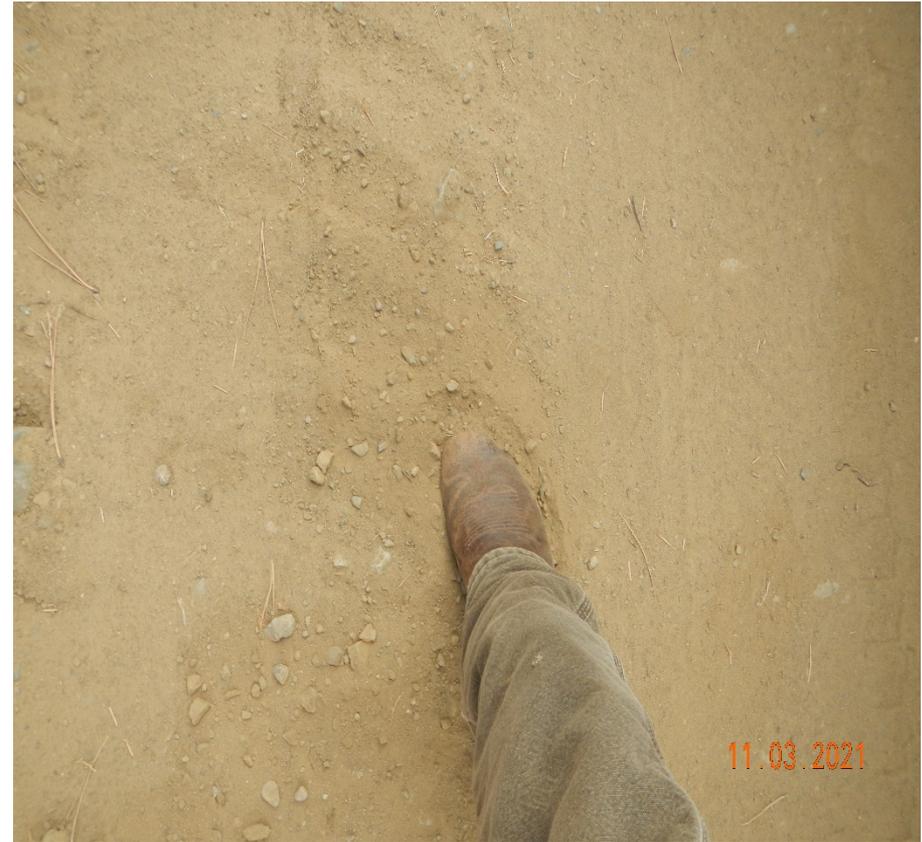
**Photo 6.** This steep area of the road was regraded however there is now loose soils shown in photo on the right. This area needs to be stabilized (e.g. gravel, road base).

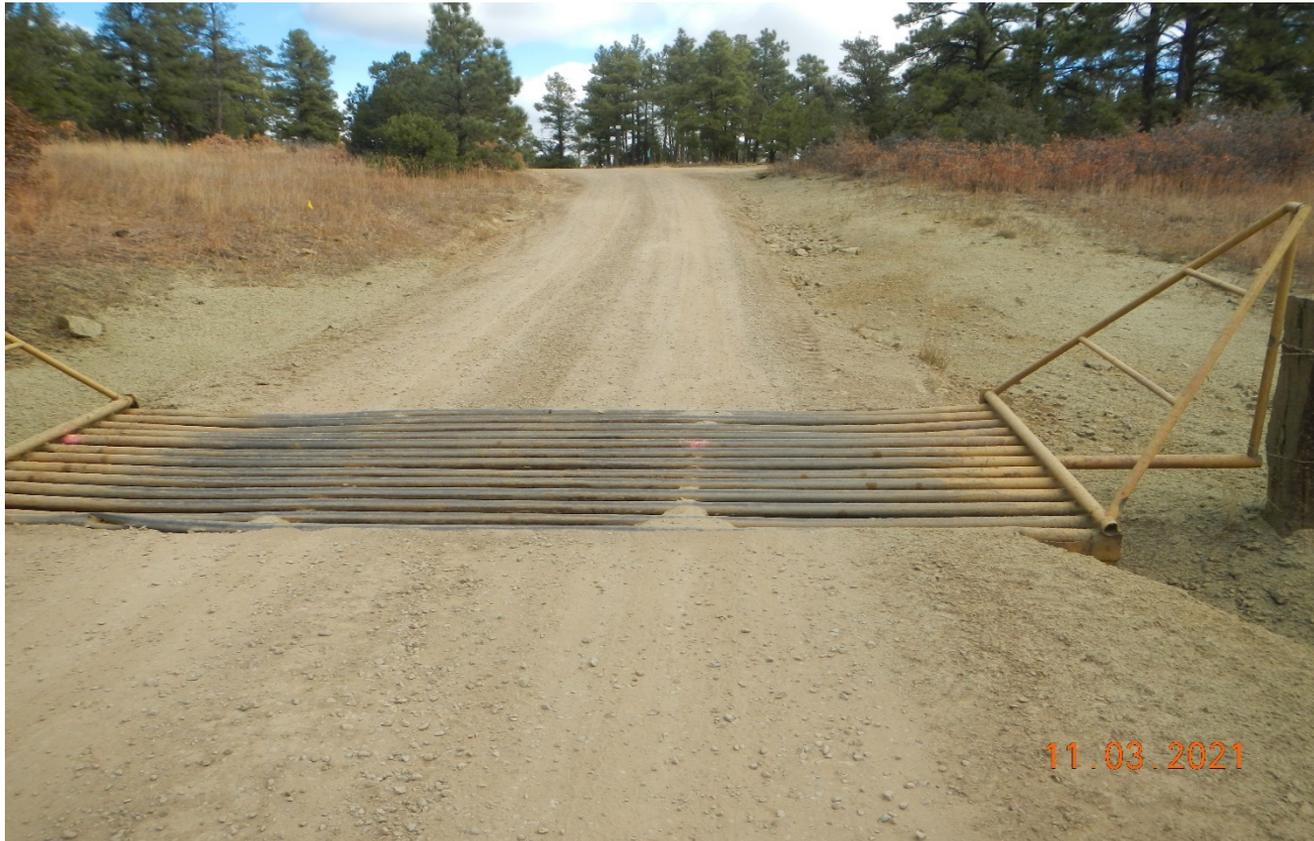
**Photo 7.** The cattleguard along the road has been repaired. Further up the road another cattle guard was also repaired.

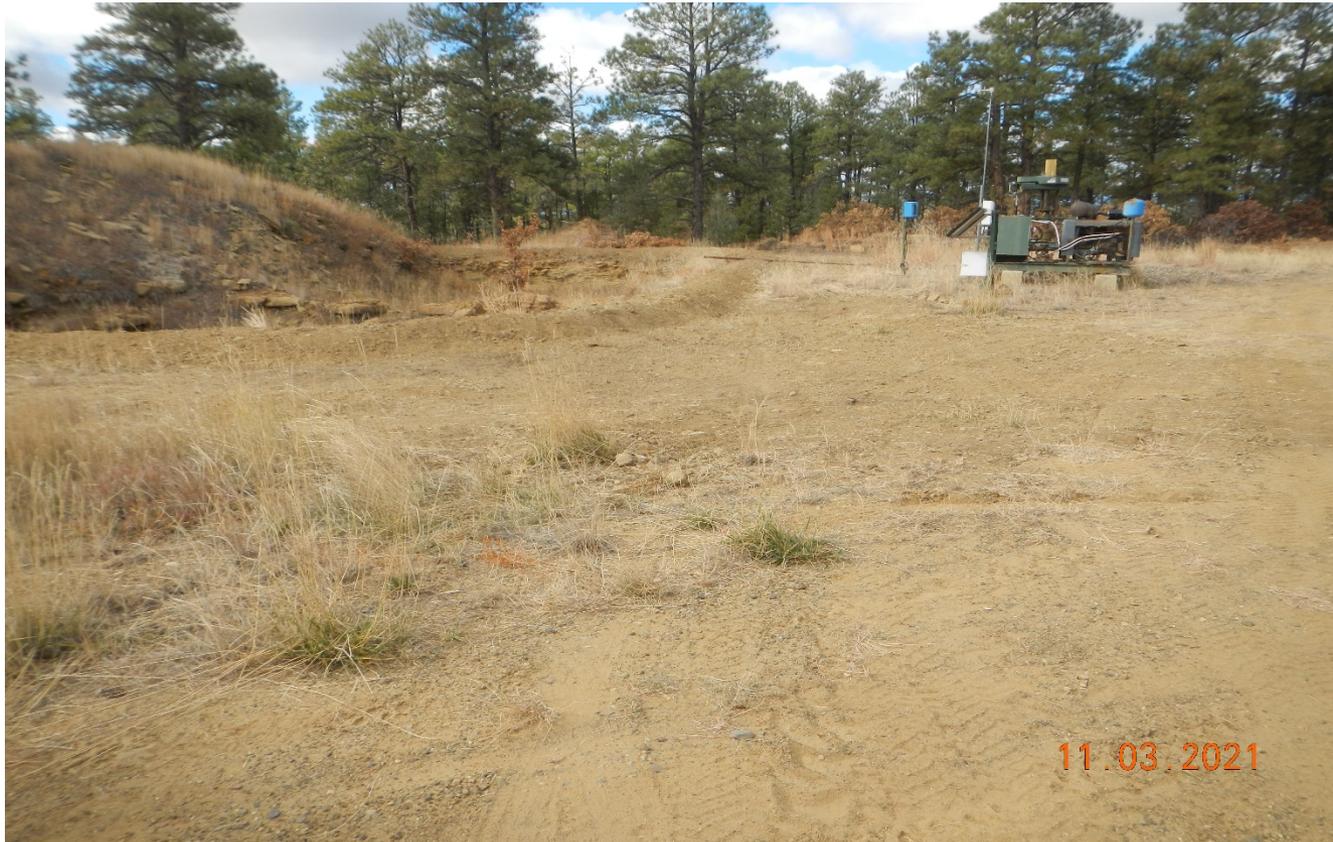
**Photo 8.** Facing west at the location.

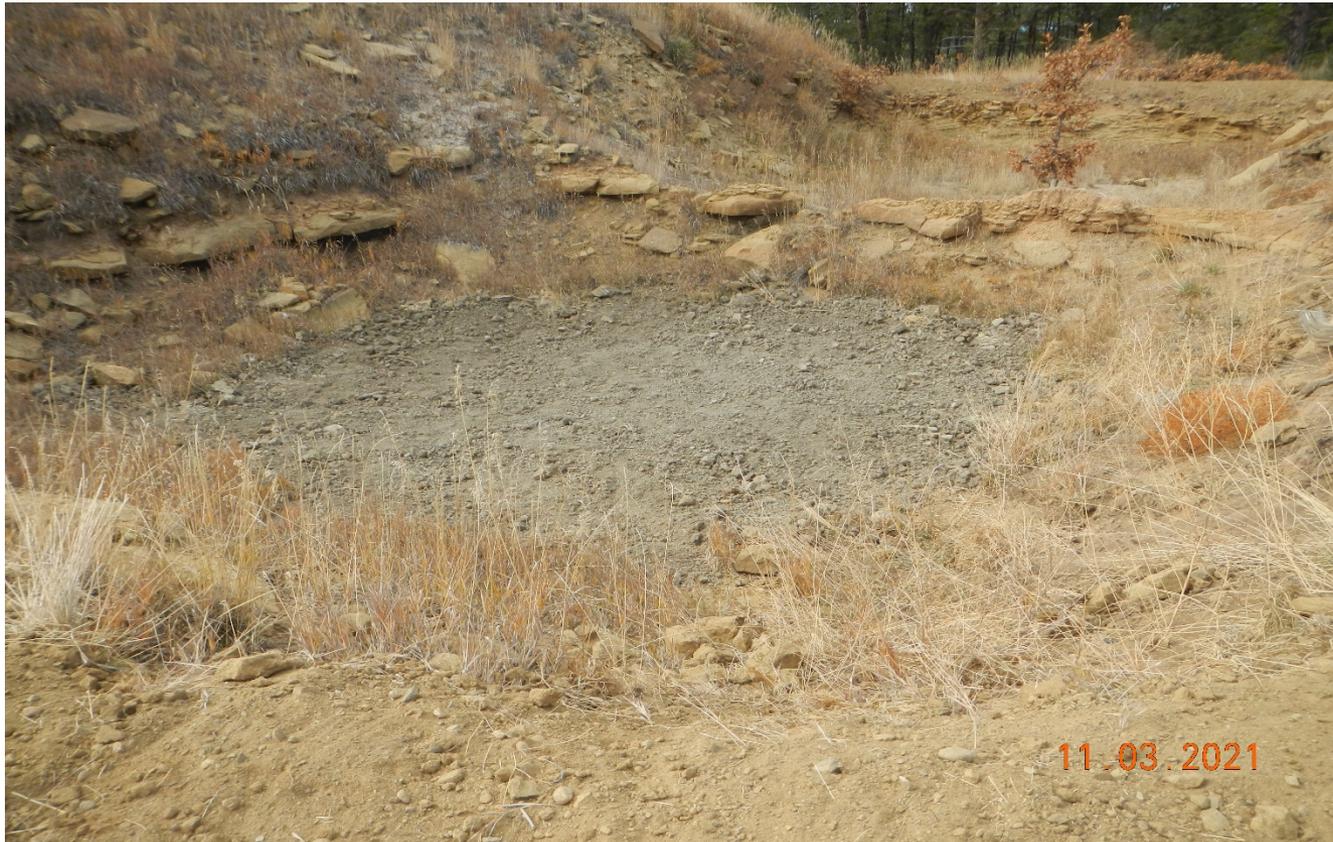
**Photo 9.** Facing toward the pit. The pit was scuffed but there is still gray soil that remains.

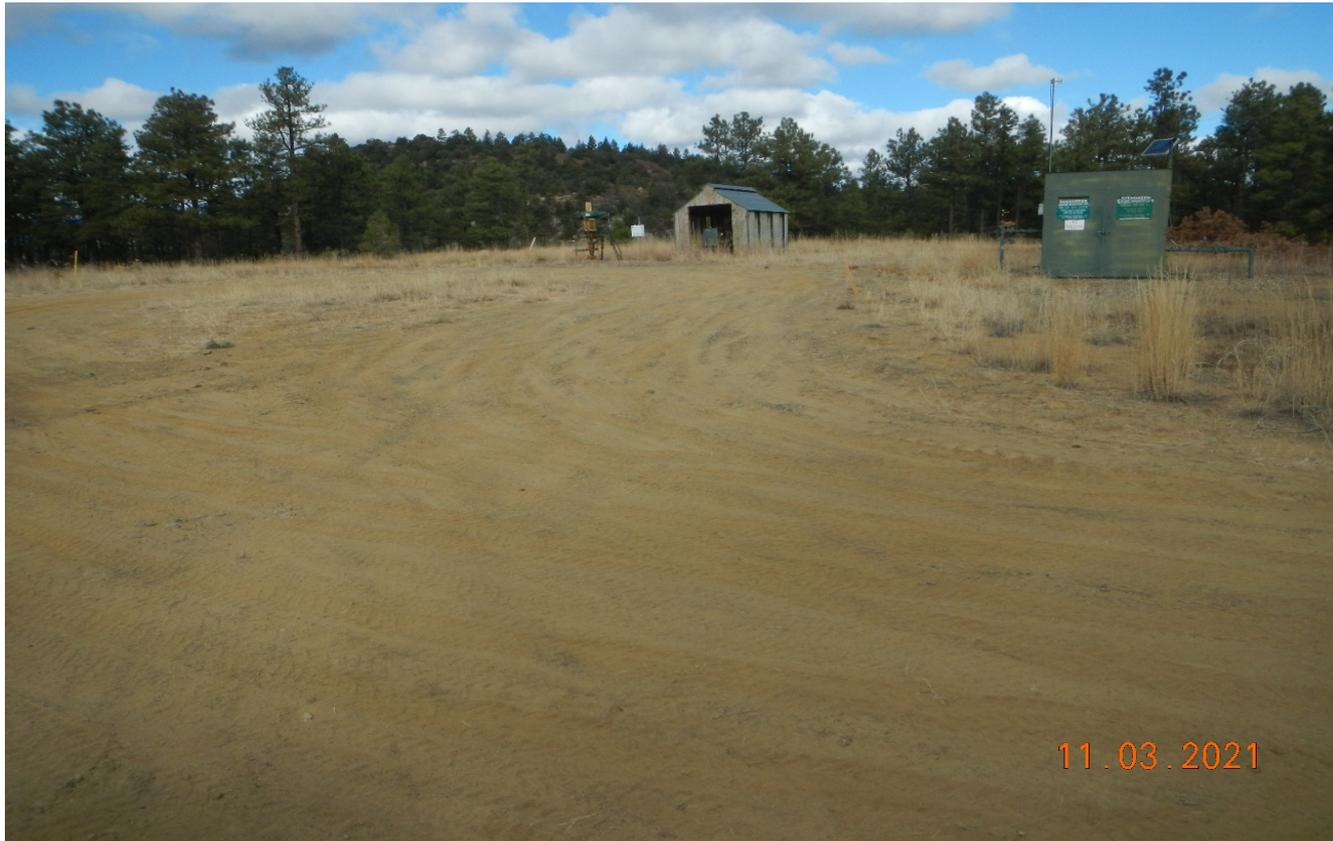
**Photo 10.** Facing north at the location.
