TEP RWF 433-10 Location # 335615

COLORADO
Oil & Gas Conservation
Commission
Department of Natural Resources

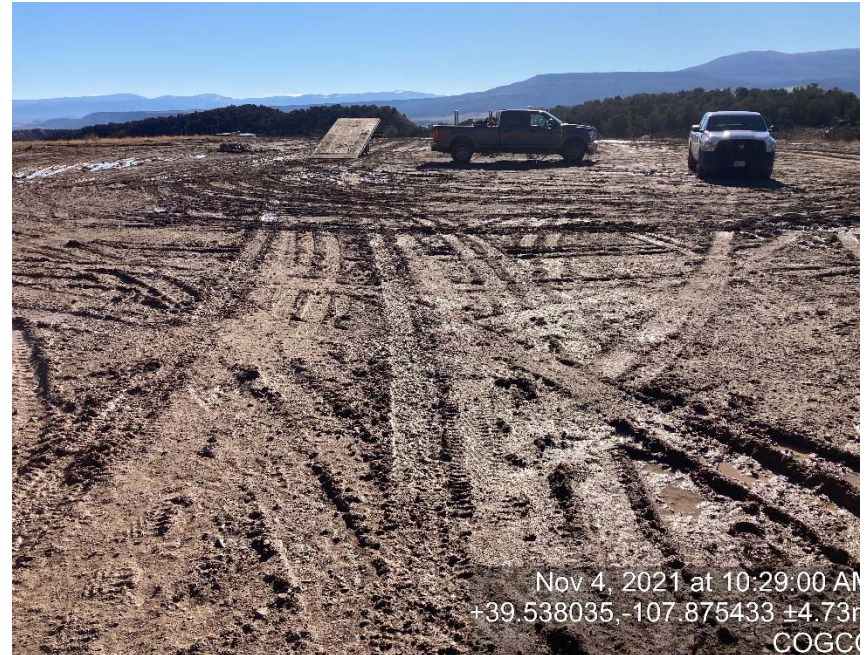
Lack of stabilization/compaction

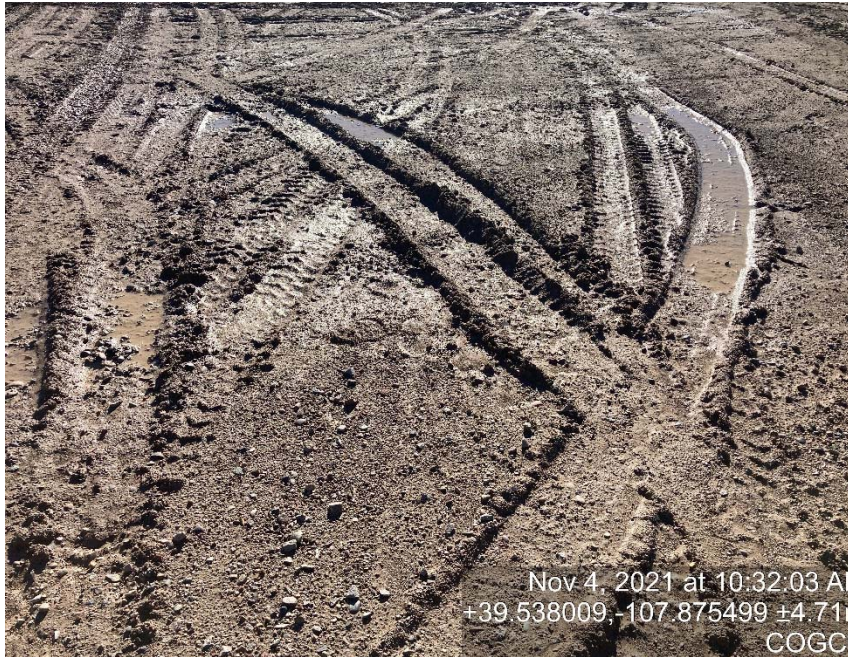
Lack of stabilization/compaction

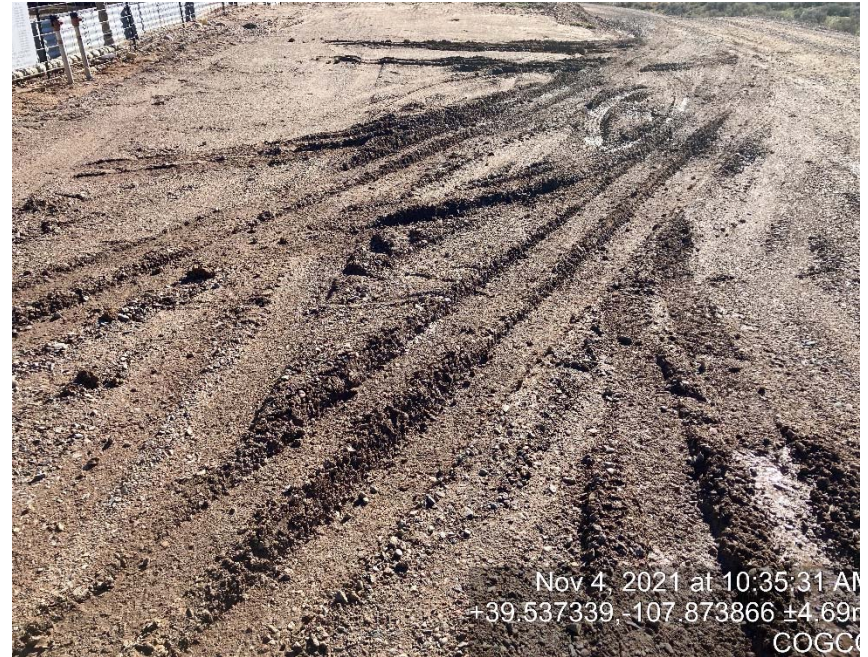
Lack of stabilization/compaction

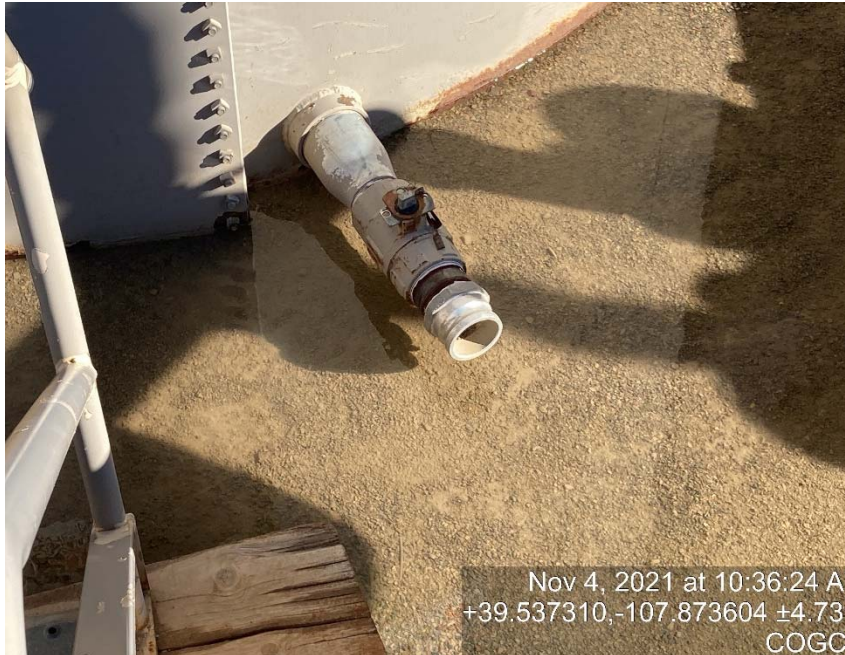
Load out line missing cap/bull plug

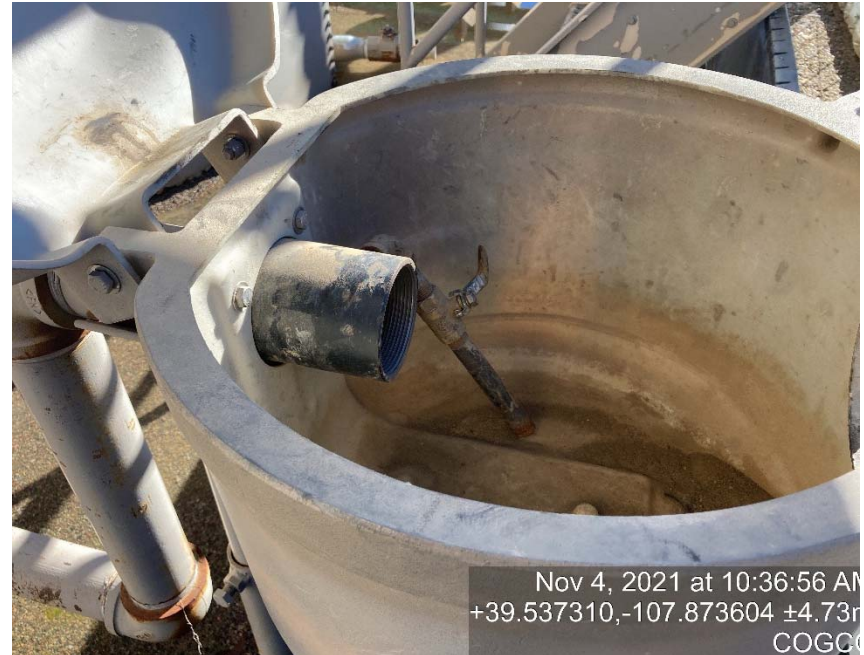
Load out line missing cap/bull plug

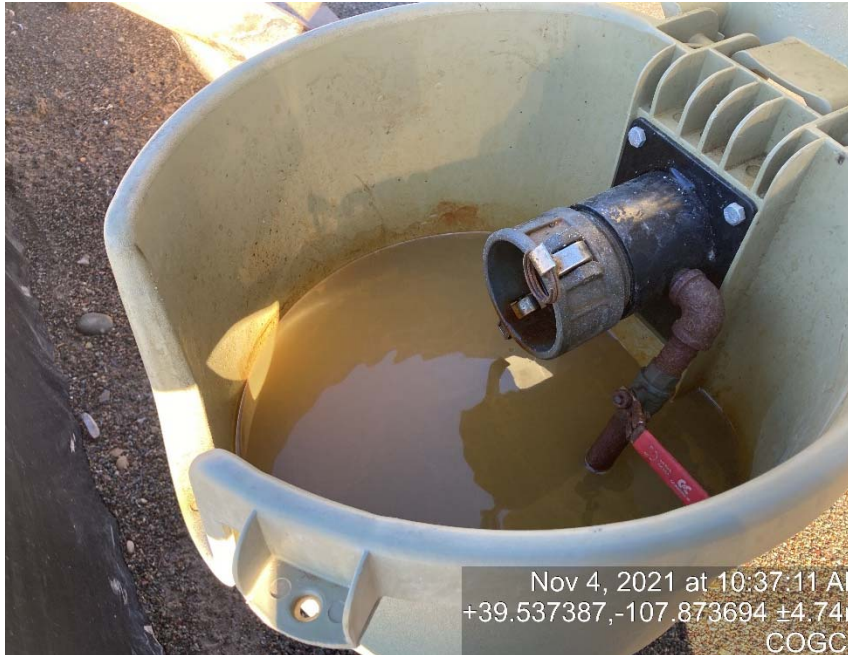
Load out line missing cap/bull plug

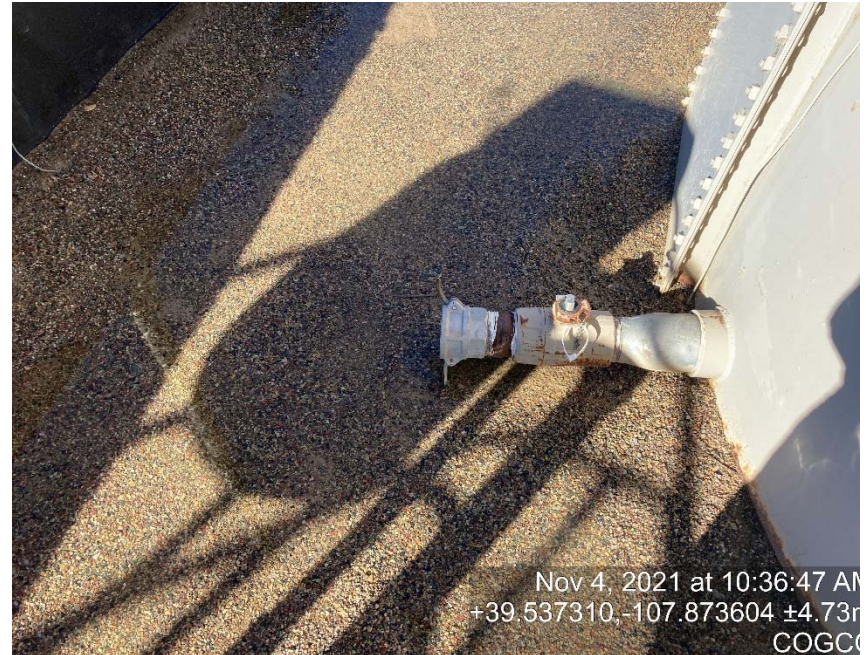
Load out line missing cap/bull plug

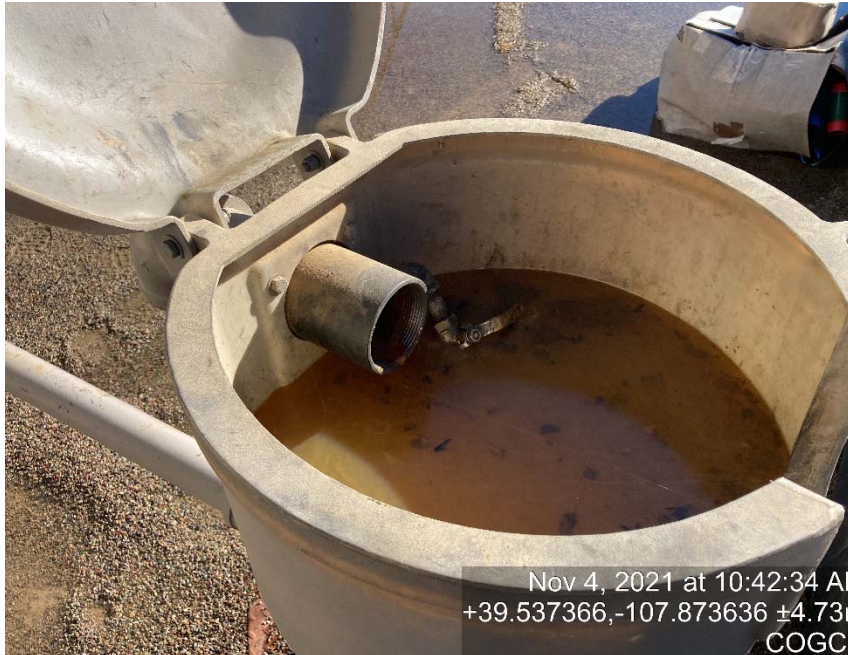
**Load out line missing cap/bull plug, leaking and
bucket full of fluid**

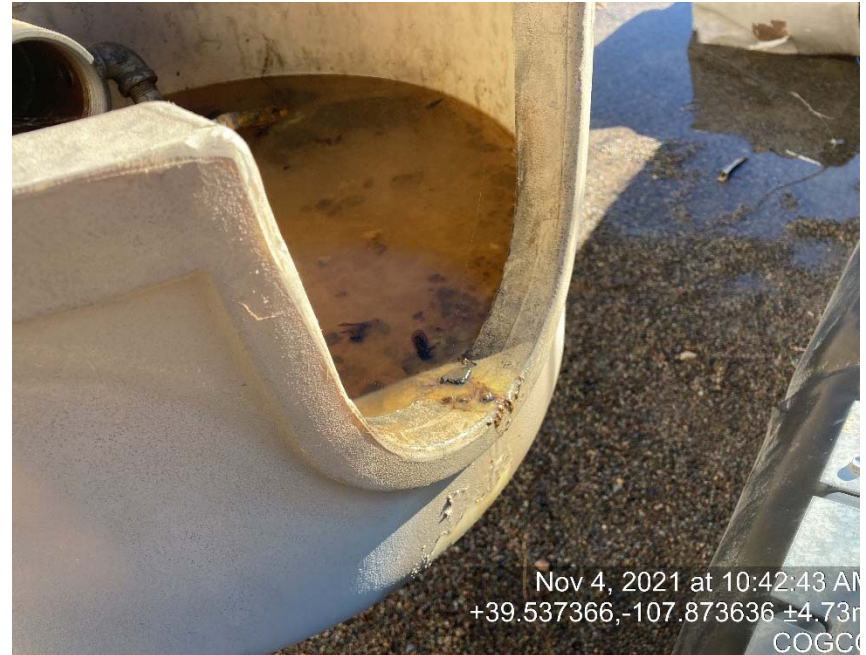
bucket full of fluid and spilling out

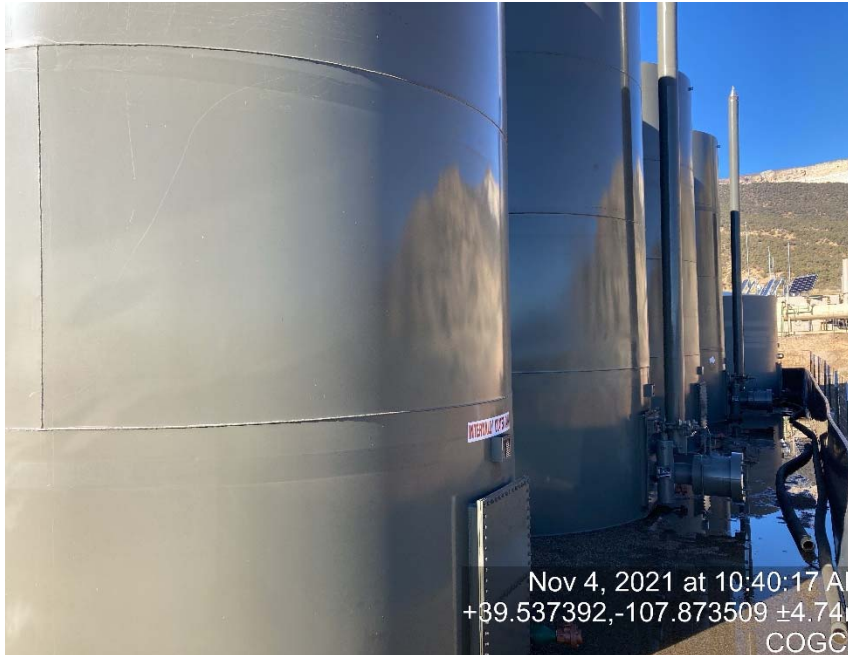
Unmarked tanks

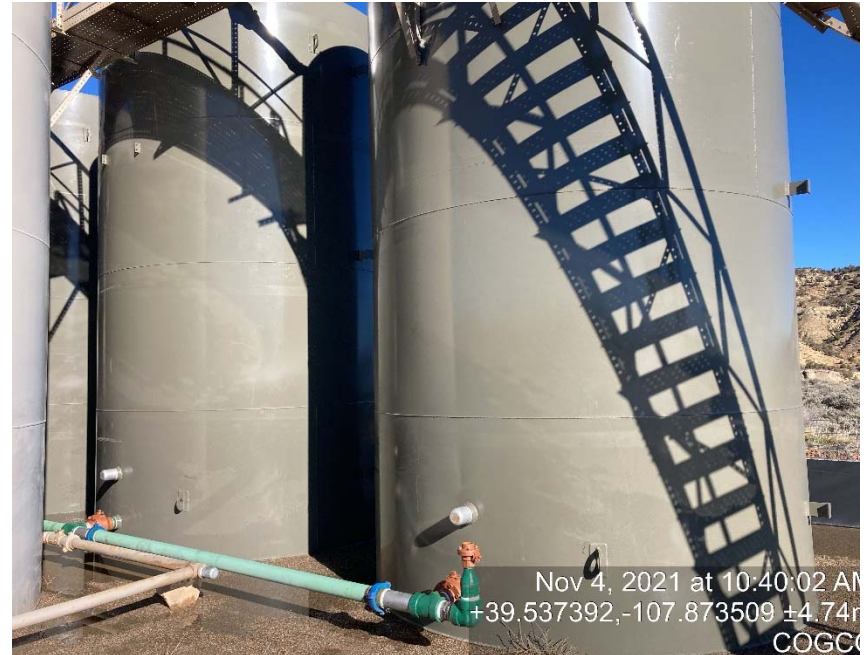
Unmarked tanks

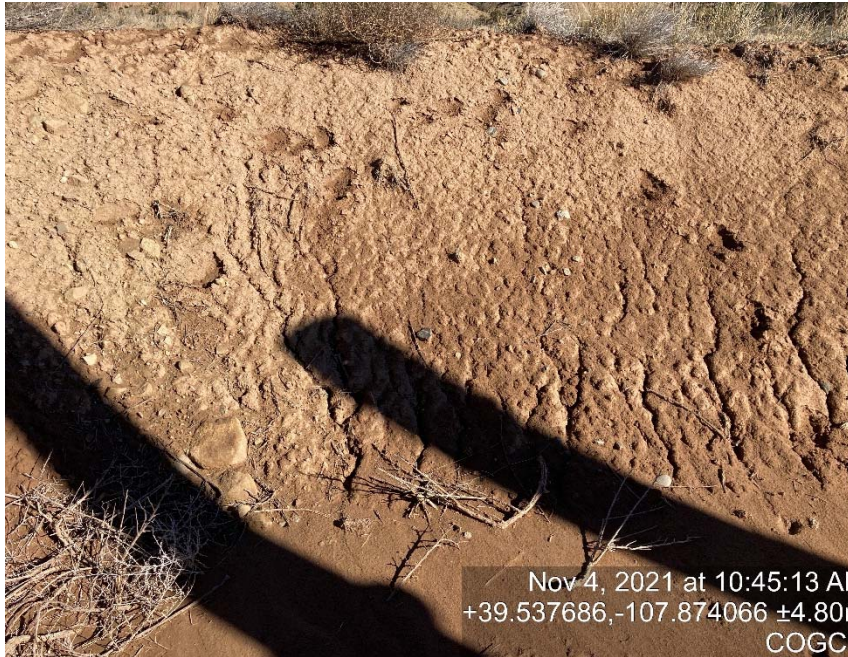
Lack of stabilization/erosion

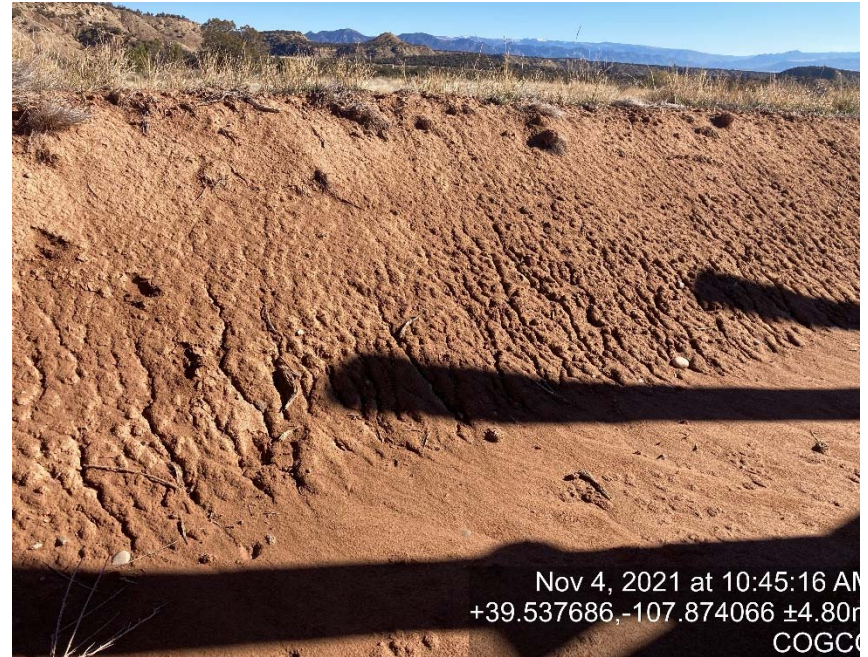
Lack of stabilization/erosion

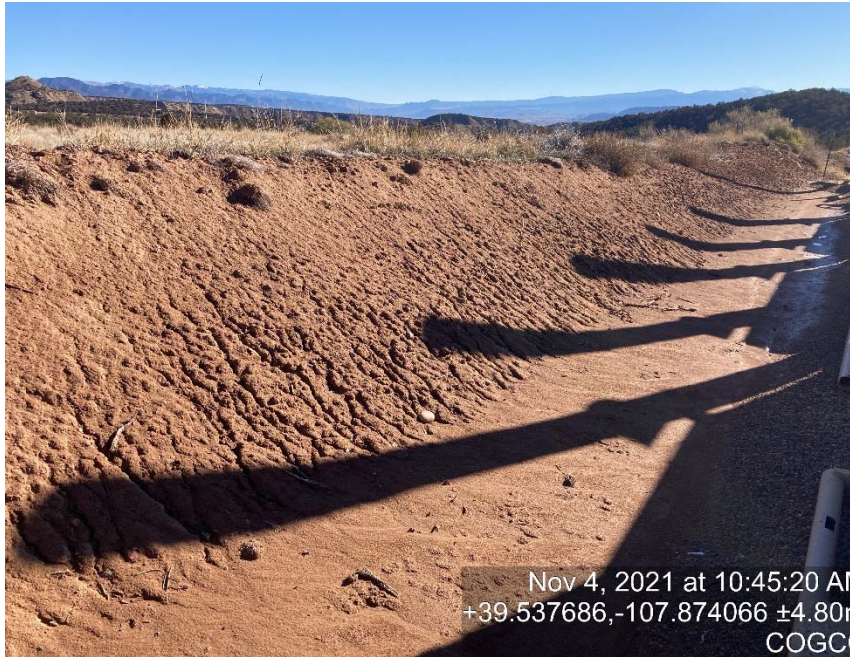
Lack of stabilization/erosion

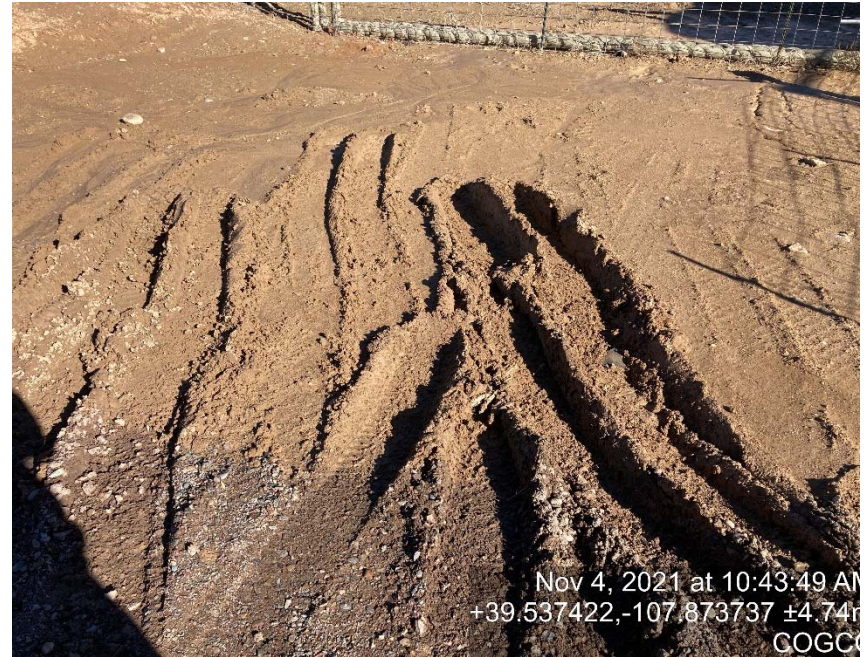
Lack of stabilization/compaction

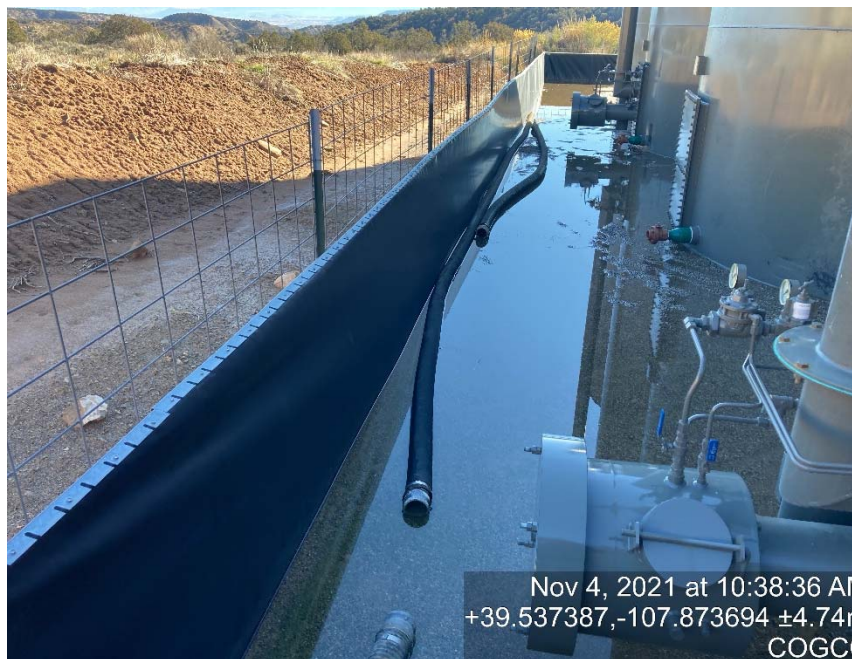
Debris

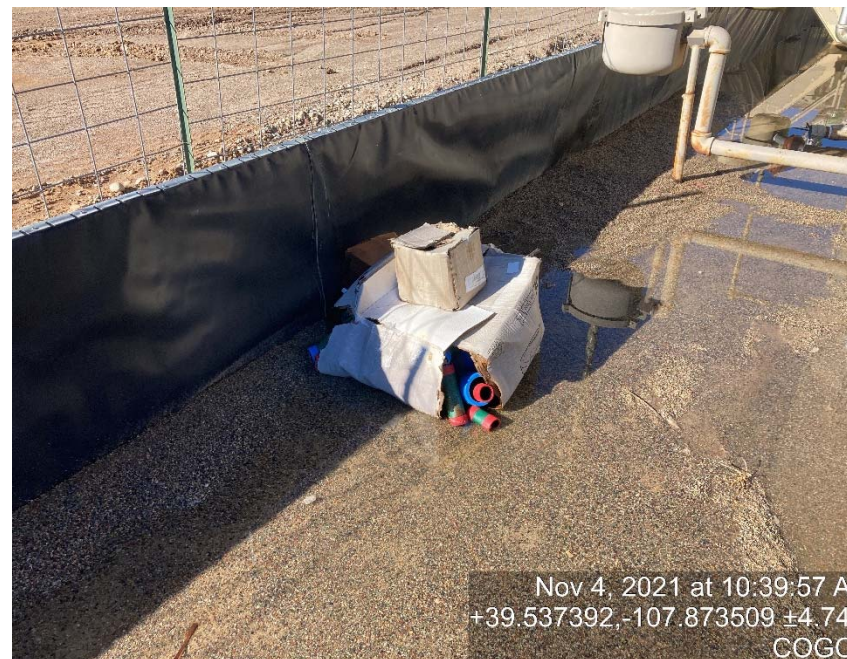
Debris
