TEP
RWF 32-10
Location # 335659

COLORADO
Oil & Gas Conservation
Commission
Department of Natural Resources

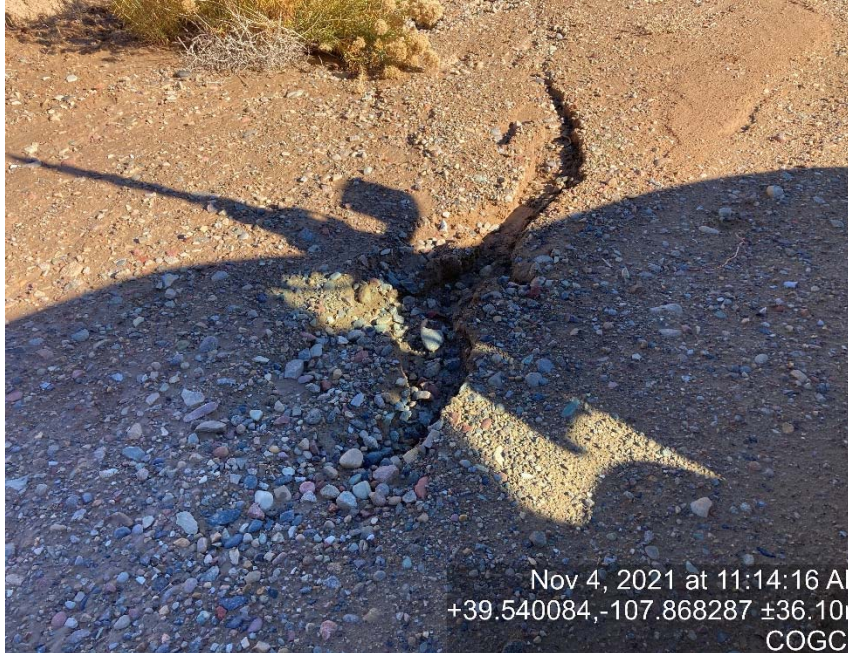
Erosion on access to wells

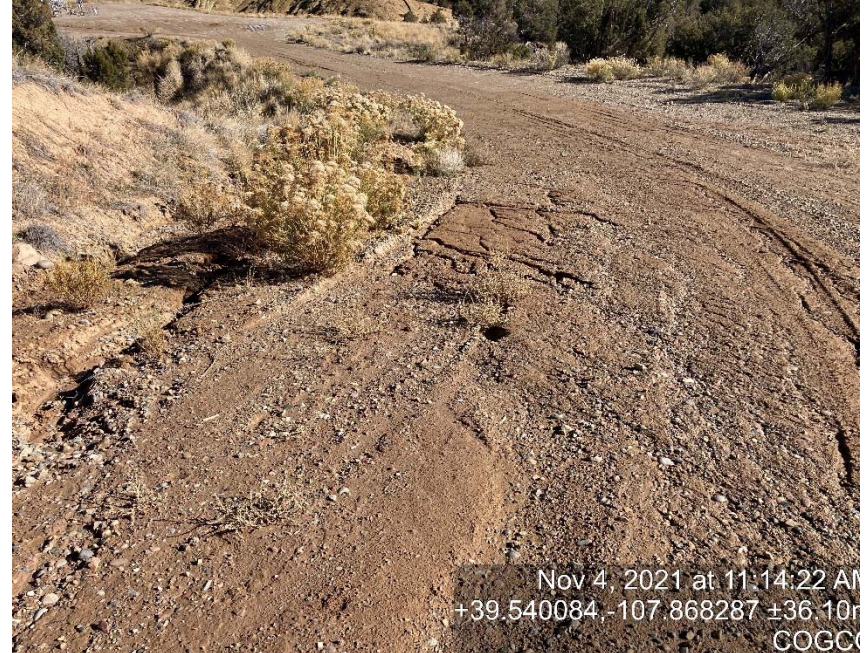
Erosion on access to wells

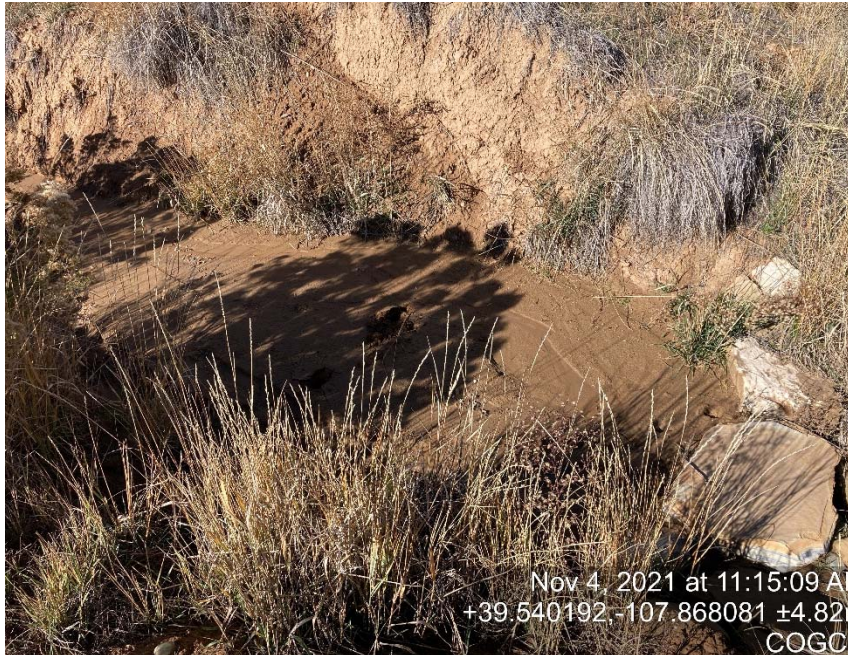
Sediment trap is full

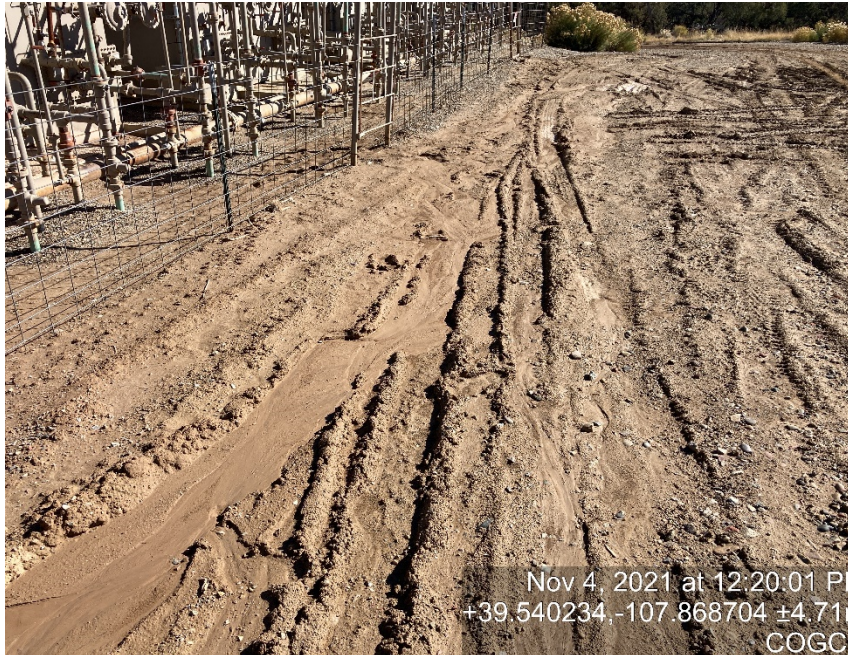
Lack of stabilization/compaction

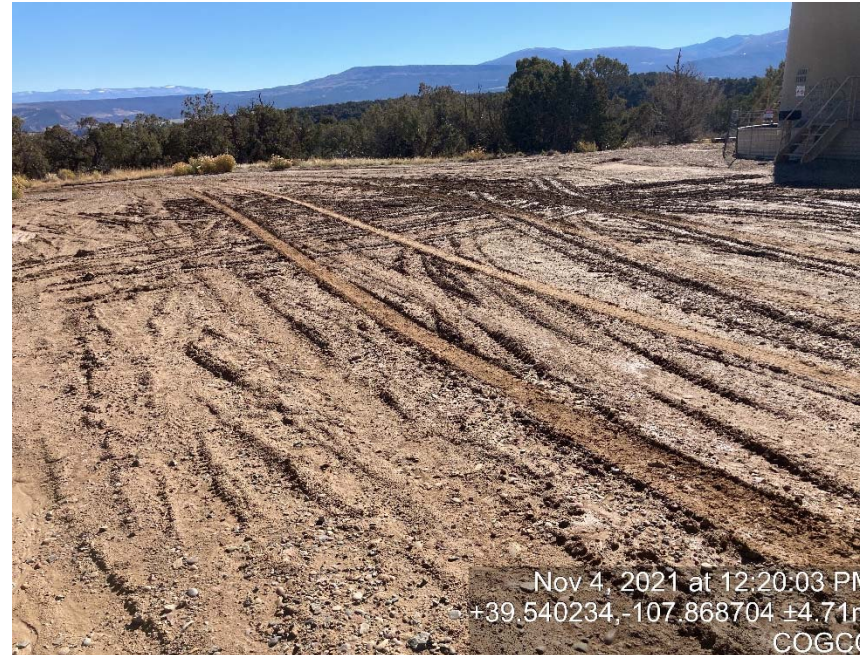
Lack of stabilization/compaction

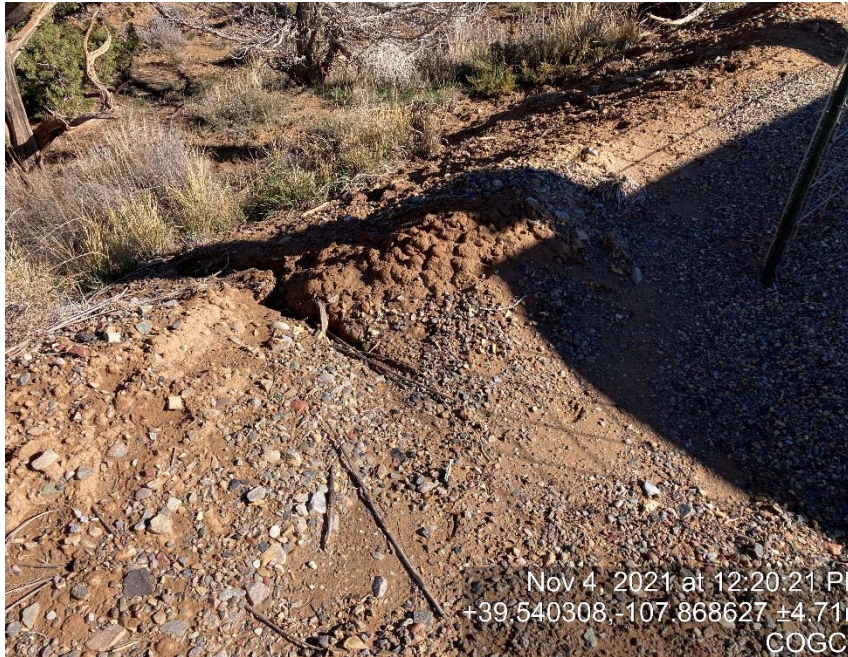
Erosion/sediment migration behind separators

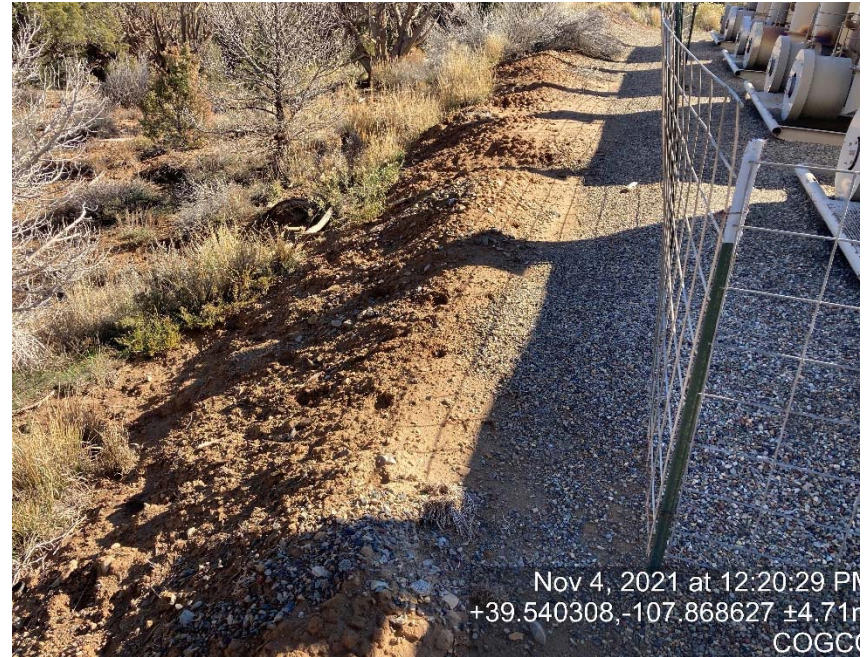
Erosion/sediment migration behind separators

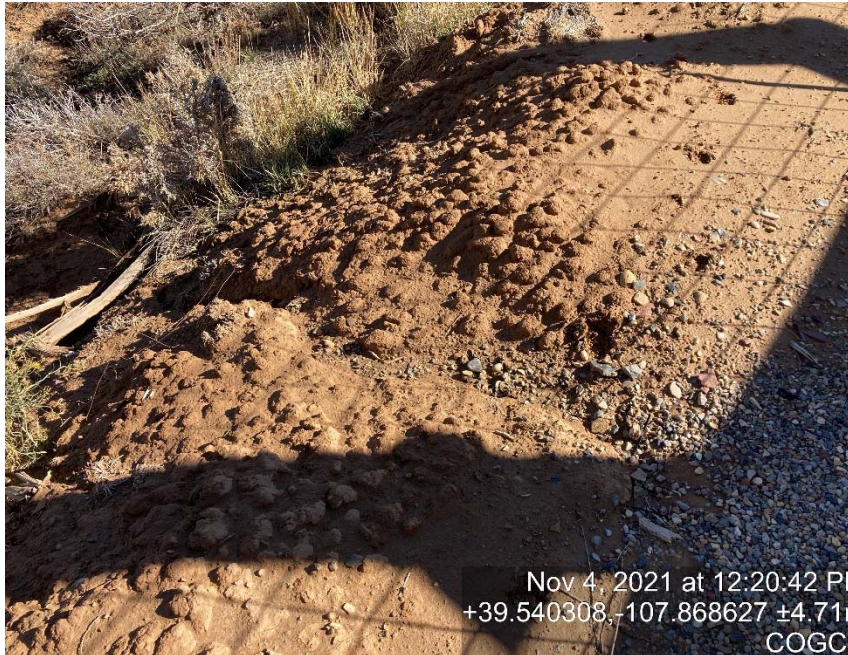
Erosion/sediment migration behind separators

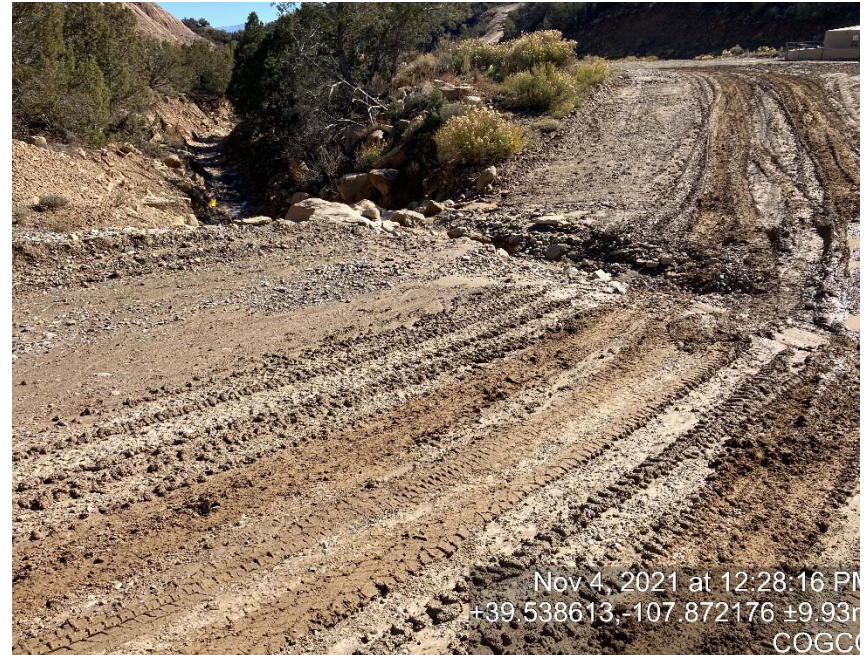
Access road drainage crossing needs maintained

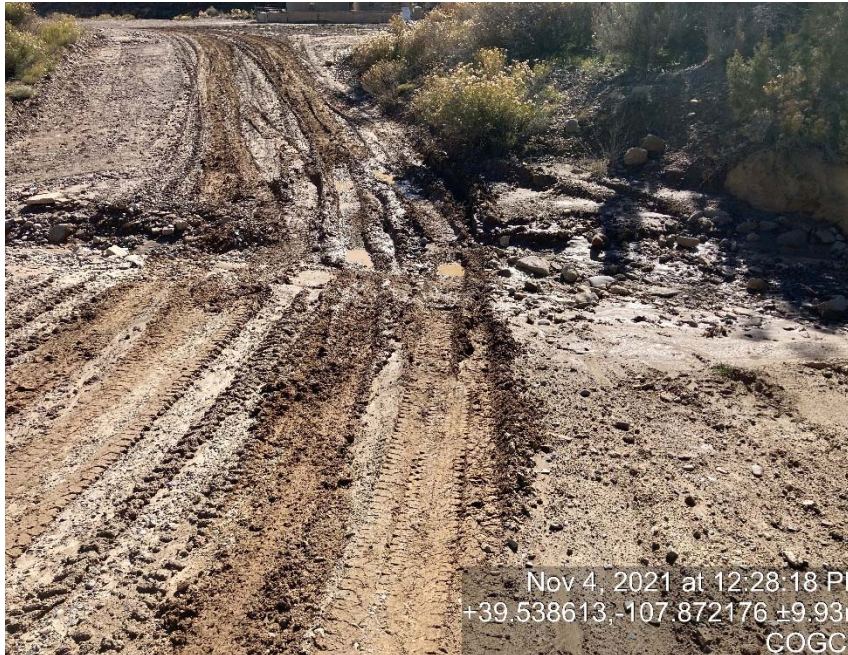
Access road drainage crossing needs maintained

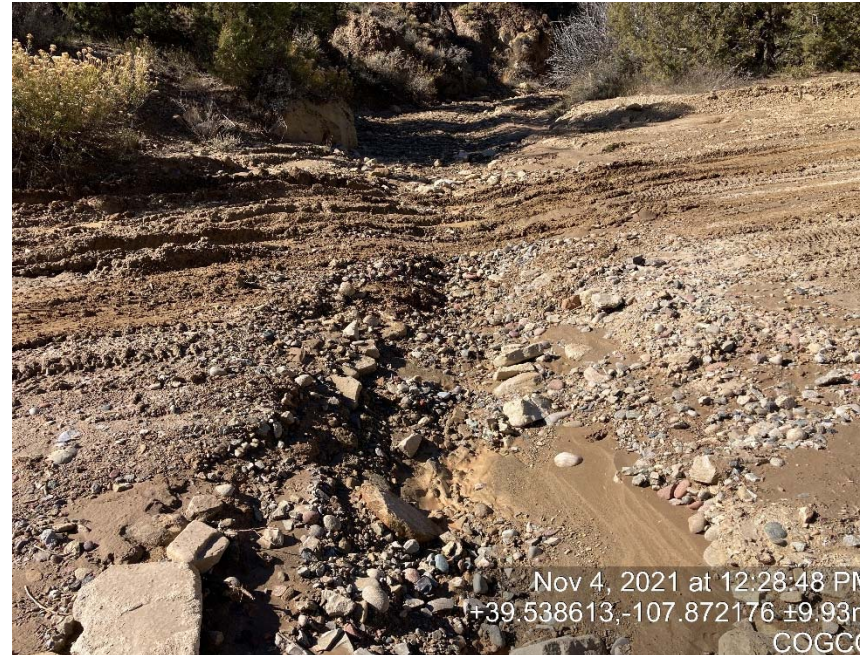
Access road drainage crossing needs maintained

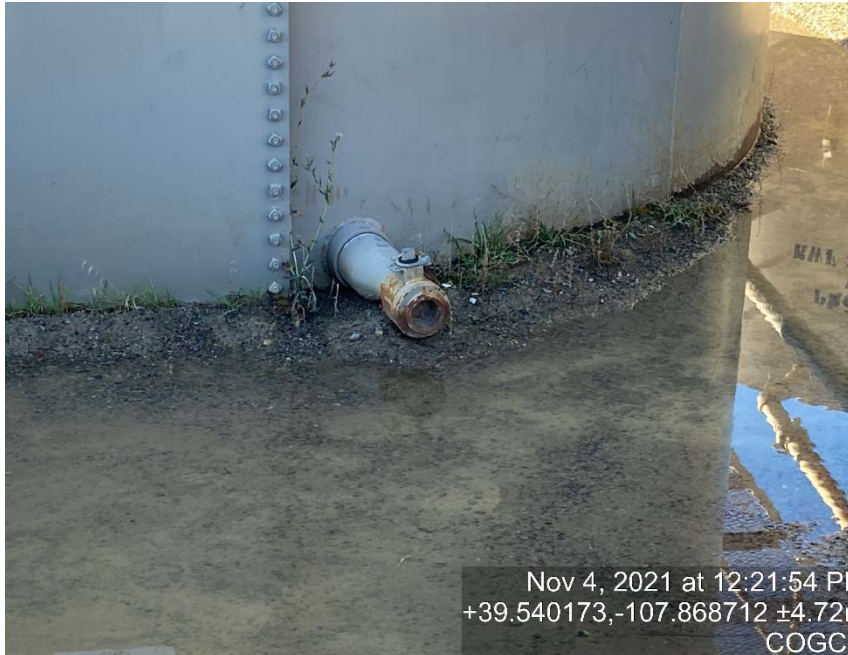
Load line missing bull plug/cap

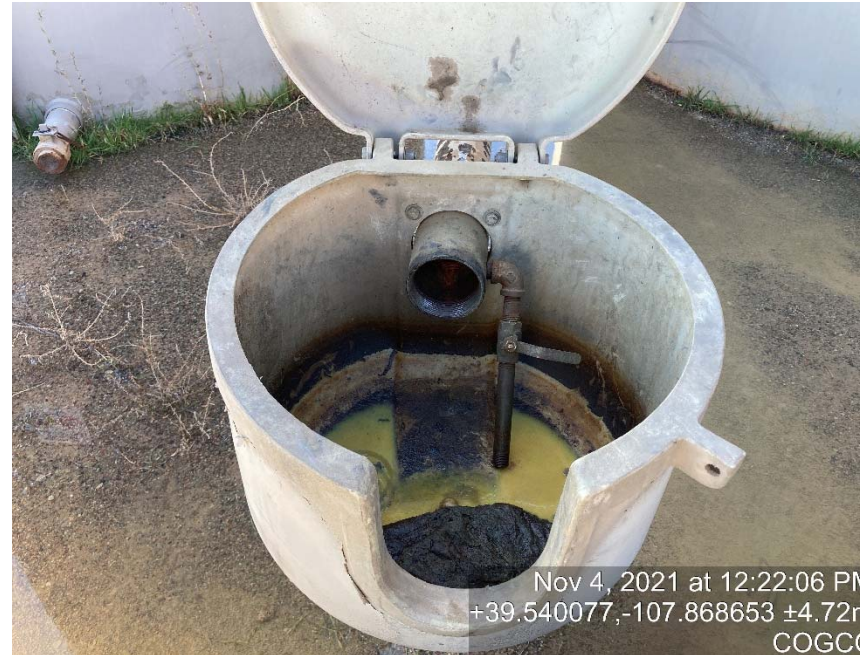
Load line missing bull plug/cap
