TEP Clough 119 Location # 322434

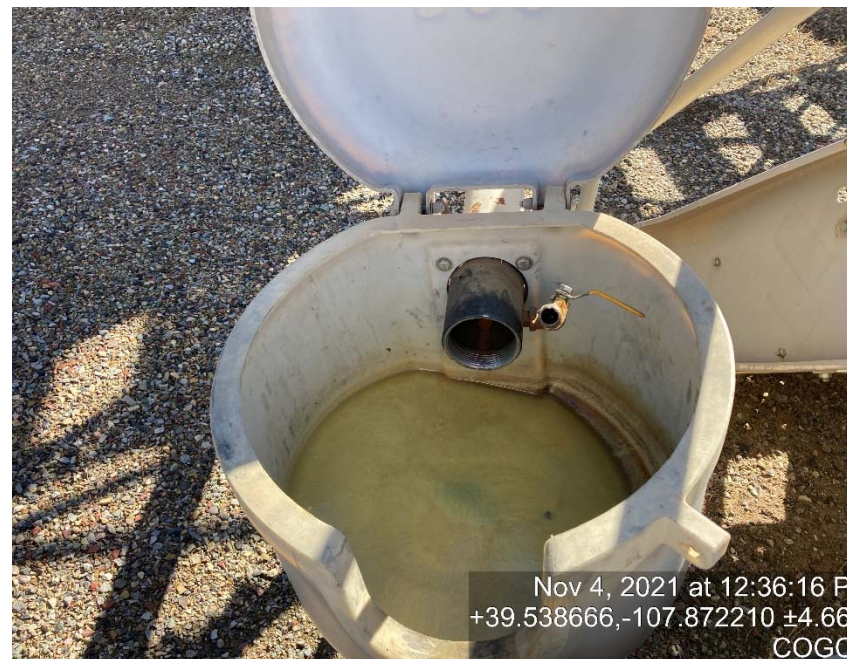
Load line missing bull plug/cap

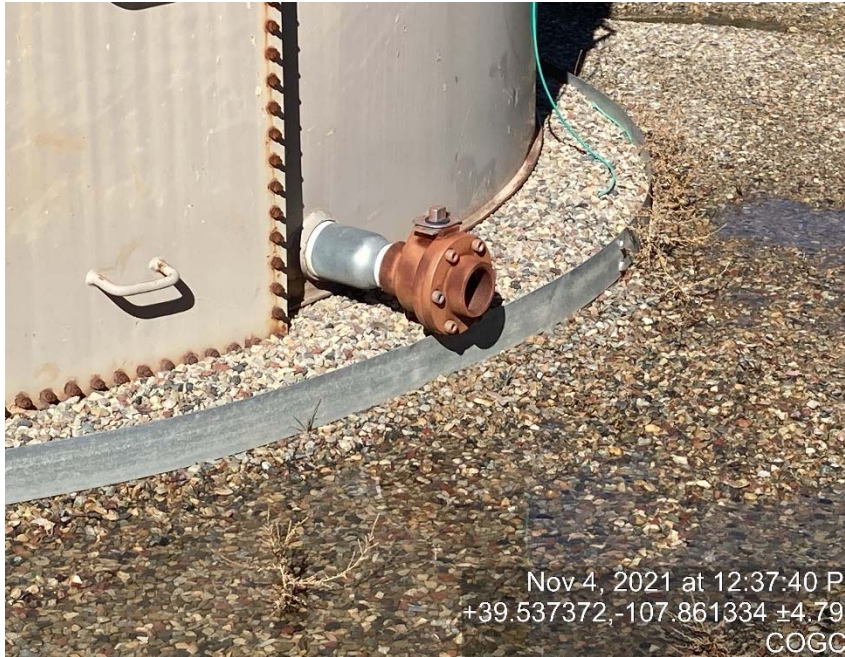
Load line missing bull plug/cap

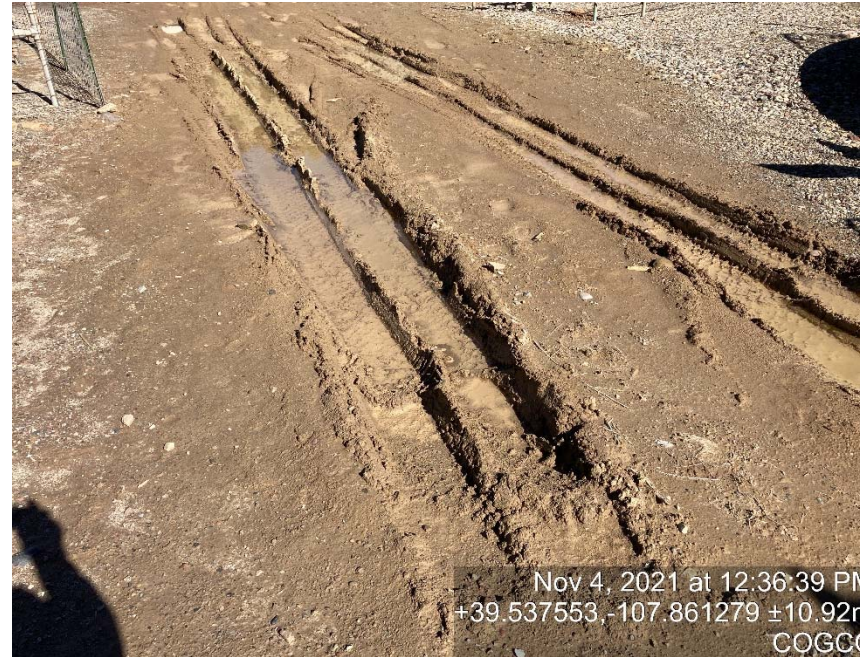
Lack of stabilization/compaction

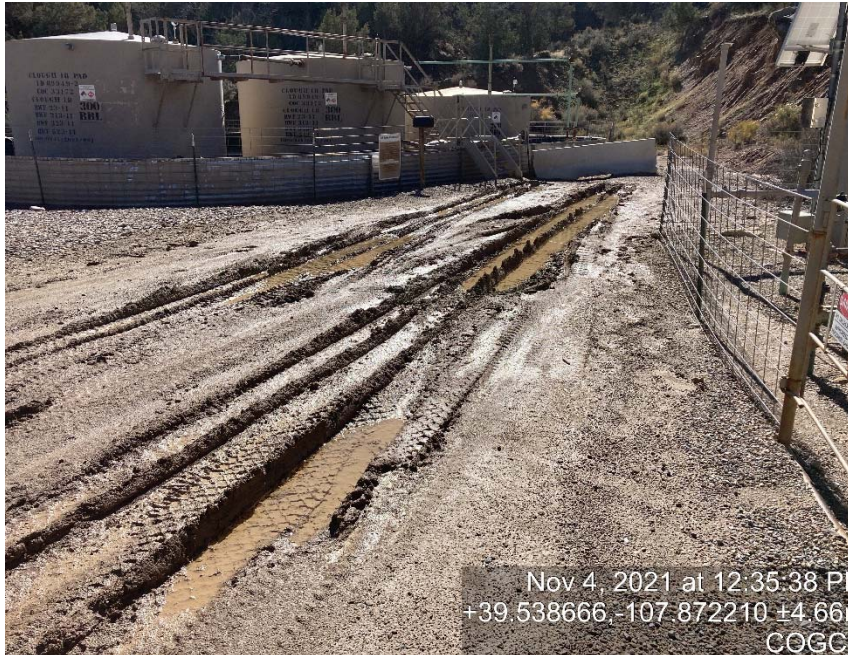
Lack of stabilization/compaction

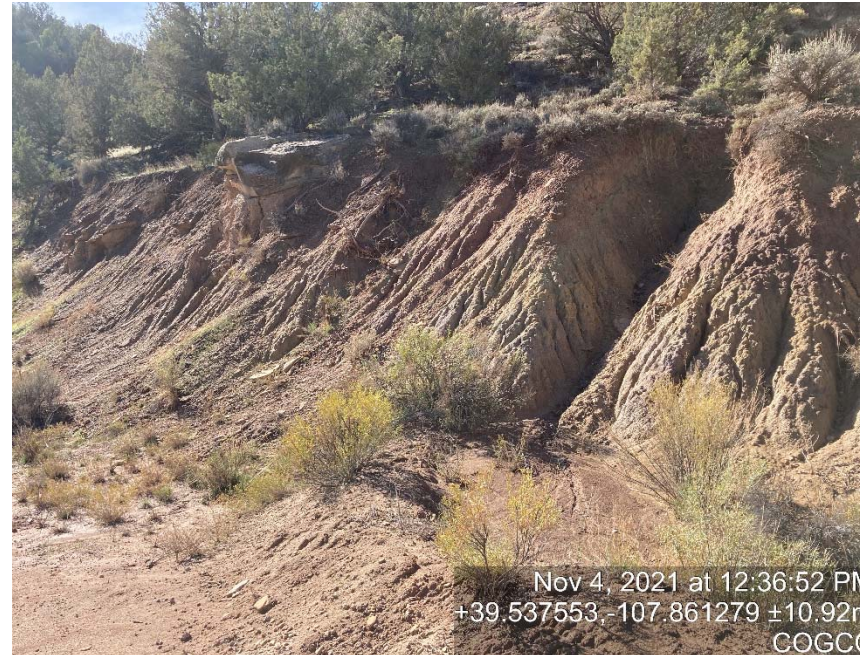
Cut slope erosion

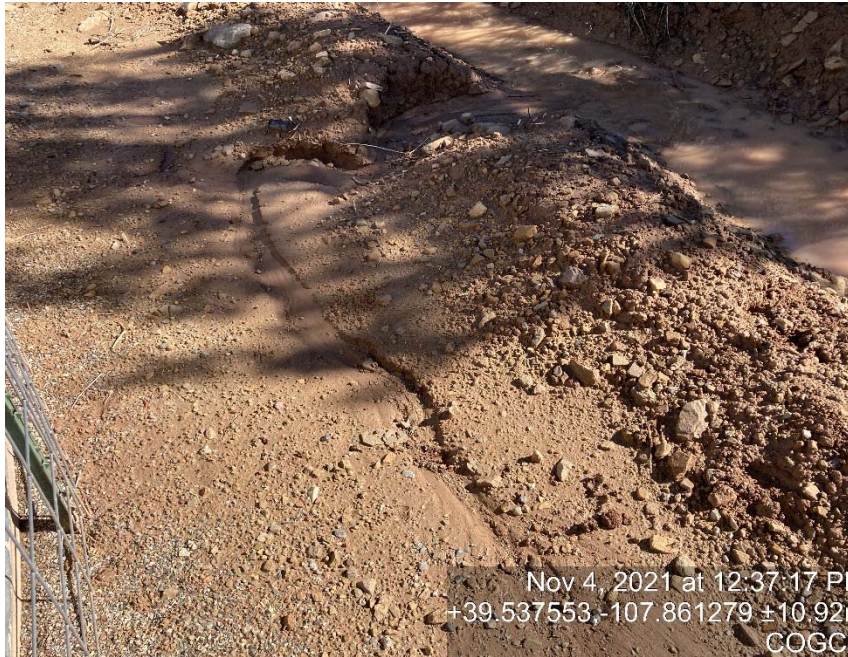
Berm is failing

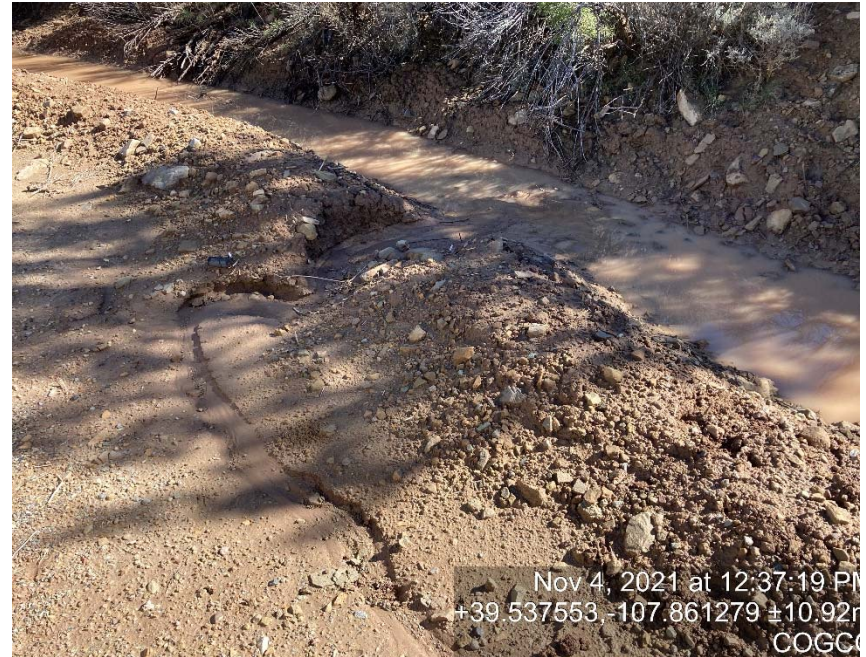
Berm is failing
