Inspection Photos

11/05/2021

Operator: CAERUS PICEANCE LLC - 10456

Location ID: 334336

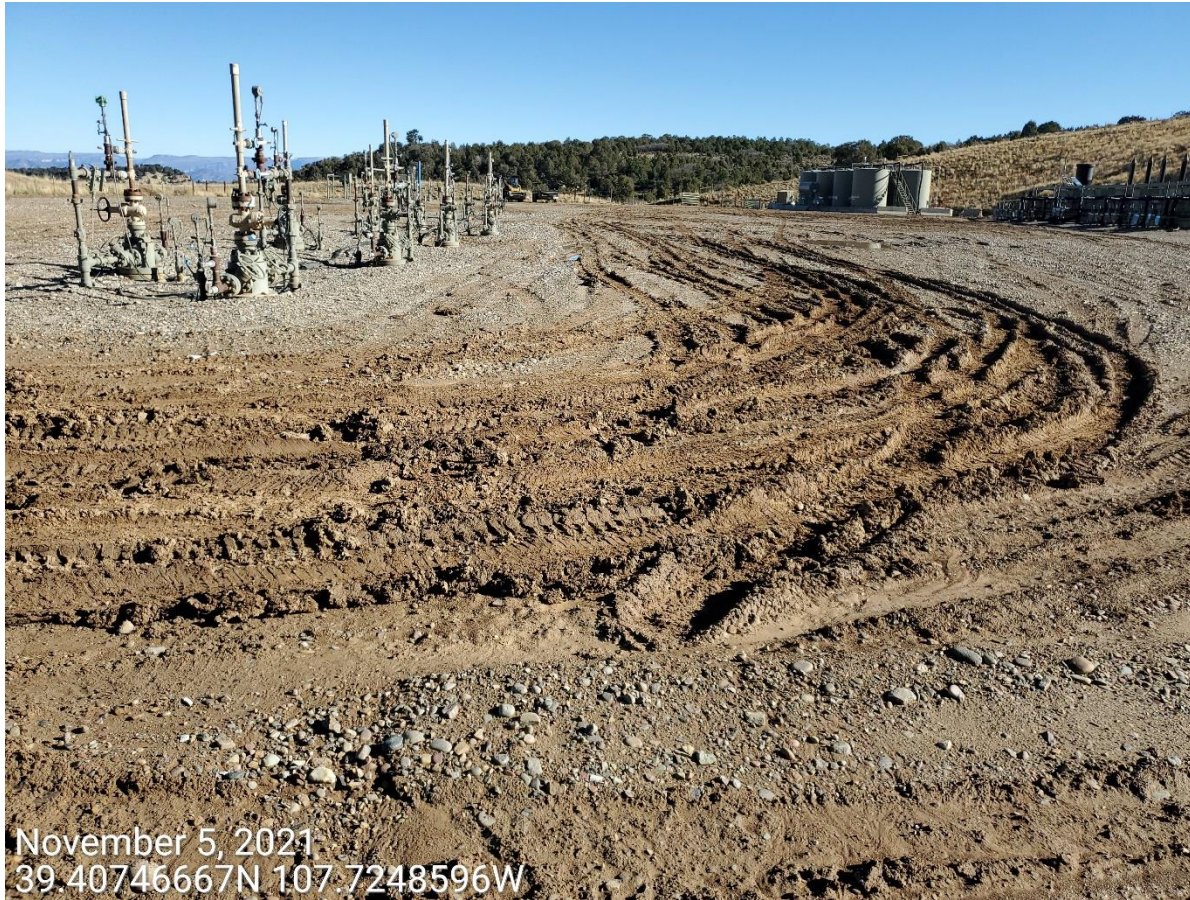
Photo 1: Photos 1-3 taken from the production areas of the Location. Photos provide examples showing that control measures to stabilize, mitigate tracking and offsite sediment transport at the production areas of the Location are missing or insufficient.

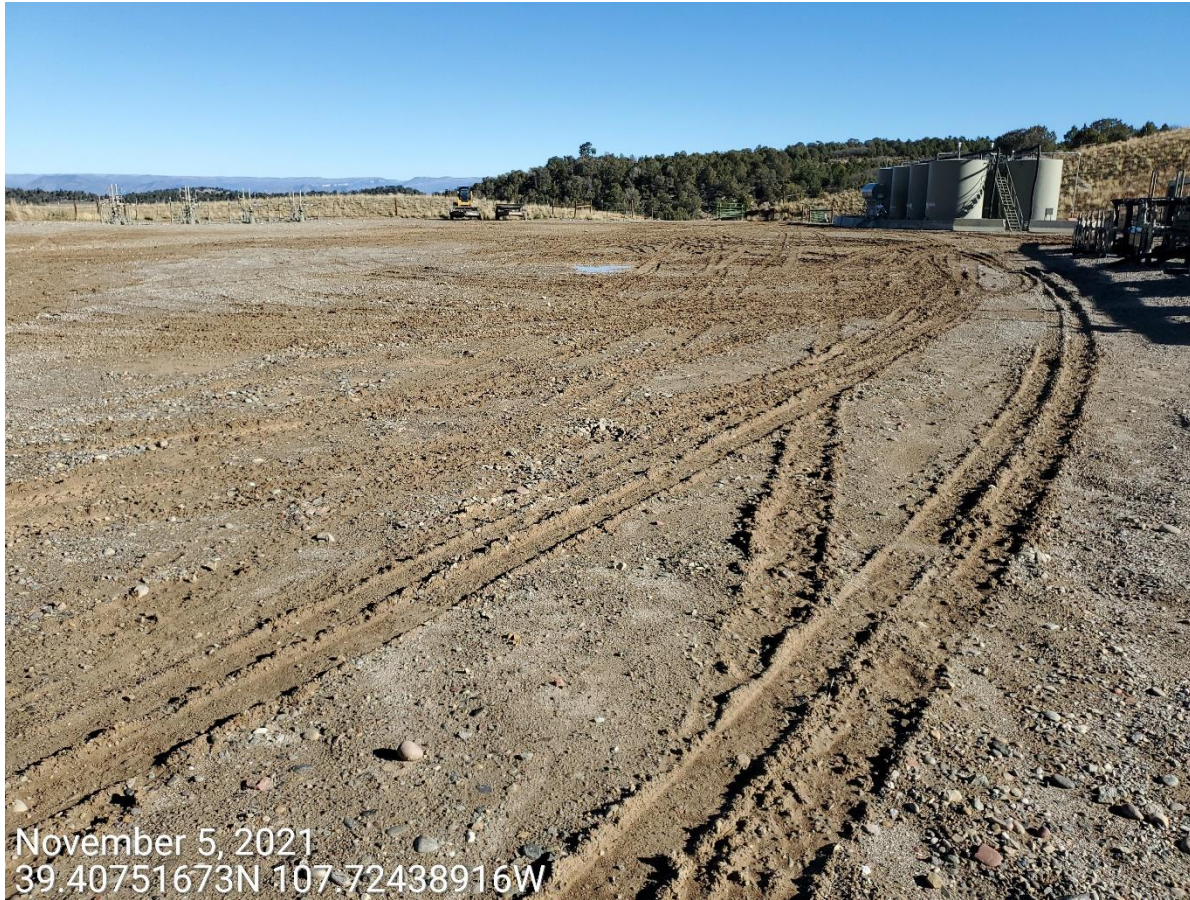
Photo 2: See comments under photo 1.

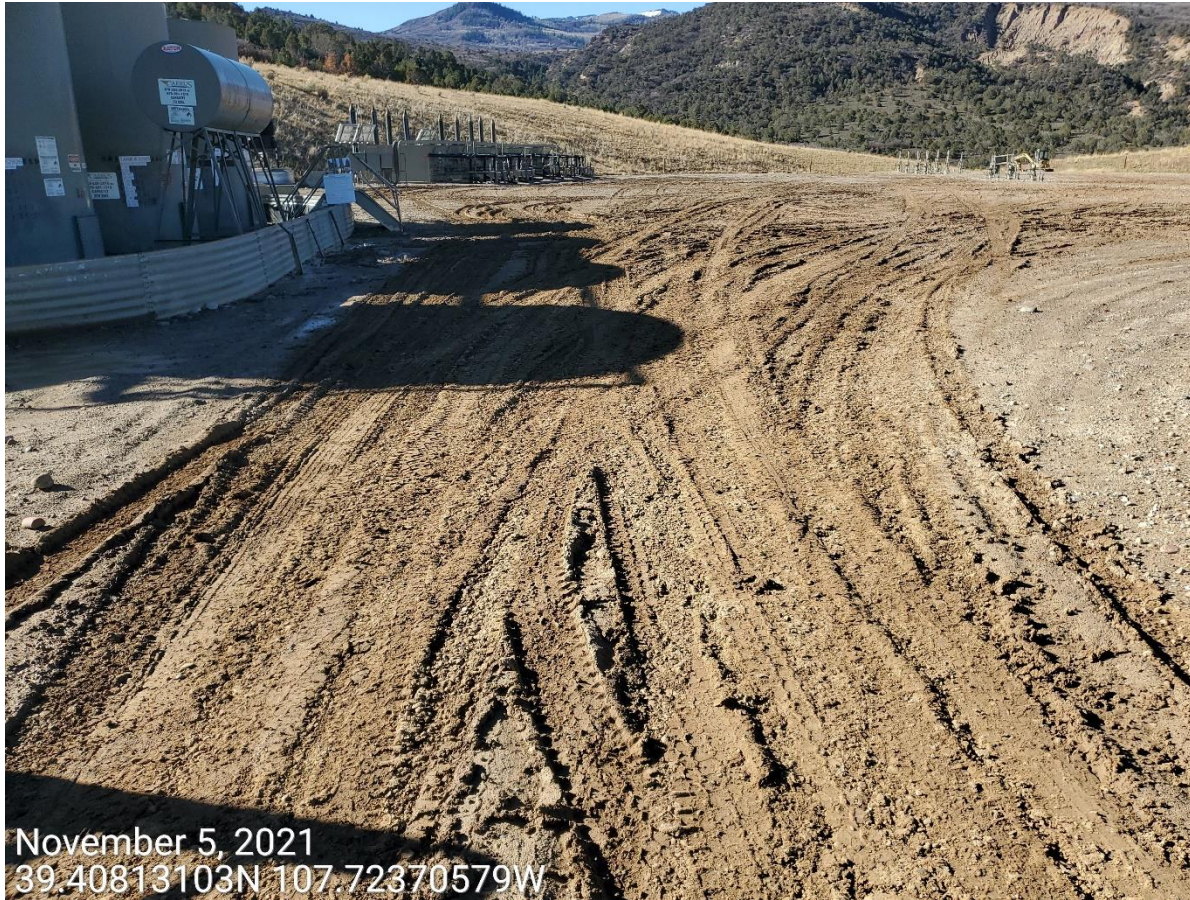
Photo 3: See comments under photo 1.

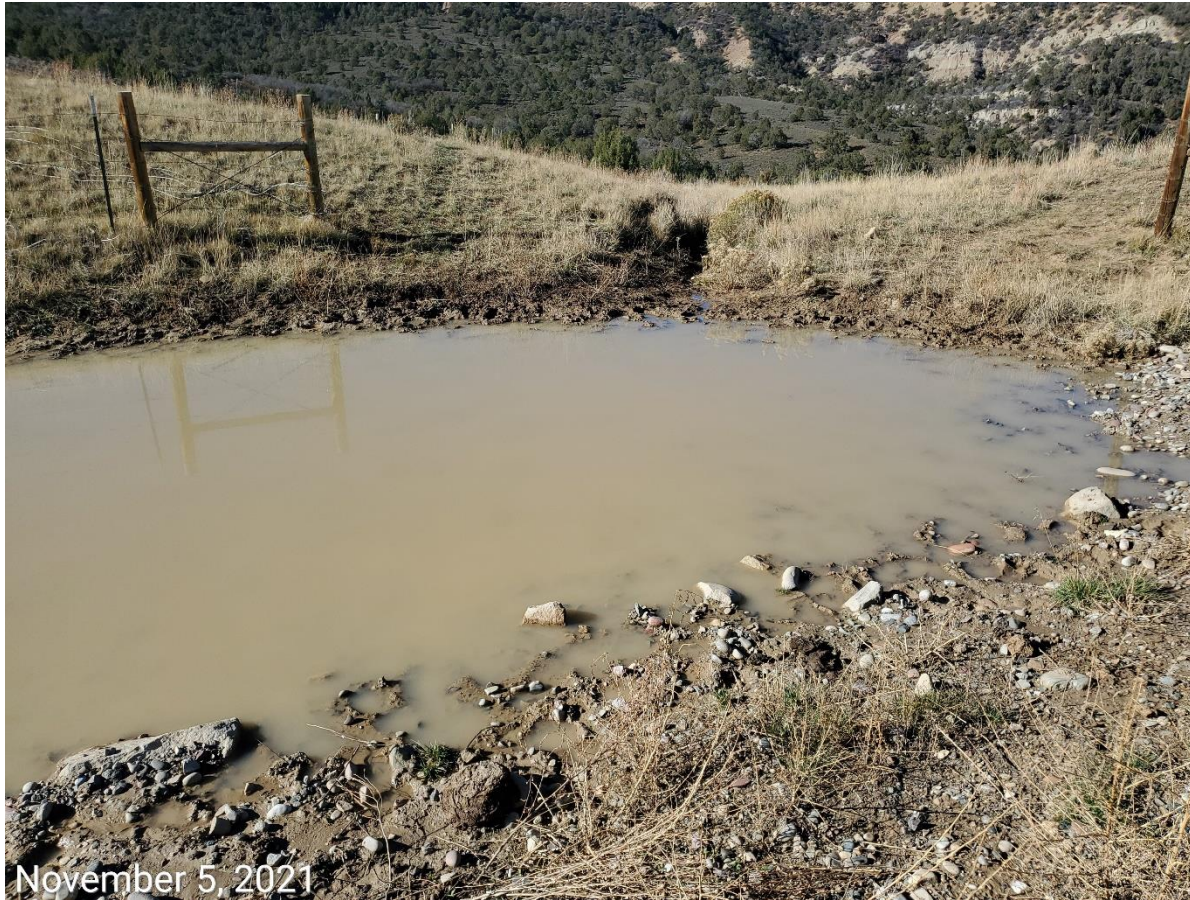
Photo 4: Photo taken from the sediment trap on the southwest end of the Location; stormwater discharge from the trap continues into a stormwater diversion ditch that travels southwest of the Location. Photo shows control measure has not been constructed with an appropriate outlet in accordance with good engineering practices.

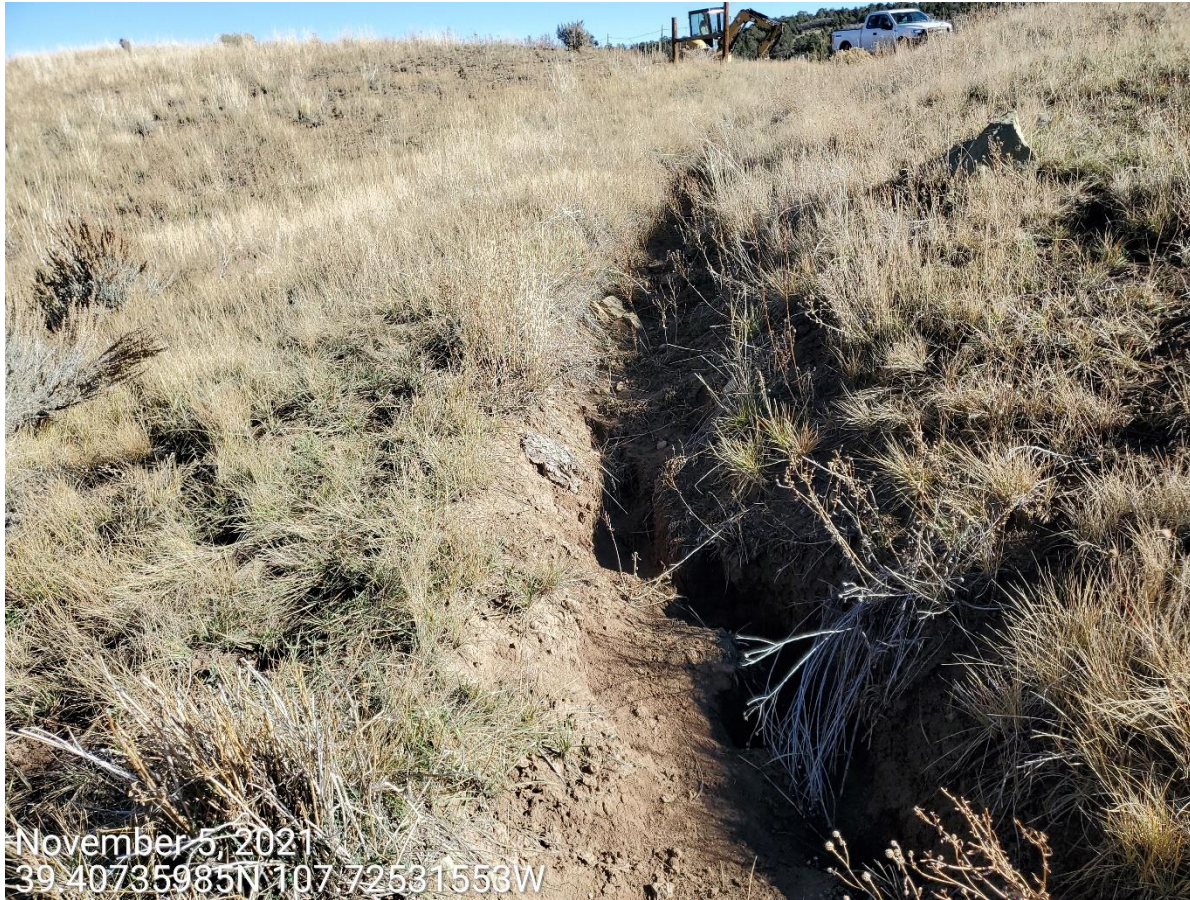
Photo 5: Photo taken from the stormwater diversion ditch southwest from the Location and the sediment trap; erosion degradation and incising due to stormwater runoff evident within ditch; control measures have not been constructed per good engineering practices or maintained in proper functioning condition

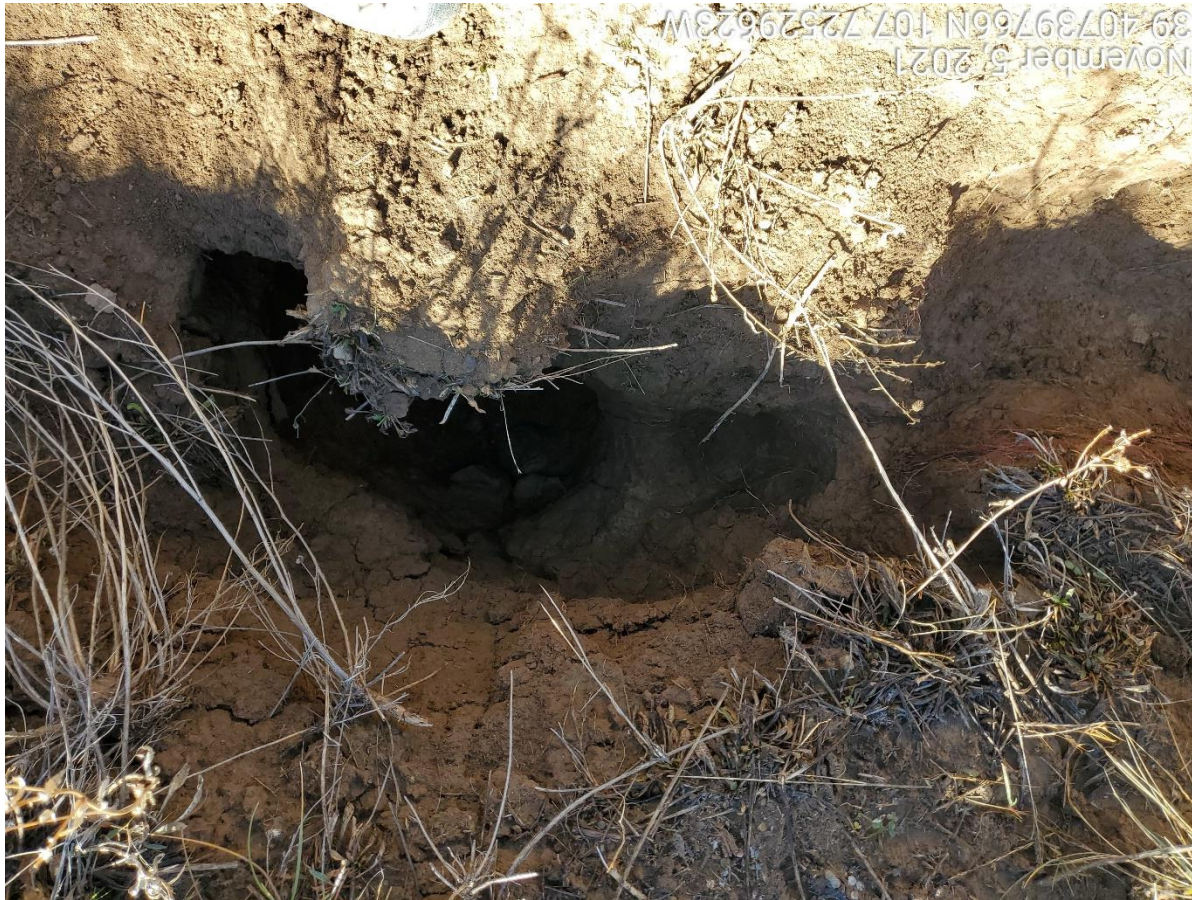
Photo 6: Continued from photo 5. Photo shows erosion degradation within the ditch.

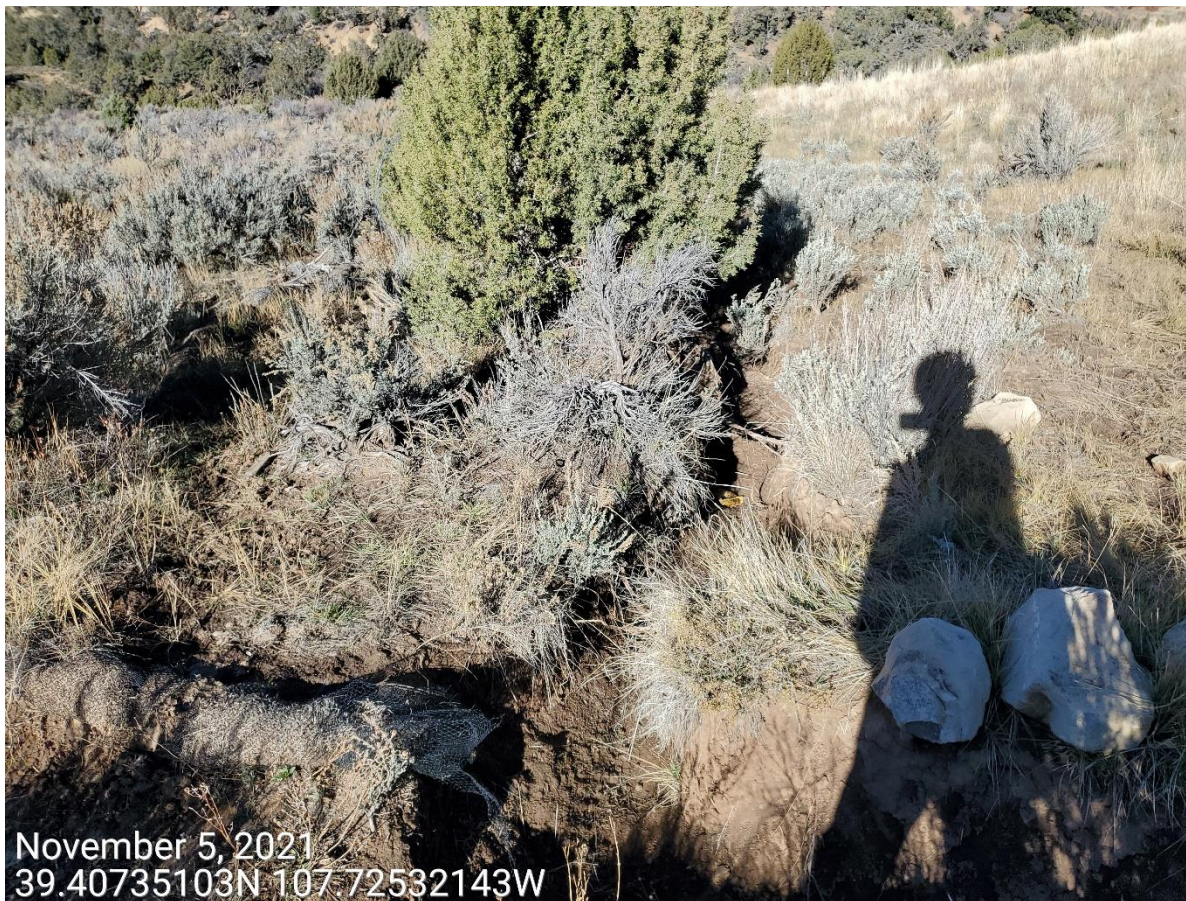
Photo 7: Photo taken southwest of the location, at the point where the stormwater diversion ditch and runoff turns 90 degrees and continues to travel to the northwest. Photos 8-10 show the erosion degradation due to improper stormwater discharge northwest from this position.

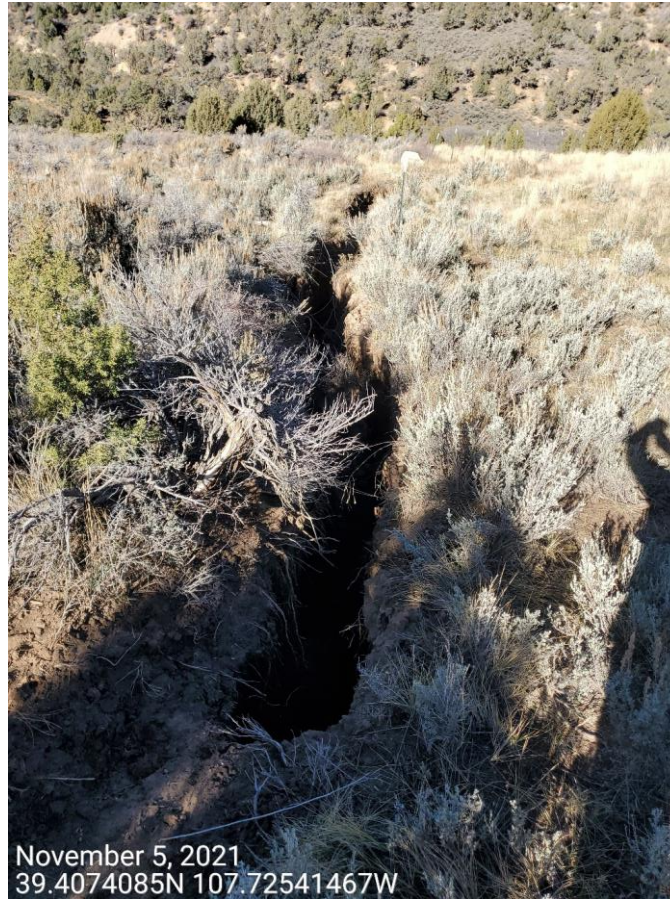
Photo 8: Continued from photo 7. Photo shows gully erosion due to inadequate stormwater and erosion control measures, and improper stormwater discharge from the Location.

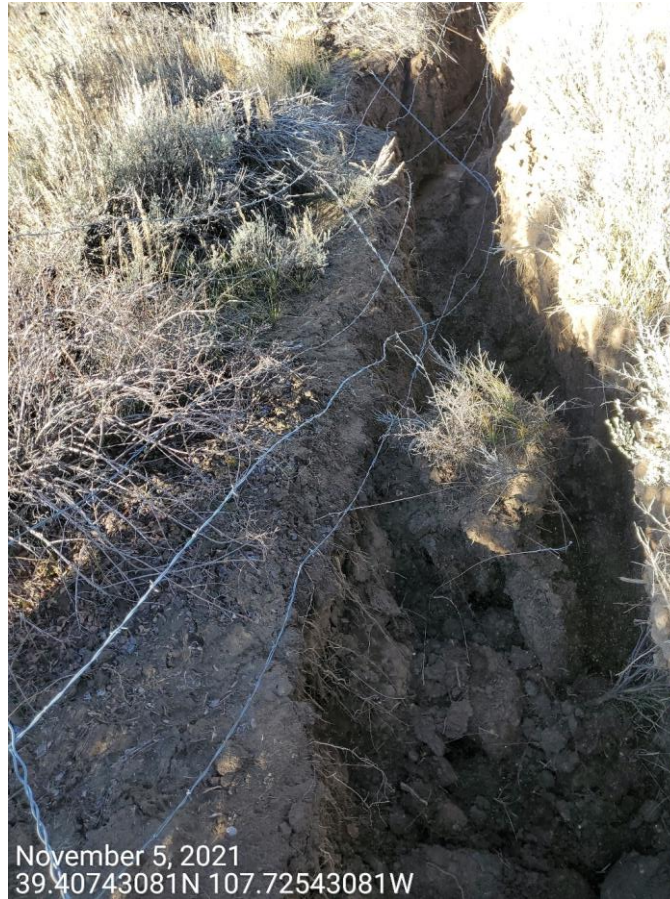
Photo 9: Photo shows gully erosion due to inadequate stormwater and erosion control measures, and improper stormwater discharge from the Location.

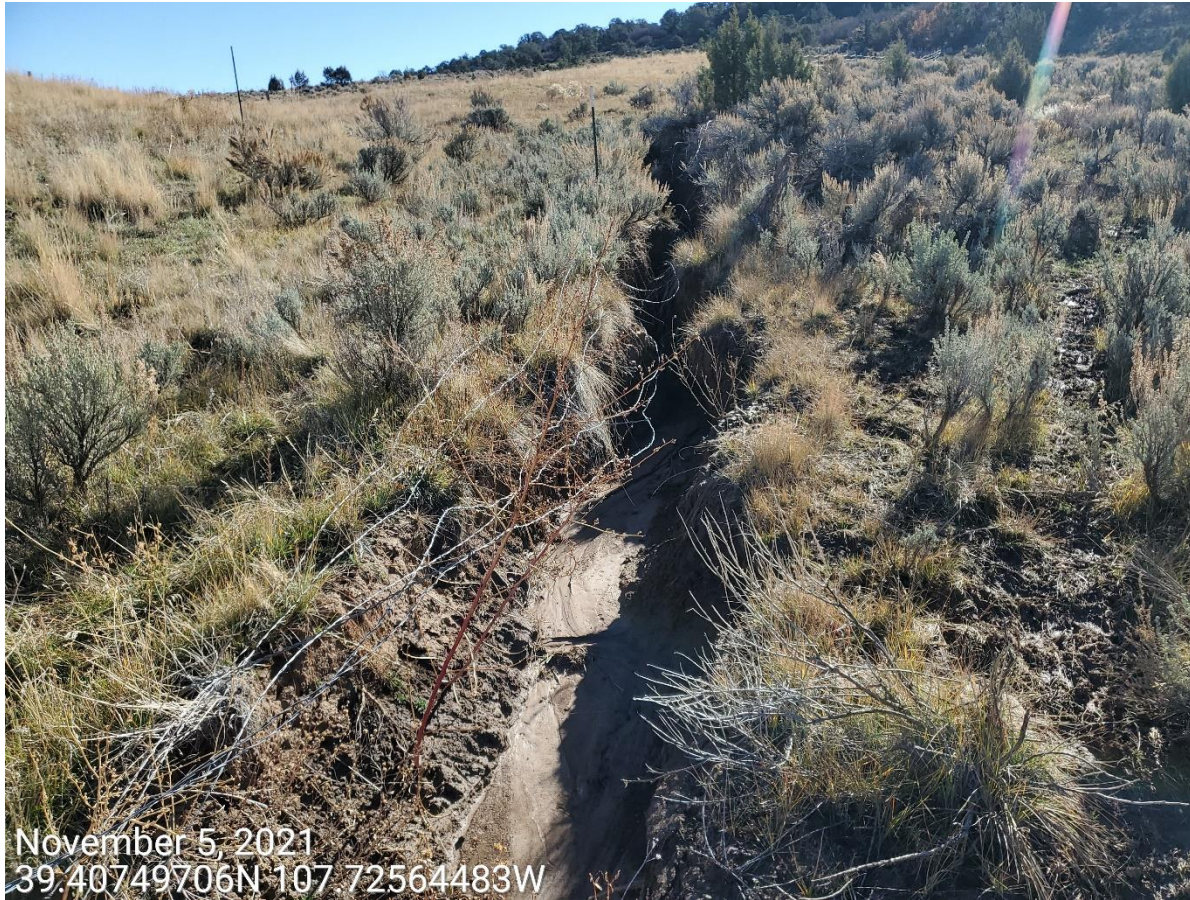
Photo 10: Photo shows gully erosion due to inadequate stormwater and erosion control measures, and improper stormwater discharge from the Location.
