Inspection Photos

API: 071-08927

Operator: OGRIS OPERATING LLC

Inspection Date: 11/8/2021

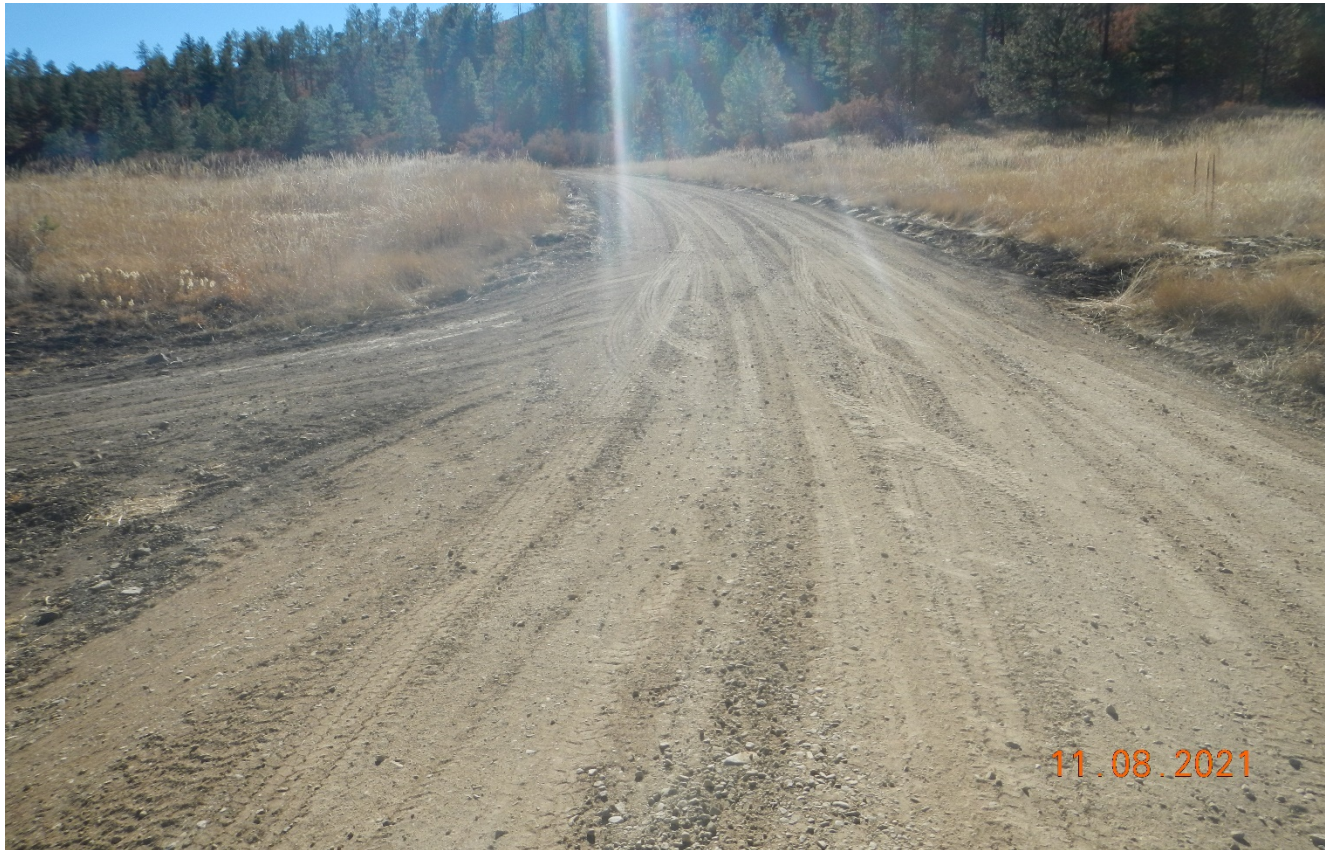
Photo 1. Facing southeast along the access road. The road was regraded and additional gravel was spread along the road.

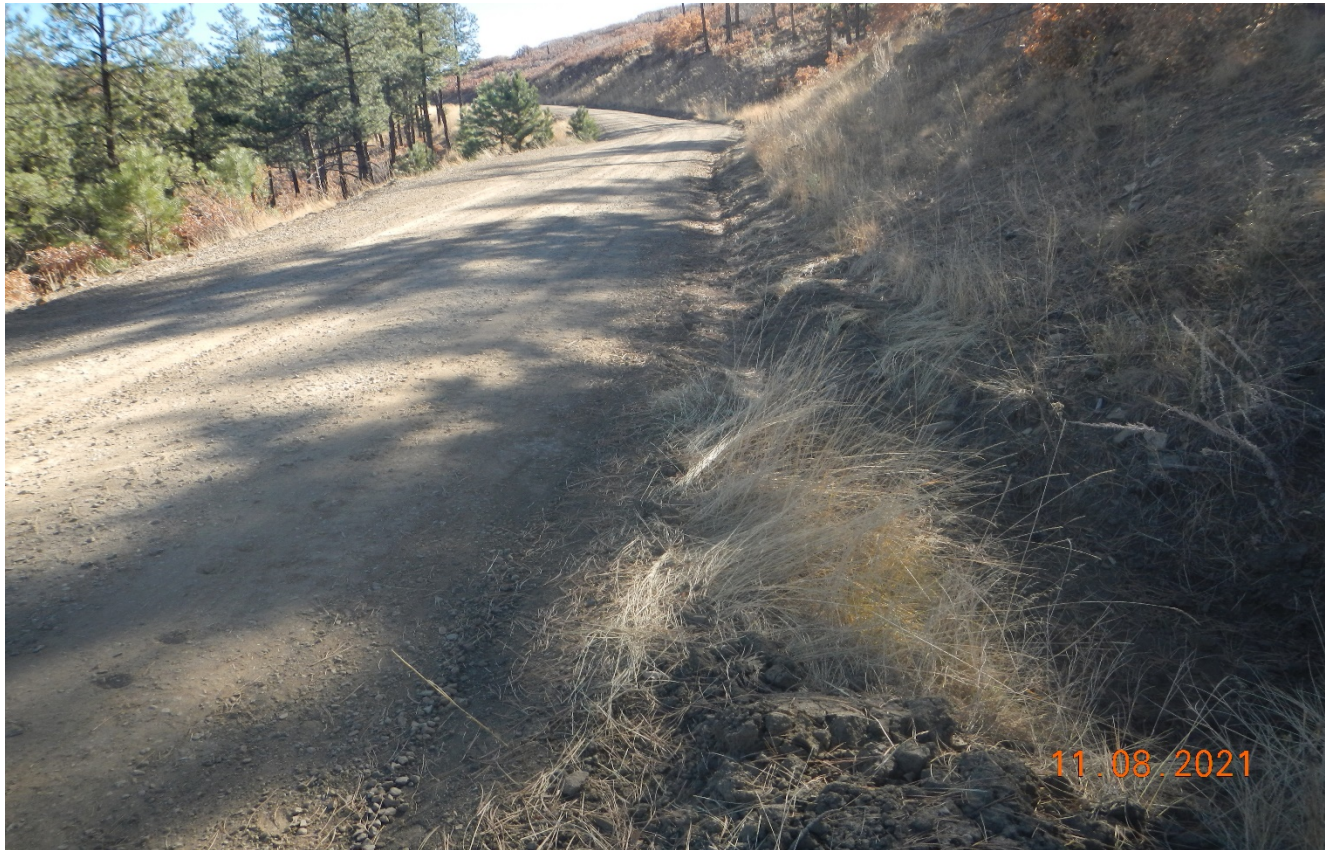
Photo 2. Facing southeast further along the access road. The culverts have been maintained.

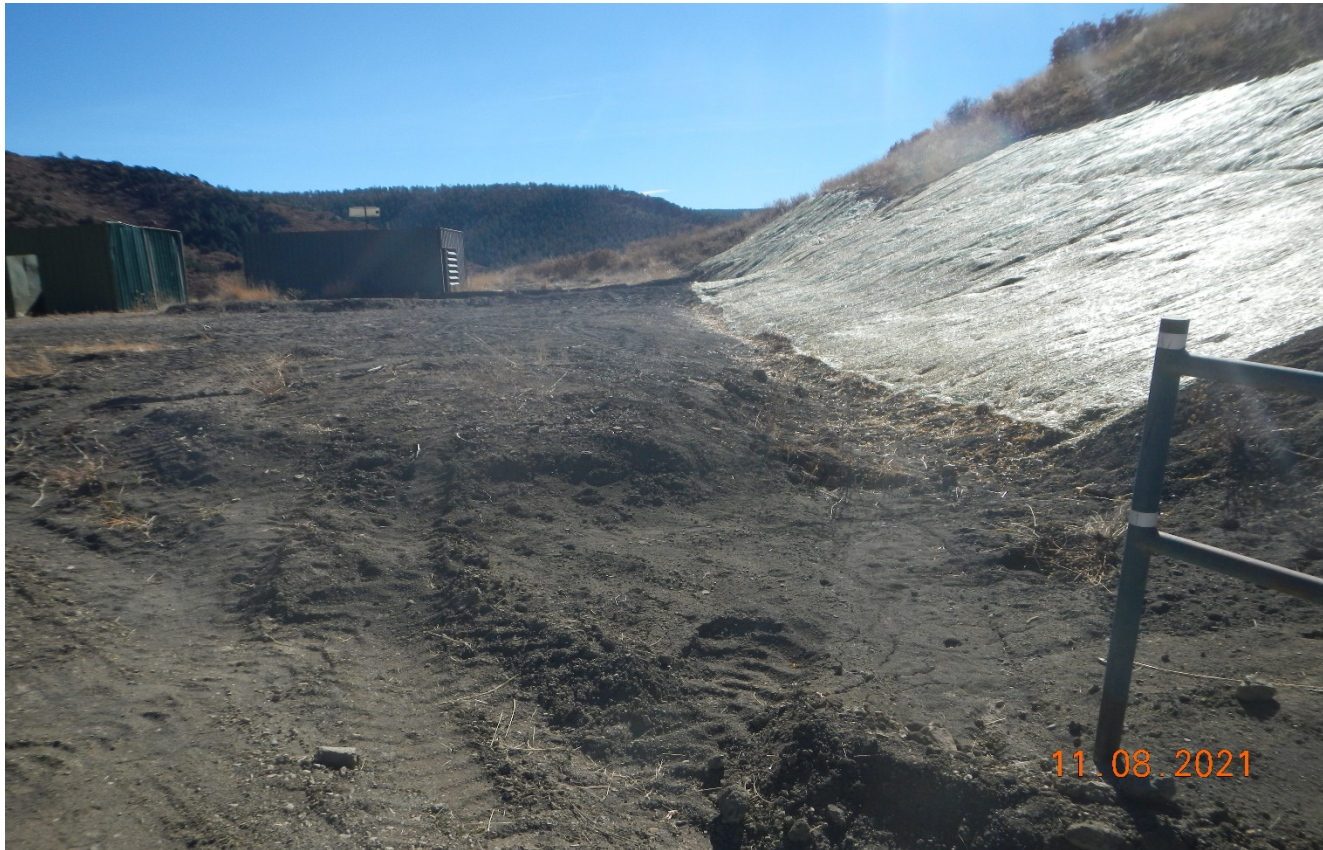
Photo 3. Facing south at the location. There is straw blanket installed along the cut slope where erosion was previously occurring. The bare soils on the flat portion were not reclaimed.

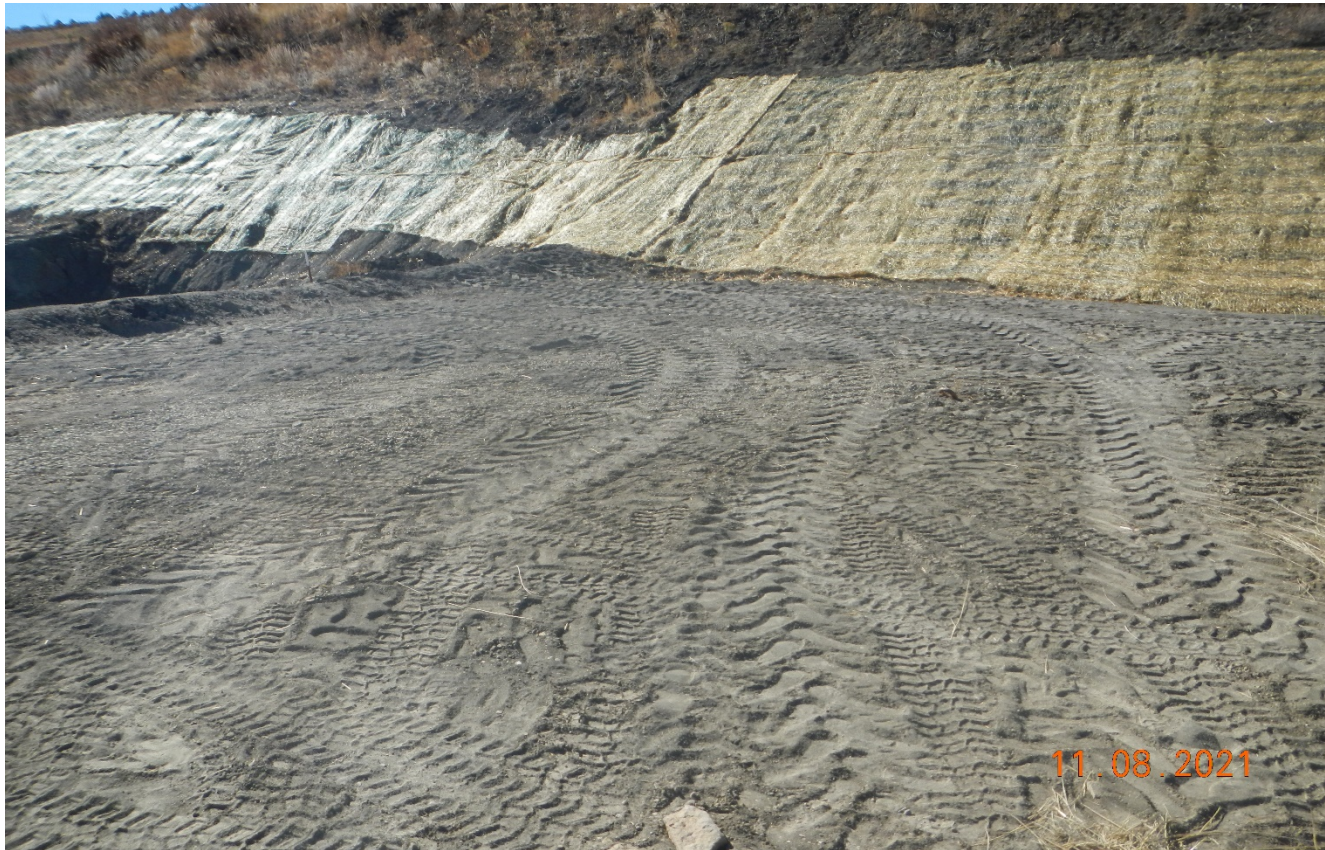
Photo 4. This area next to the pit has bare soils which did not appear to be seeded. This area needs to be reclaimed.

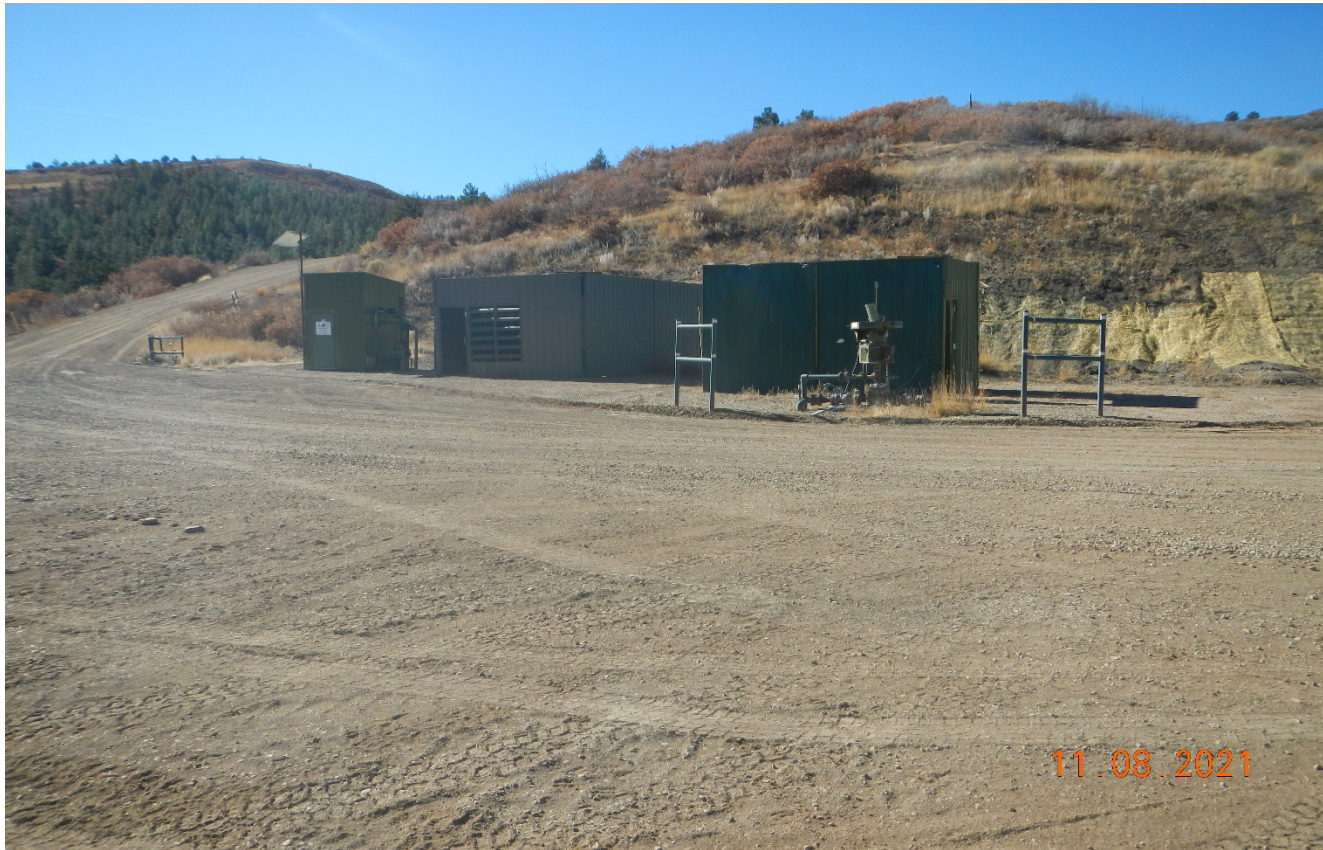
Photo 5. Facing toward the well site.
