Inspection Photos  
Operator: Hilcorp  
API: 067-08319  
Date: 11/3/2021

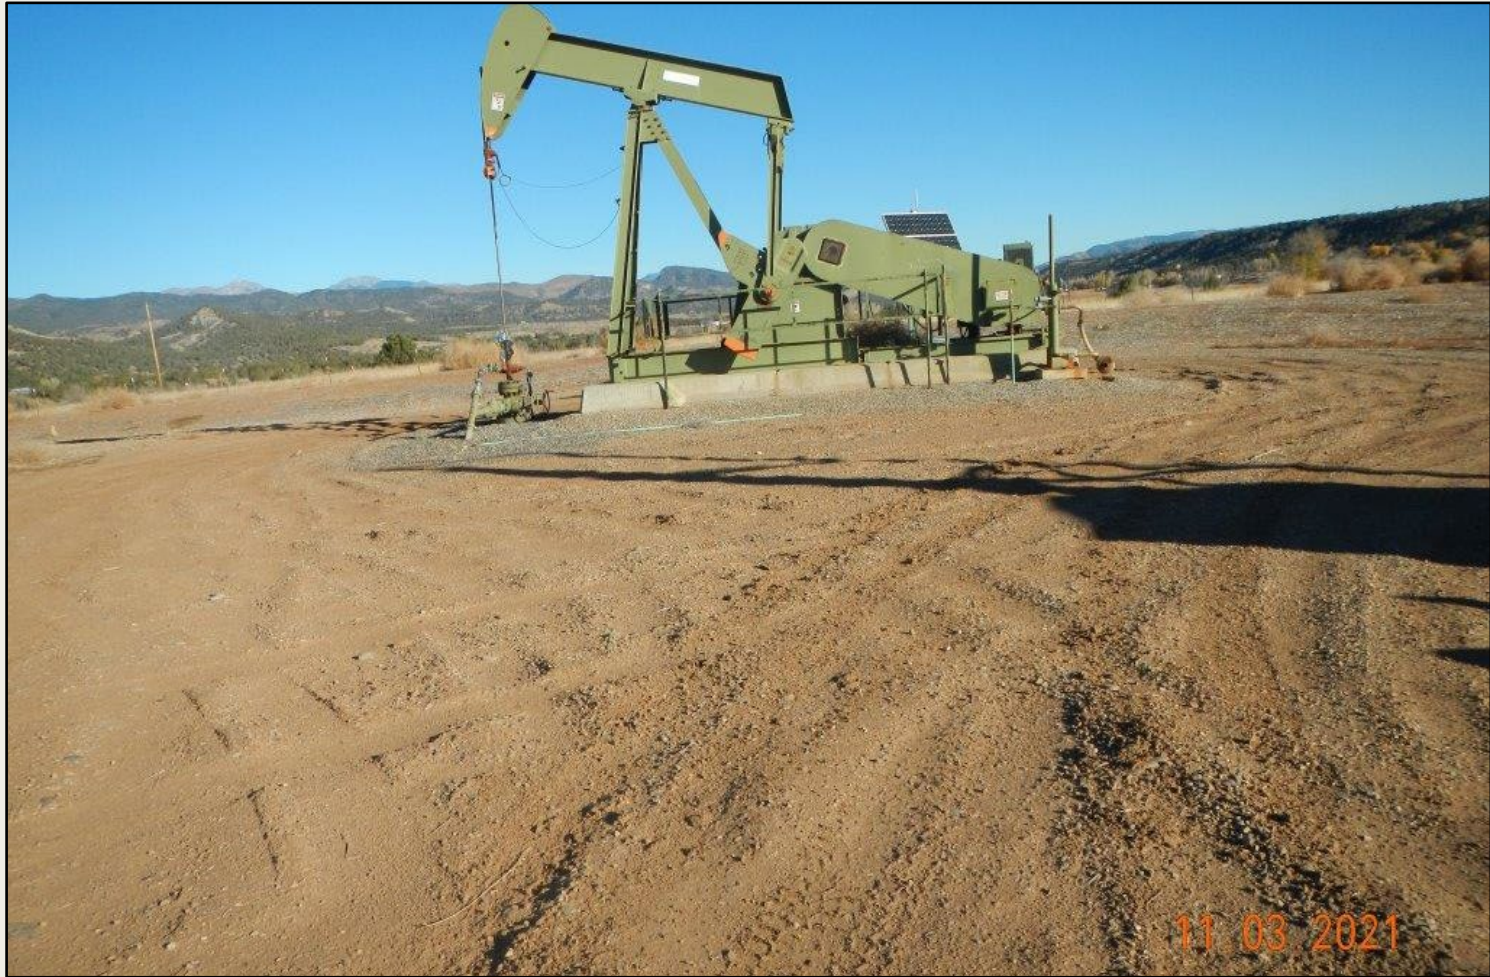
Photo 1. View of the project area from the well pad entrance facing center.

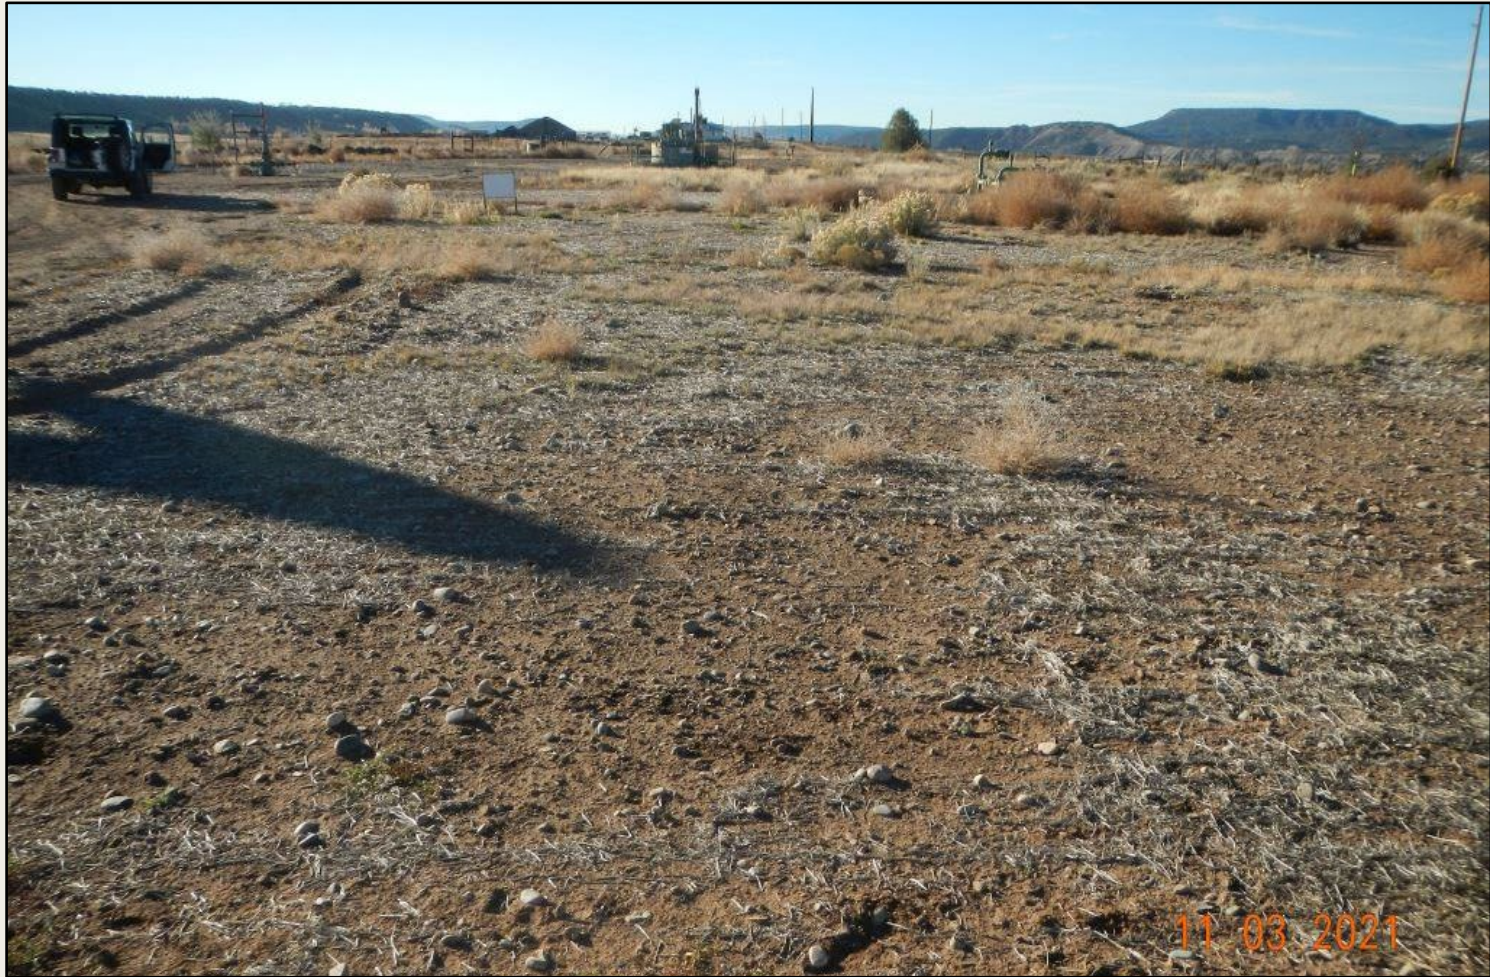
Photo 2. View of the western project area from the northwestern corner facing southward. Seeding and mulch installation is conducted in sparsely vegetated areas. Revegetation is progressing in other portions.

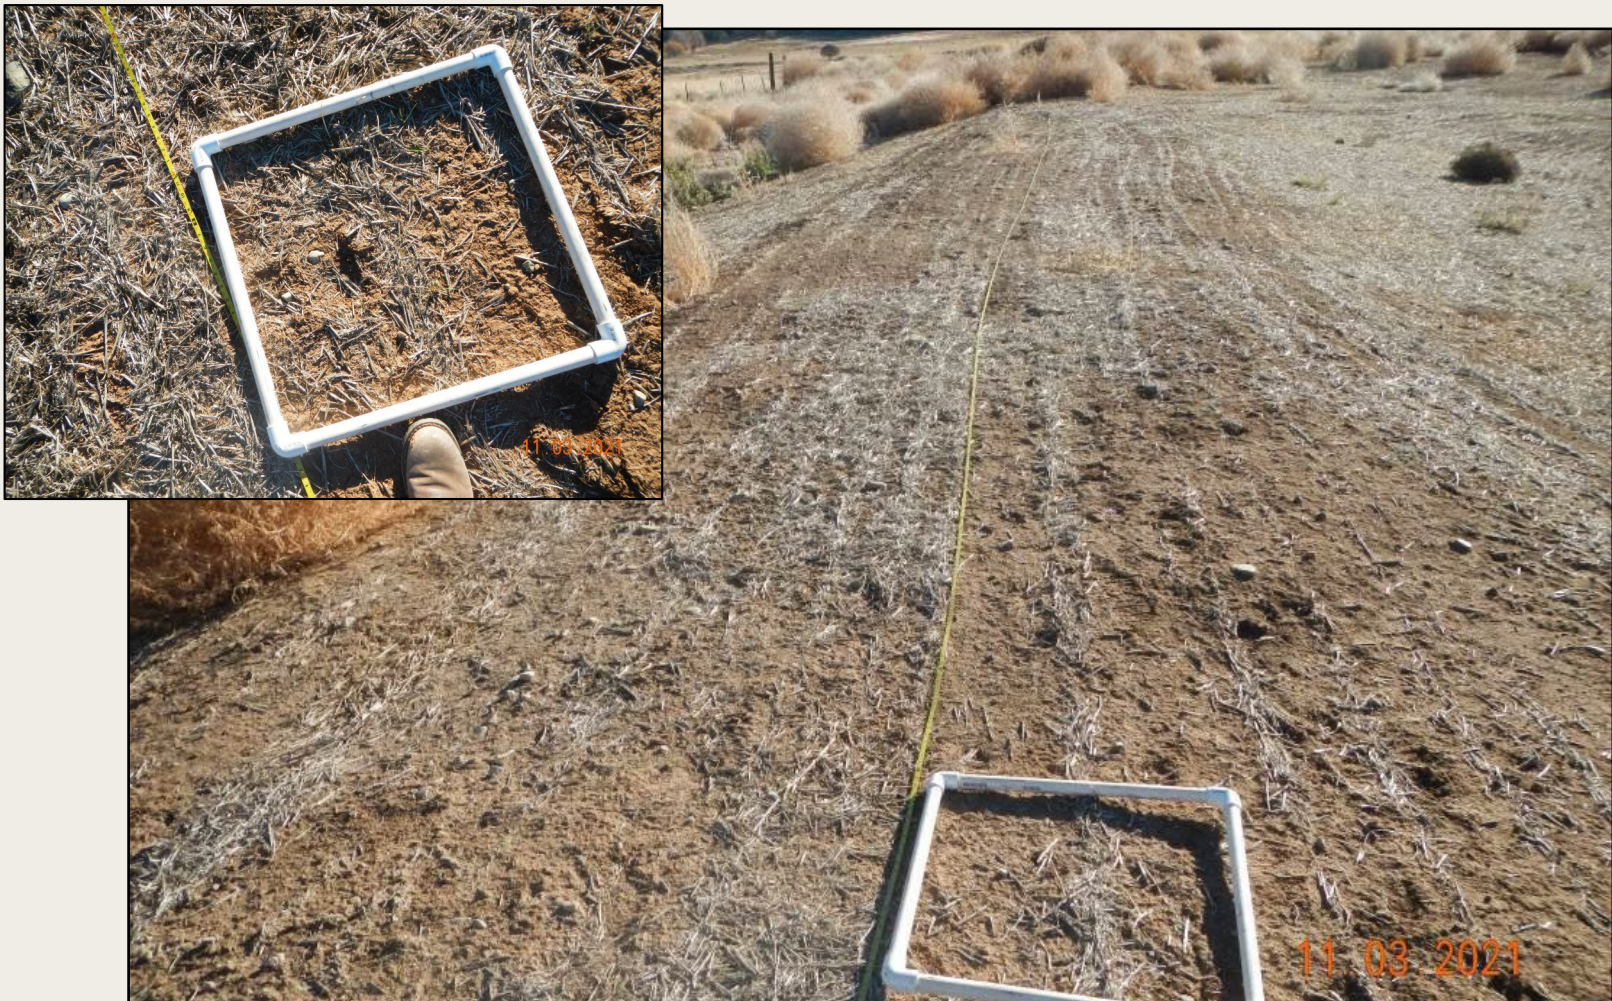
Photo 3. View of the germination quadrat transect facing eastward. Inset shows birdseye view of typical quadrat along transect.

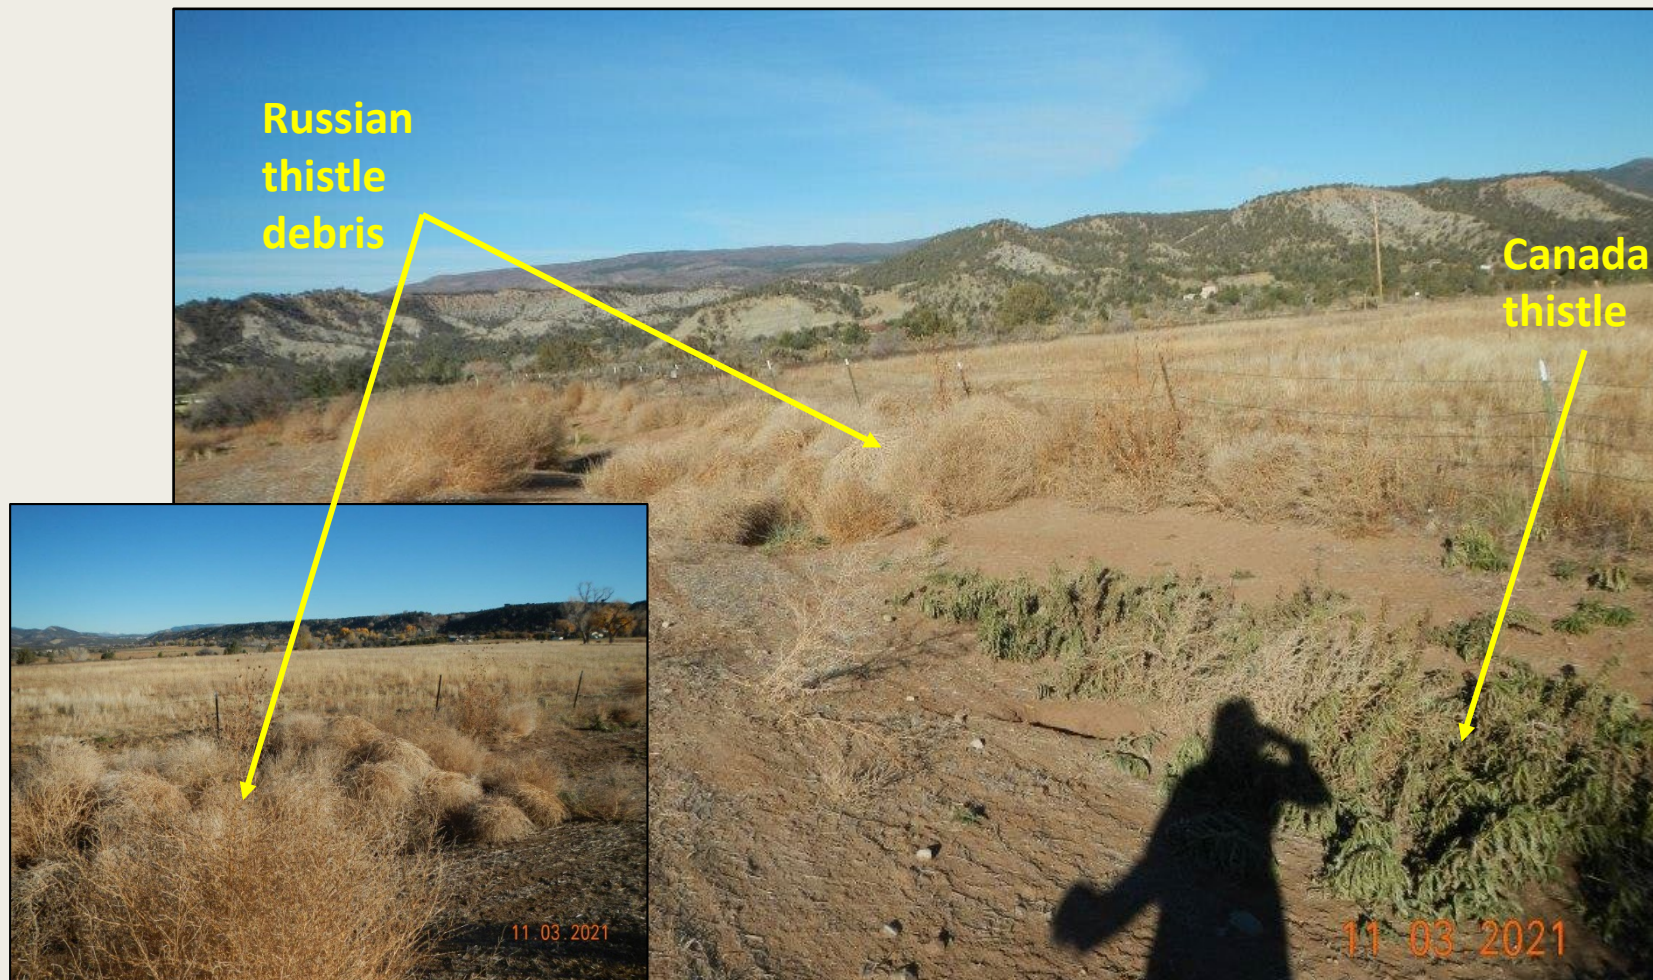
Photo 4. View of Russian thistle debris within the northern project area. Green vegetation is approximately 250 Canada thistles.

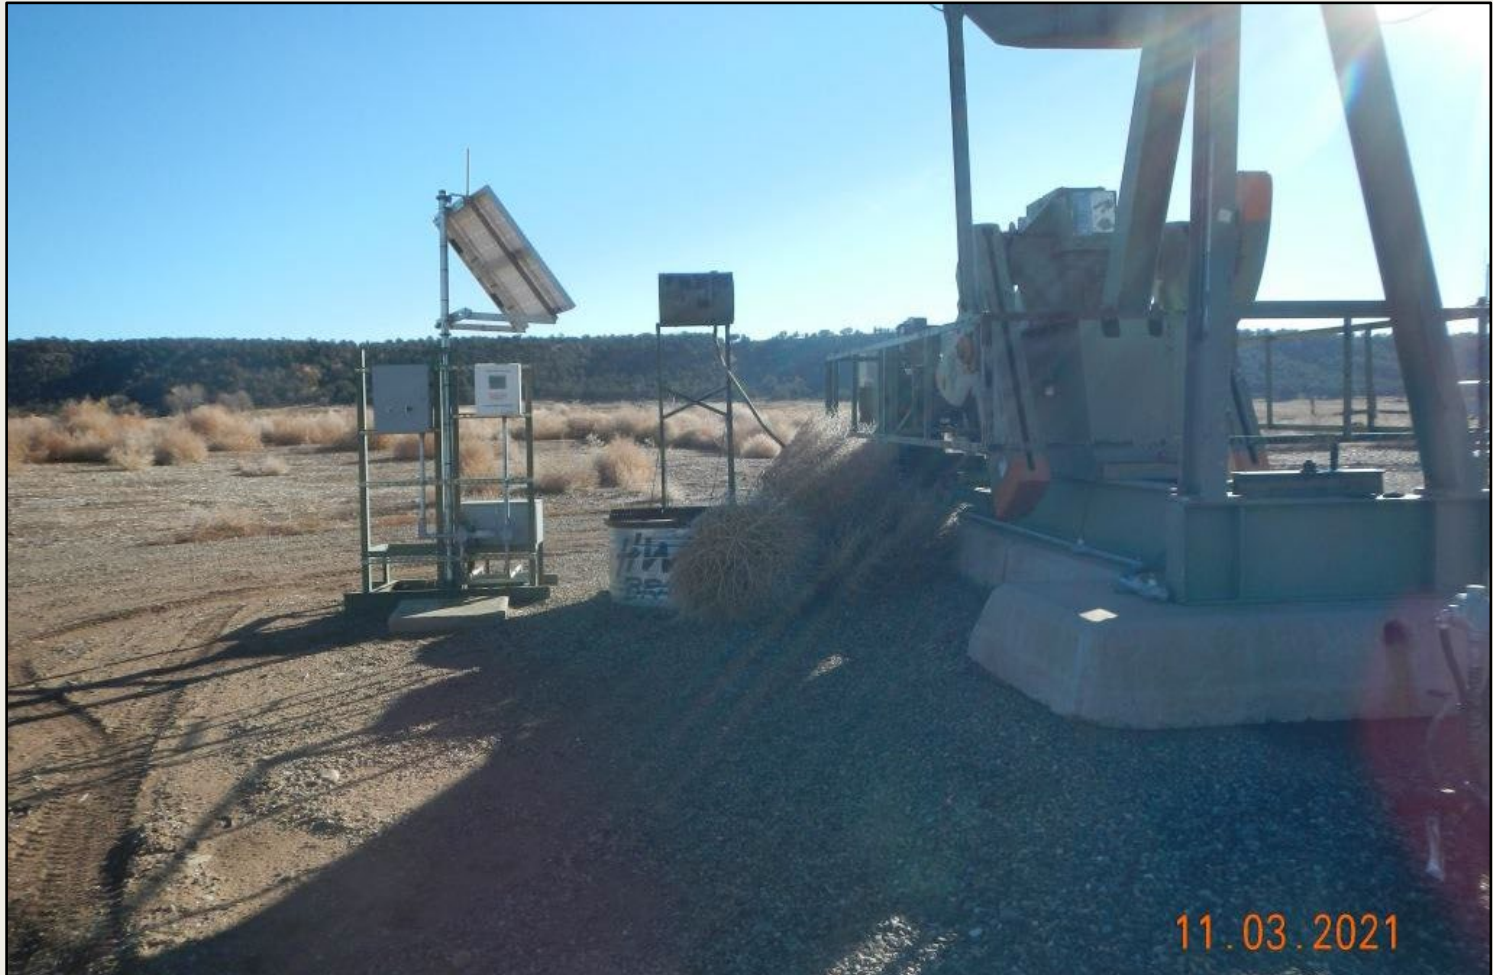
Photo 5. View of weeds stuck around well equipment

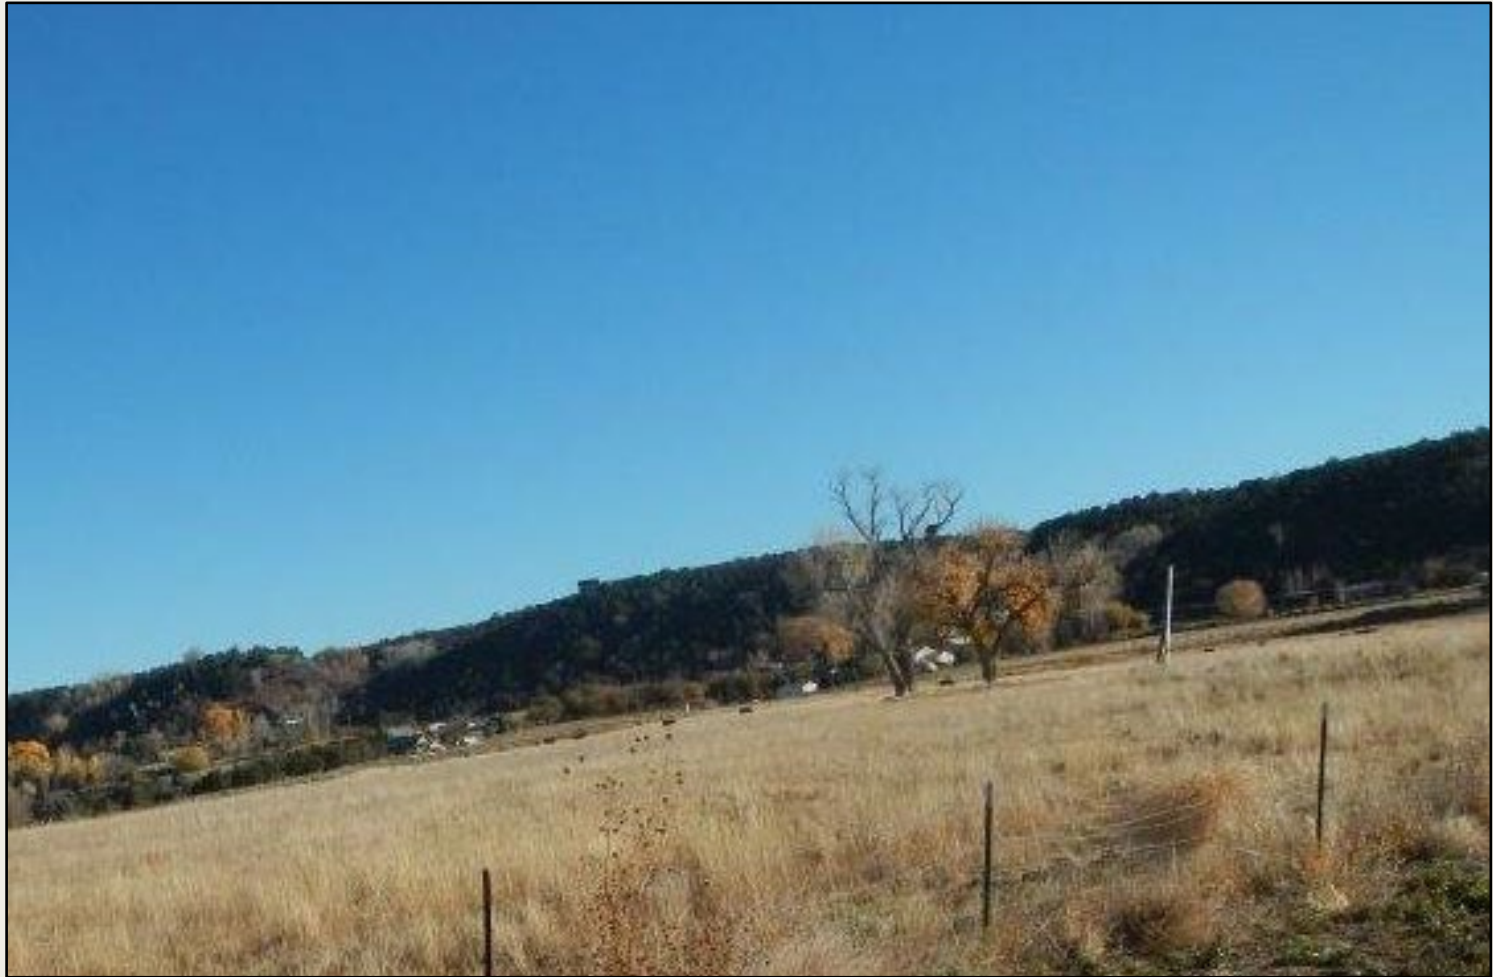
Photo 6. View of reference area comprised of open grass field.
