Today's Date:	11/10/2021					
Well Name:	BONDAD 33-10 COM 104	Location:	Sec: 01	Twn: 033N	Rng: 010W	UL: I
API Number:	05.067.07403	Footage:	1400' FSL & 1135' FEL			
Operator:	Hilcorp Energy Company	Area/Run/MSO:	01	0101	Bob Percell	
Meter #:	06633052		Pipeline:	HEC		
INC Number:	693903833	Agency:	COGCC	Inspector:	Catherine Roy	
Type of INC:	Written	Photos Required:	Yes	Due Date:	11/25/2021	
Issue of Concern:	<p>On 11/3/2021 Catherine Roy conducted a reclamation and stormwater inspection. During this inspection the following compliance issues were observed: -Remove and properly dispose of weed debris by 5/13/2021. Manage weeds (ie: mowing) to prevent debris. Corrective action date is backdated as corrective action from April 2021 inspection is not adequately addressed.</p> <ul style="list-style-type: none"> - Control weeds by 11/25/2021. See below, and attached photos for additional detail. Corrective Action: <p>Dense kochia debris up to 4ft tall observed within the project area. Remove and properly dispose of weed debris. Manage location to prevent weed debris (ie: mowing).</p> <p>Approximately 15 musk thistles observed within the northern revegetation area. Control weeds.</p> <p>S

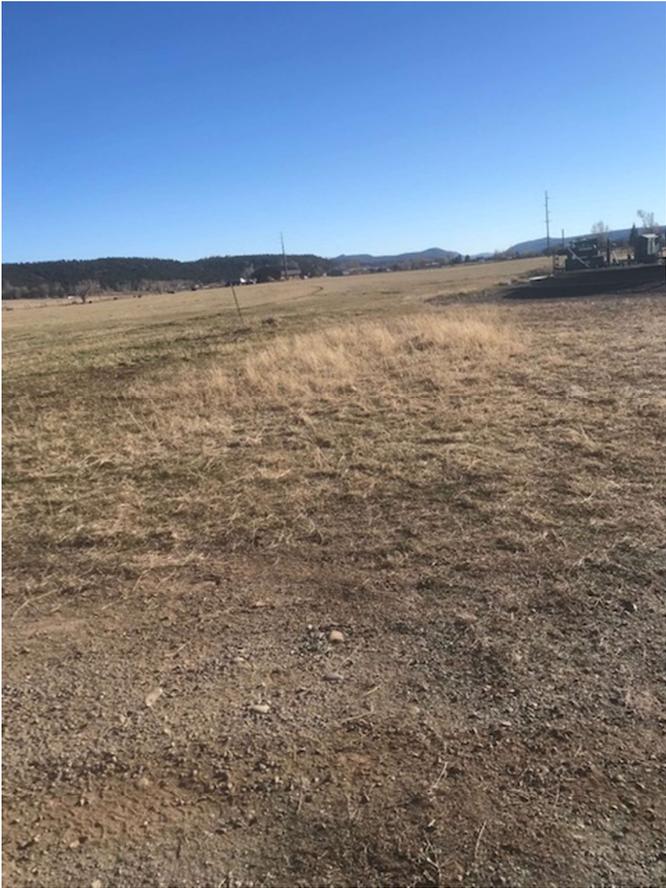
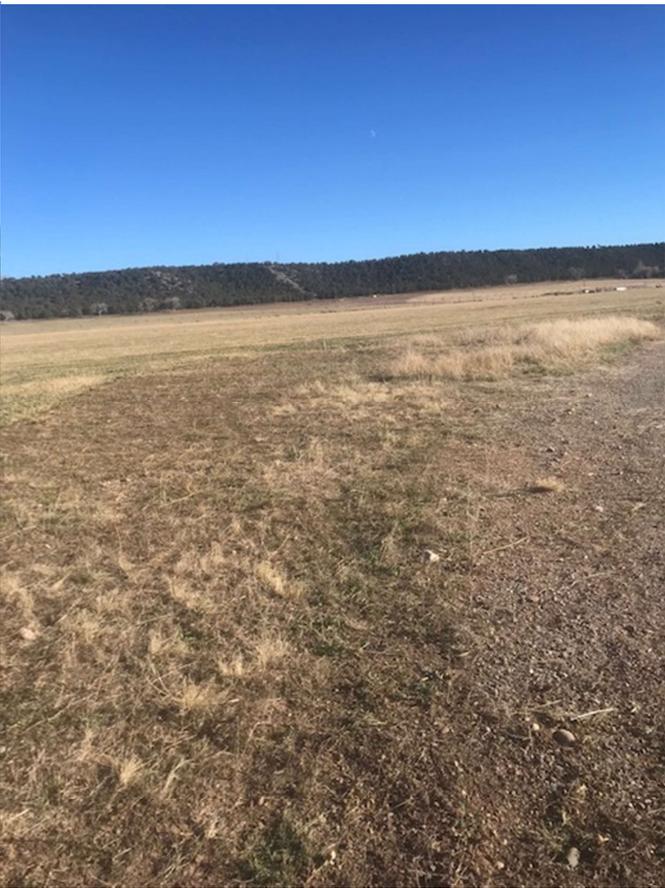
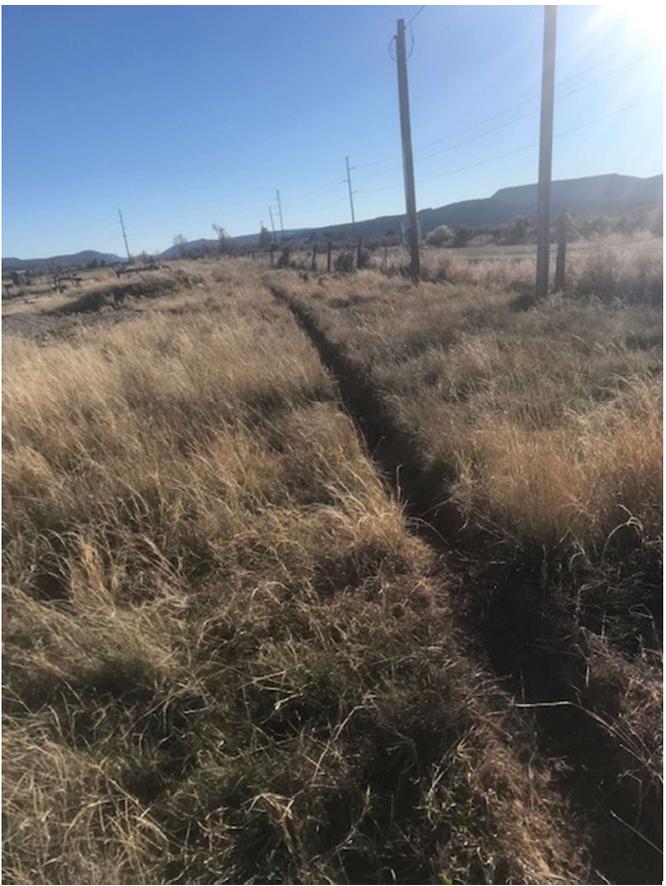
Weeds and weed debris removed from location.
