Stormwater Inspection Report

Operator:	Laramie Energy, LLC
Project:	Cascade Creek
Location:	Cascade Creek 697-16-28 Pad
Date:	Wednesday, November 3, 2021
Weather:	Partly Cloudy, Light Wind, Hi 60°, Lo 31°

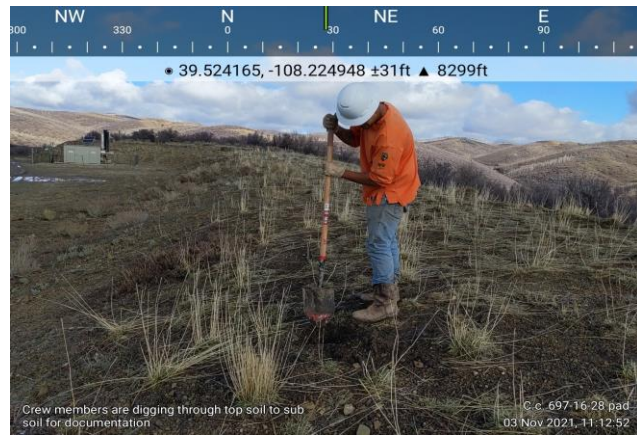
Photo 1

Hand Digging Test Holes on CC 697-16-28 Pad to Determine Topsoil Depth

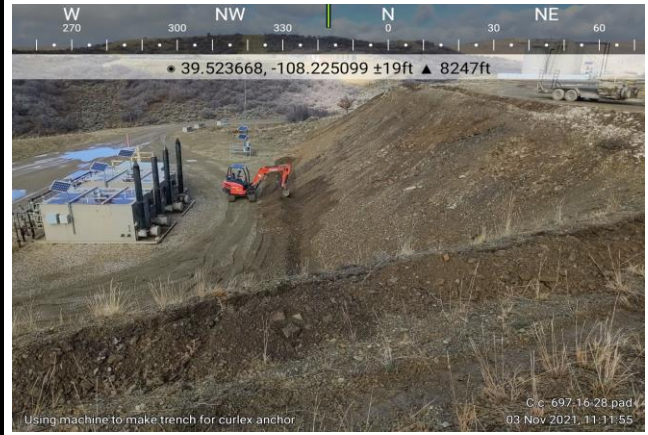
Photo 2

Installing Trench to Anchor Bottom of Erosion Control Blanket Installation

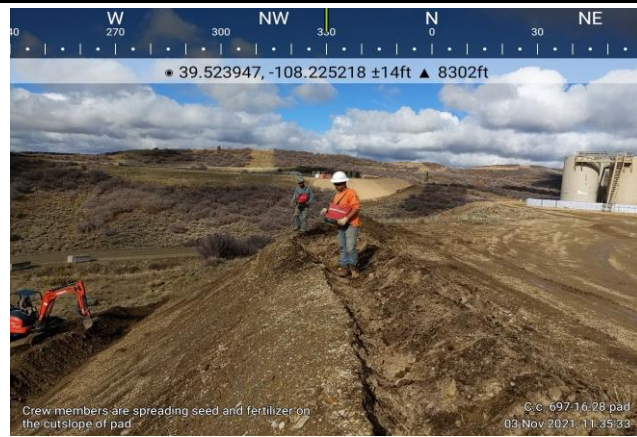
Photo 3

Broadcasting Seed and Fertilizer over the Erosion Control Blanket Installation

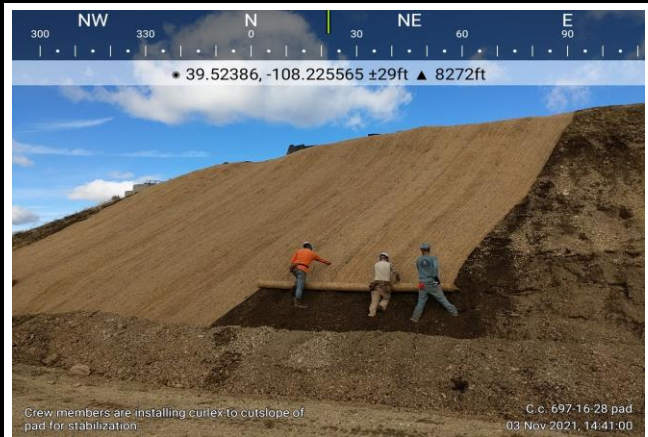
Photo 4

Installing Erosion Control Blankets on the CC 697-16-28 Pad

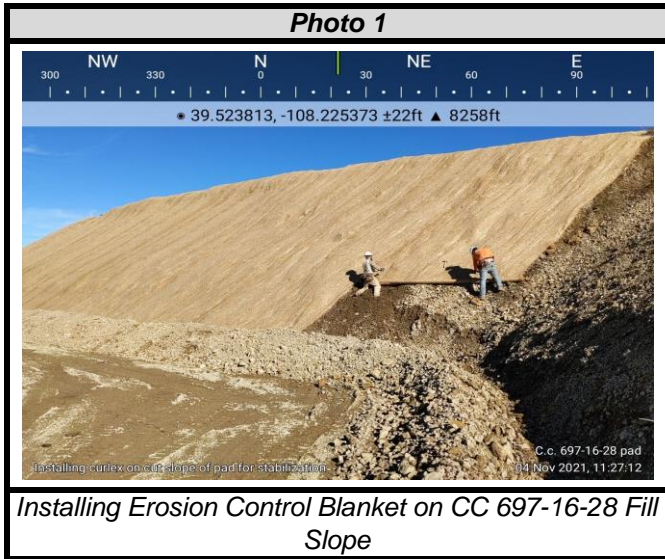
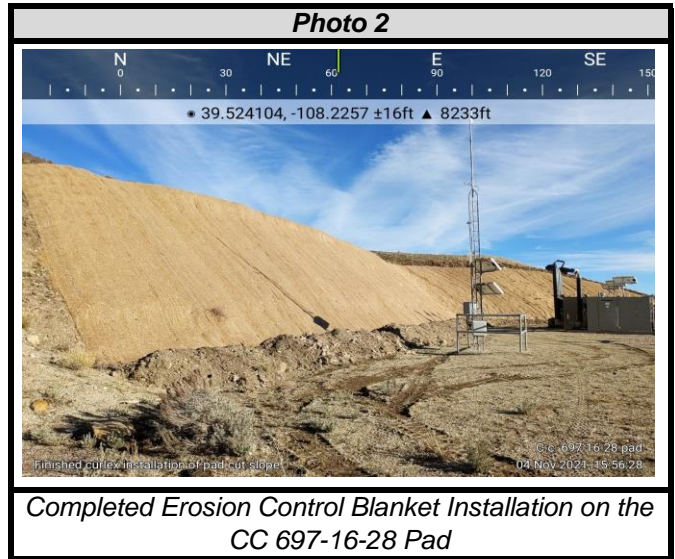
Comments / Descriptions / Explanations
<p>Two BMP crews continued addressing issues on the Cascade Creek 697-16-28 pad which were identified in COGCC Document #696203156. The crews were able to complete the erosion control blanket installation they started yesterday. An additional two rolls of erosion control blankets were installed and the installation of the previous four rolls completed.</p>

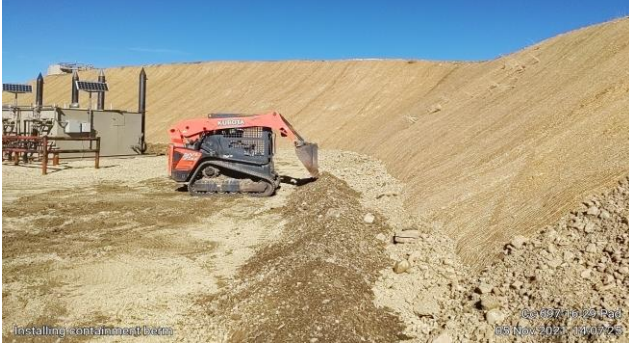
Photo 1

Installing Earthen Berm below Erosion Control Blanket Installations on CC 697-16-28 Pad

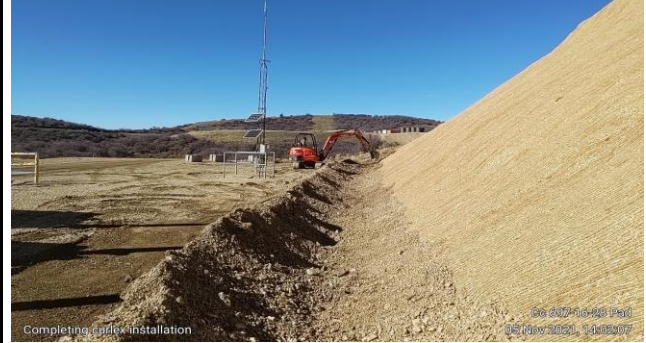
Photo 2

Installing Earthen Berm below Erosion Control Blanket Installations on CC 697-16-28 Pad

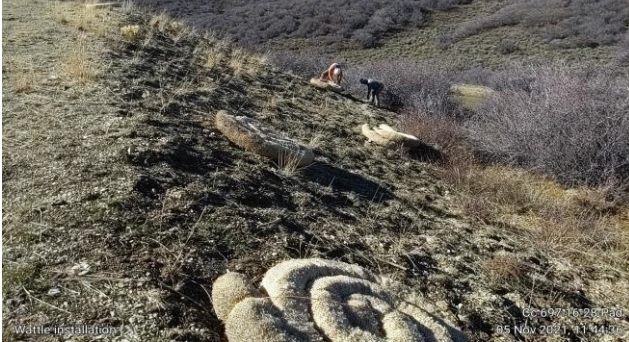
Photo 3

Installing Excelsior Wattle below Slopes on the CC 697-16-28 Pad

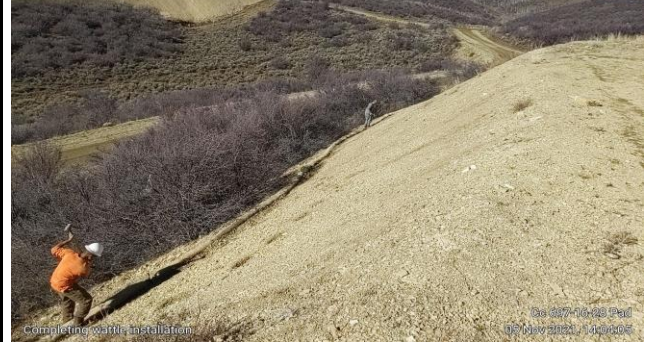
Photo 4

Installing Excelsior Wattle below Slopes on the CC 697-16-28 Pad

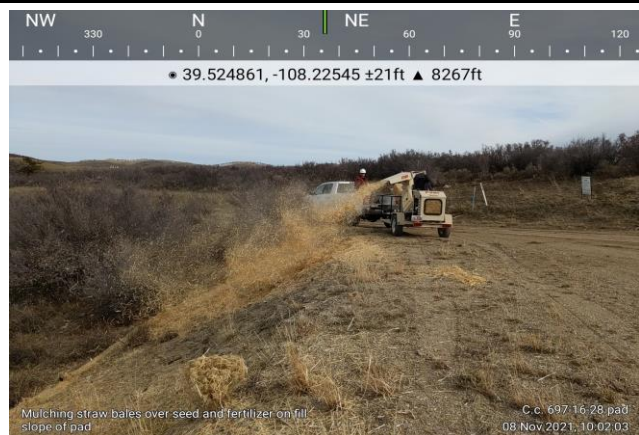
Photo 1

Applying Straw Mulch to Fill Slope on the Cascade Creek 697-16-28 Pad

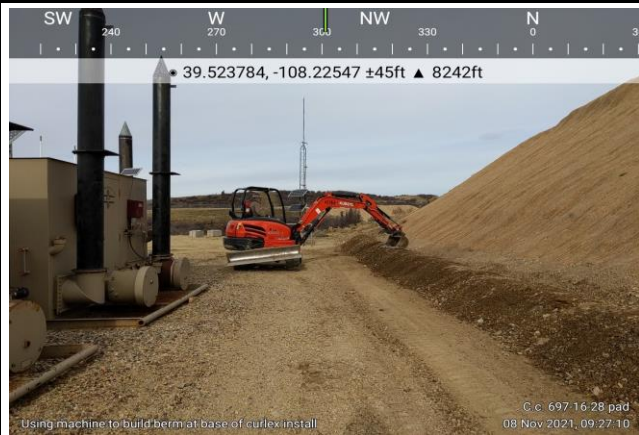
Photo 2

Compacting Earthen Berm below Erosion Control Blanket Installation on the CC 697-16-28 Pad

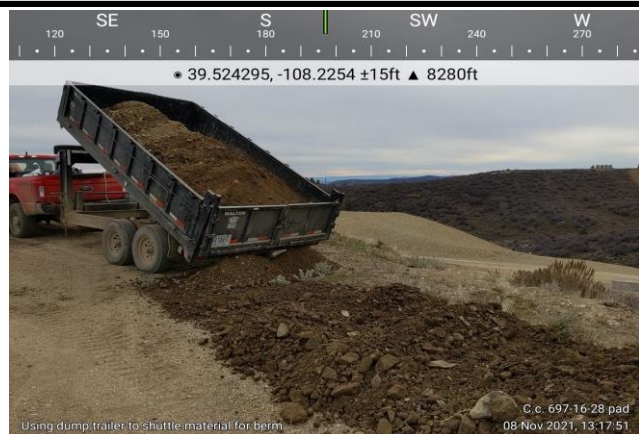
Photo 3

Delivering Material to Create a Flex Pipe Outlet on the Cascade Creek 697-16-28 Pad

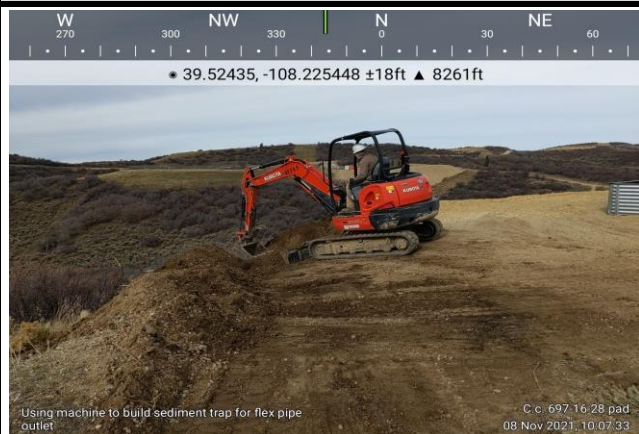
Photo 4

Installing Flex Pipe Outlet on the Cascade Creek 697-16-28 Pad

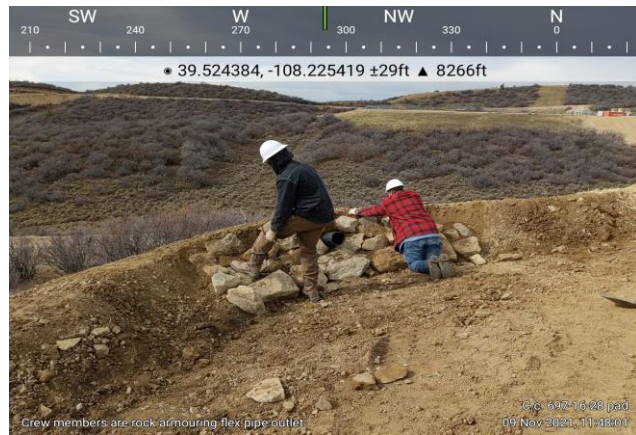
Photo 1

Installing Rock Armor Face on Flex Pipe Installation on Cascade Creek 697-16-28 Pad

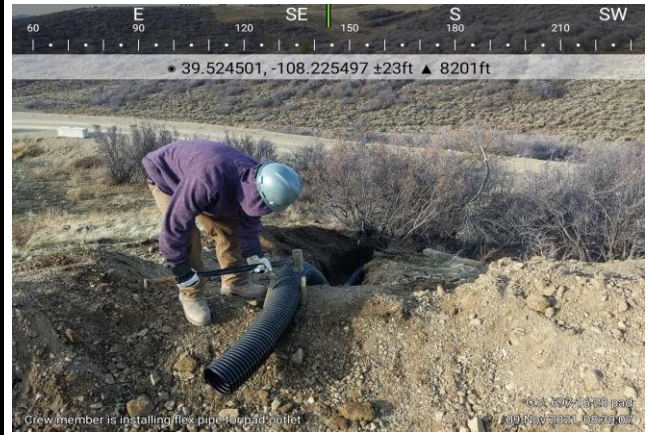
Photo 2

Installing Flex Pipe on Cascade Creek 697-16-28 Pad

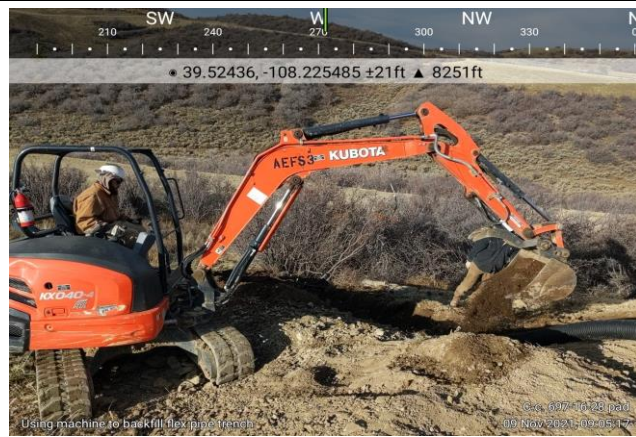
Photo 3

Installing Flex Pipe on Cascade Creek 697-16-28 Pad

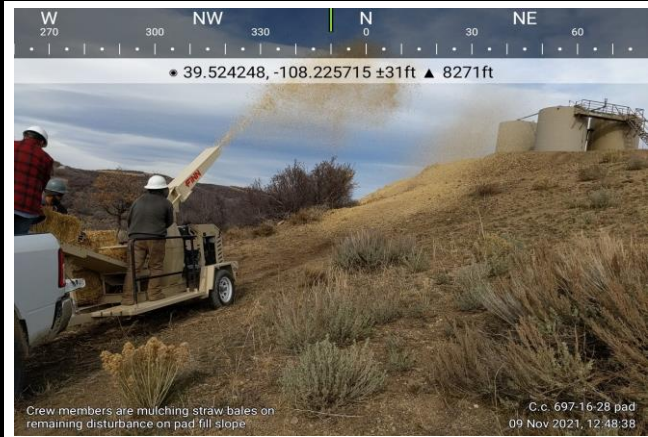
Photo 4

Applying Straw Mulch to Cascade Creek 697-16-28 Pad
