Today's Date:	10/21/2021					
Well Name:	HUBER SPC FEDERAL 2 14	Location:	Sec: 14	Twn: 035N	Rng: 008W	UL: O
API Number:	05.067.07645	Footage:	990 FSL, 1500 FWL			
Operator:	Hilcorp Energy Company	Area/Run/MSO:	01	0100	Charlie Ruybal	
Meter #:			Pipeline:			
INC Number:	693903772	Agency:	COGCC	Inspector:	Catherine Roy	
Type of INC:	Written	Photos Required:	Yes	Due Date:	11/15/2021	
Issue of Concern:	<p>COMMENT: Dense Russian thistle debris observed within and around the edges of the project area. Revegetation is failed throughout the majority of the former well pad where significant portions of the former well pad do not support any desirable portions and sparse desirable vegetation in other portions.</p> <p>-Remove and properly dispose of weed debris by 11/15/2021. Manage weeds to prevent debris and promote desirable vegetation.</p> <p>-Revegetation needs to be conducted across the majority of the project area by 11/15/2021.</p> <p>COMMENT: Erosional rilling and scouring observed on bare and weedy soils within the project area.</p> <p>-Stormwater (BMPs) and erosion controls (ie: ecofiber, straw mulch, etc.) need to be installed and maintained throughout the reclamation process to s

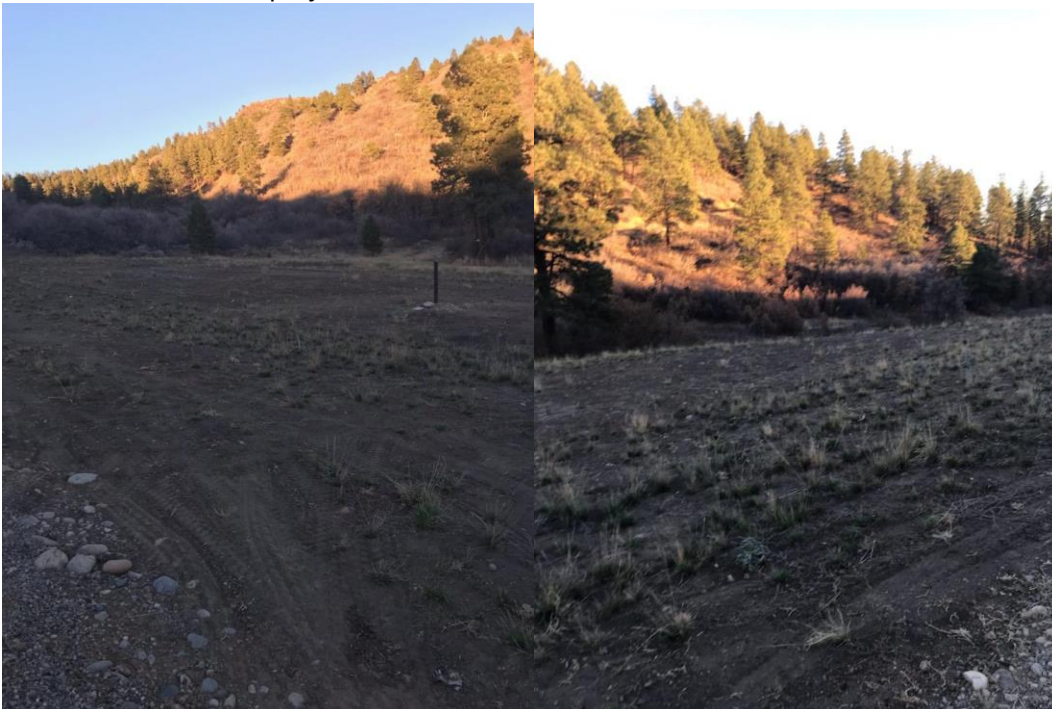
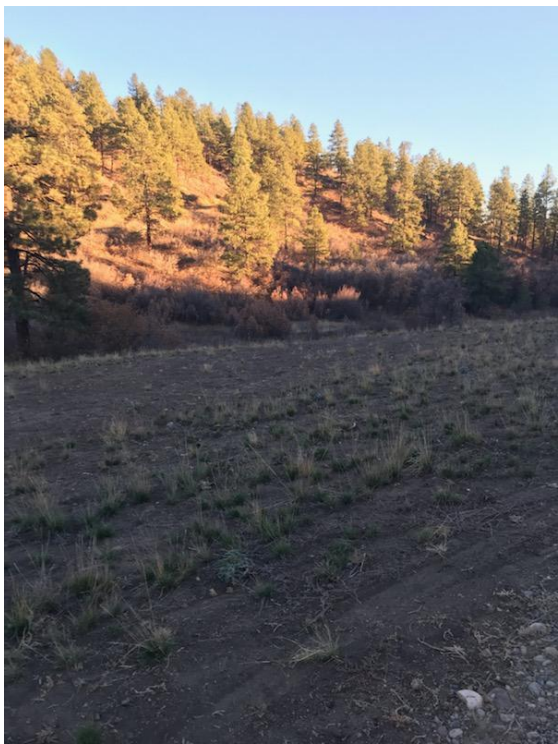
Weeds removed from project area.

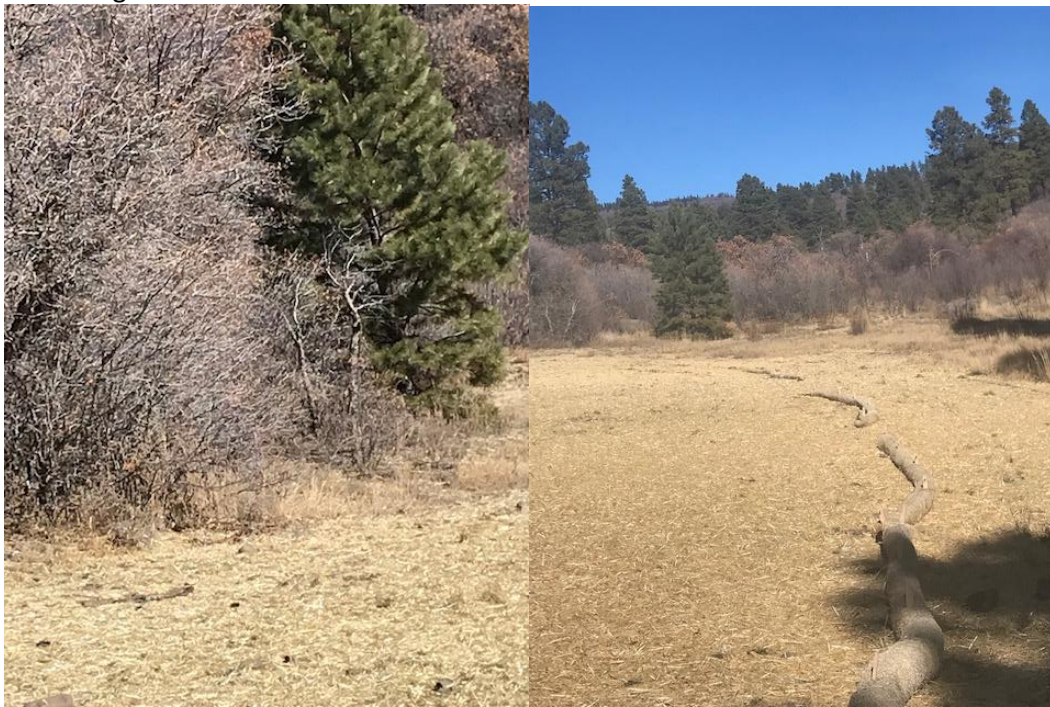
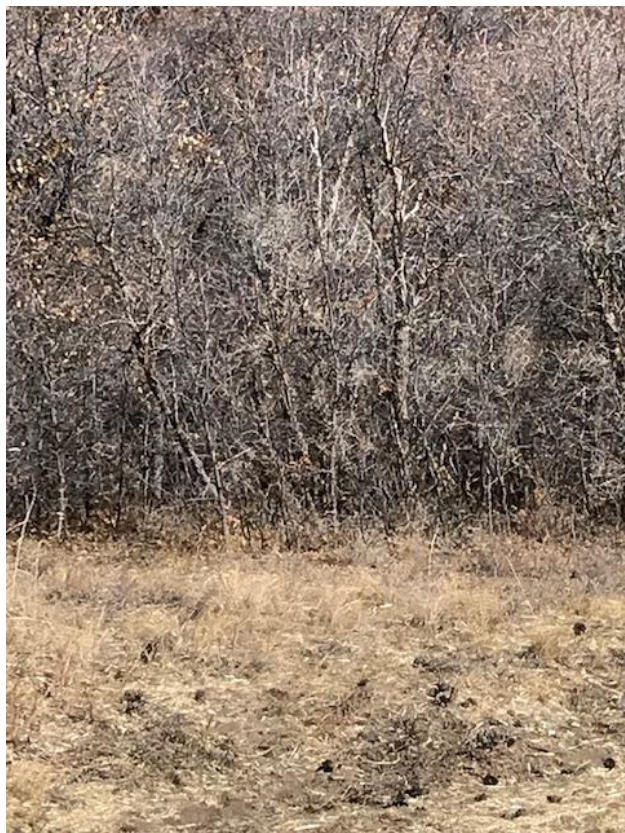
Reseeding and Erosion control installed.
